Subject: Installation of New Cobalt-60 Source in Theratron 780 (AECL)

Reference: NRC License #20-01412-03
Baystate Medical Center:SHWW Unit
Date of Expiration: July 31,1984

REPORT OF TELETHERAPY TESTS AND SURVEYS

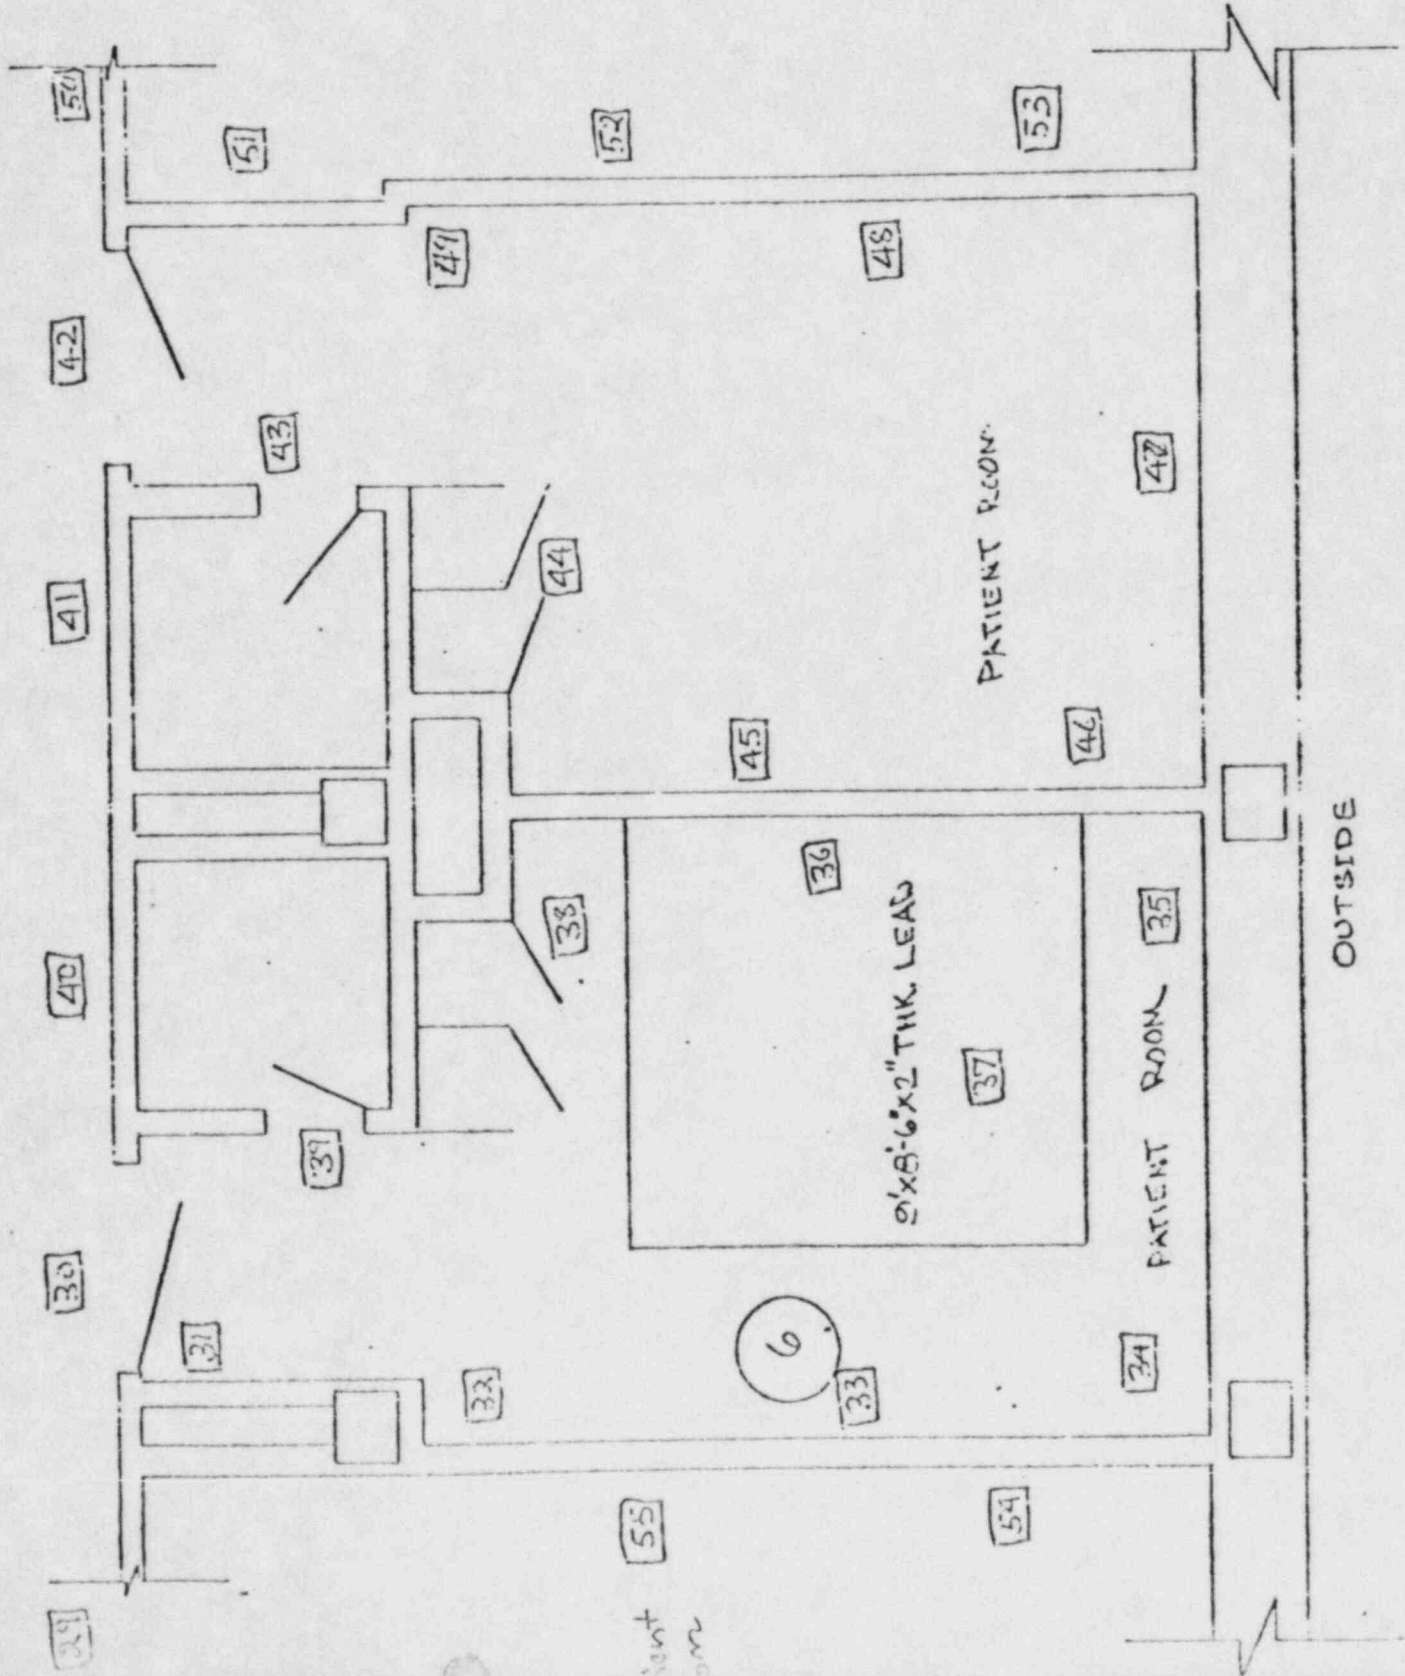
1ST FLOOR - PLAN VIEW

Method: The radiation levels were measured (in mr/hr) on the most sensitive range of the above survey meter. Repeated measurements were made at the locations indicated by numerals on the enclosed floor plans. The measurements were repeated to include all the routine treatment conditions with the beam "CN" and with the phantom. During these measurements the Cobalt-60 machine was operated in 360° rotational mode; fixed distances and with the source head rotated to 60° and 89° to direct the primary beam to wall "A" (see the enclosed diagram).
