U.S. NUCLEAR REGULATORY COMMISSION  
REGION I

Docket/  
Report No. 50-213/94-05

Facility: Haddam Neck Plant

### HADDAM NECK PLANT INSPECTION 50-213/94-05

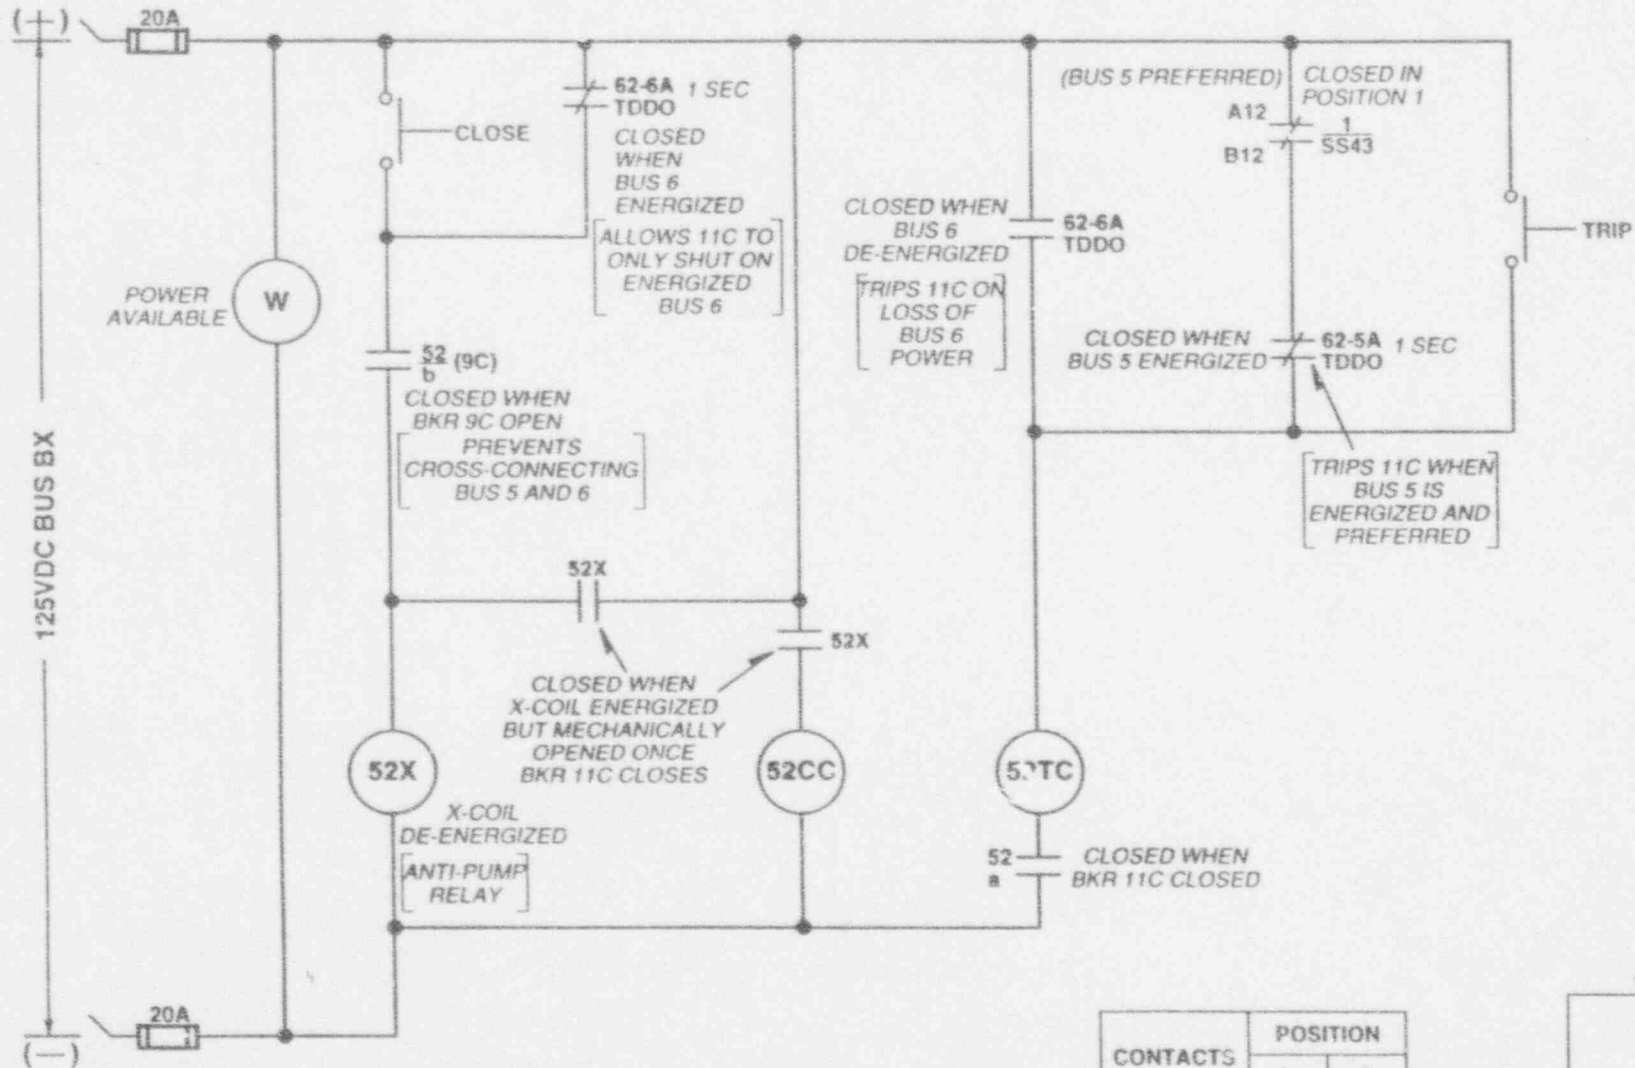
## 480V BUS 6 BKR 11C SUPPLY TO MCC5

- Troubleshooting Breaker 11C:
  - Visual Inspection Revealed Snap Ring Out of Position
  - Breaker 11C Failed to Close on Bench
  - Breaker 11C Successfully Tested on Bench (5 Cycles) With New Operating Mechanism
  - Breaker 11C Inserted Back Into Switchgear and Tested Successfully
- A Similar DB-25 Breaker Failed on Bench With Its Snap Ring Intentionally Mispositioned
- Dimensional Inspection of Snap Ring and Shaft of Breaker 11C in Comparison to Design
- Tensile Test of Snap Ring in Comparison to New Item
- Historical Review Identified Similar Event During 1986 Refueling Outage (1/17/86)

- The Cause of the Failures of MCC-5 Supply Breaker 11C is the Operating Shaft Snap Ring Being Out of Position
- The Root Cause has been Determined to be Improper Installation of the Snap Ring Following Breaker Maintenance

- A New Operating Mechanism Has Been Installed in The 11C Cubicle And Satisfactorily Tested
- Preventive Maintenance Procedures Will be Revised to Provide Detailed Guidance on DB-25 Breaker Maintenance
- Technical Training Will Incorporate This Experience Into The Breaker Training Module
- Inspected Similar Breakers For Snap Ring Position
- Replaced 52X Relays With Westinghouse Improved Design (Controlled Magnetic Air Gap)
