SUBJECT: OPERATING REACTORS EVENTS BRIEFING
 MAY 18, 1994 - BRIEFING 94-16

OPERATING REACTORS EVENTS BRIEFING 94-16

MCGUIRE, UNITS 1 AND 2

VARIOUS PLANTS

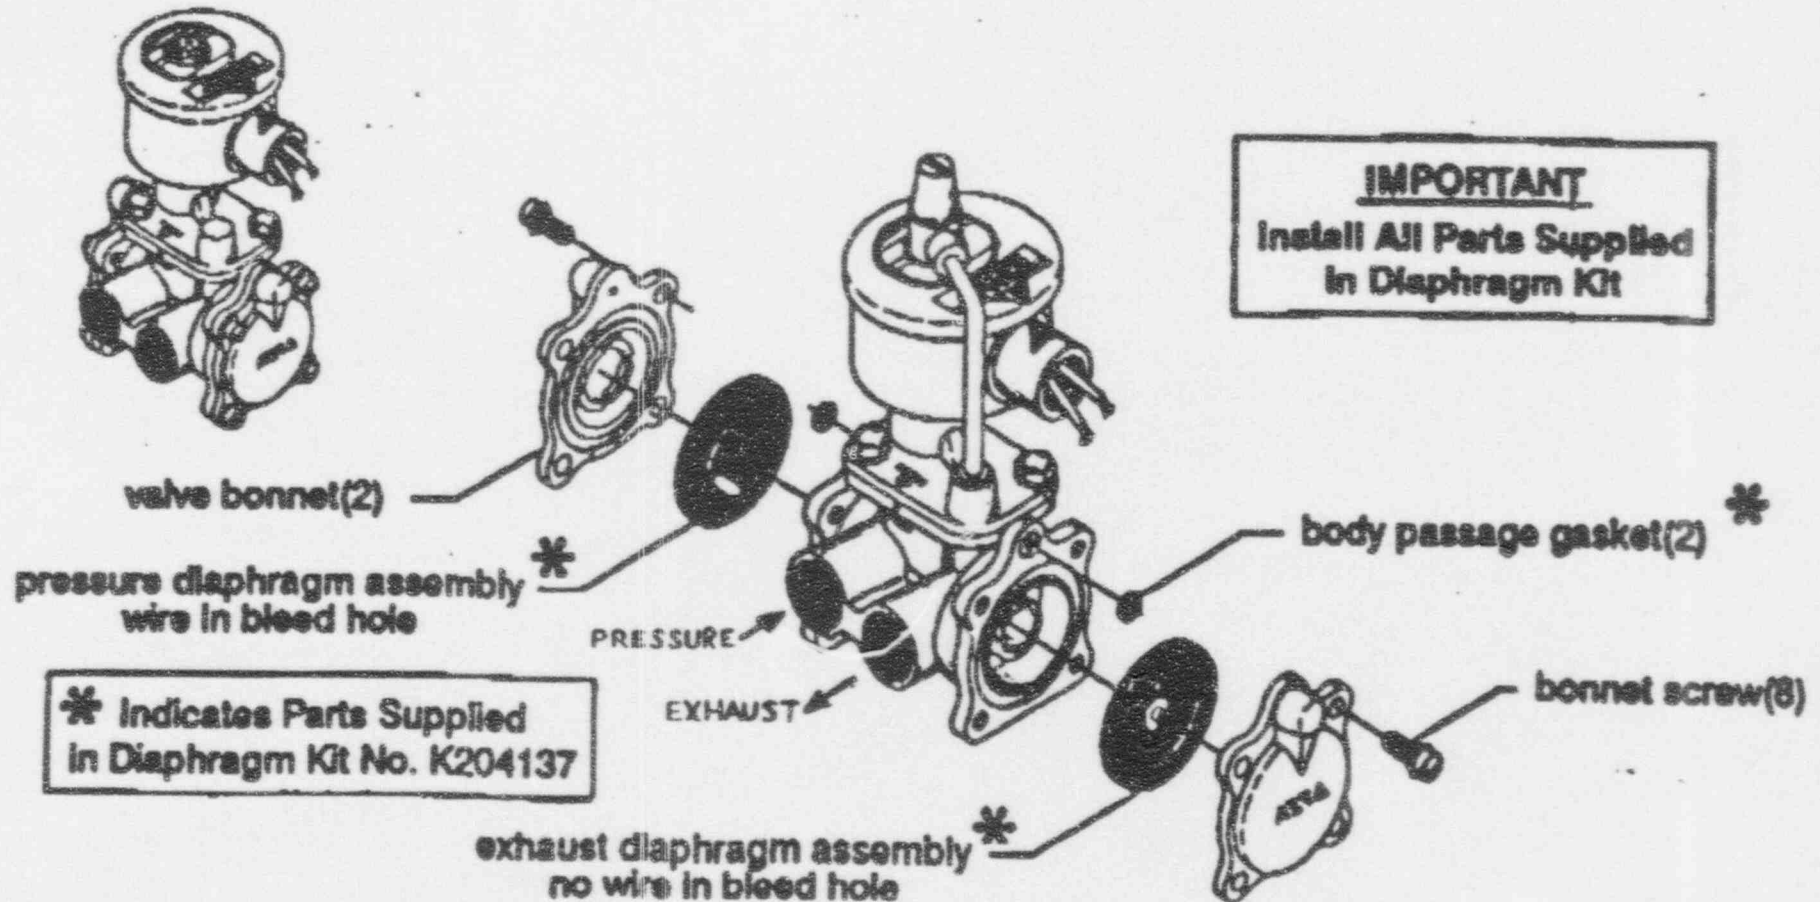
Figure 3. Diaphragm Replacement 1/2" NPT Catalog Nos. HV-90-405-1 or -2.

- MARCH 26 - DURING INDIVIDUAL CONTROL ROD SCRAM TIME TESTING, A ROD FAILED TO INSERT. FOUR OTHER RODS WERE FOUND WITH SLOWER THAN PREVIOUSLY RECORDED SCRAM TIMES.
- TROUBLESHOOTING DETERMINED THAT THE BUNA-N DIAPHRAGMS IN THE SSPVs OF THE INOPERABLE ROD AND THE FOUR SLOW ONES WERE CRACKED AND BRITTLE.

- APRIL 18 - WITH THE UNIT AT 58% POWER, DURING SCRAM TIME TESTING, ONE ROD EXCEEDED THE FULL INSERTION TIME LIMIT AND SEVERAL OTHERS EXHIBITED SLOWER THAN PREVIOUSLY MEASURED SCRAM TIMES.
- THE LICENSEE DETERMINED THAT THE 118-E DIAPHRAGM FOR THE ROD THAT EXCEEDED THE FULL INSERTION TIME HAD RUPTURED.
- TESTING OF ALL CONTROL RODS FOUND THAT THREE CONTROL RODS CAUSED THEIR 2X2 ARRAYS TO EXCEED TS LIMITS FOR 10% INSERTION. A TOTAL OF 20 RODS WERE SLOW ENOUGH TO WARRANT REBUILDING THE SSPVs.
- INSPECTION OF THE REMOVED DIAPHRAGMS FOUND THAT SOME WERE HARDENED AND AT LEAST 2 WERE CRACKED.

- ALL OF THE SSPVs WERE REBUILT DURING THE 1991 REFUEL OUTAGE. THE DIAPHRAGM KITS INSTALLED HAD PACKAGE DATES OF 1987 AND 1990.
- THE 1990 DIAPHRAGMS ARE THE MOST SEVERELY DEGRADED.
- THE LICENSEE SENT SOME DIAPHRAGMS TO GE FOR MATERIALS ANALYSIS AND COMPARISON TO THE WNP-2 DIAPHRAGMS.
- VENDOR BRANCH DISCUSSED THIS ISSUE WITH GE DURING A RECENT INSPECTION.
- VERMONT YANKEE REPORTED SEVERAL SLOW RODS DUE TO A VARIETY OF FACTORS ON 4/12/93.
- MAY 11 - GE ISSUED GUIDANCE RECOMMENDING LICENSEES IDENTIFY SSPVs THAT WERE REPLACED OR REFURBISHED WITH DIAPHRAGM KITS OR NEW VALVES WITH ASSEMBLY DATES AFTER EARLY 1989, AND EXAMINE A SAMPLE OF THE DIAPHRAGMS.
- AN INFORMATION NOTICE ALERTING THE INDUSTRY THAT SOME SSPV DIAPHRAGMS MAY NOT FUNCTION TO THE END OF THEIR RECOMMENDED SERVICE LIFE IS BEING DEVELOPED.

- THE THREADLOCKER IS USED WHEN CONNECTING THE INSTRUMENT AIR LINES TO THE SSPV ASSEMBLY TO PREVENT LEAKAGE.
- ALL 193 SSPVs WERE CLEANED AND NEW REPLACEMENT KITS INSTALLED. THE UNIT WAS RESTARTED AND THE RODS TESTED SATISFACTORY.

- SOME LICENSEES HAVE REPLACED THREADLOCKER WITH TEFLON TAPE TO AVOID POTENTIAL CONTAMINATION PROBLEMS.
- GE HAS ISSUED GUIDANCE RECOMMENDING USE OF TEFLON TAPE ON THE SSPVs.
- TWO PREVIOUS NRC INFORMATION NOTICES (84-53 AND 87-48) DEALT WITH ANAEROBIC ADHESIVE/SEALANTS CAUSING SOV PLUNGERS TO STICK.
- AN INFORMATION NOTICE IS BEING DRAFTED TO ALERT THE INDUSTRY THAT THREAD SEALANTS CAN CAUSE OTHER SOV COMPONENTS TO STICK (DIAPHRAGMS AND SEALS).
