NUREG/CR-6095  
SAND93-1803

# Aging, Loss-of-Coolant Accident (LOCA), and High Potential Testing of Damaged Cables

Prepared by  
R. A. Vigil/SEA  
M. J. Jacobus/SNL

Sandia National Laboratories  
Operated by  
Sandia Corporation

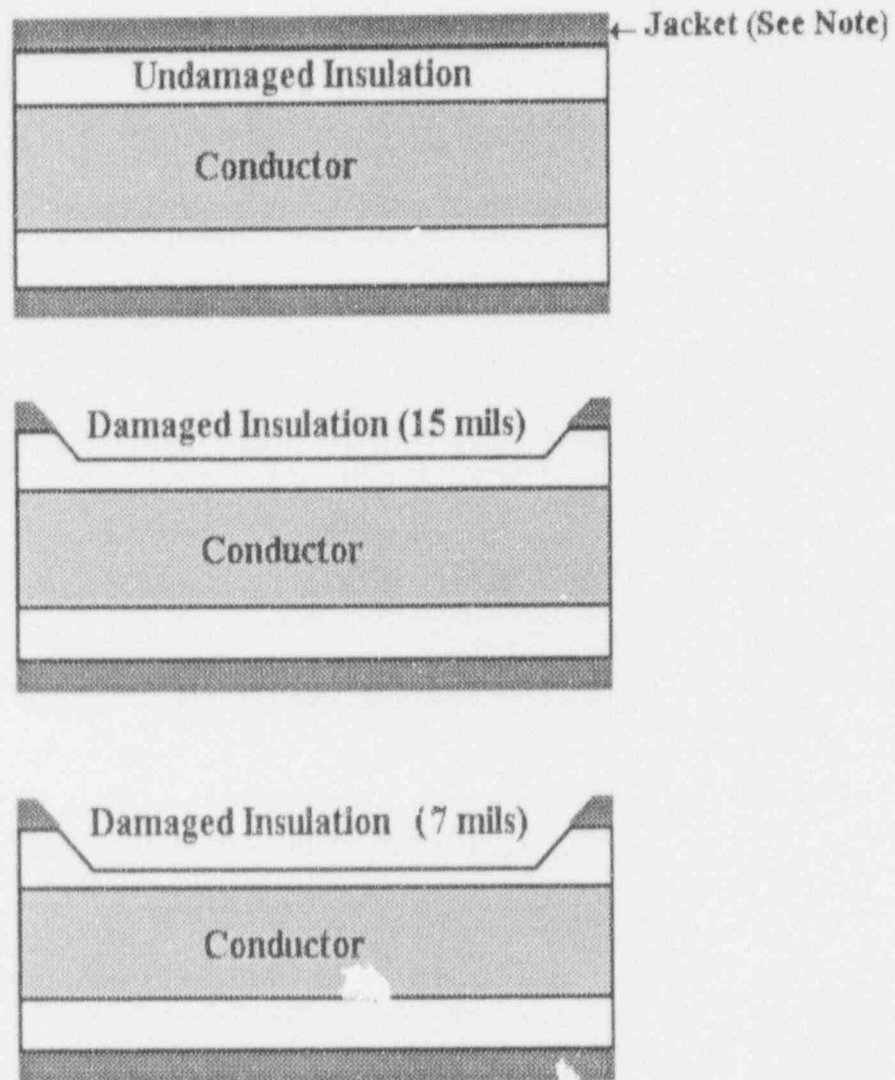
Figure 1 Lengthwise Cross-Sections of Samples With 30, 15, 7 mils of Insulation Remaining  
(NOTE: Only Okonite Samples Have the Additional 15-mil Bonded CSPE Jacket.)

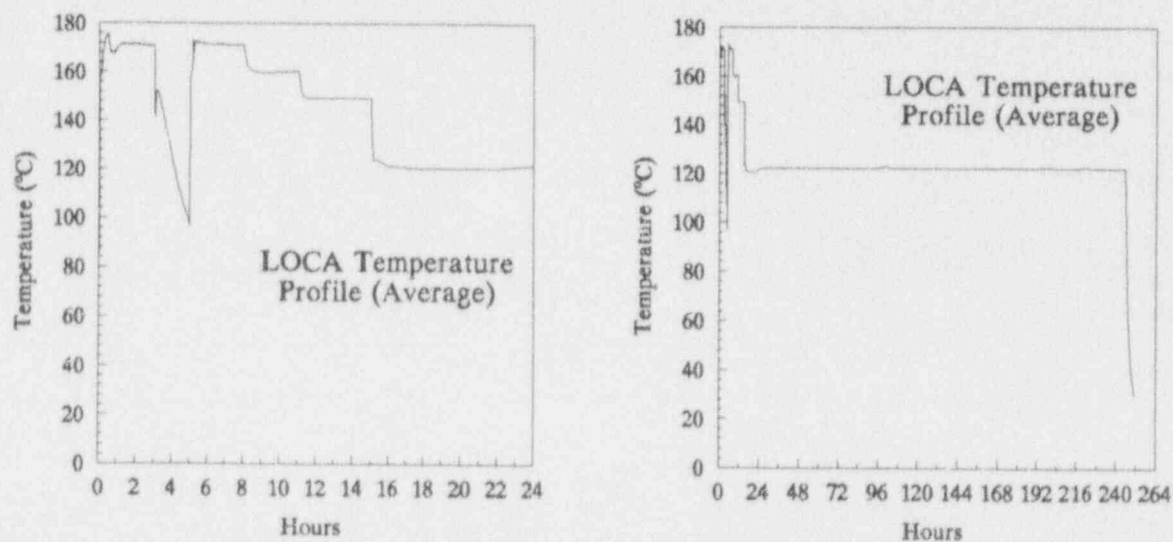
thermal aging. Note the drop in temperature at approximately 6 days. This anomaly in temperature was caused by a failed electric circulation heater. The defective electric circulation heater was removed while the remaining electric circulation heater maintained the chamber temperature above 100°C until a new electric circulation heater was added to restore the chamber to the desired temperature. The drop in temperature existed for approximately 24 hours. The thermal aging was extended by 24 hours to compensate for this anomaly. The effect of this anomaly is an insignificant increase in the total thermal aging.

Figure 4 LOCA Simulation Temperature Profiles

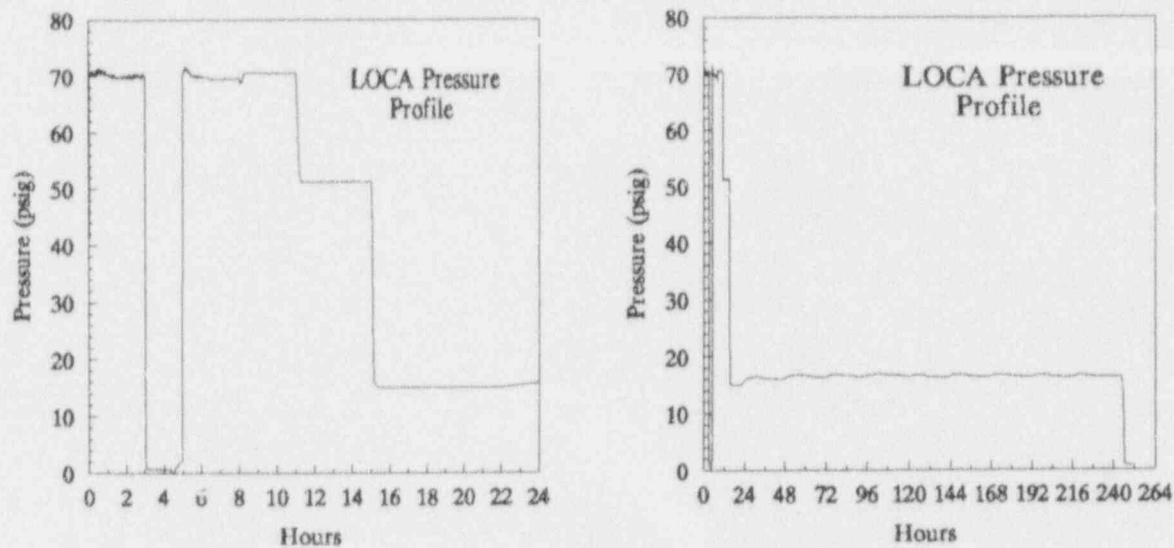
Figure 5 LOCA Simulation Pressure Profiles

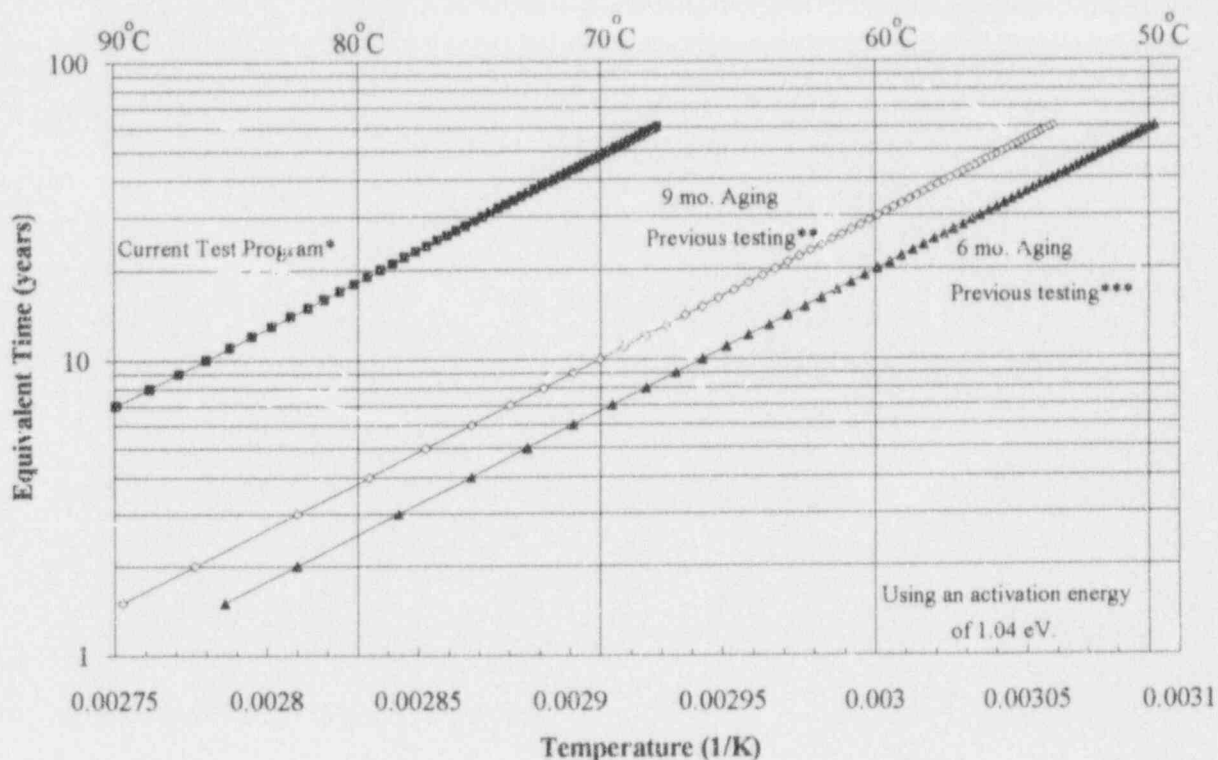
To apply the data to lifetimes of other than 40 years, the Arrhenius theory can be used to equate the test conditions to a temperature for any given lifetime (or conversely, a lifetime at any given temperature). This is shown in Figure 7, where the thermal aging data from the previous testing and the current testing is compared, using an activation energy of 1.04 eV. The top curve is based on the current testing and is obviously the most severe of the thermal aging conditions. The middle curve corresponds to 9 month of aging at 98°C (208°F) and the lower curve corresponds to 6 months of aging at 98°C (208°F). Assuming the Arrhenius theory to be valid, any time-

temperature point on a given curve represents the same thermal aging as any other point on the same curve. Thus, for example, at 50°C for 60 years, no failures would be expected; at 54°C for 60 years, some failures would be expected; and at 68°C for 60 years, almost certain failure would be expected (with the radiation and accident profile used in this testing).

- \* All Okonite cables failed.
- \*\* 1 of 3 Okonite cables failed.
- \*\*\* 0 of 3 Okonite cables failed.

Figure 7 Equivalent Time-Temperature Corresponding to the Thermal Aging in this program and Previous Sandia Testing

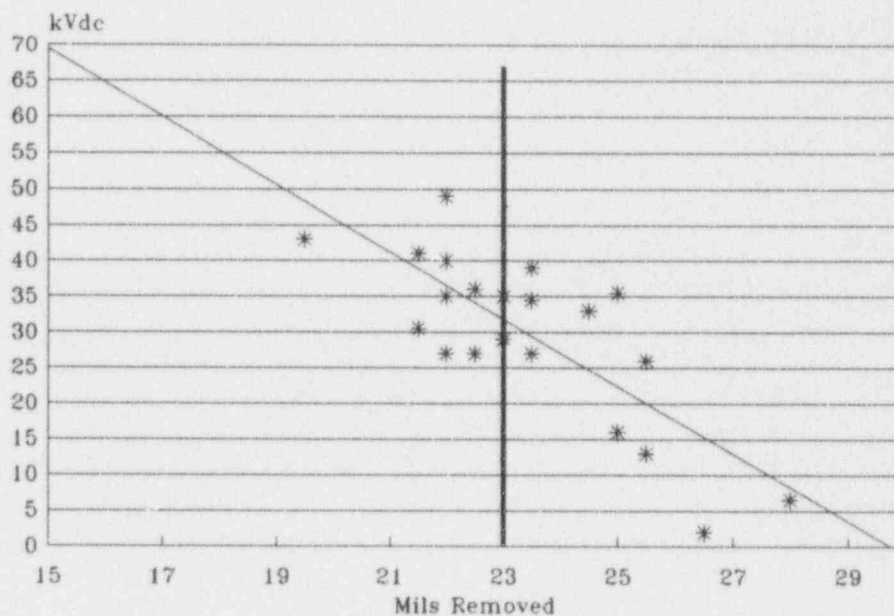
The results from the Phase III testing show the differences in breakdown voltages between Brand Rex cables cycled at 35 kVdc and the uncycled Brand Rex cables from Phase I. The 35 kVdc cycling voltage criterion was determined by examining the results of numerous breakdown tests of damaged (milled) Brand Rex cables as shown in Figure 9 and from previous Sandia tests [2]. The 35 kVdc test voltage will detect when Brand Rex cables have insulation damage greater than 23 mils provided that the cables are tested in water. Twenty-five cables were cycled as in Phase I for a total of 60 minutes at 35 kVdc (30 minutes

**Figure 9 Breakdown Voltages for Damaged Brand Rex Cables Tested in Water**
