SUBJECT: WAIVER OF CRGR REVIEW OF PROPOSED GENERIC  
LETTER ON SOLENOID-OPERATED VALVE PROBLEMS

SUBJECT: OPERATING EXPERIENCE FEEDBACK REPORT, SOLENOID-OPERATED  
VALVE PROBLEMS AT U.S. REACTORS

This report highlights significant operating events involving observed or potential common-mode failures of solenoid-operated valves (SOVs) in U.S. plants. These events resulted in degradation or malfunction of multiple trains of safety systems as well as of multiple safety systems. On the basis of the evaluation of these events, the Office for Analysis and Evaluation of Operational Data

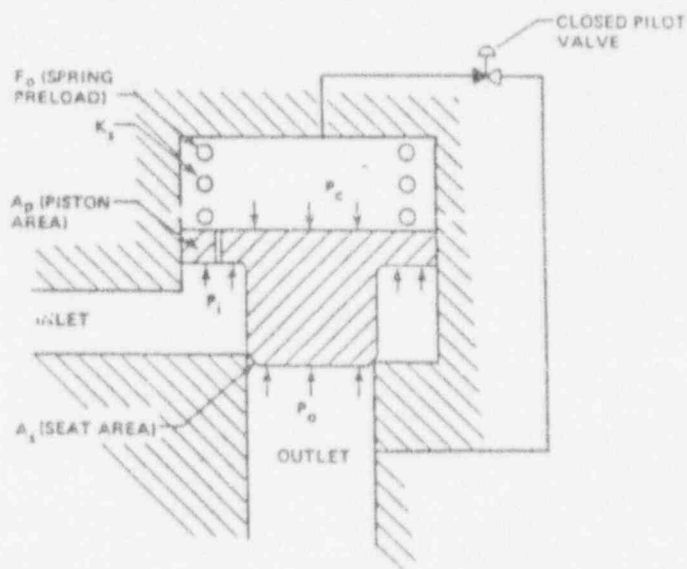
Figure 3. Closed Valve Loadings

Before the analysis can proceed, it is necessary to define what constitutes a severe pressure transient that would be of concern. To do this, we refer to Figure 3, which shows schematically a fully seated hydraulic-assisted, pilot-operated globe valve.

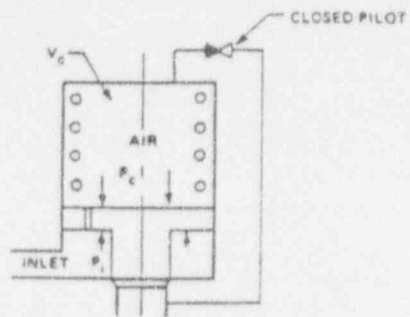
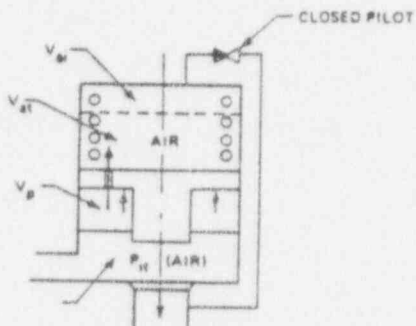
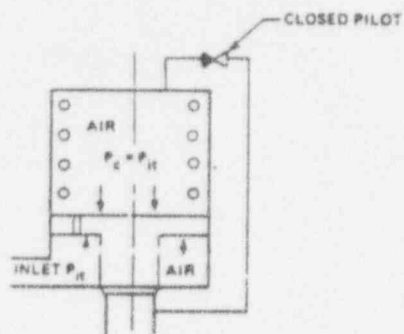
Figure 4a. Valve Closed (Air to Air)

The valve is air-filled and is suddenly exposed to higher pressure air. Figures 4a, 4b and 4c illustrate what would happen if the valve spuriously opens.

Let  $V_c$  be the volume of the control chamber. Therefore, at the force reversal point as shown in Figure 4b,

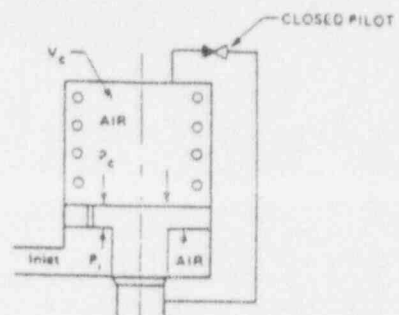
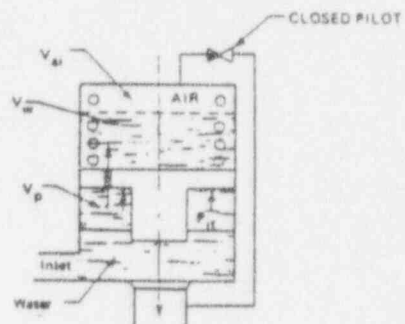
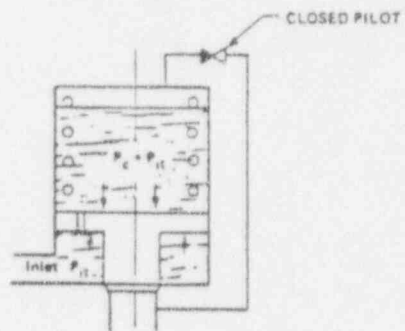
Figure 5a. Valve Closed (Water to Air)

In the water-to-air transient, the valve is air-filled and is suddenly exposed to a step-up higher pressure water. Figures 5a, 5b, and 5c illustrate the valve dynamics. As in the air-to-air case, Figure 5b corresponds to the force reversal point. At this point, the following relationships exist:

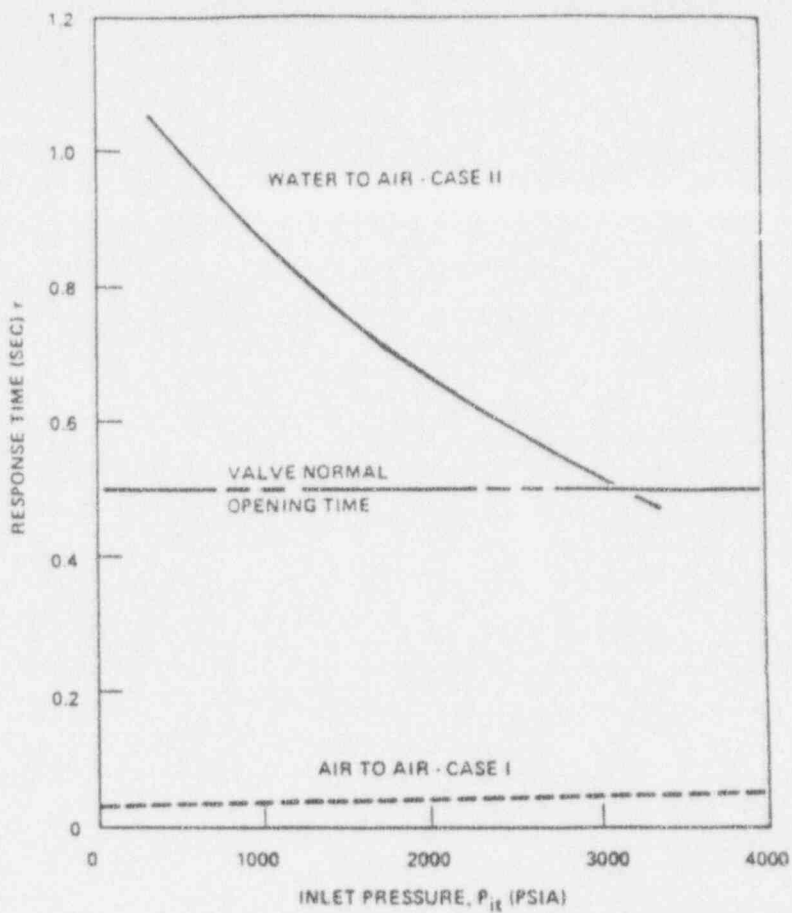
Figure 6. Response Time versus Inlet Pressure ( $P_c = 15$  psia)

In the foregoing analyses, we have developed the equations describing the response times for air-to-air system and water-to-air system. At this time, therefore, it is important to restate the criteria for opening. To do this, we would like to point out that most of these valves normally open fully between 0.1 and 0.5 seconds. Therefore, any valve which responds to a pressure surge in less than 10% of its normal opening time will not open. Using this criterion, we evaluated the response times for an air-to-air case and a water-to-air case for a hypothetical valve using the parameters tabulated in Table 1. The results of the analysis are plotted in Figure 6. As can be seen, the air-to-air system is rather insensitive to pressure surges while in the water-to-air system the valve opens.

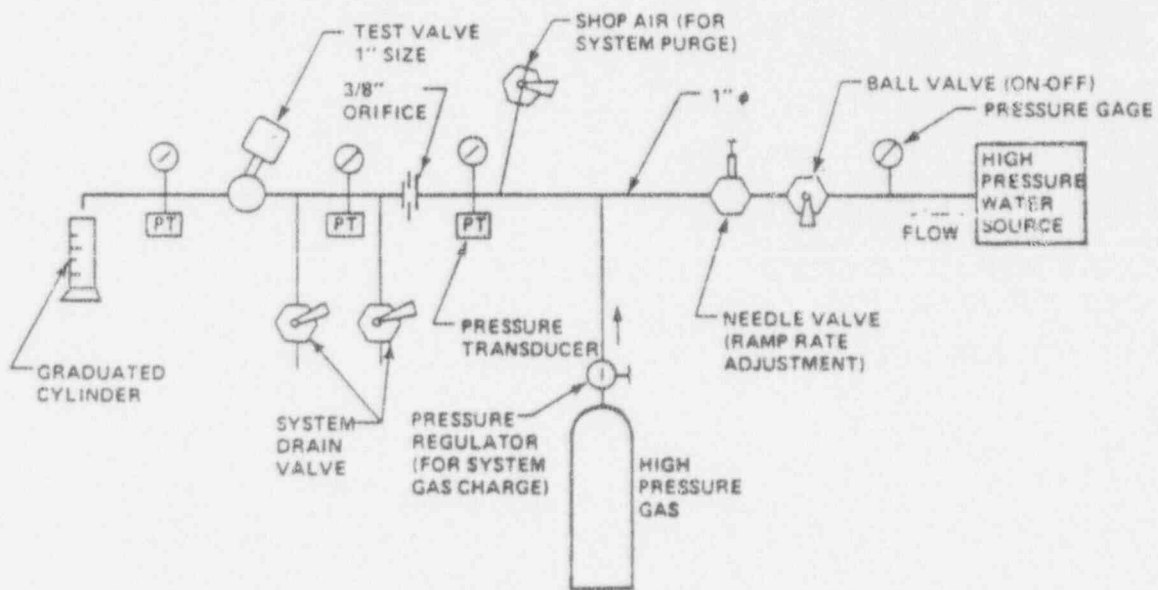
Figure 7. Valve Test Set-Up

To verify the validity of the analysis, a limited test was conducted to demonstrate the phenomenon. Figure 7 illustrates the test setup. Three tests were conducted to simulate each of the three cases. The results of the tests are summarized in Table 2.
