AN INVESTIGATION OF FLAWS ON THE  
INSIDE SURFACE OF A TYPE 304 STAINLESS  
STEEL SCHEDULE 80 PIPE

POWER AUTHORITY OF THE STATE OF NEW YORK  
JAMES A. FITZPATRICK NUCLEAR POWER PLANT

July 30, 1982

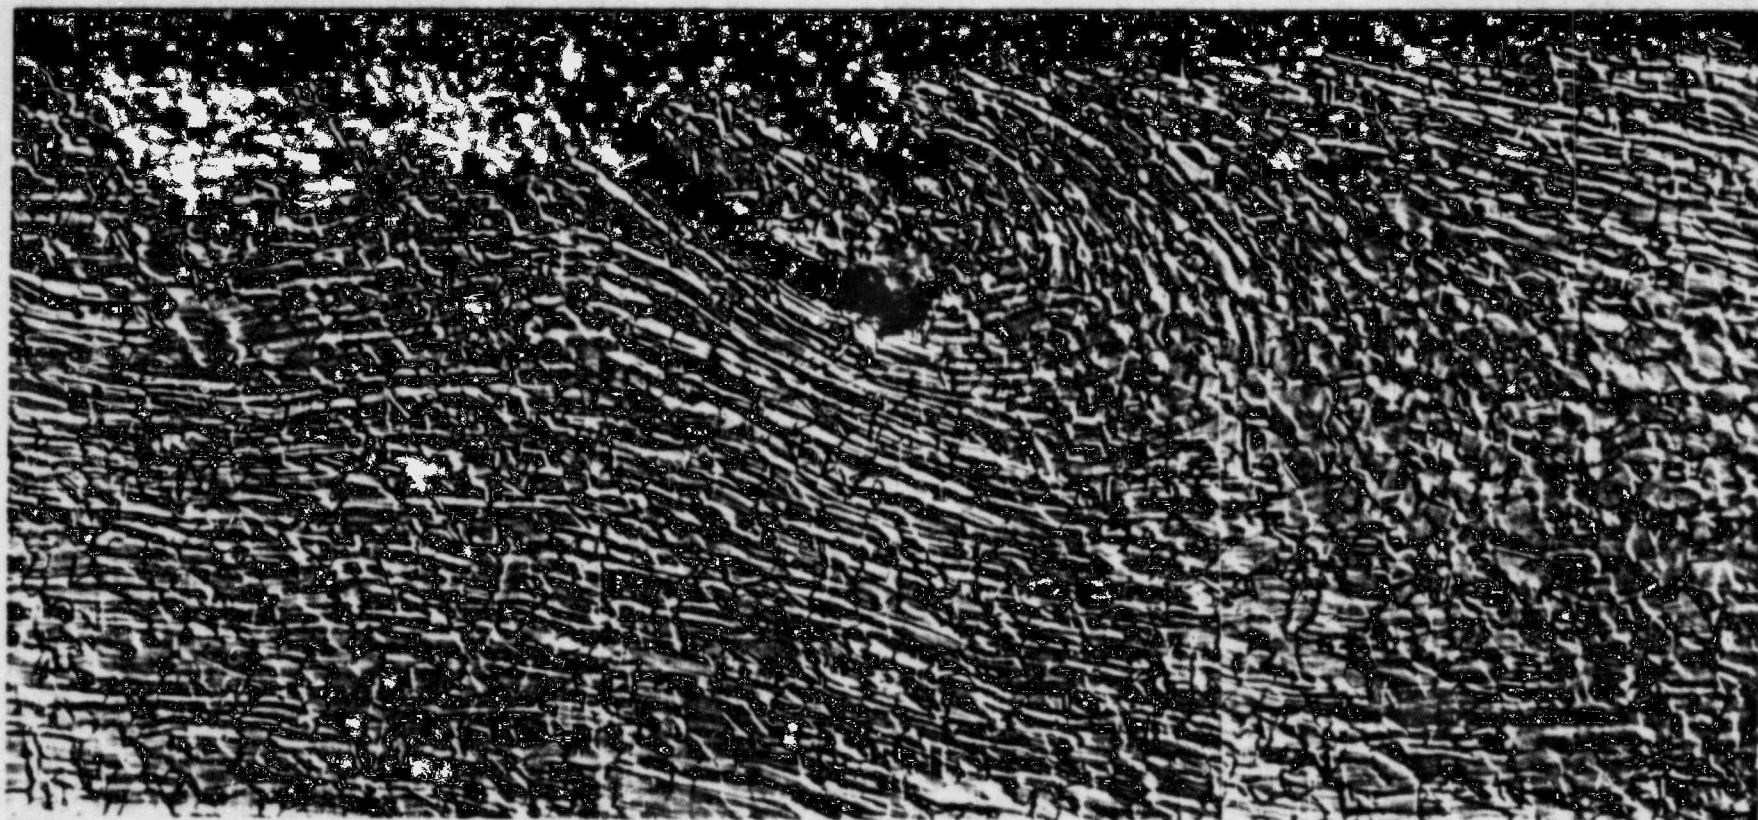
FIGURE 10. THE FLOW PATTERN OF METAL AROUND SURFACE FLAW NO. 2 IN SPECIMEN 2-R-R

at some earlier time. Specimen 2-N-N was taken at approximately the mid-length of Flaw No. 2. In that section, shown in Figure 9, the flaw appears very much like a surface fold, or lap. The depth of the flaw was about 0.035 inch. Specimen 2-R-R was taken across a thin sliver of surface metal that had been lifted, but not removed, from the surface; the appearance of the sliver can be seen in Figure 10. Part of the sliver was detached from the surface of the pipe at the location of Specimen 2-R-R.

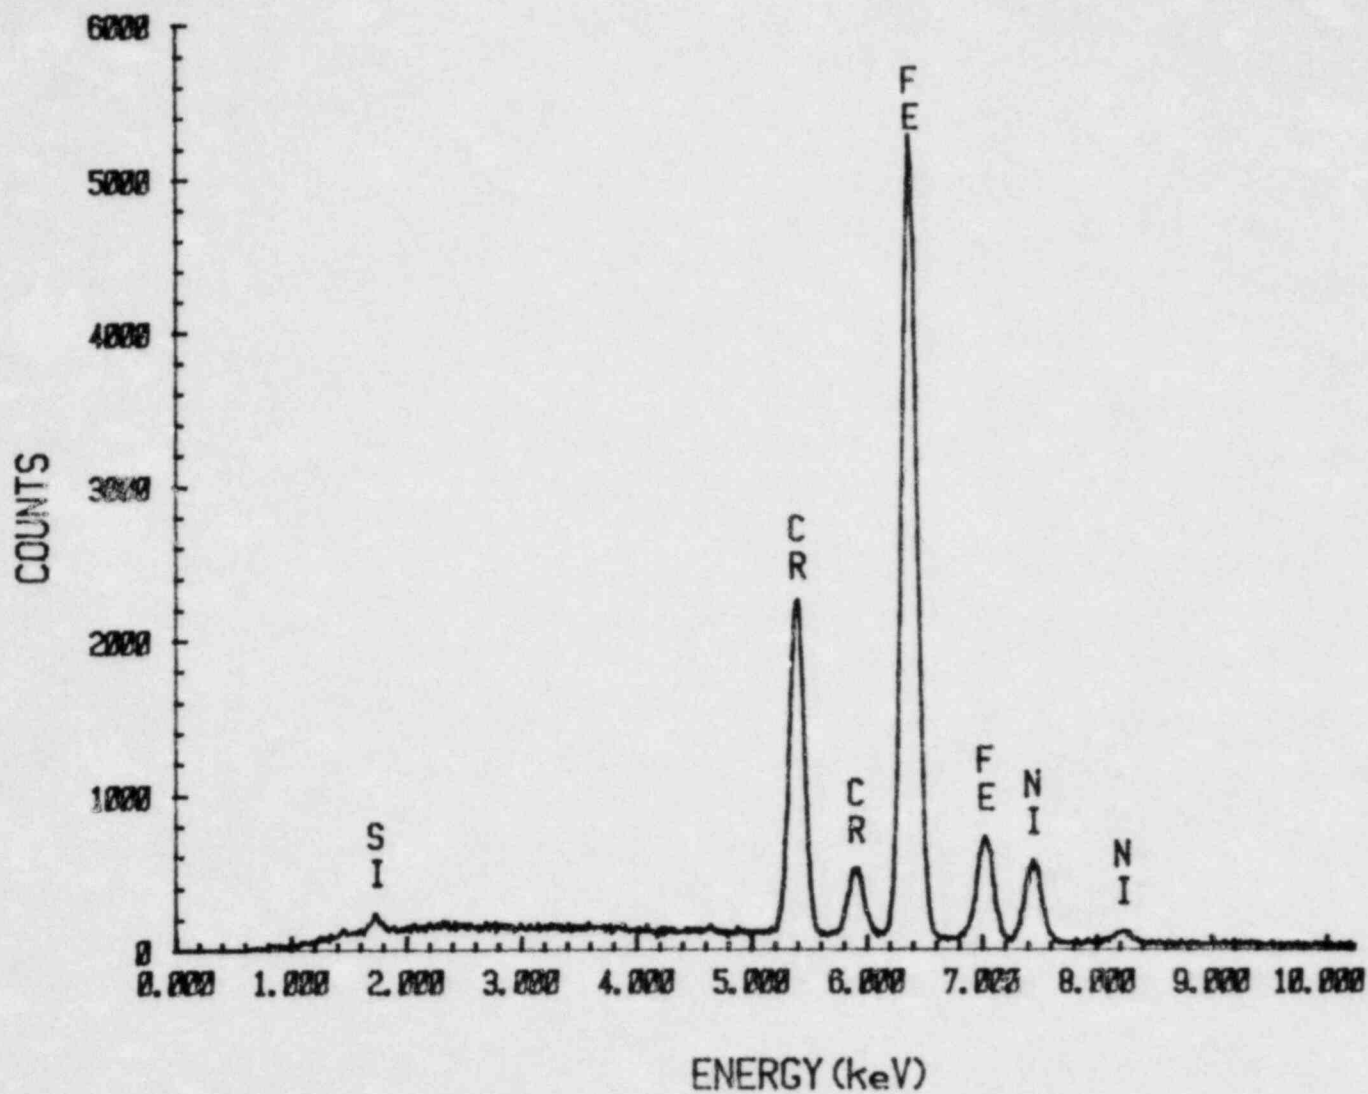
The relative concentrations of chromium and nickel in the pipe (Area 1 in Table 4) and in the weld metal (Area 2 in Table 4) agree quite well with the contents of those two elements that were obtained by emission-spectrographic analytical techniques. (Refer to Table 1 for the comparison.) The X-ray-energy spectrum for the pipe, which was nearly the same as the spectrum for the weld metal, is shown in Figure 12.

FIGURE 12. ENERGY-DISPERSIVE X-RAY SPECTRUM OBTAINED FROM AN ANALYSIS OF THE TYPE 304 STAINLESS STEEL MATRIX IN SPECIMEN 1-S-S OF FLAW NO. 1 (AREA 1 in TABLE 4)

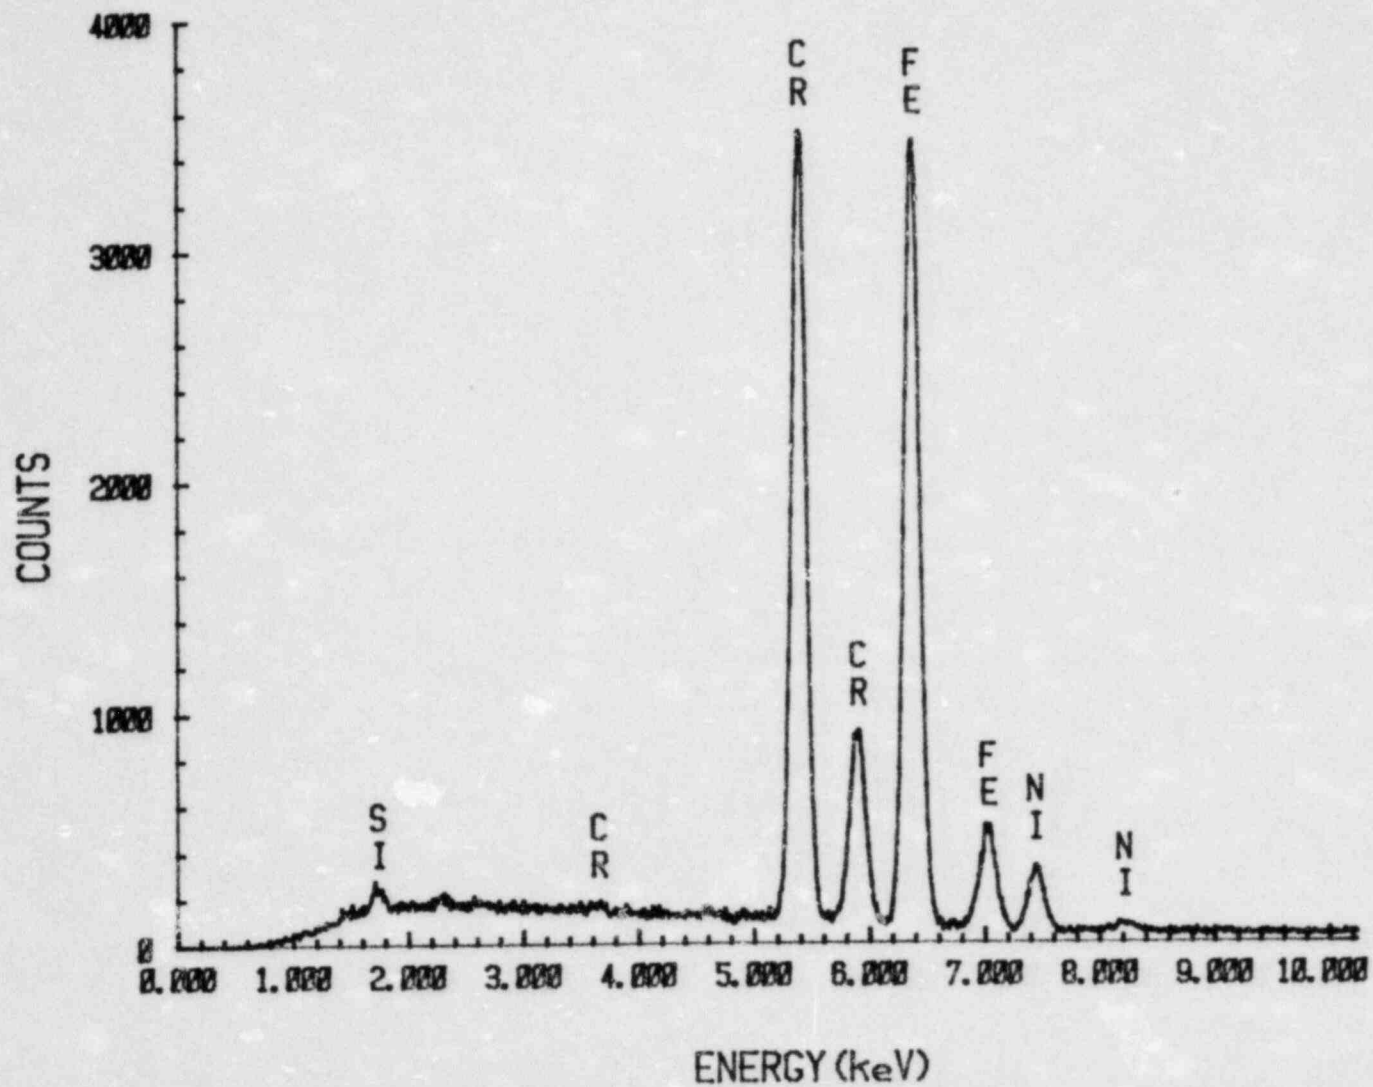
The corrosion products that were analyzed in Flaw No. 1 (Area 3 in Table 4) are identified by the arrow in Figure 13, a cross section of Flaw No. 1 observed in Specimen 1-S-S. The X-ray-energy spectrum for Area 3 is presented in Figure 14. The analysis of the chromium present in the corrosion products indicated that the chromium content was nearly twice the chromium content of the pipe. The increase in the chromium content was accompanied by decreases in the iron and nickel contents.

FIGURE 14. ENERGY-DISPERSIVE X-RAY SPECTRUM OBTAINED FROM AN ANALYSIS OF CORROSION PRODUCTS IN FLAW NO. 1 OBSERVED IN SPECIMEN 1-S-S (AREA 3 in TABLE 4)

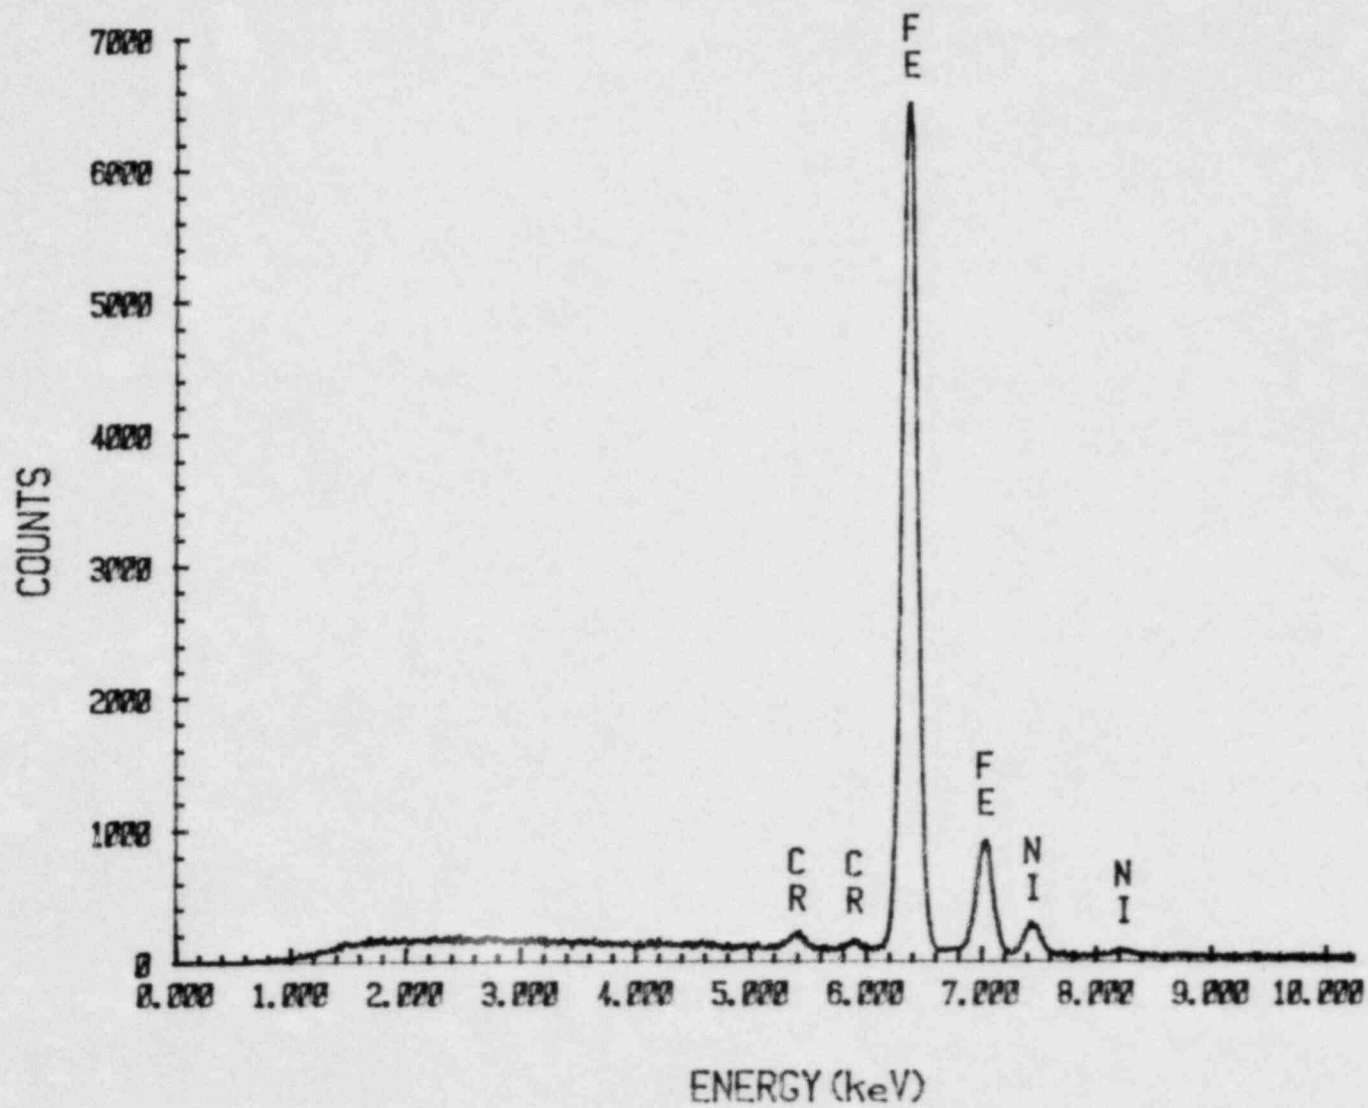
The region represented by Area 4 in Table 4, a region of corrosion products in the IGSCC below Flaw No. 1 near the inside surface of the pipe, is shown in Figure 15a. Those corrosion products contained a relatively low concentration of chromium, as was indicated also by the X-ray-energy spectrum of Area 4 presented in Figure 16. The X-ray distribution map of chromium presented in Figure 15b indicates the low concentration of chromium in the major portion of the corrosion products in the grain boundaries. (A region that exhibits a relatively sparse population of white dots in an X-ray-distribution map of an element indicates that the region contains a lower concentration of the element than do the regions that exhibit more dense populations of white dots.) The major decrease in the chromium content was balanced by a major increase in the iron content.

FIGURE 16. ENERGY-DISPERSIVE X-RAY SPECTRUM OBTAINED FROM AN ANALYSIS OF CORROSION PRODUCTS IN THE CRACK (AREA 4 IN TABLE 4)

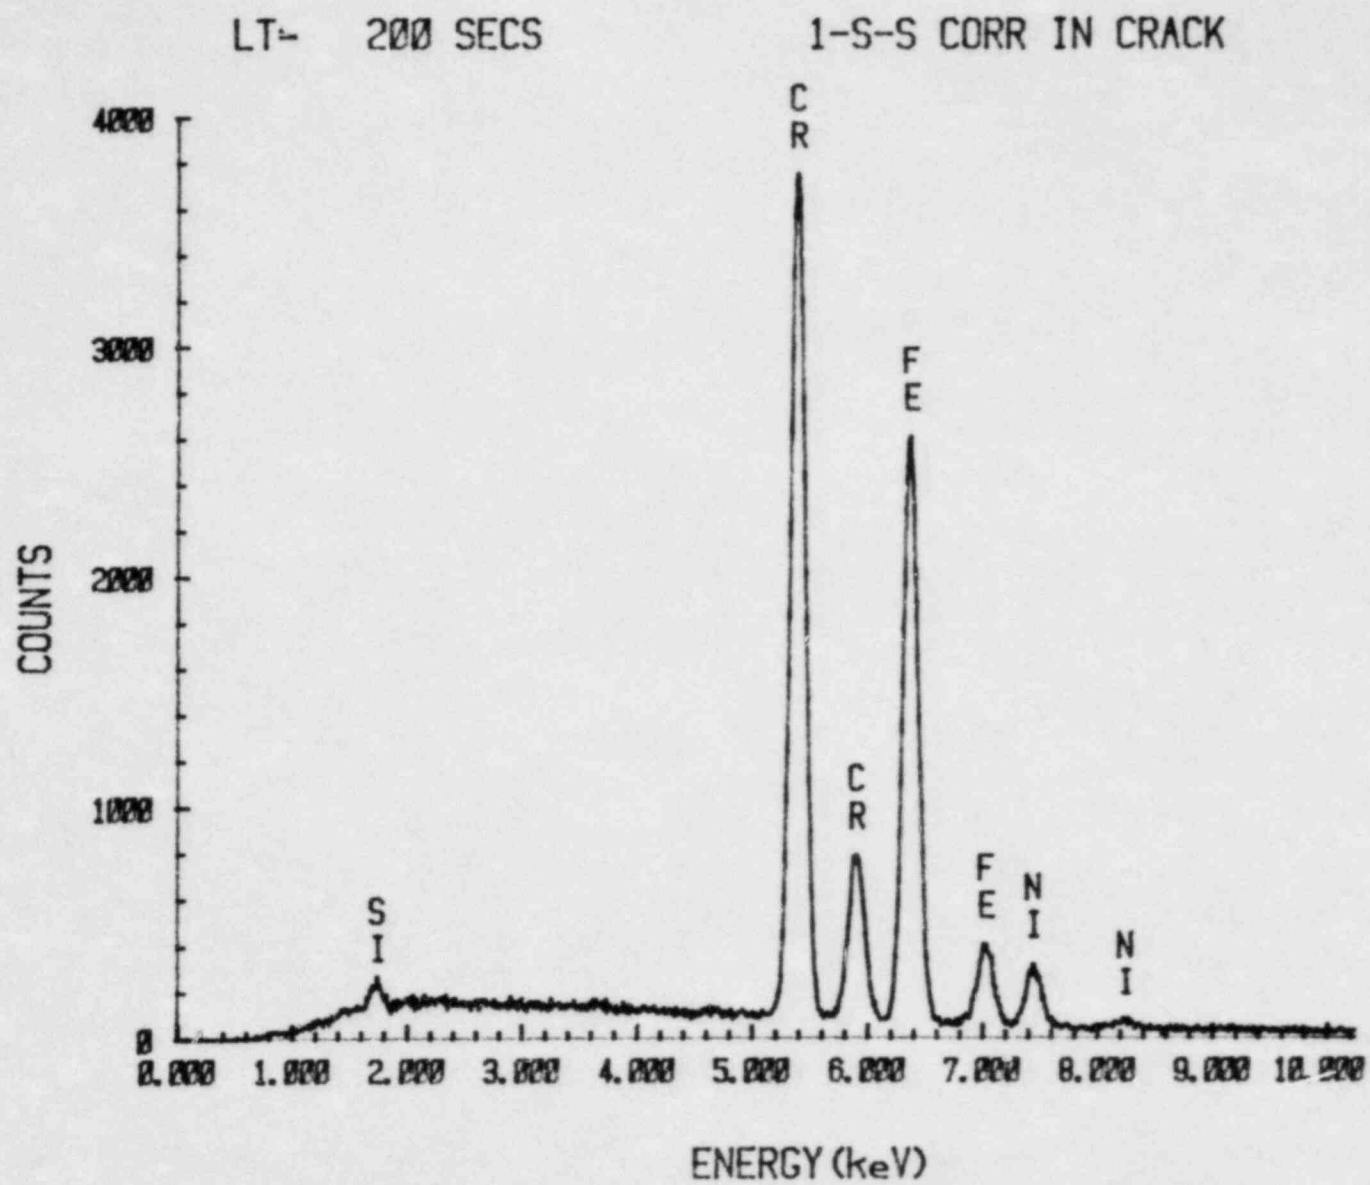
Areas 5 and 6 in Table 4 were the regions of corrosion products observed in two different, but nearby, intergranular cracks that branched out from the main intergranular crack. The chromium and iron contents appeared to differ significantly between those two areas, and the chromium content in both areas was well above that in the pipe. The X-ray-energy spectrum of Area 6 is shown in Figure 17.

FIGURE 17. ENERGY-DISPERSIVE X-RAY SPECTRUM OBTAINED FROM AN ANALYSIS OF CORROSION PRODUCTS IN A BRANCH CRACK (AREA 6 IN TABLE 4)

chromium; the low chromium concentrations were similar to that found in the corrosion products in the main crack near the inside surface (Area 4 in Table 4).

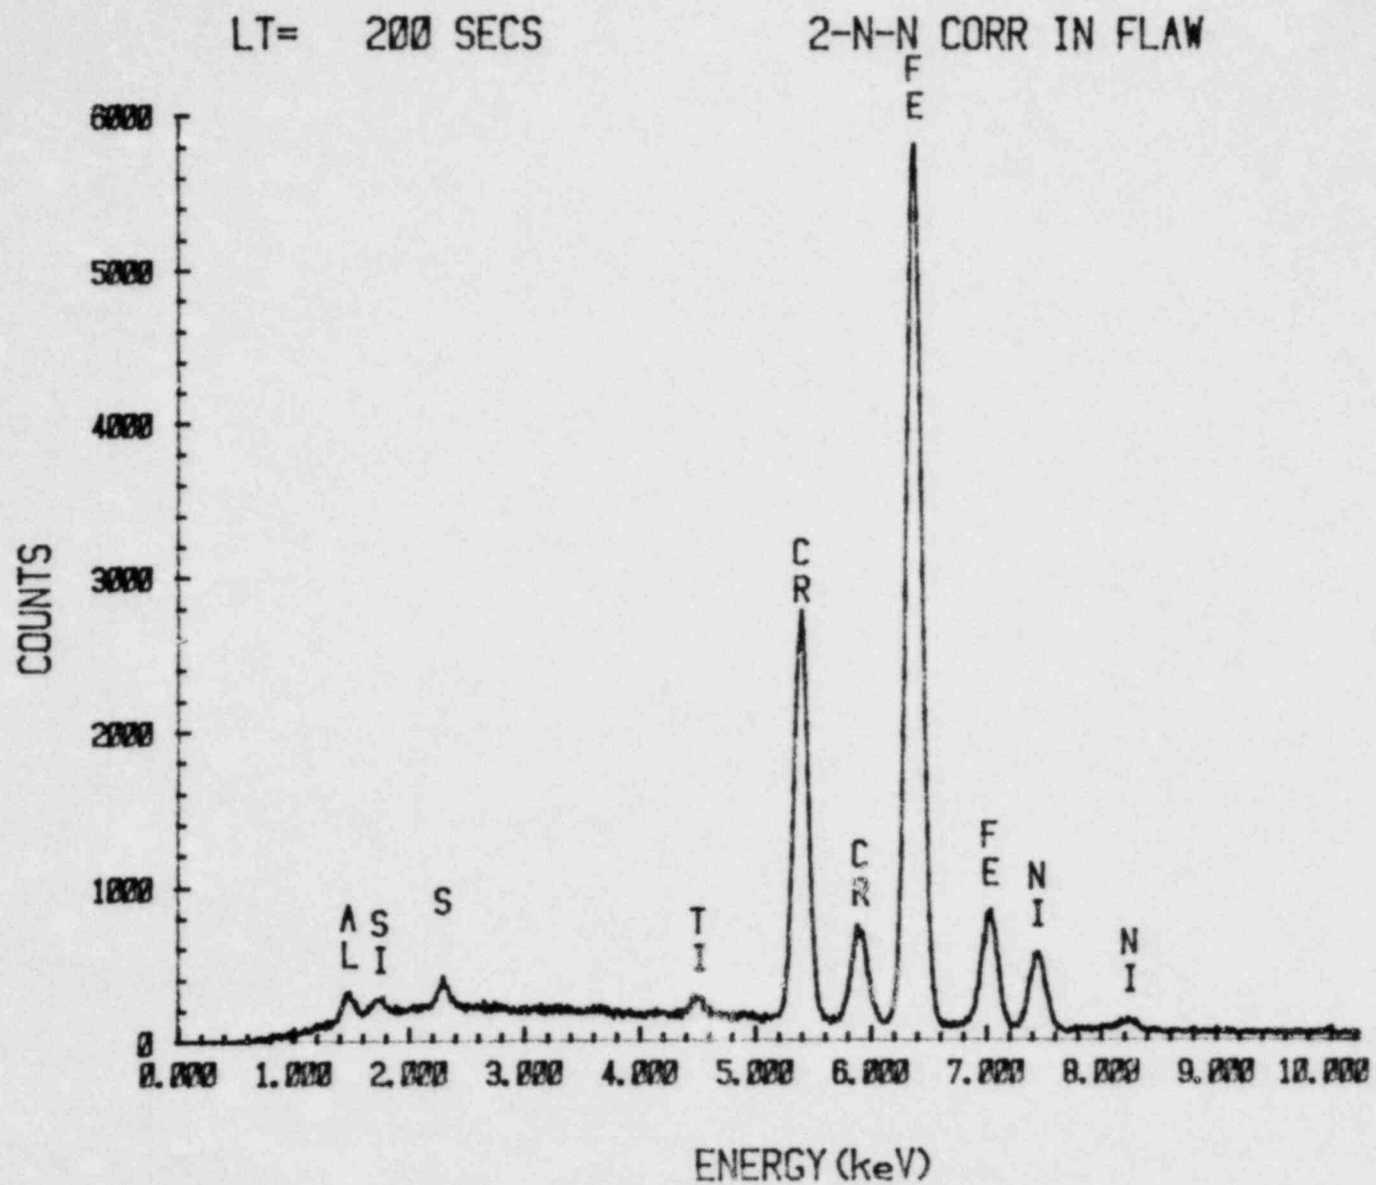
obtained by an area scan at a magnification of 2000X. The X-ray-energy spectrum for Area 1 is presented in Figure 18; Area 1 is revealed in Figure 19a. Area 2 in Table 5 was a spot analysis of the large particle within Area 1 that is visible in the center of Figure 19a. Nickel, silicon, and sulfur were not detected in the large particle, whereas those elements, in addition to iron, chromium, aluminum, and titanium, were detected within Area 1 (Figure 19a) that included the particle. X-ray-distribution maps of the elements detected in Area 1, except silicon, are presented in Figures 19b through 19j. Figures 19f and 19g show, respectively, that the nickel and sulfur were concentrated in a small particle, apparently nickel sulfide, adjacent to the large particle.

FIGURE 18. ENERGY-DISPERSIVE X-RAY SPECTRUM OBTAINED FROM AN AREA SCAN OF CORROSION PRODUCTS IN FLAW NO. 2, SPECIMEN 2-N-N (AREA 1 IN TABLE 5)
