SUBJECT: SALEM RESTART EVALUATION

NRC SAFETY EVALUATION
RELATED TO PLANT RESTART
PUBLIC SERVICE ELECTRIC & GAS COMPANY
SALEM NUCLEAR GENERATION STATION
UNIT NOS. 1 AND 2
DOCKET NOS. 50-272 AND 50-311

EVALUATION OF FAILURE TO TRIP
OF REACTOR TRIP CIRCUIT BREAKERS
ON FEBRUARY 22 AND 25, 1983
SALEM NUCLEAR GENERATING STATION UNIT 1

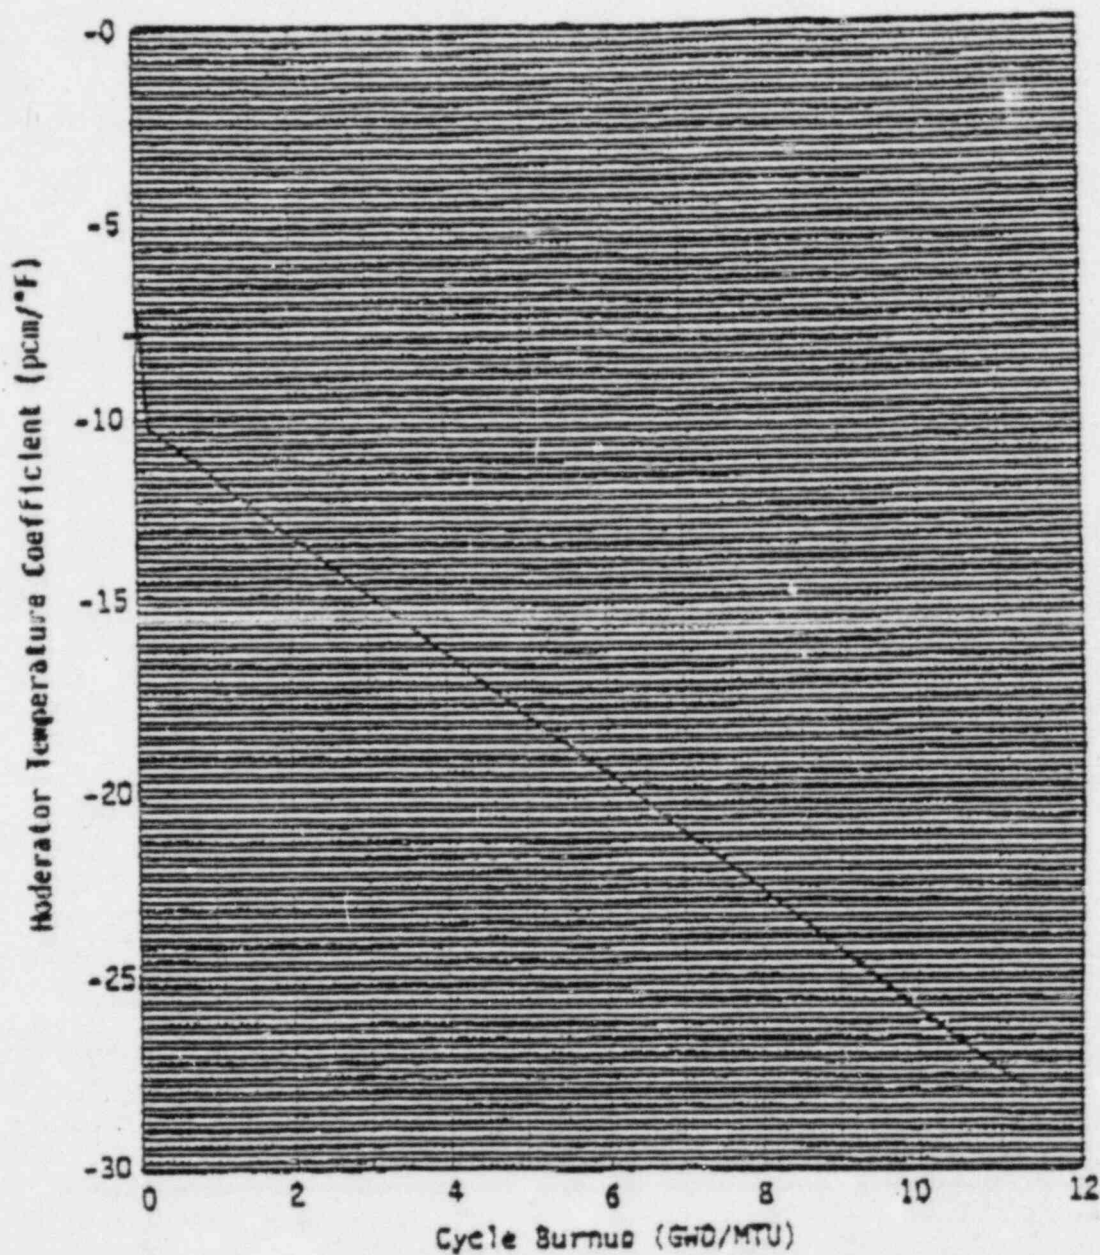
FIGURE 3

MODERATOR TEMPERATURE COEFFICIENT DURING CYCLE 5
-- AT HFP, ARO, EQUILIBRIUM XENON CONDITIONS *

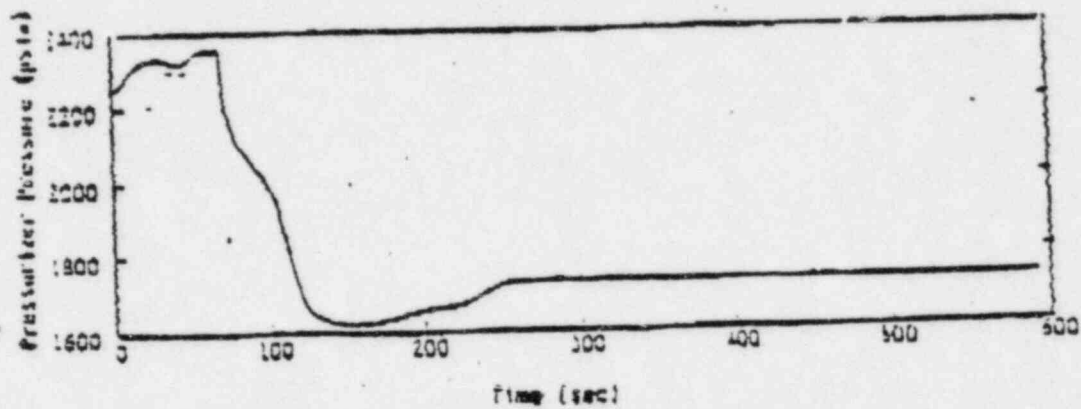
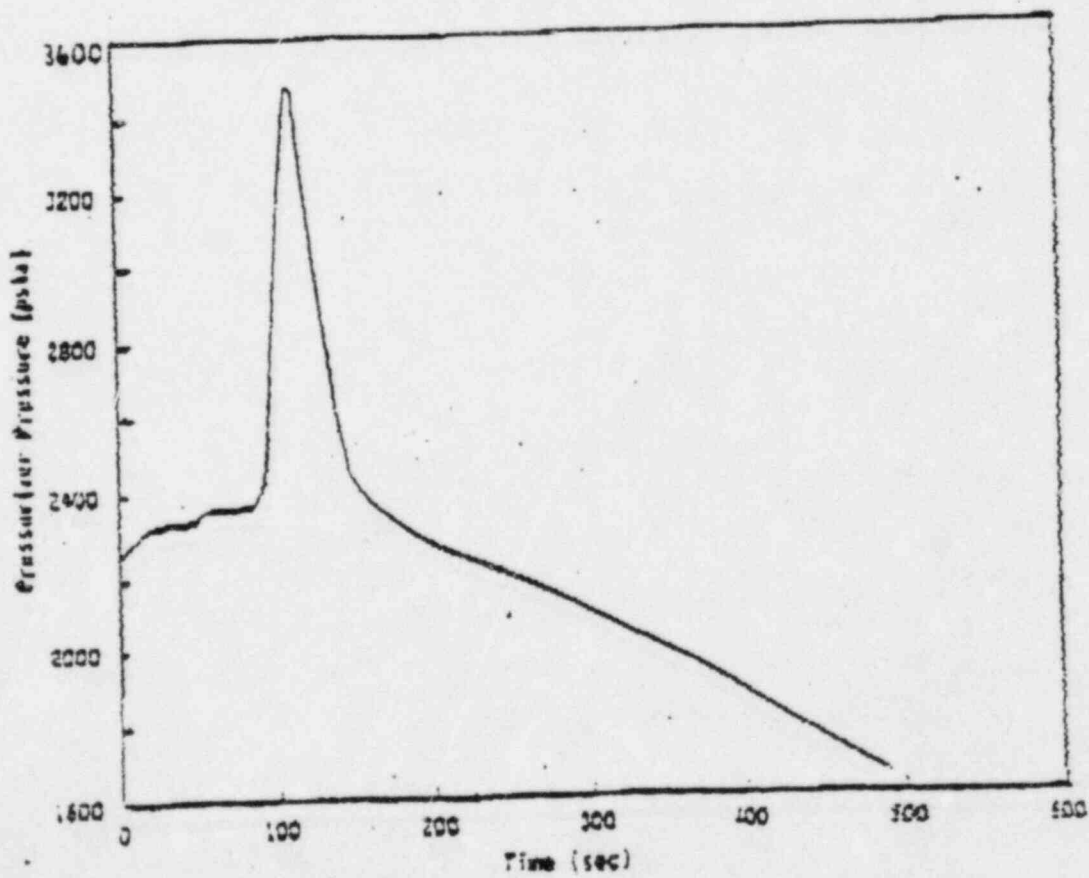
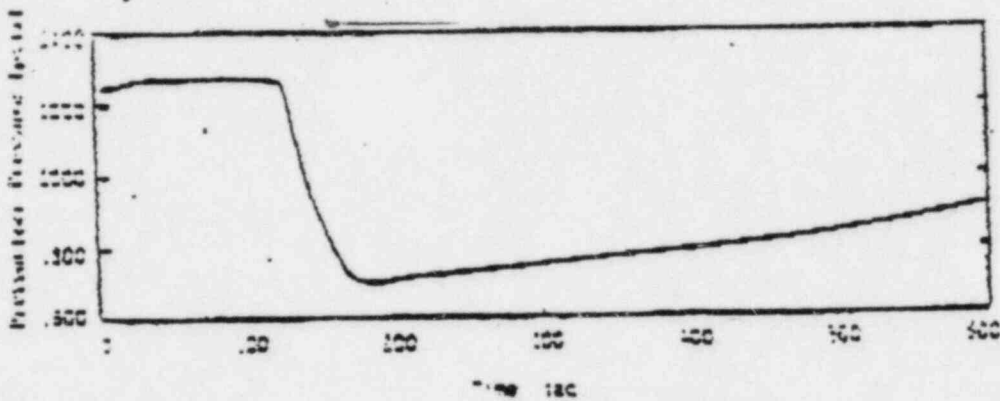
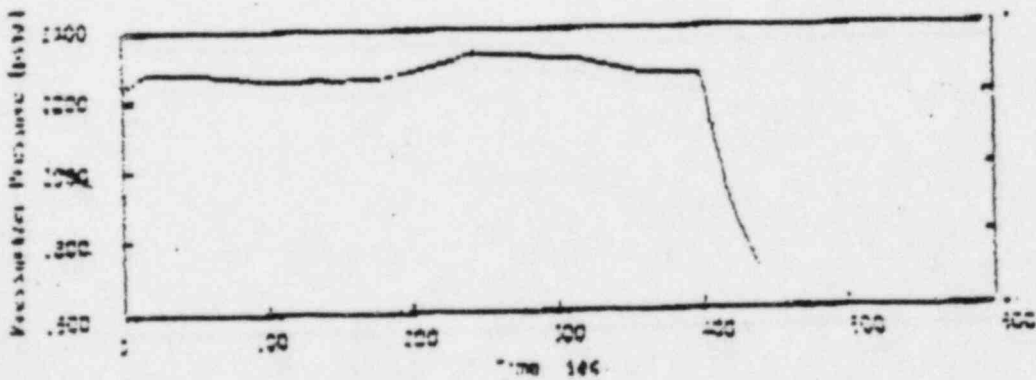
FIGURE 2
Pressure Transient - Loss of All Main Feedwater

The sequence of events for this transient are presented in Table 2. The transient pressure calculations are depicted in Figure 2.

It should be noted that the core nuclear characteristics (a moderator reactivity coefficient of $-8 \text{ pcm}/^\circ\text{F}$) used are not representative of the actual core design for the Salem Plant. Previous ATWS analyses have shown the peak pressure to be a strong function of the coefficient and there is a 100 psi reduction for every 1 pcm decrease in the coefficient. The Salem core is designed to operate such that by the time the plant reached full power it would have a coefficient of $-10.5 \text{ pcm}/^\circ\text{F}$ or 2.5 pcm less than the coefficient in the study. This coefficient would be reduced even further by approximately $2 \text{ pcm}/^\circ\text{F}$ per month of operation (see Figure 3). The 10.5 pcm coefficient results in a peak pressure for the limiting case of five minute operator action of 3241 psia (a 250 psia reduction from 3491 psia) which is within the calculational band of the ASME Stress Level C limit. Therefore, the case represented in Figure 2 would not exceed the acceptance criteria.
