Examination of Crystal River Unit #3 Steam Generator Tube Sections

TR-103756

Final Report, January 1994

B&W NUCLEAR TECHNOLOGIES
Special Products & Integrated Services Division
and
THE BABCOCK & WILCOX COMPANY
Nuclear Environmental Services, Inc.

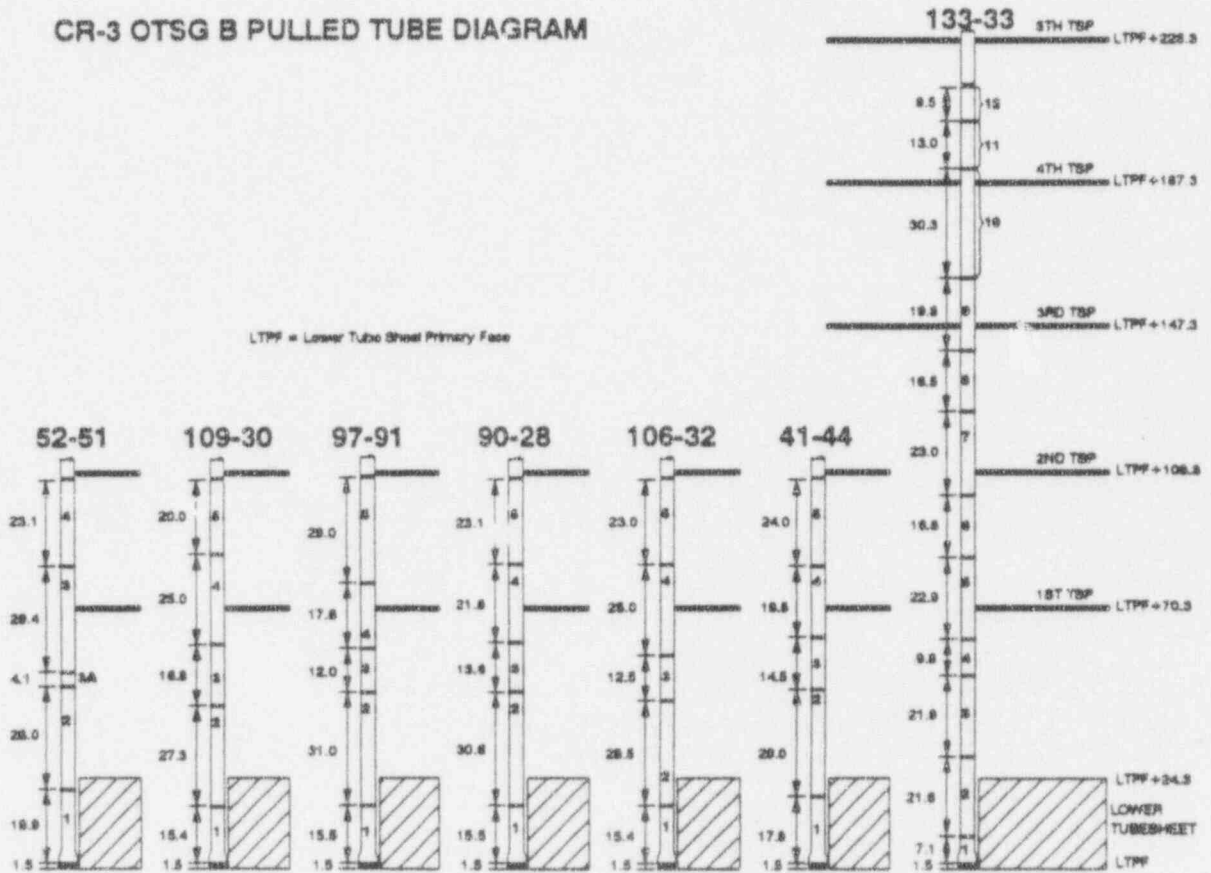
Figure 1-1: CR-3 OTSG B Pulled Tube Diagram

A sketch of the pulled tube segments and their approximate elevation in the CR-3 steam generator is provided in Figure 1-1.

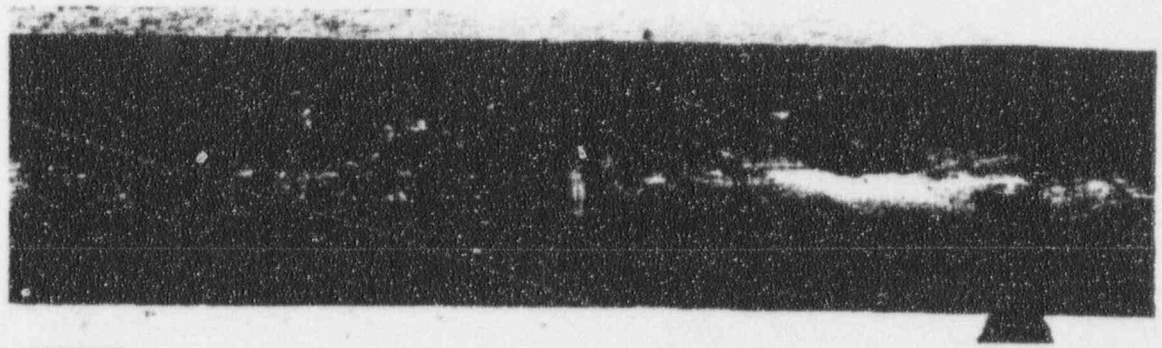
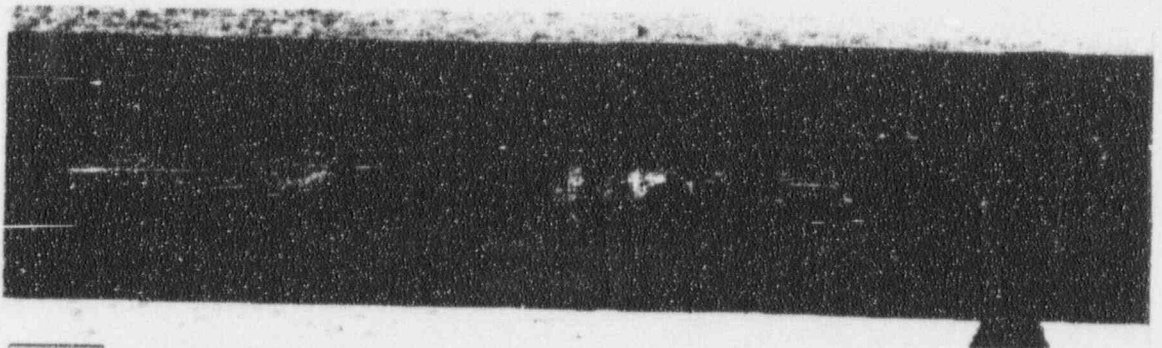
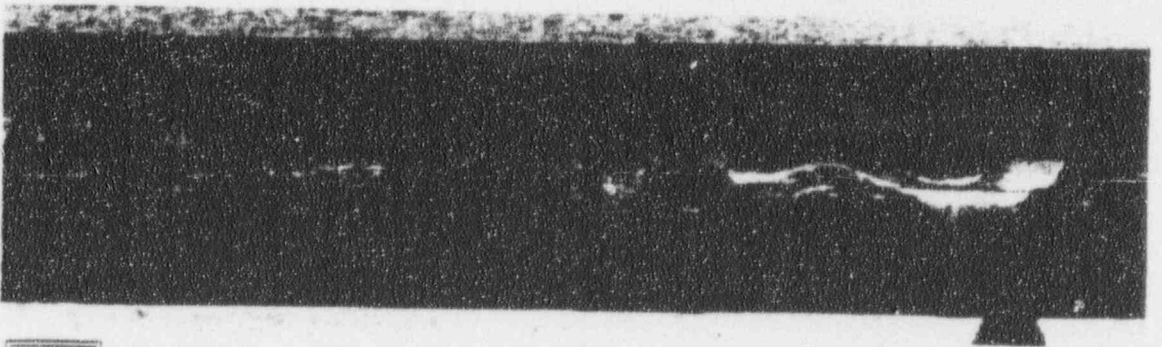
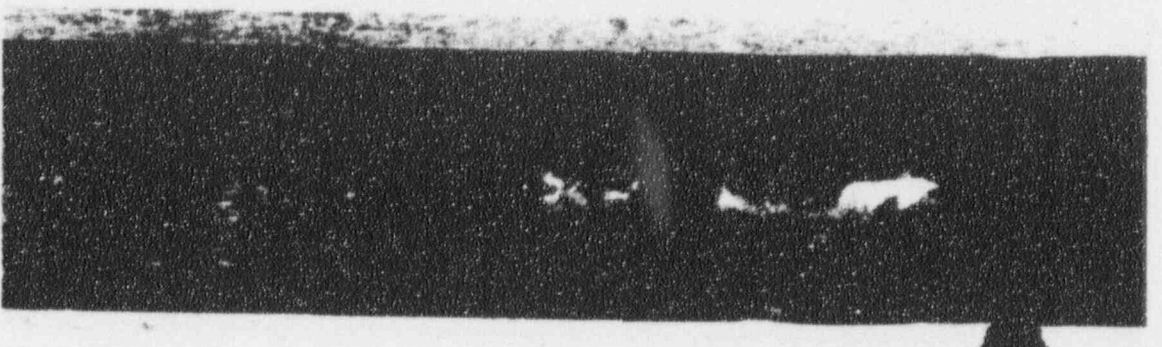
Figure 2-1: Tube Section 52-51-2, LTSF Region As-Received (2.2X; Bottom At Left)

On all tubes, regions contained within the tubesheet were essentially free of deposits, although some light green deposits were noted on most tubes in the first few inches below the LTSF. The areas void of deposit typically exhibited a copper-colored sheen; this may simply have been due to a thin Ni-Cr oxide film on the metal surface. Some minor pitting was also typically observed within 2 to 3 inches below the LTSF. The LTSF regions for all tubes except 133-33 are shown in Figures 2-1 through 2-6.

Tube Section 52-51-2: The scalloped patterns were less prevalent in the 0° orientation. Also, coarser scallop patterns were present along the 180° and 270° orientations. A half inch wide circumferential band of relatively smooth uniform deposit was noted 19 inches above the LTSF; immediately adjacent to and on either side of this band, the scallop patterns were very coarse and appeared to have some significant depth (see Fig. 2-13). A 3/8 inch wide circumferential band of apparently deep scallop patterns was observed about 21 inches above the LTSF (see Fig. 2-14).

In any case, no defects were identified by visual inspection in any of these tube sections in the first freespan zone; particularly in the area immediately above the LTSF (i.e., the location of the field reported bobbin coil indications).

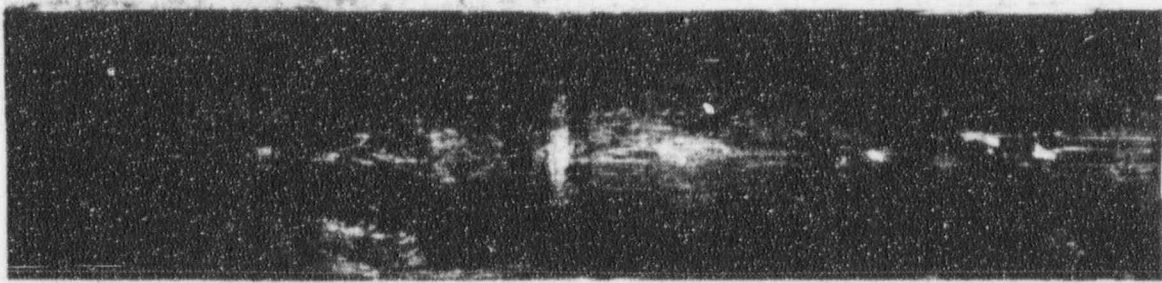
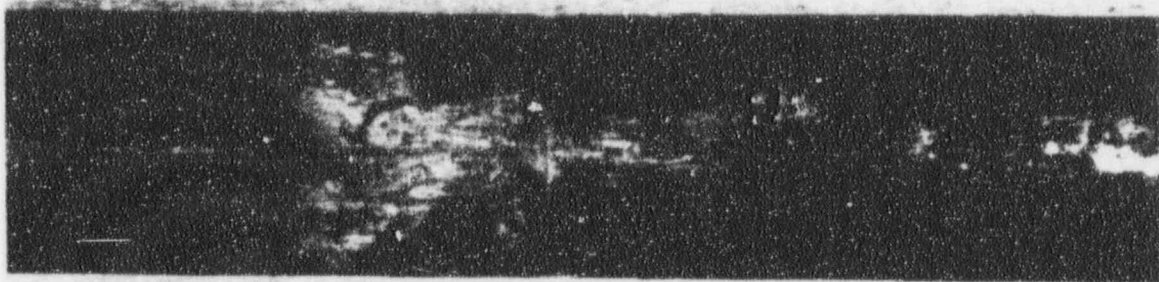
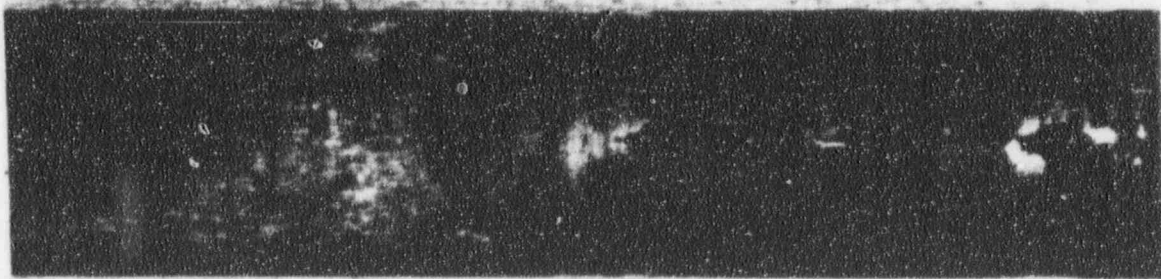
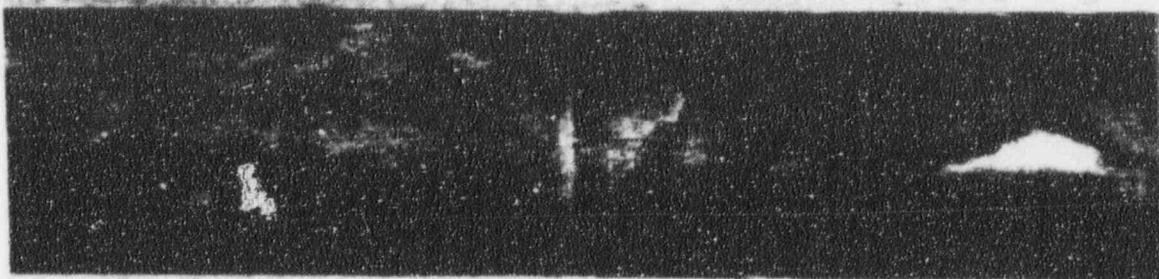
Figure 2-2: Tube Section 90-28-2. LTSF Region As-Received (2.2X; Bottom At Left)

Tube Section 90-28-2: The scalloped deposit patterns were generally coarser than 52-51-2 and were more prevalent in the 0° and 270° orientations. Also, there was large areas of spalled deposit.

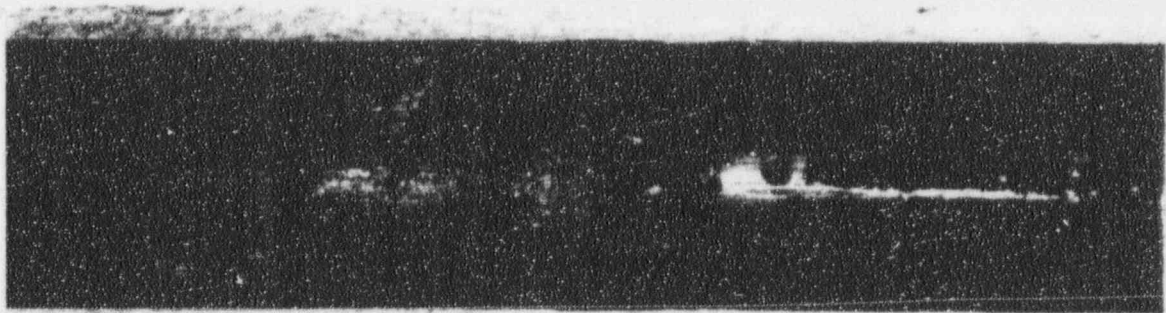
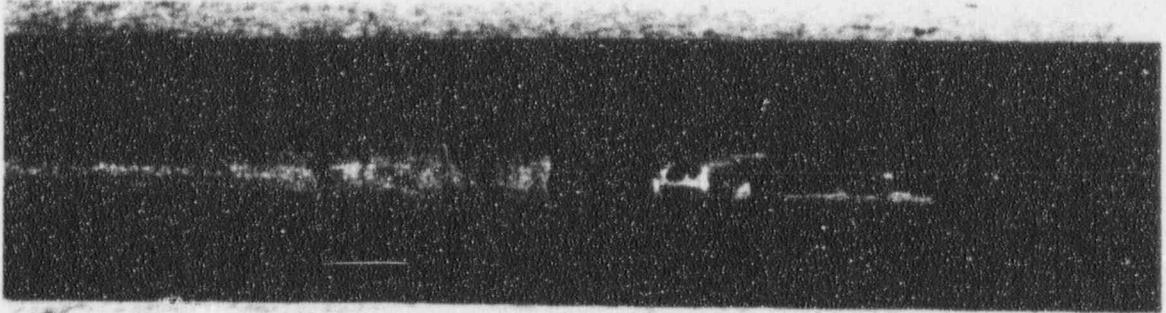
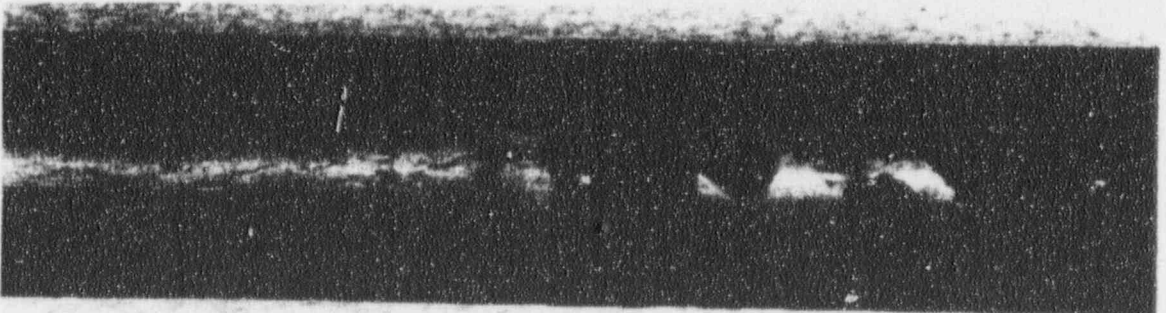
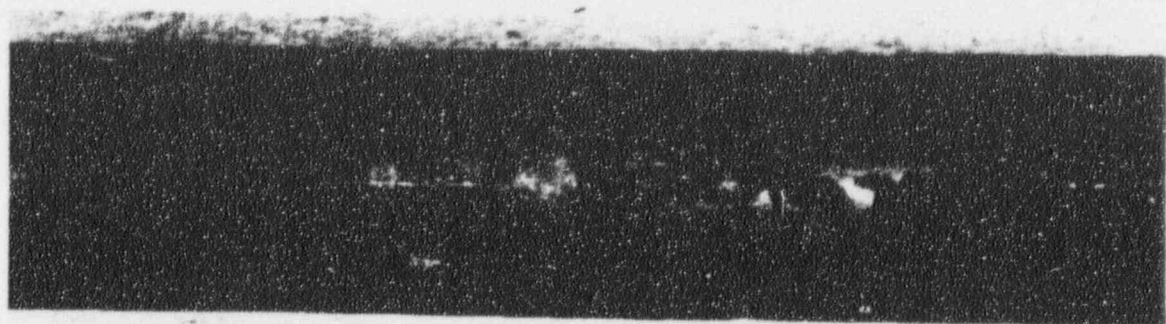
Figure 2-3: Tube Section 97-91-2, LTSF Region As-Received (2.2X; Bottom At Left)

Tube Section 97-91-2: The deposits on this tube section were more uniform than the other tubes. The dark scalloped patterns were not nearly as evident, although there were many tiny spots of spalled deposit.

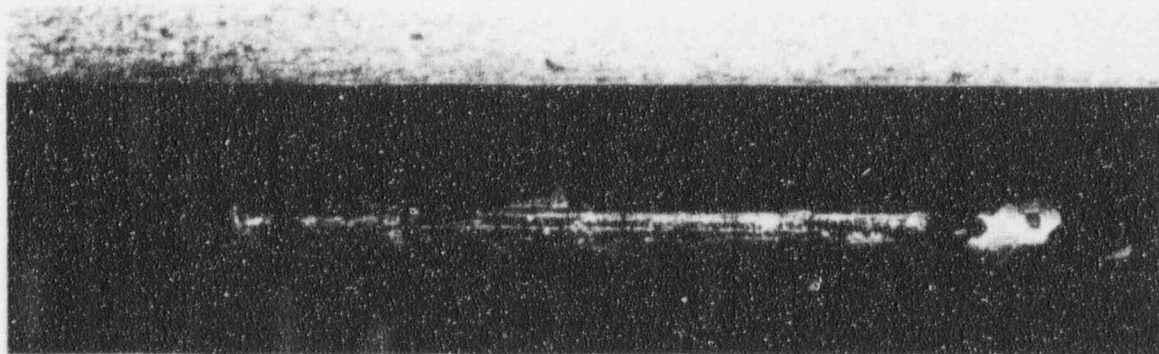
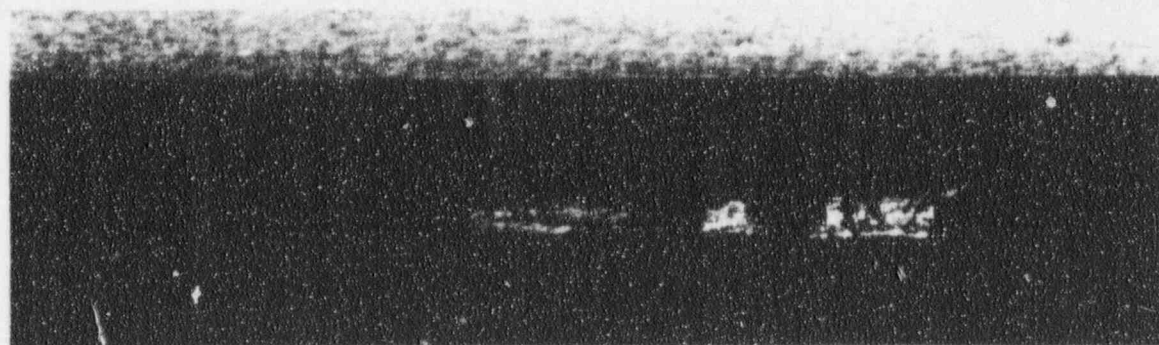
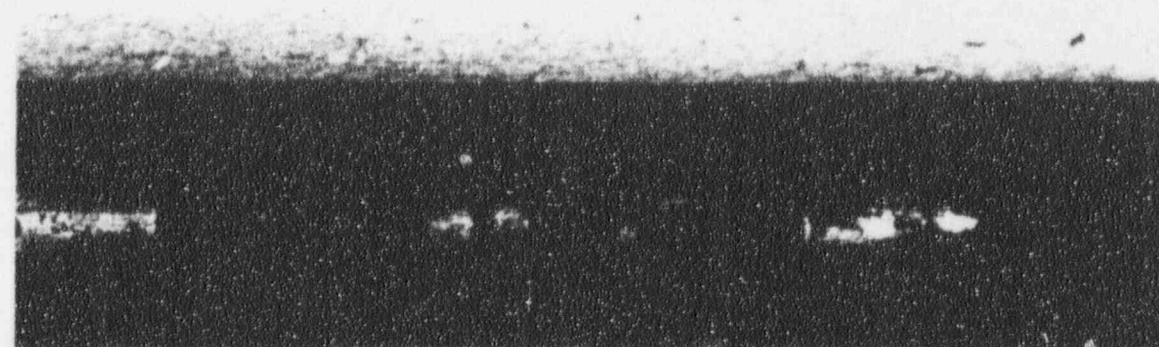
Figure 2-15: Tube Section 52-51-3, TSP Region (As-Received)

In general, the support plate land contact positions were easily visible on these tubes due to the general absence of deposit (see Figs. 2-15 through 2-20). There were no obvious signs of wear or significant pitting in the TSP regions. The deposit patterns described previously generally persisted up to the TSP, then continued on above. Tube-to-tube differences are discussed below.

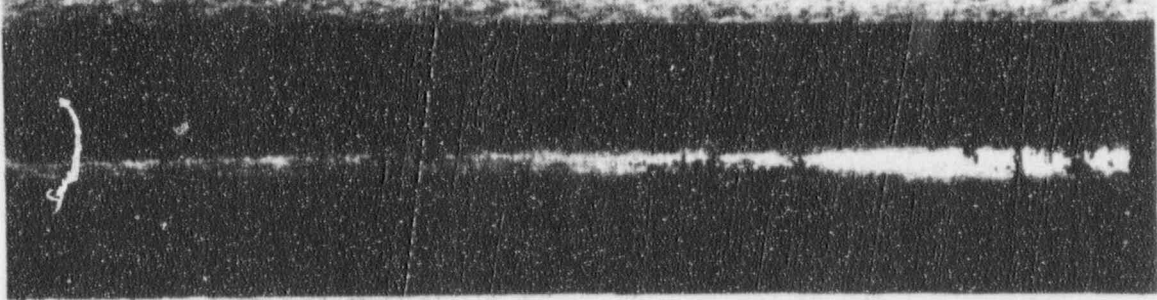
Figure 2-21: 52-51-3, Spalled Deposit at TSP-2¼" Where Tube Was Bowed

Tube Section 52-51-3: Tube section 52-51-3 was bowed rather severely just below the TSP and the deposits were severely spalled in this area (see Fig. 2-21). This was probably a result of the tube pulling operation. Deposits above the TSP were similar to those described previously, except the scalloped patterns were much larger (see Fig. 2-22).

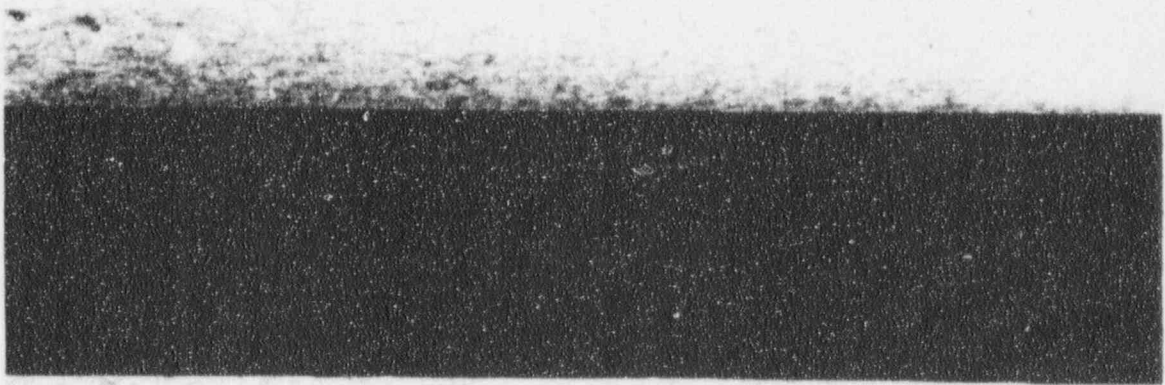
Figure 2-23: 90-28-4, Axial Lines of Slightly Heavier Deposit

Tube Section 90-28-4: There was extensive deposit spalling within the TSP region on this tube section. A typical deposit pattern above the TSP is shown in Figure 2-23).

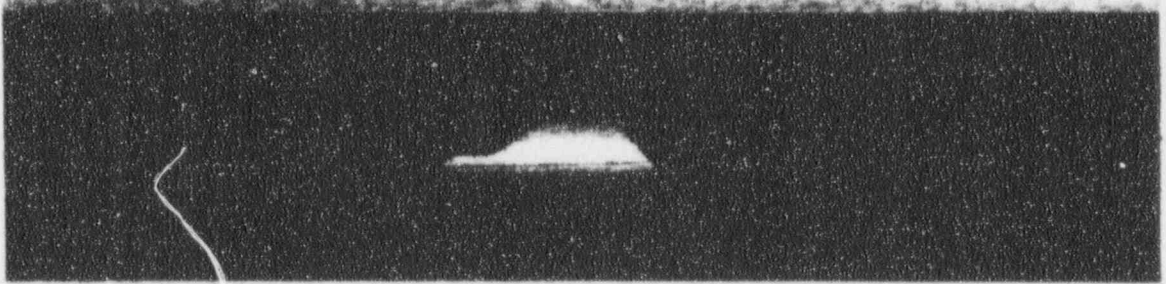
Figure 2-24: 97-91-4, Spalled Deposit 1st TSP-5 5/8"

Tube Section 97-91-4: Deposit spalling within the TSP was also reasonably extensive on this tube. This tube section was different than the others in that the deposit was very uniform, with the exception of some occasional spalling. A typical area is shown in Figure 2-24.

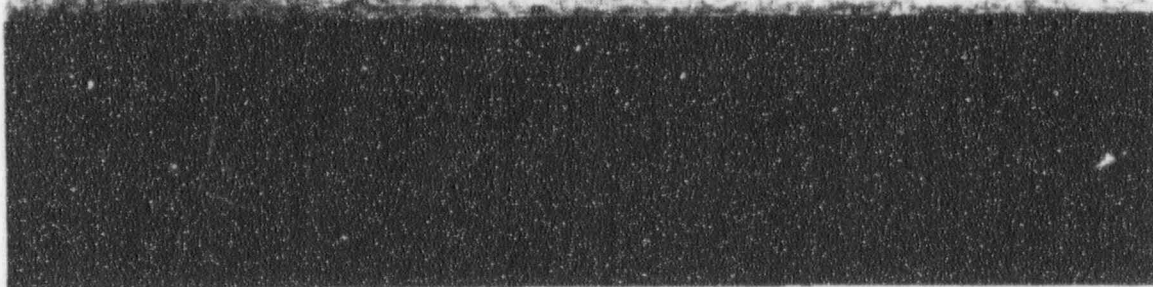
Figure 2-25: 106-32-4, Typical Deposit above TSP

Tube Section 106-32-4: The scalloped deposits persisted above the TSP on this tube, but the patterns were coarser than those in the free span below the TSP. A typical area is shown in Figure 2-25.

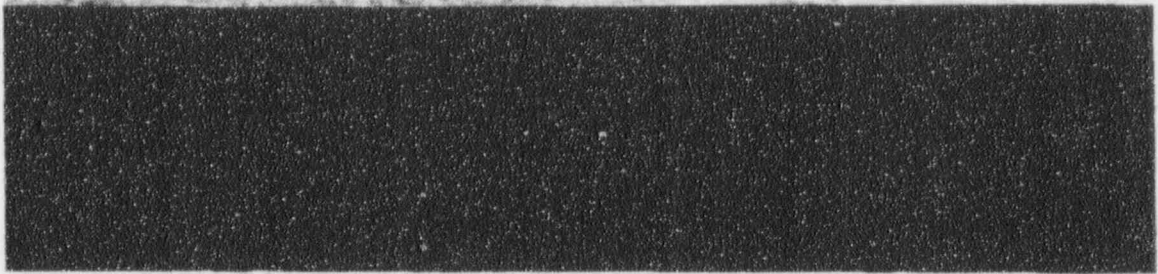
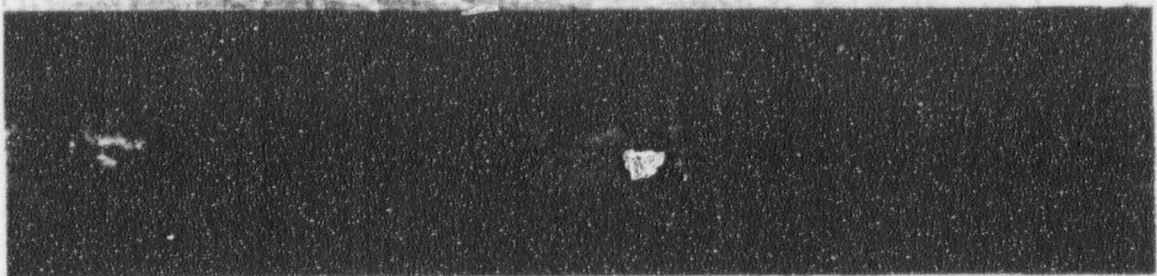
Figure 2-26: 109-30-4, Typical Non-Uniform Deposits Above and Below TSP

Tube Section 109-30-4: Similar to tube section 106-32-4 (see Fig. 2-26).

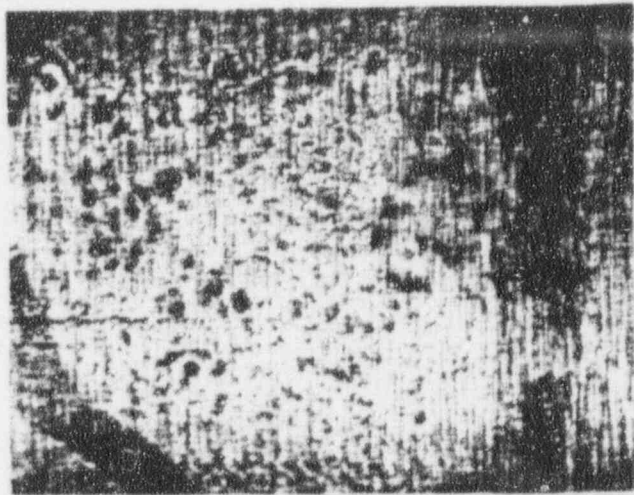
Other than minor pitting noted in a few locations, no significant defects were identified. There were localized areas exhibiting general surface roughness - possibly a result of IGA. However, only a few of these indications were actually verified to be IGA after swelling and metallographic examination. The results of this inspection are summarized below in Table 2-3; pitting and suspect IGA areas are shown in Figures 2-28 (Section 97-91-2) and 2-29 (Section 106-32-2).

703 LTSF+0.0° 140° 17.3X
SHALLOW PITTING TYPICAL

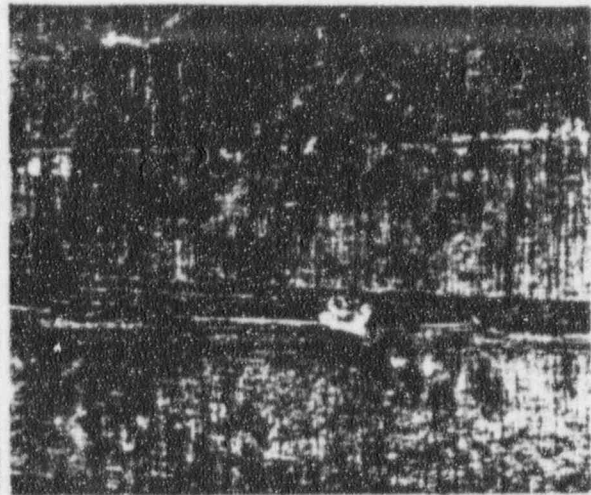
704 LTSF+8.4° 90° 28.5X
MINOR PITTING NEAR AXIAL SCRATCH

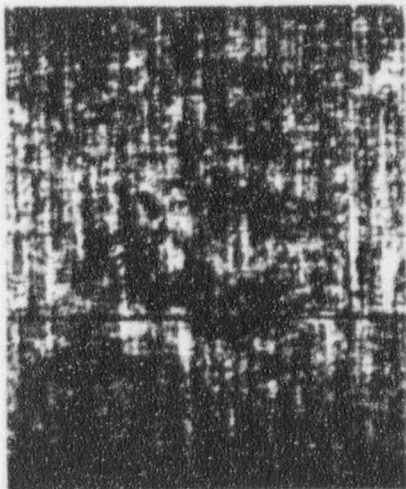
705 LTSF+8.9° 45° 34.3X 1
SHALLOW PITTING

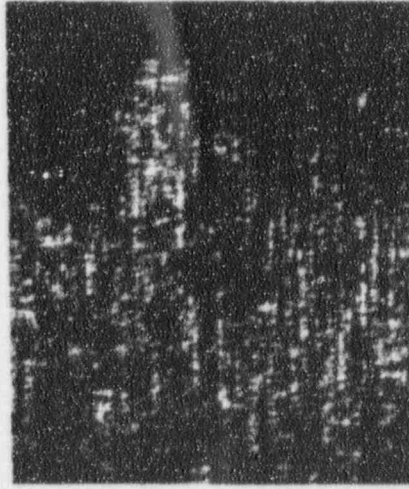
LTSF+9.6° 135° 34.3X 2
SMALL PIT WITH WHITE DEPOSIT

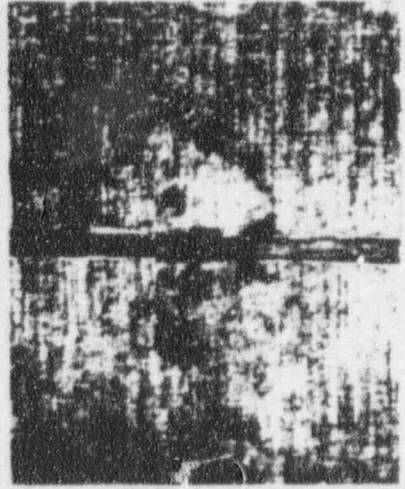
LTSF+11.4° 90° 28.5X
SMALL PITS IN AXIAL SCRATCH

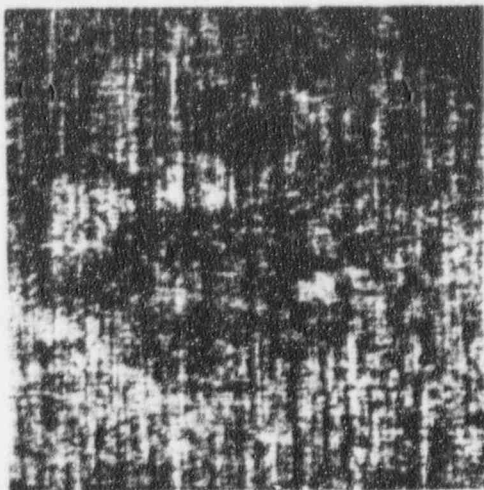
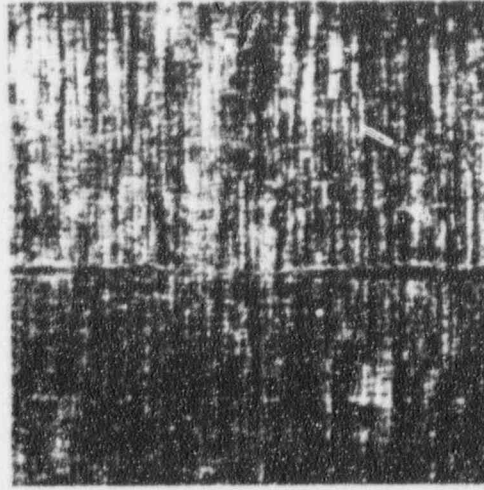
Figure 2-28: Liquid Penetrant Inspection (LPI) Results on Tube Section 97-91-2

3 LTSF+13.3° 350° 34.3X
SUPERFICIAL PITTING AND

4 LTSF+13.8° 0° 34.3X
LOCALIZED SURFACE ROUGHNESS

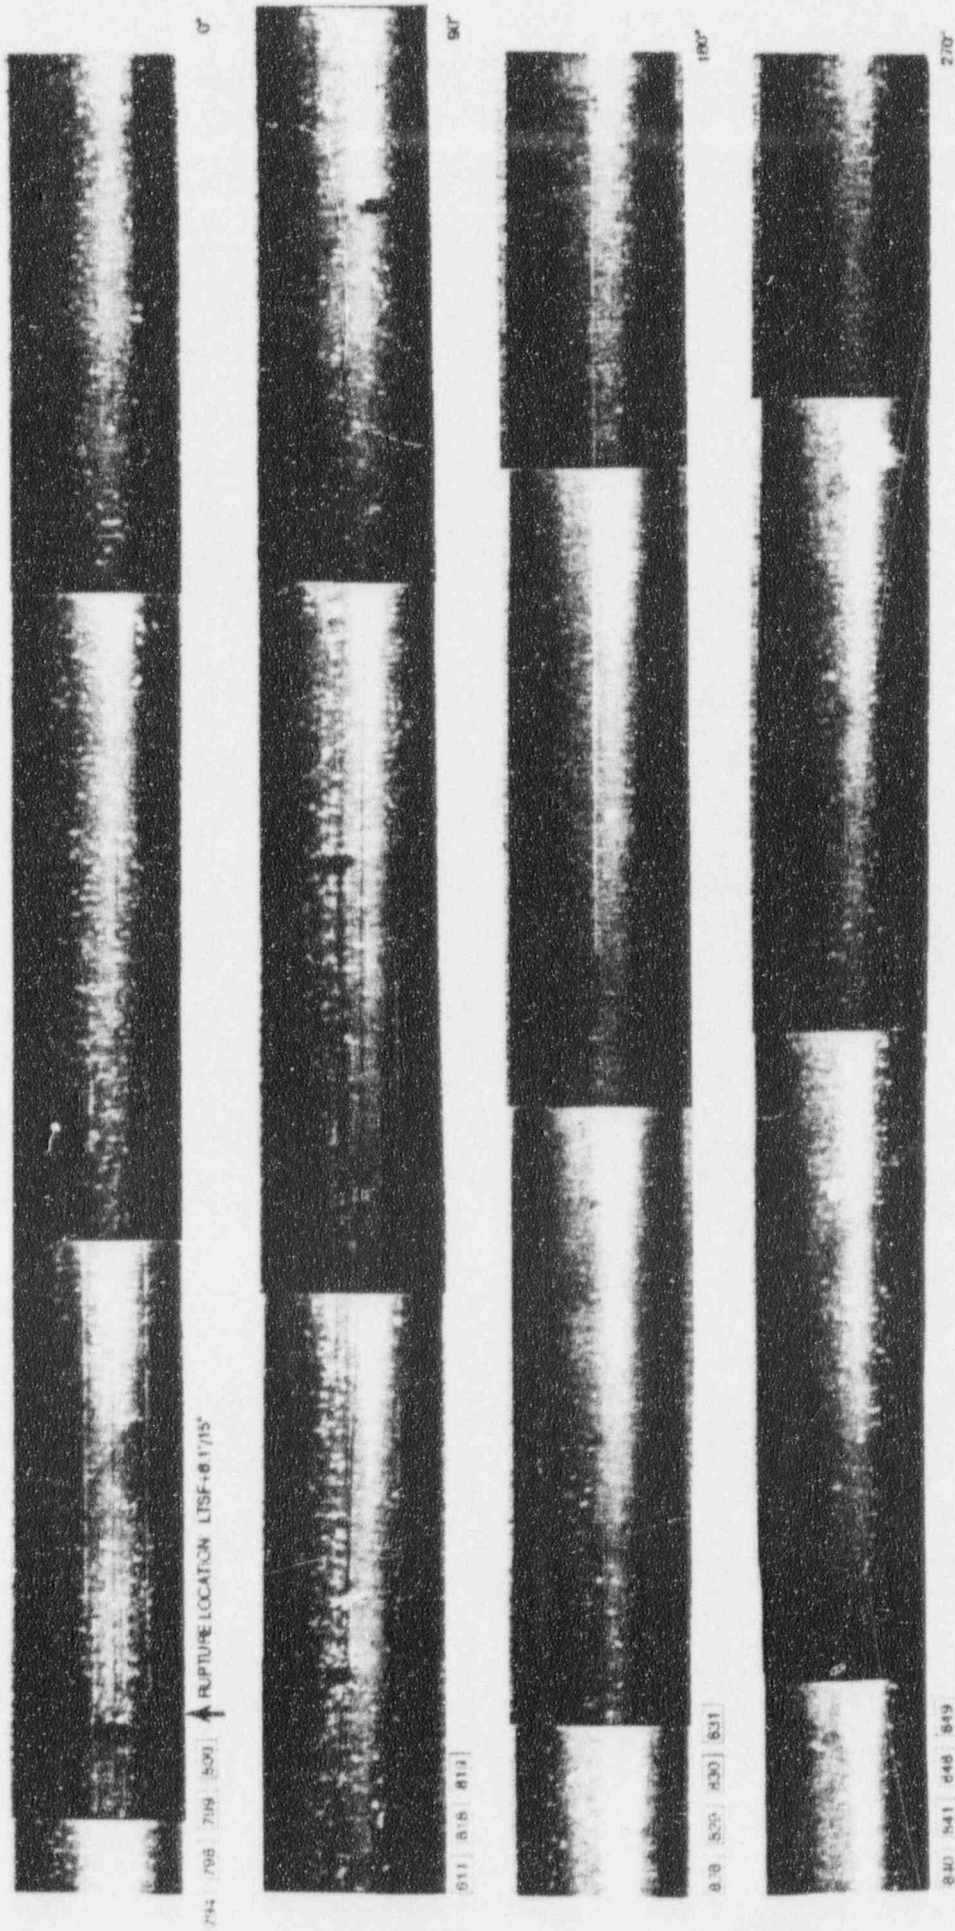
Figure 2-31: Mosaic of 97-91-2 After Being Burst

Representative mosaics of tube sections 97-91-2, 106-32-2, and 52-51-2, are shown in Figures 2-30 through 2-32. As stated in Section 2.2.2, light-colored "stains" were present over much of the OD surface on the descaled tube sections; these stains generally correlated with the spalled deposit regions and darker scalloped areas noted previously during the visual inspection. The stereovisual inspection revealed defects within some of these light stains. Most of the degradation was in the form of small IGA patches, although some minor pitting was occasionally observed. It was also observed that some of the defects were located at axial scratches. These scratches were most likely created during tube installation since fresh scratches caused by tube removal would have been observed in the initial examination but were not. A total of 17 and 56 potential defect areas were identified on burst tube sections 97-91-2 and 106-32-2, respectively. Representative defect areas are shown at higher magnification in Figures 2-33. All defect information is summarized in Table 2-6 below.

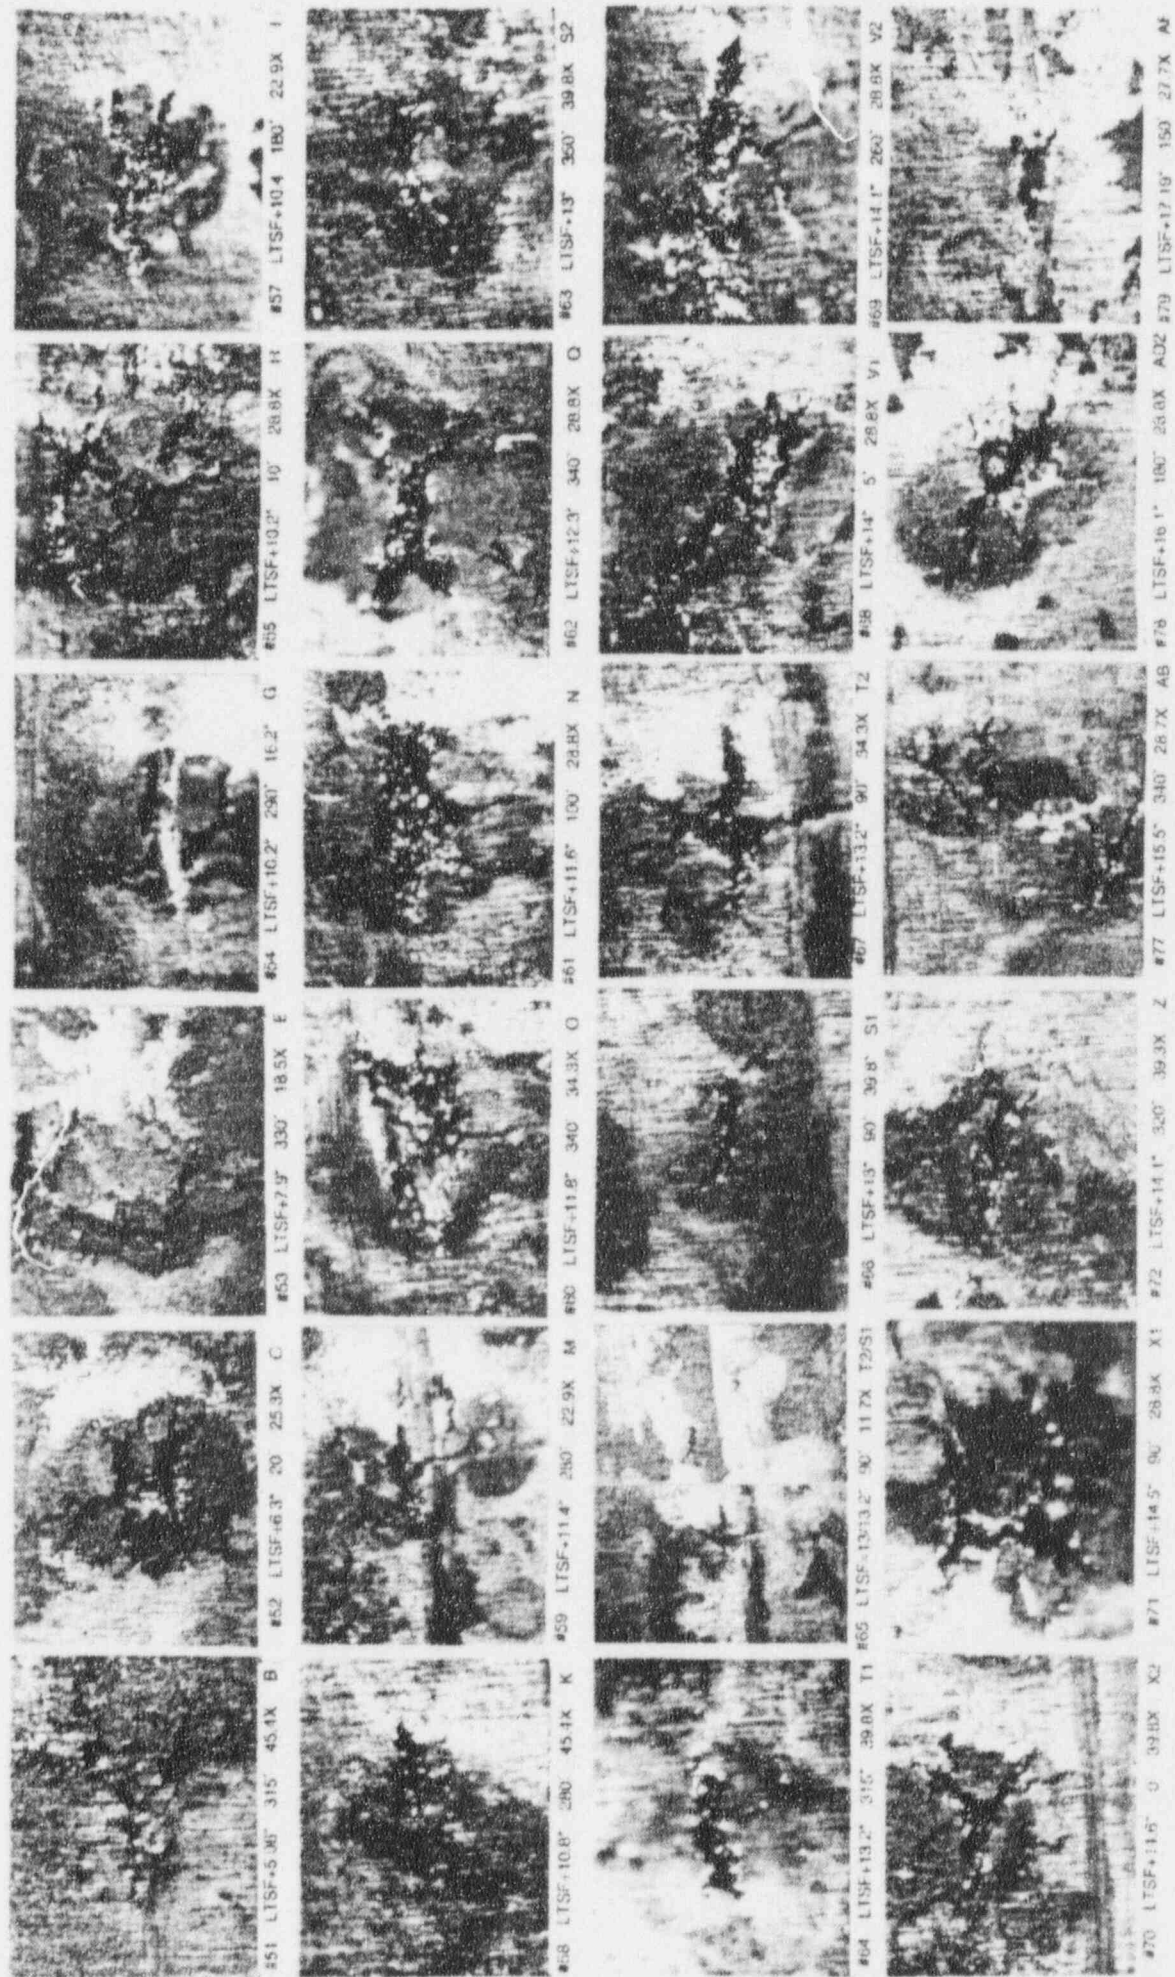
Figure 2-35: Stereovisual Result on 90-28-2 After Swelling

For tube sections 52-51-2 and 90-28-2, the deposits spalled in such a manner that a spotty pattern of adhering deposit remained on the tube surface. The adhering deposit areas correlated precisely with the thin, dark, scallop shaped deposits noted during the initial visual inspection. Additional patterns of dark stains, with essentially no associated deposit, were also noted; these areas appeared to correlate quite well with the spotty patterns of spalled deposit previously noted. The stereovisual inspection revealed defects within some of the scallop shaped deposit regions. Essentially all the degradation was in the form of small IGA patches, although it is possible minor pitting, as observed on the other two tube sections, may not have been visible due to obstructing deposits. Again, several of the IGA patches were located at "old-appearing" axial scratches, which were most likely created during tube installation. A total of 17 and 24 potential defect areas were identified on tube sections 52-51-2 and 90-28-2, respectively (see Figs. 2-34 & 2-35); the defects are summarized in Table 2-7 below.

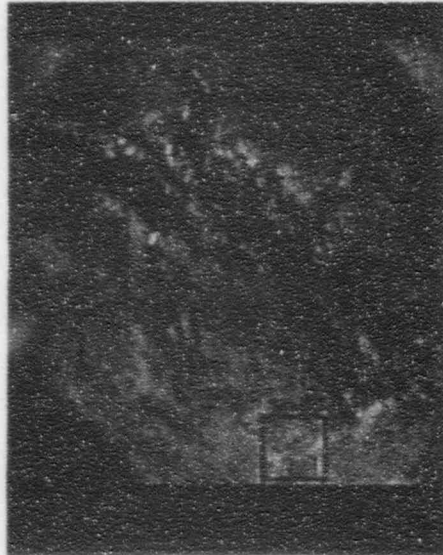
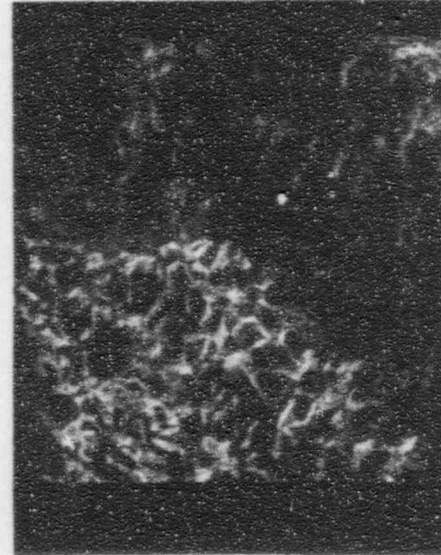
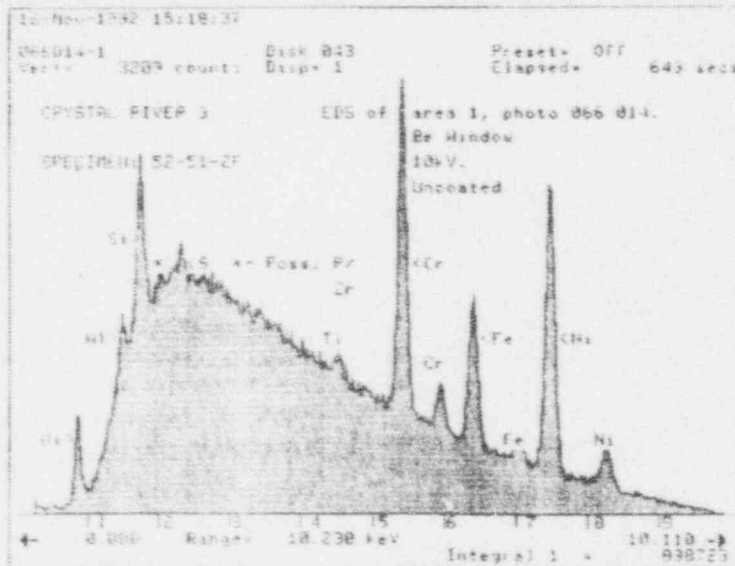
Figure 2-41: SEM/EDS Results on Specimen 52-51-2F (IGA Patch at LTSF+8.8" and 350°)

Typical IGA regions are shown after swelling in Figures 2-41 through 2-44. The intergranular nature of the fracture surfaces is readily apparent. At higher magnifications an obvious grain boundary film was noted (see Figs. 2-43 and 2-44). EDS analysis of the grain facets indicated chromium, oxygen and nickel were the major corrosion film constituents. However, significant levels of iron, sulfur, aluminum, silicon and carbon were also detected.

NOTE IGA CONTAINED WITHIN STAIN AND ADJACENT CRACK

NOTE SI AND AL PEAKS ALSO LOW S PEAK

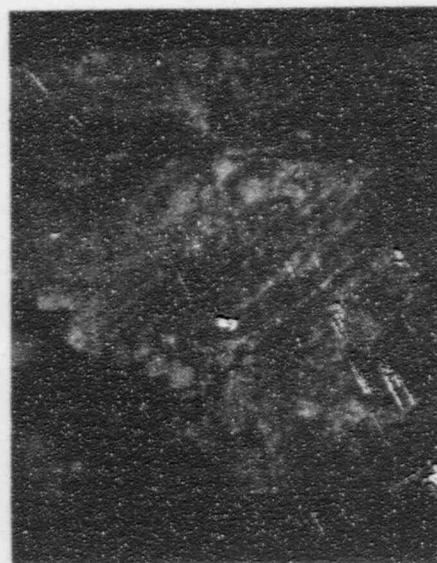
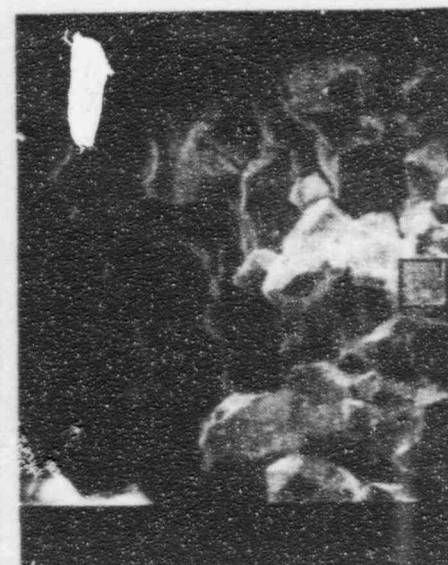
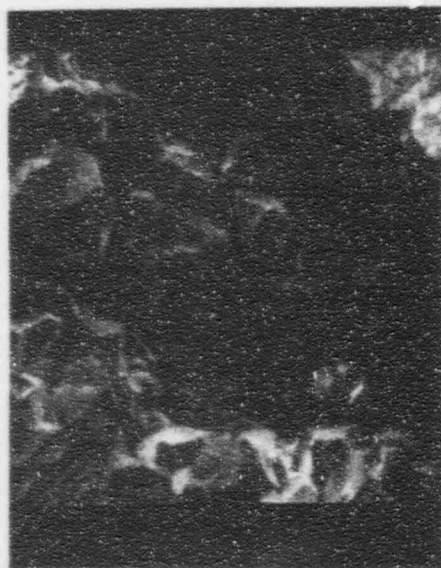
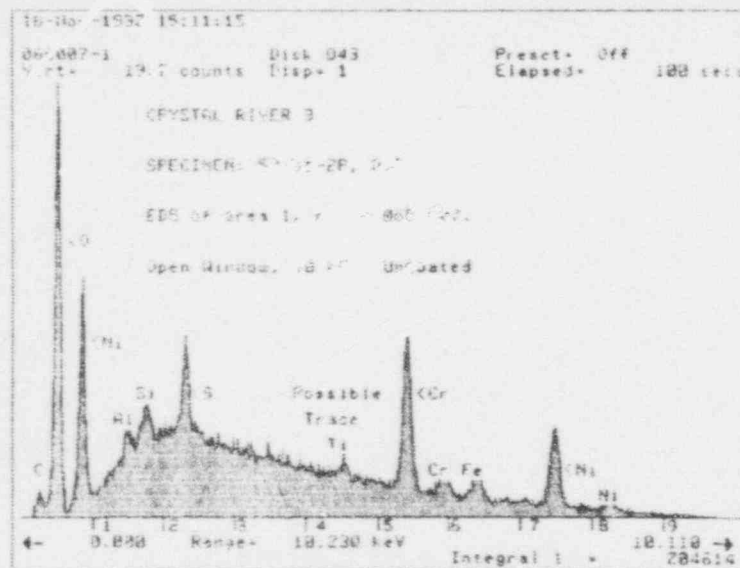
Figure 2-42: SEM/EDS Results on Specimen 52-51-2P
 (IGA Patch at LTSE+13.1" and 200°)

NOTE DARK STAINS SURROUNDING IGA AND ADJACENT SCRATCH

NOTE HIGH S IN GRAIN BOUNDARY CORROSION FILM

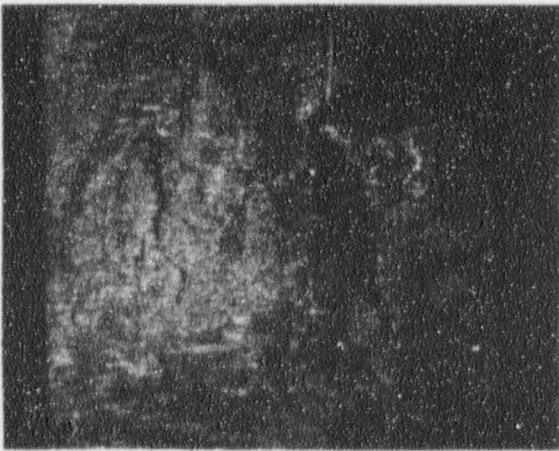
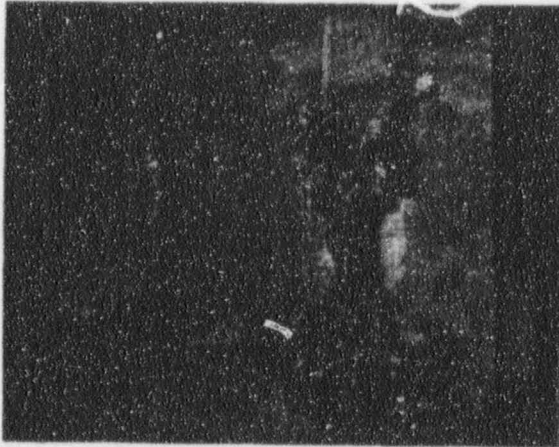
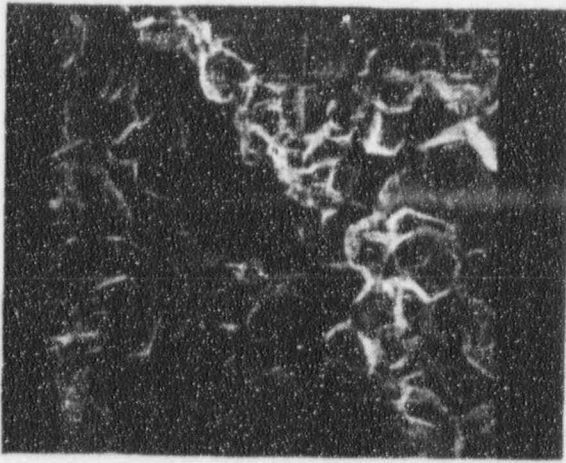
Figure 2-43: SEM/EDS Results on Specimen 90-28-2B (IGA Patch at LTSF+5.1" and 315°)

NOTE STAINS

NOTE GRAIN BOUNDARY CORROSION
FILM AND SULFUR INDICATIONS

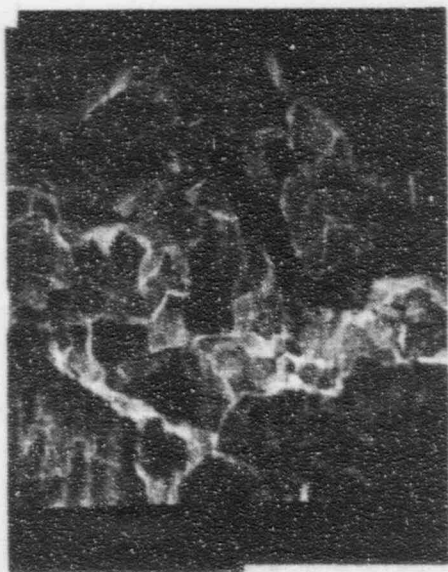
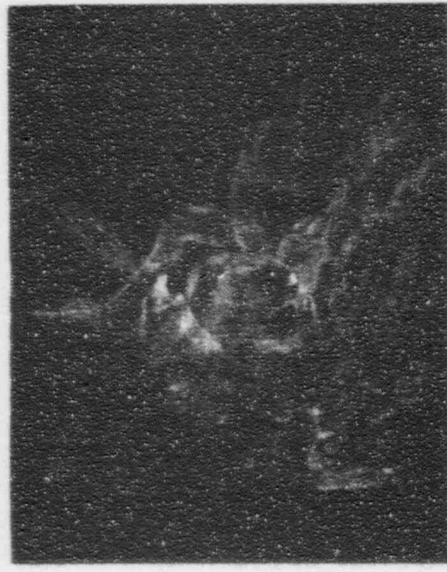
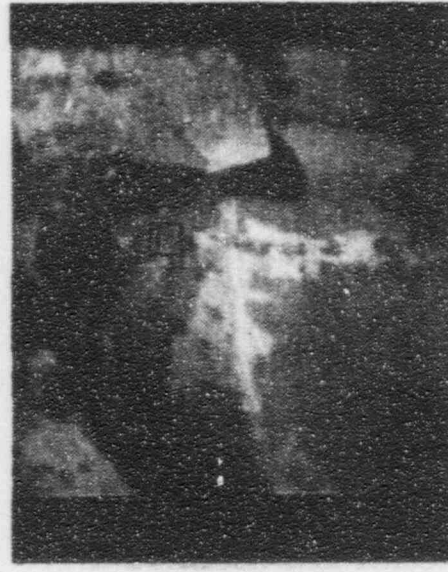
Figure 2-44: SEM/EDS Results on Specimen 90-28-2N (IGA Patch at LTSF+11.6" and 100°)

NOTE GRAIN BOUNDARY CORROSION
 FILM AND SULFUR INDICATIONS ABOVE

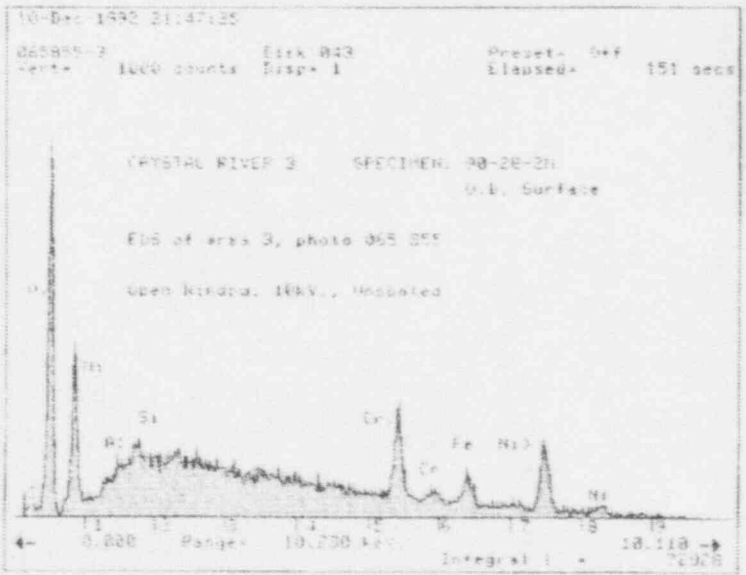
Figure 2-45: SEM/EDS Results on Specimen 90-28-2N OD Tube Surface

As noted previously, although the majority of the deposit spalled away from the tube as a result of swelling, "stains" were left on the tube OD surface where the scalloped areas of dark thin deposit had been. It was noted that the IGA patches were contained entirely within these stained regions, although there were obviously large numbers of "stained" regions which had not developed IGA. A ring of deposit typically remained on the surface outlining each stain (see Fig. 2-45). EDS analysis indicated the heavier deposits in this surrounding ring were rich in aluminum, silicon and oxygen; lower levels of base metal elements were also detected. Within the ring of heavier deposit (i.e., within the stain itself) and on the tube surface outside of the stain, a EDS fingerprint more typical of oxidized I-600 was observed, although the chromium appeared to be somewhat enriched relative to base metal composition. It was also noted that the area within the stain exhibited a higher oxygen peak and had slightly higher silicon and aluminum levels than the tube surface outside of the stain.

2 INNER PORTION ON STAIN
SOME SI AND Al; SLIGHTLY Cr-RICH

1 OUTER RING HIGH SI AND Al

3 "CLEAN" TUBE OD SURFACE
LOW SI AND Al; Ni/Cr/Fe RATIO
ABOUT SAME, BUT LOWER O
