Examination of Crystal River Unit #3 Steam Generator Tube Sections

TR-103756

Final Report, January 1994

B&W NUCLEAR TECHNOLOGIES
Special Products & Integrated Services Division
and
THE BABCOCK & WILCOX COMPANY
Nuclear Environmental Services, Inc.

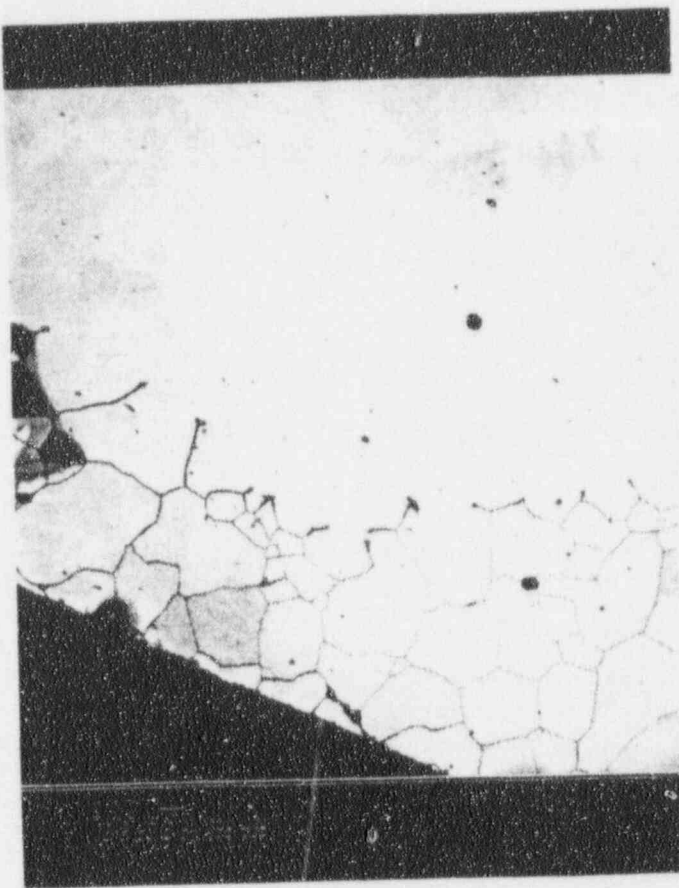
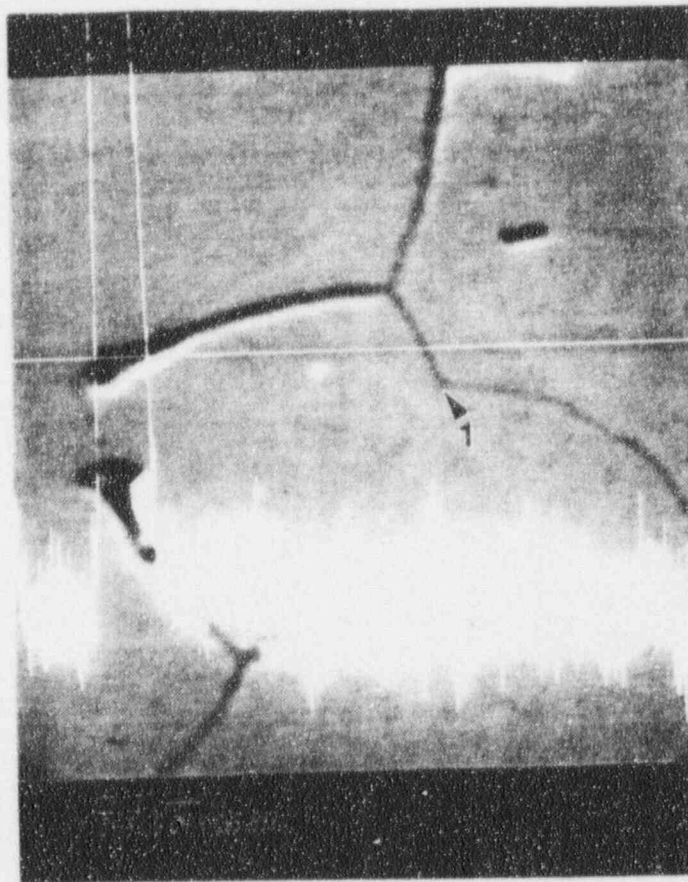
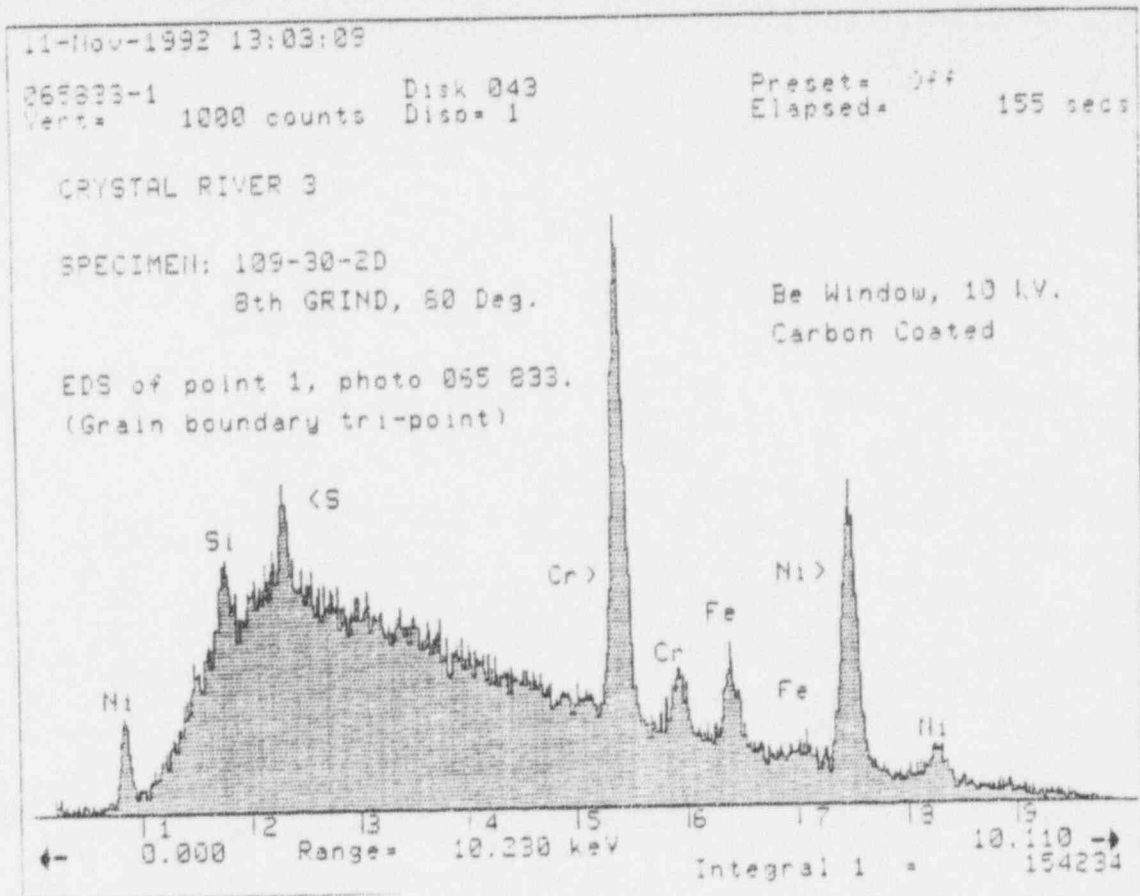
One (1) grinding plane from each of these specimens was inspected by SEM/EDS. Typical patches of IGA are shown in Figures 2-46 and 2-47. EDS analysis of the grain boundary corrosion products revealed very high sulfur levels (see also Fig. 2-48). Sulfur enrichment at the grain boundaries is further illustrated by the sulfur line scans in Figures 2-46 and 2-47.

Figure 2-48: SEM/EDS Results on Specimen 109-30-2D, 8th Grind, 80° IGA Patch
 (Note indications of sulfur at grain boundaries)

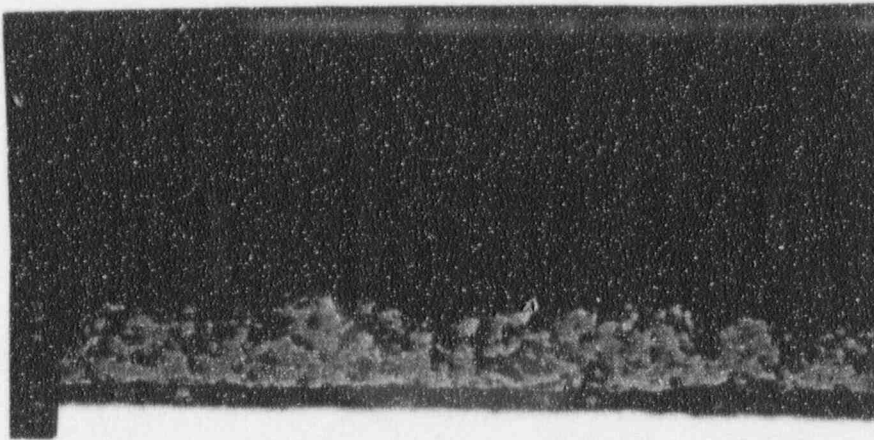
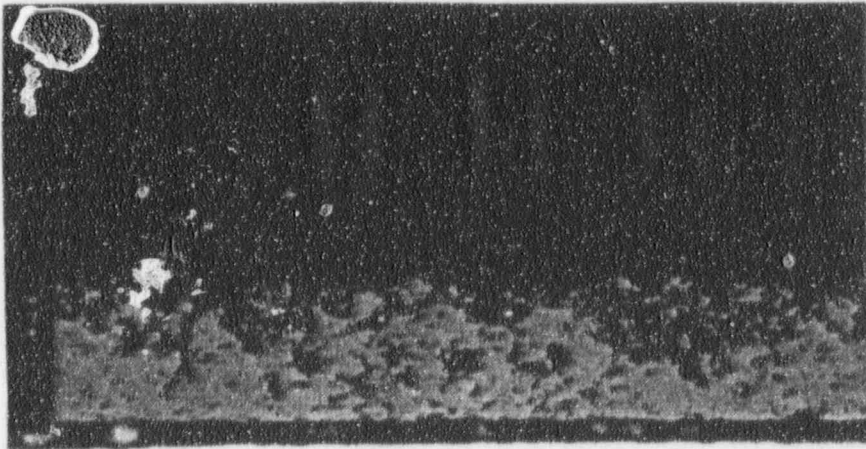
Figure 2-49: Typical Deposit Cross Sections (630X)

Metallography and SEM/EDS results on these metallography specimens revealed a relatively thin (about 1 mil thick or less) porous deposit layer. The deposits on specimen 133-33-3 were slightly thinner on average than the other specimens, while specimen 133-33-8 exhibited slightly thicker (up to 1.5 mil) deposits. Typical deposit cross sections are shown in Figure 2-49. The porosity levels were highest at the outer surface, giving the outer deposit a "fluffy" appearance, and decreased to very low levels near the deposit/tube interface.

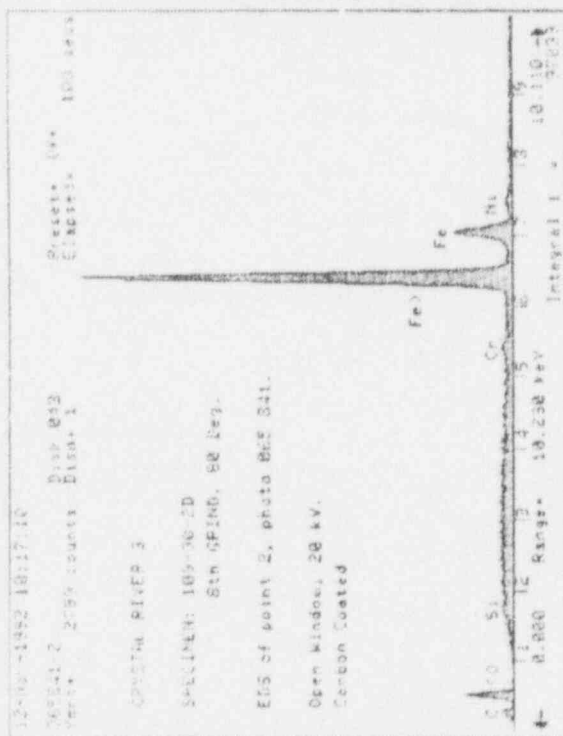
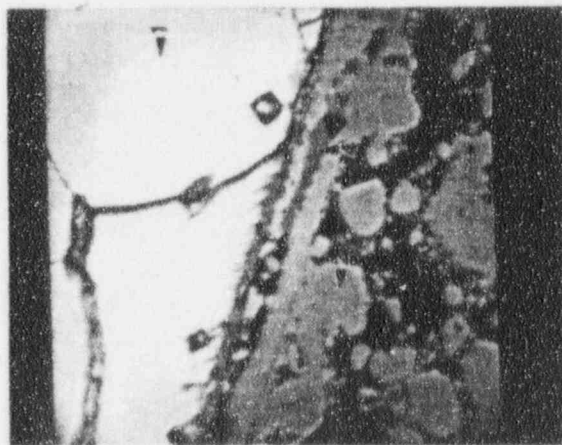
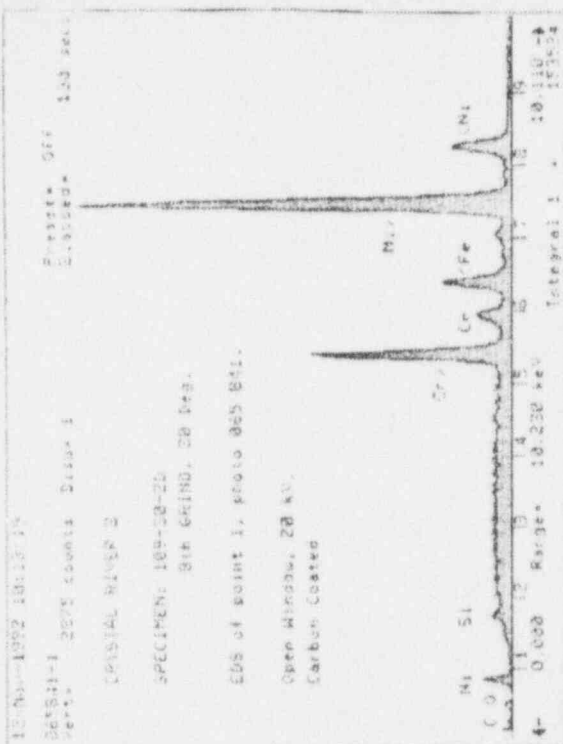
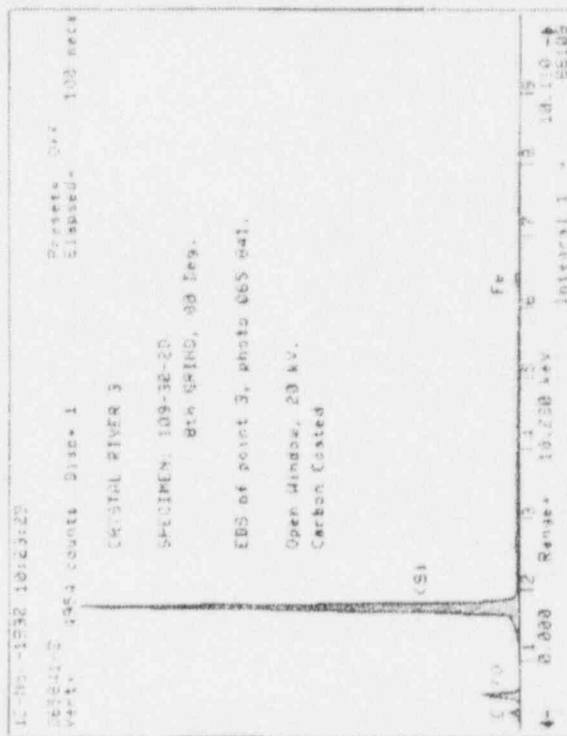
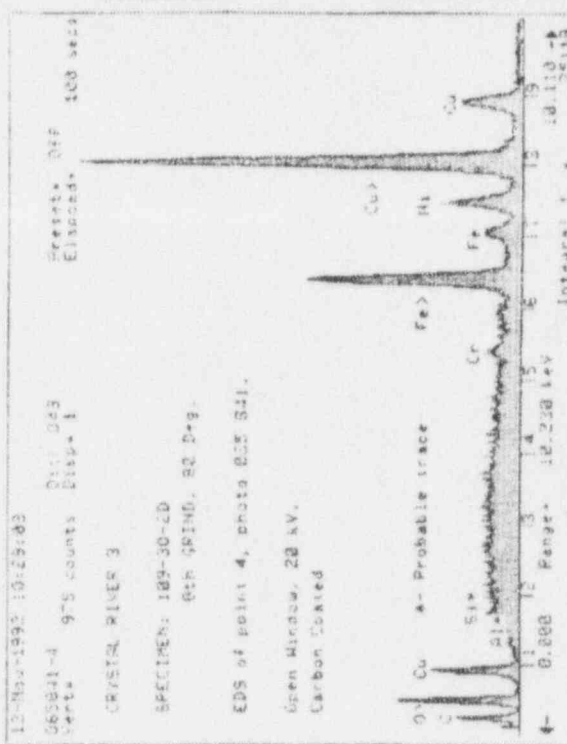
Figure 2-50: SEM/EDS Results on Specimen 109-30-2D, 8th Grind, 80° IGA Patch

For the most part, the deposits appeared to be a single phase, with iron and oxygen as the major elemental constituents (see Figs. 2-50 through 2-53); trace levels of chromium, nickel, copper, and silicon were also detected. It was interesting to observe that a thin layer (perhaps on the order of 1 μm thick) of deposit at the tube/deposit interface was typically enriched in chromium and nickel relative to the bulk deposit (see esp. Fig. 2-52). Very infrequently, a copper-rich secondary phase, which was generally

present as discrete particles in the deposit, was observed on most of the samples. In specimen 109-30-2D a copper-rich particle appeared to be present as an oxide (see Fig. 2-50), while small particles of apparent metallic copper were observed in one location on specimen 133-33-8 (see Fig. 2-53). No sulfur was detected in the bulk deposit by EDS.

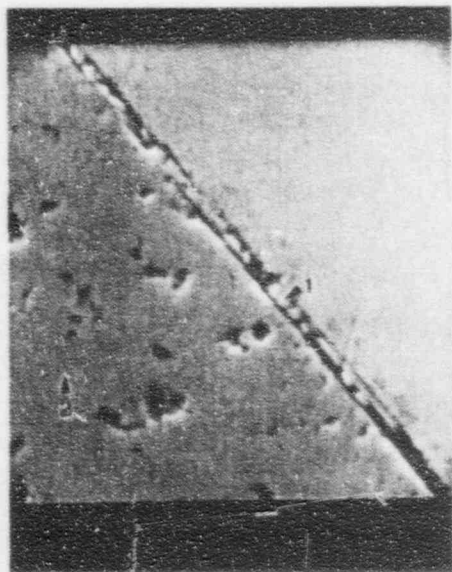
Figure 2-51: SEM/EDS Results on Specimen 90-28-5, 2nd Span
 Note: Enriched Ni & Cr Levels immediately adjacent to Tube OD Surface

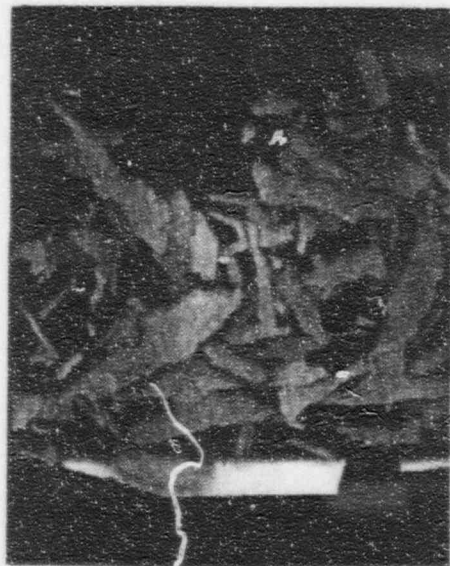
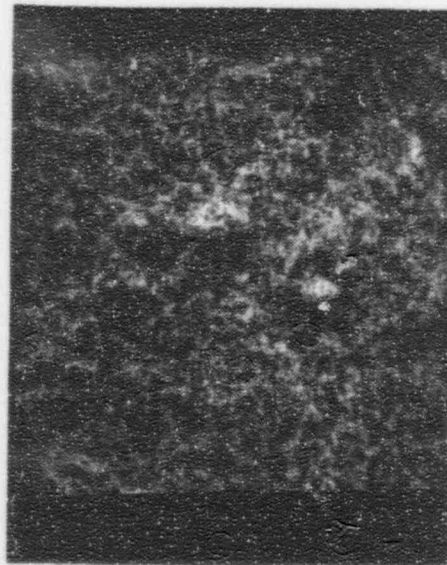
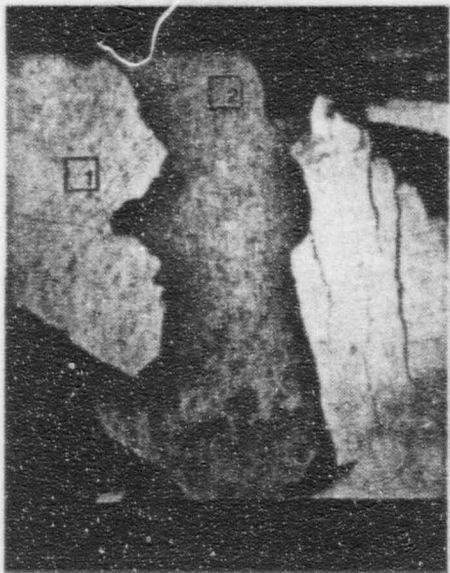
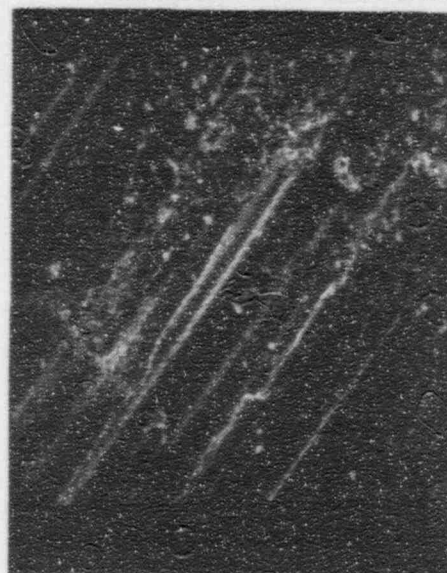
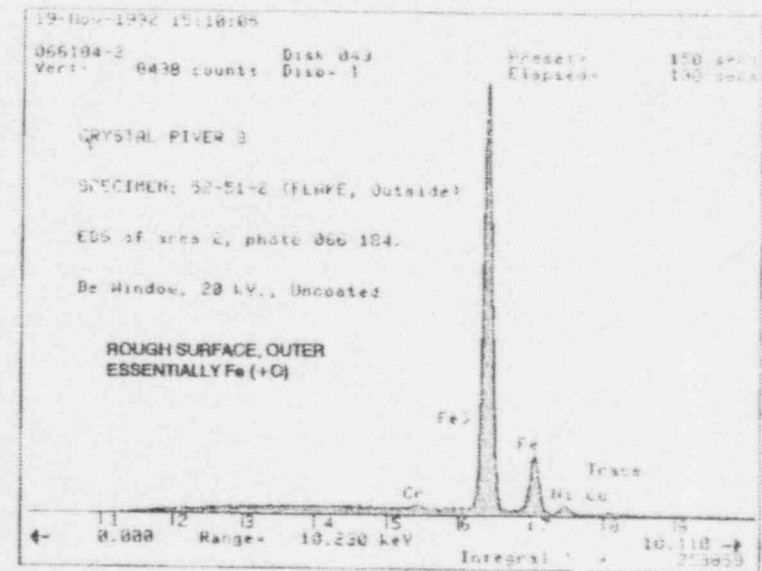
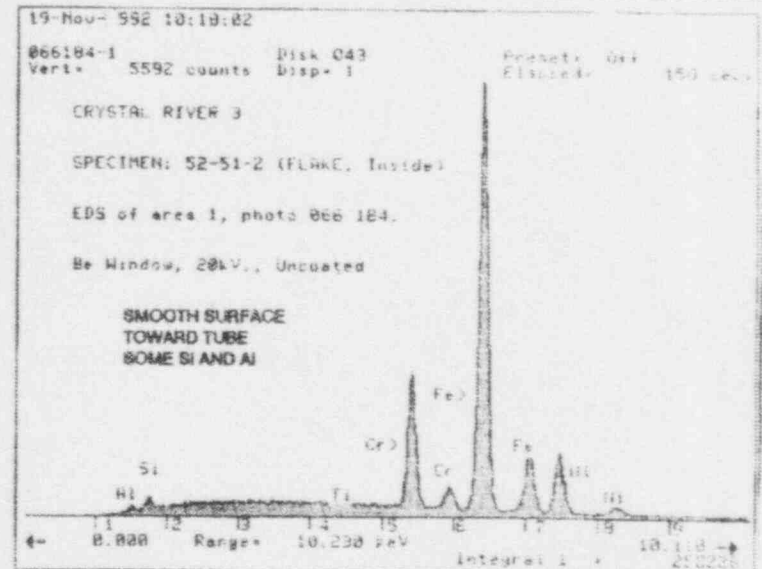
Figure 2-54: SEM/EDS Results on OD Deposit Flake from 52-51-2

SEM/EDS results indicated the outer flake surfaces were rough and porous, giving the deposit a "fluffy" appearance (see Figs. 2-54 through 2-57). The outer surfaces were comprised chiefly of iron and oxygen. The inner surfaces were smooth with the circumferential grinding marks replicated in the deposit surface; composition of the inner surfaces were also predominantly iron and oxygen, but enriched with chromium and nickel relative to the outer deposit surface. Traces of aluminum, silicon and titanium were also occasionally detected on the flake inner surfaces, but no significant amounts of sulfur were found.

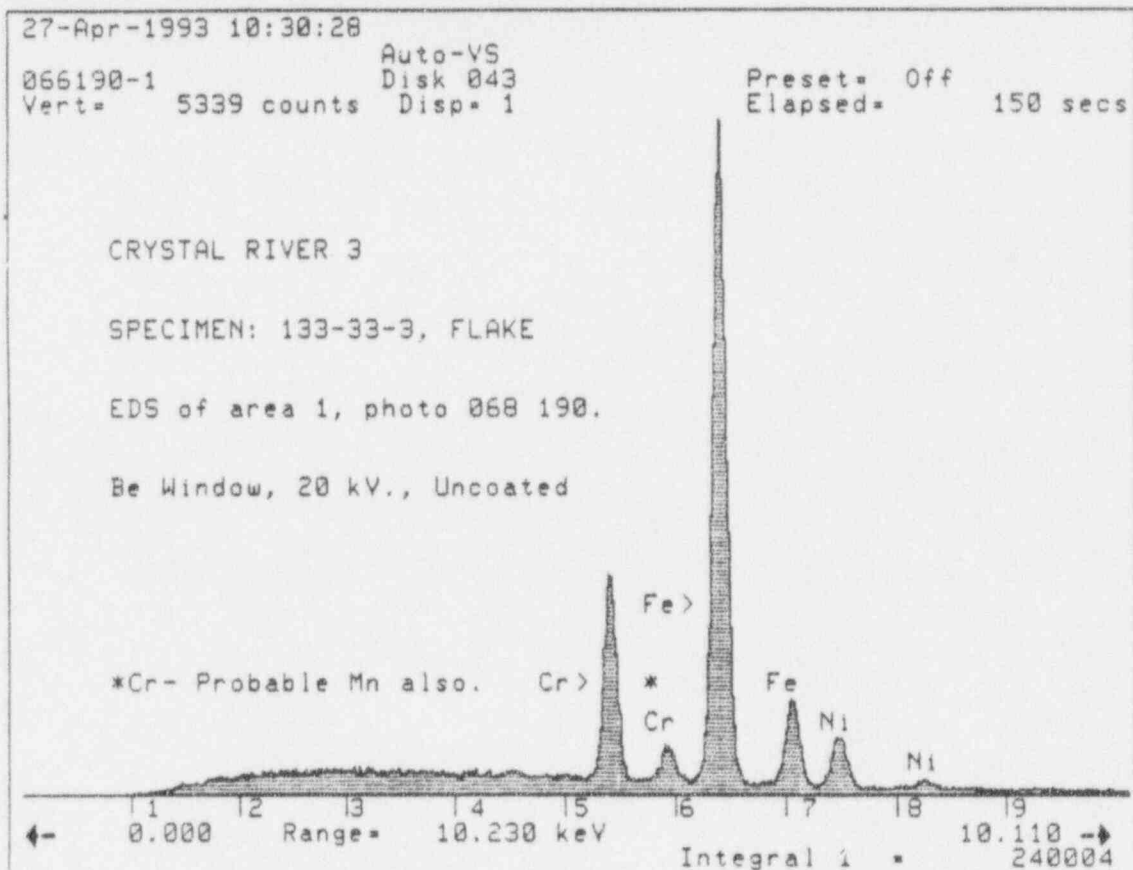
Figure 2-56B: Inner Deposit Flake Surface from Specimen 133-33-3

"X" MARKS LOCATIONS OF
DIFFERENT COMPOSITIONS
PREDOMINANTLY Ni/Cr/Fe RATIOS

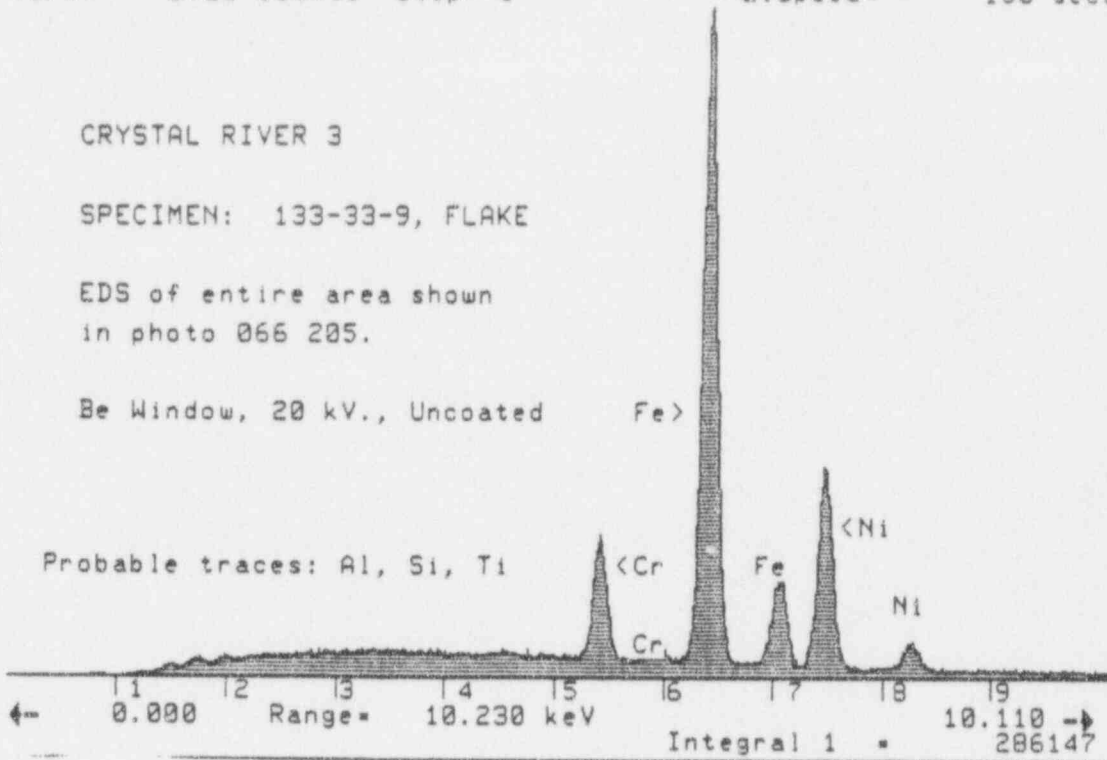
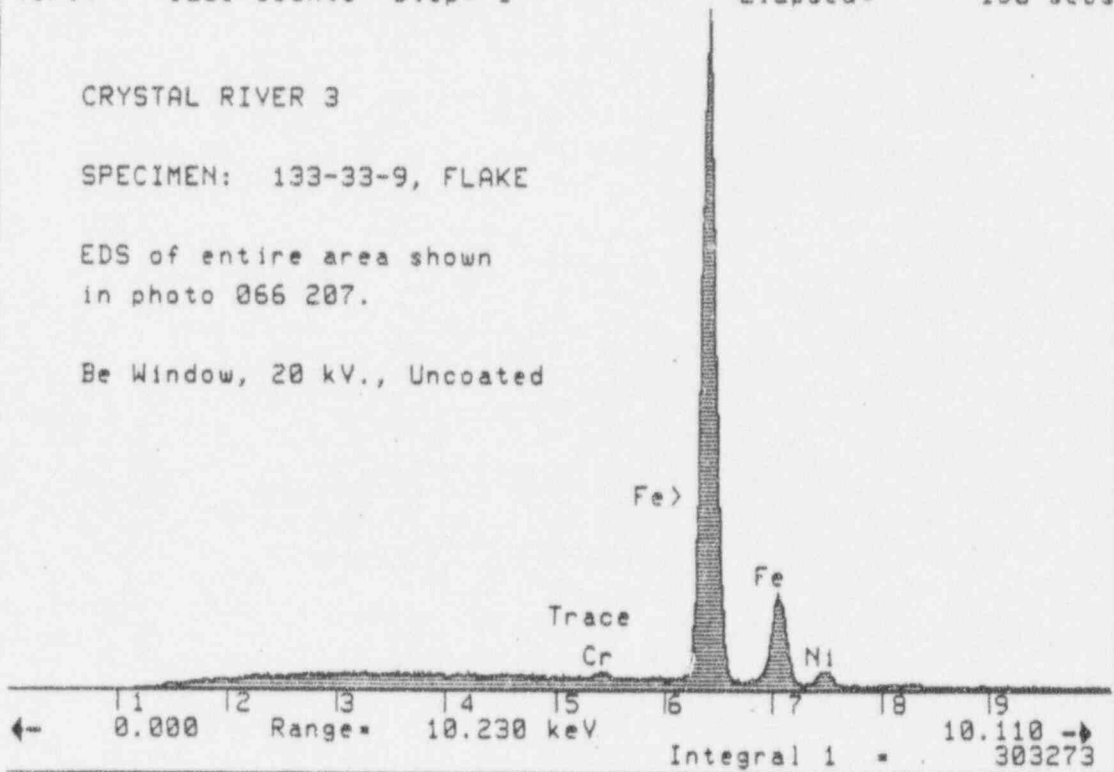
Figure 2-57B: Inner (Top) & Outer (Bottom) EDS Results on Deposit Flake Surfaces from Specimen 133-33-9

EDS of entire area shown
in photo 066 205.

EDS of entire area shown
in photo 066 207.

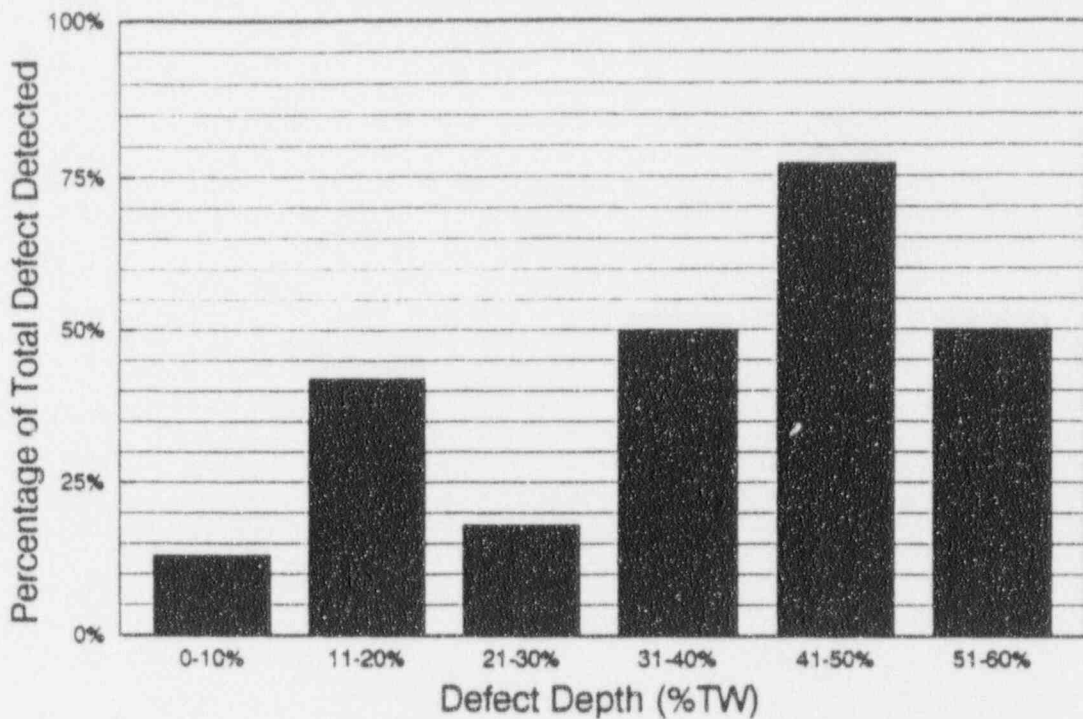
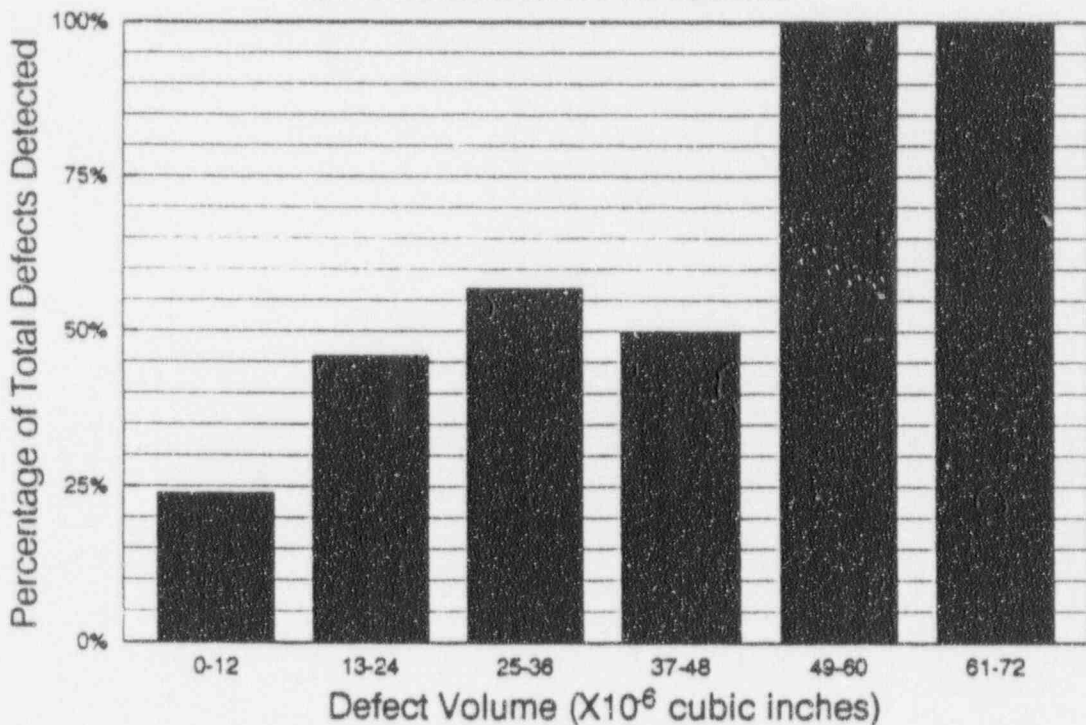
Figure 3-5: MRPC Detectability vs Depth and Volume
(Detectability based on both field and lab data)

MRPC data showed similar behavior, but in general its detectability was lower than bobbin coil (see Fig. 3-5). It had been observed previously by eddy current analysts that many of the field MRPC indications fell along a single angular position; this could easily be explained by the tendency for IGA patches to initiate at pre-existing axial scratches as noted in Section 3.1. A complete summary of eddy current detectability is provided in Table 3-2.

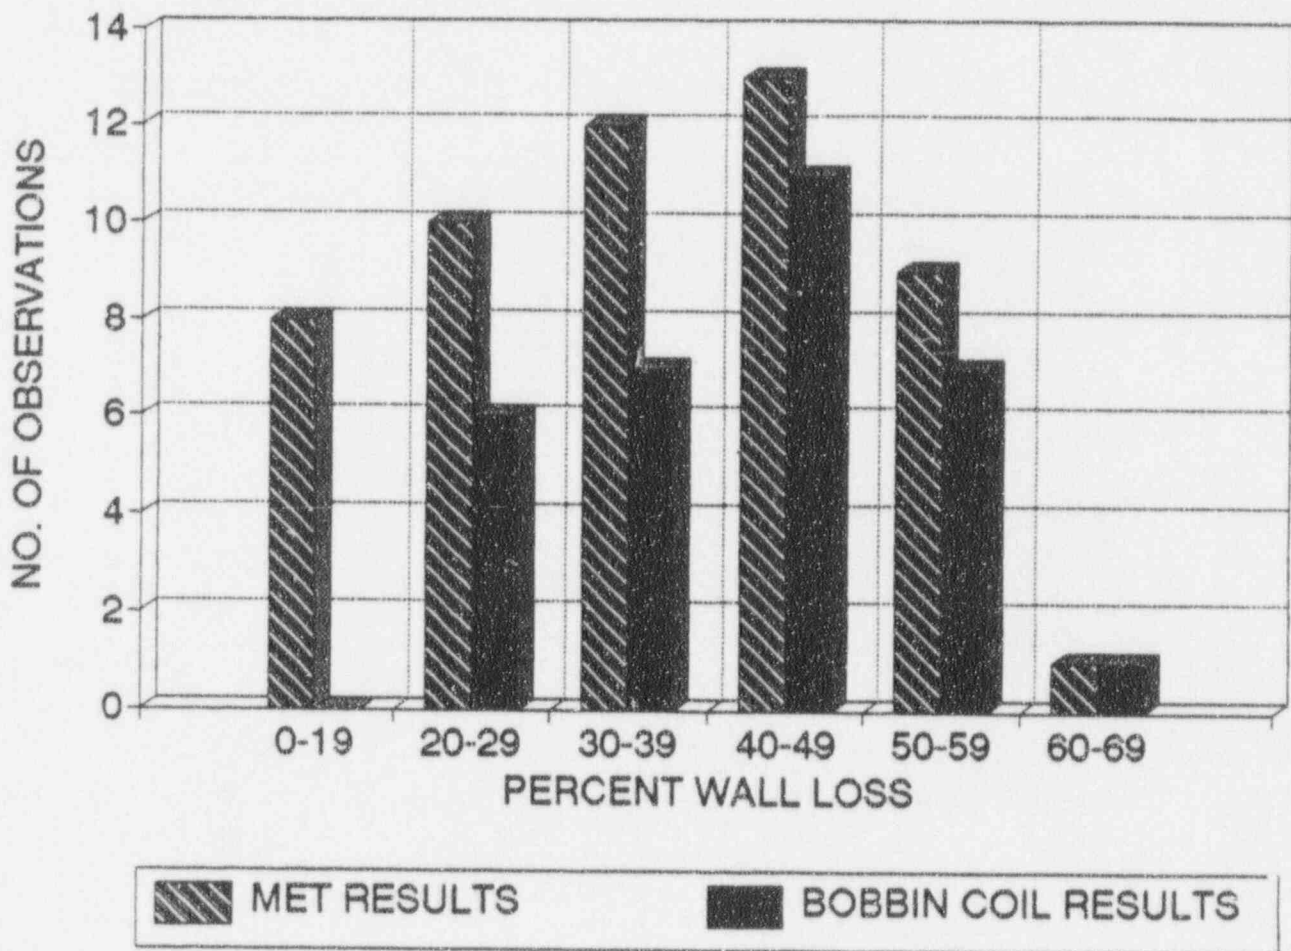
Figure 1 shows a distribution of IGA patches by different percent wall losses from primarily the following three tubes: Tubes 52-51, 106-32, and 90-28. Only two points were available for inclusion from Tube 109-30. There was a total of 23 IGA patches exhibiting 40% and greater wall losses, while the remaining 30 IGA patches exhibited less than the 40% repair limit. The IGA distribution peaked in the 40-49% wall loss range. Using the information presented in the figure, the percentage of IGAs detected by bobbin coils was next plotted at each respective flaw depth range. This IGA percent detection by bobbin coils is shown as Figure 2. In general, the plot shows any IGAs in excess of 45% wall loss are reliably detected 80% of the time.

Figure 1 - IGA distribution by depths based on the metallurgical and eddy current test results from the four pulled tubes

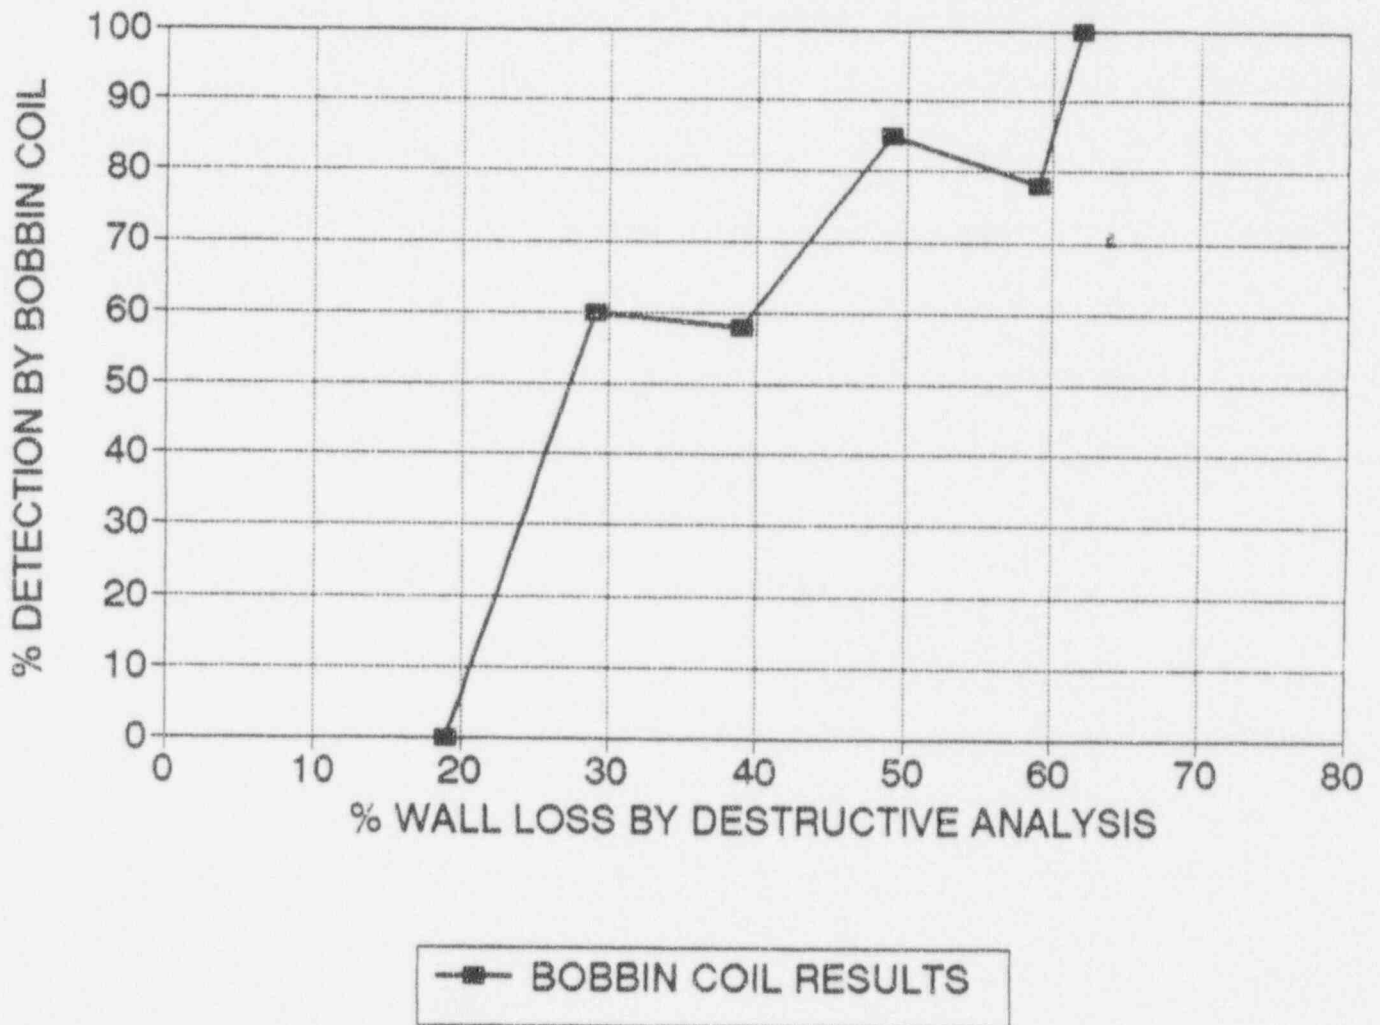
Figure 2 - IGA percent detection at various depths by bobbin coils

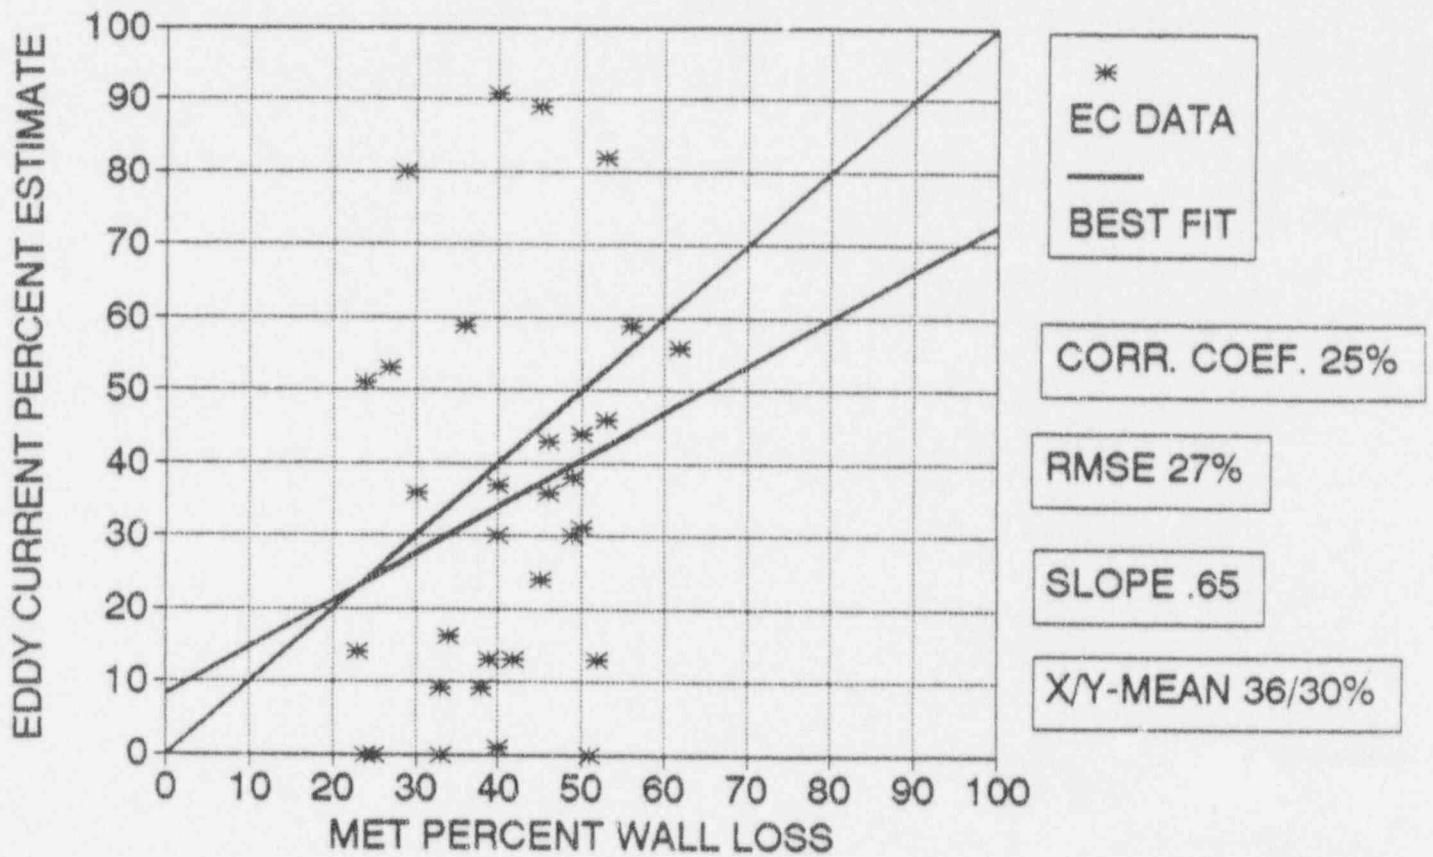
Figure 3 - Linear regression analysis of eddy current bobbin coil estimates versus metallurgical test results

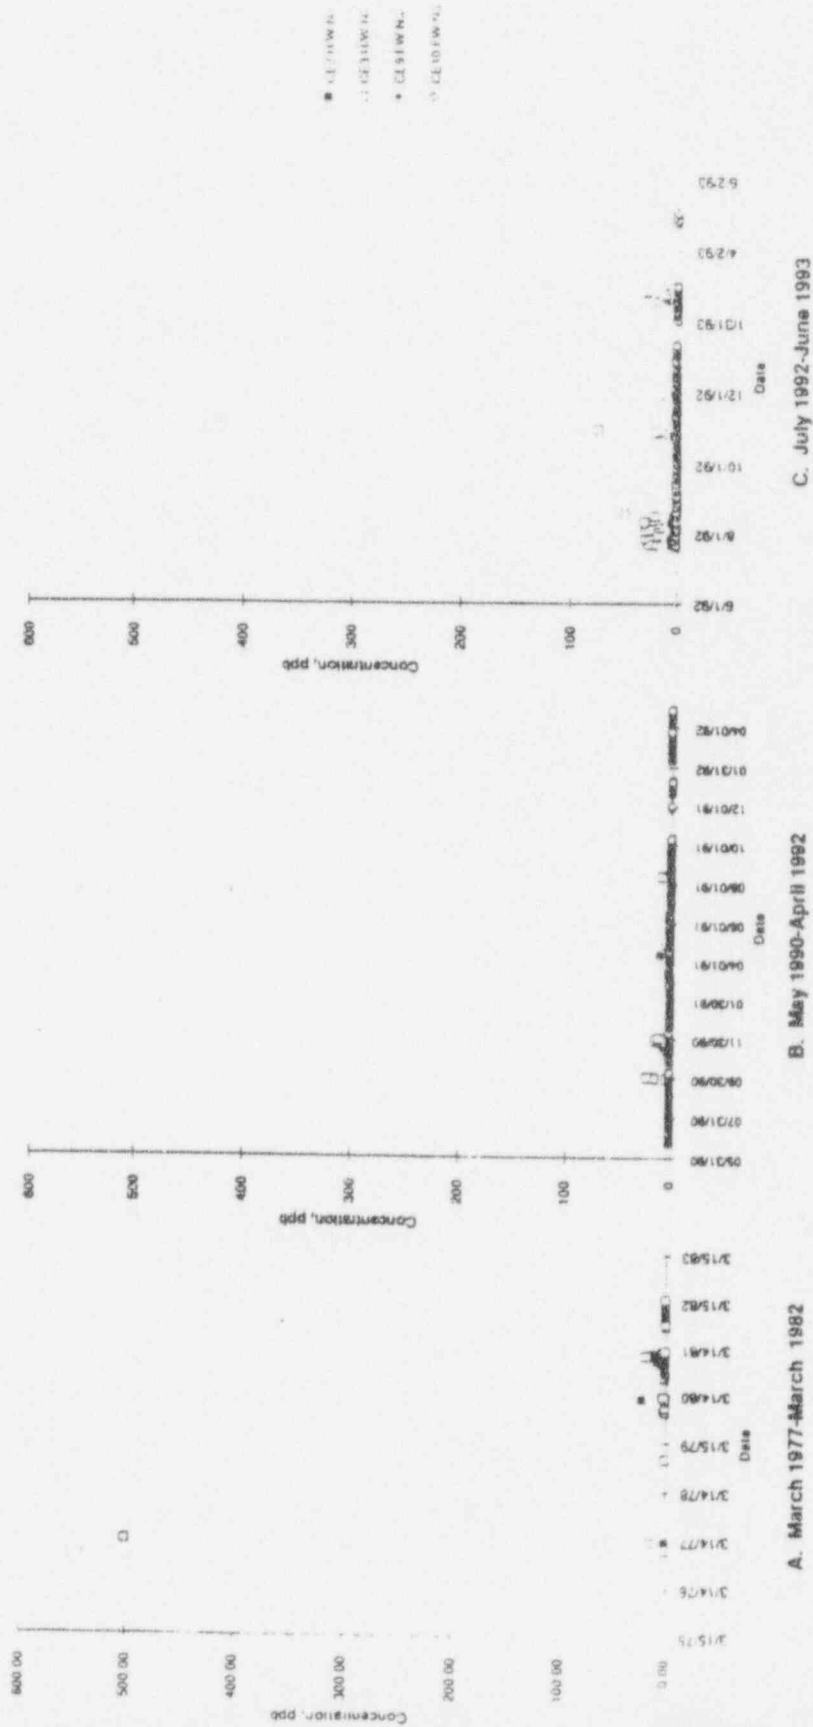
Figure 3-1 presents hotwell and feedwater sodium concentrations versus time for the three periods investigated during this study: January 1977 through April 1982, June 1990 through May 1992, and July 1992 through May 1993. There were no feedwater data available for the 1977 through 1982 time period.

There was one very high hotwell sodium concentration (500 ppb) at plant startup (1977), and it is probable that there was a corresponding elevated feedwater value. Blowdown sodium concentrations were approximately 100 ppb and 40 ppb for steam generators A and B, respectively, during this same 1977 startup time period (see Figure 3-2), which indicates that feedwater did experience elevated concentrations.

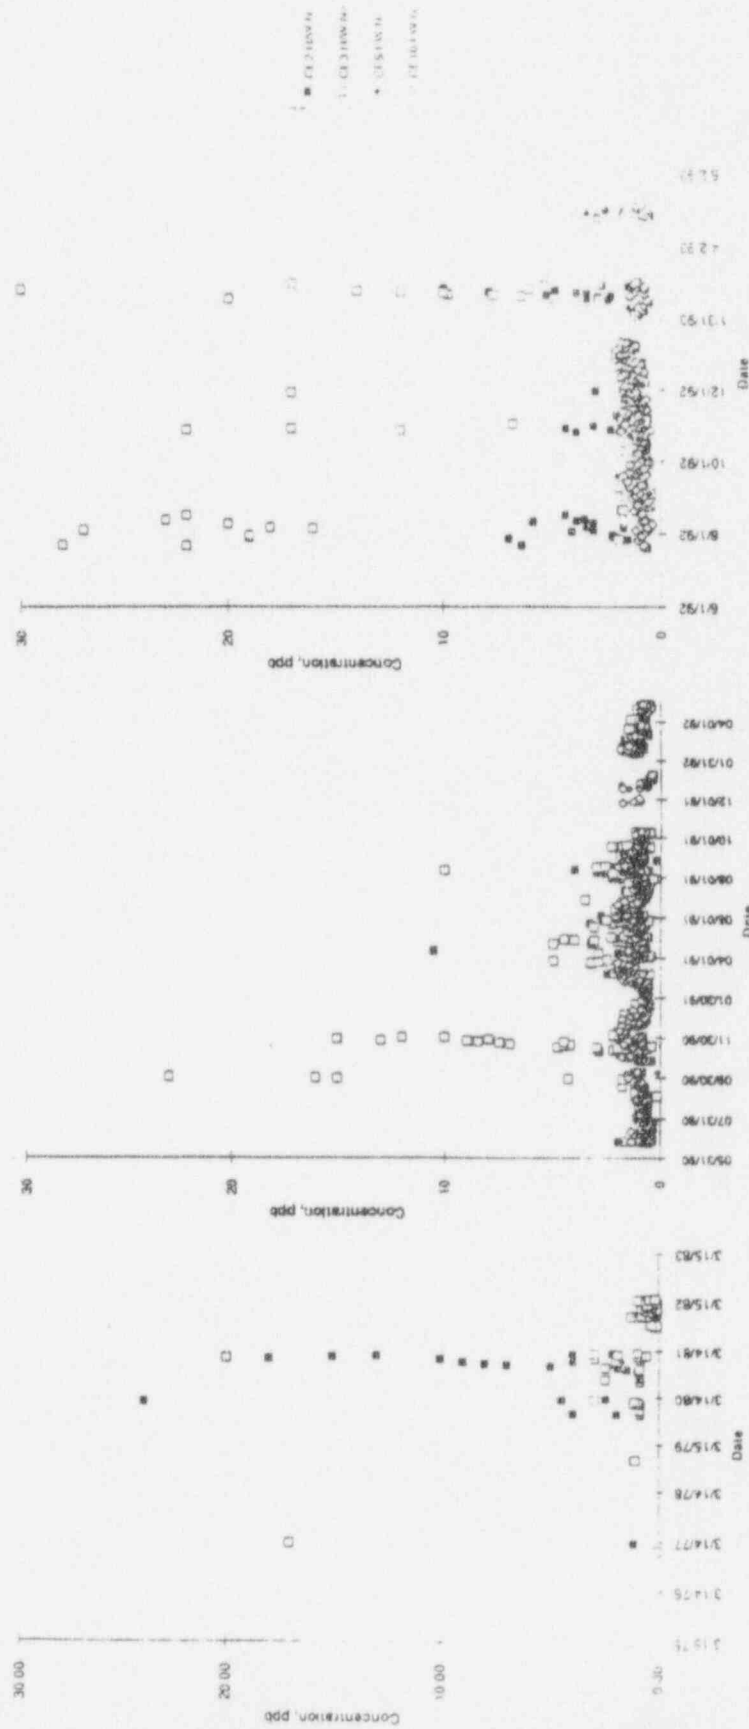
Figure 3-3

Hotwell and feedwater sodium data are shown on an expanded scale in Figure 3-3. From this presentation it can be seen that both hotwells experienced increases in sodium concentration between July 1992 and May 1993. However, the condensate polishers were able to maintain feedwater in the range of 0.5 to 2.5 ppb, except for a significant spike (4 ppb) during the May 1993 startup, corresponding to the initial introduction of ethanalamine (ETA) as a pH control agent.

A cyclical trend in feedwater sodium can be seen in Figure 3-3. Peaks in concentration of about 2 to 3 ppb occurred in June 1990, December 1990, March 1991, June 1991, August 1991, March 1992, September 1992, January 1993, and May 1993.

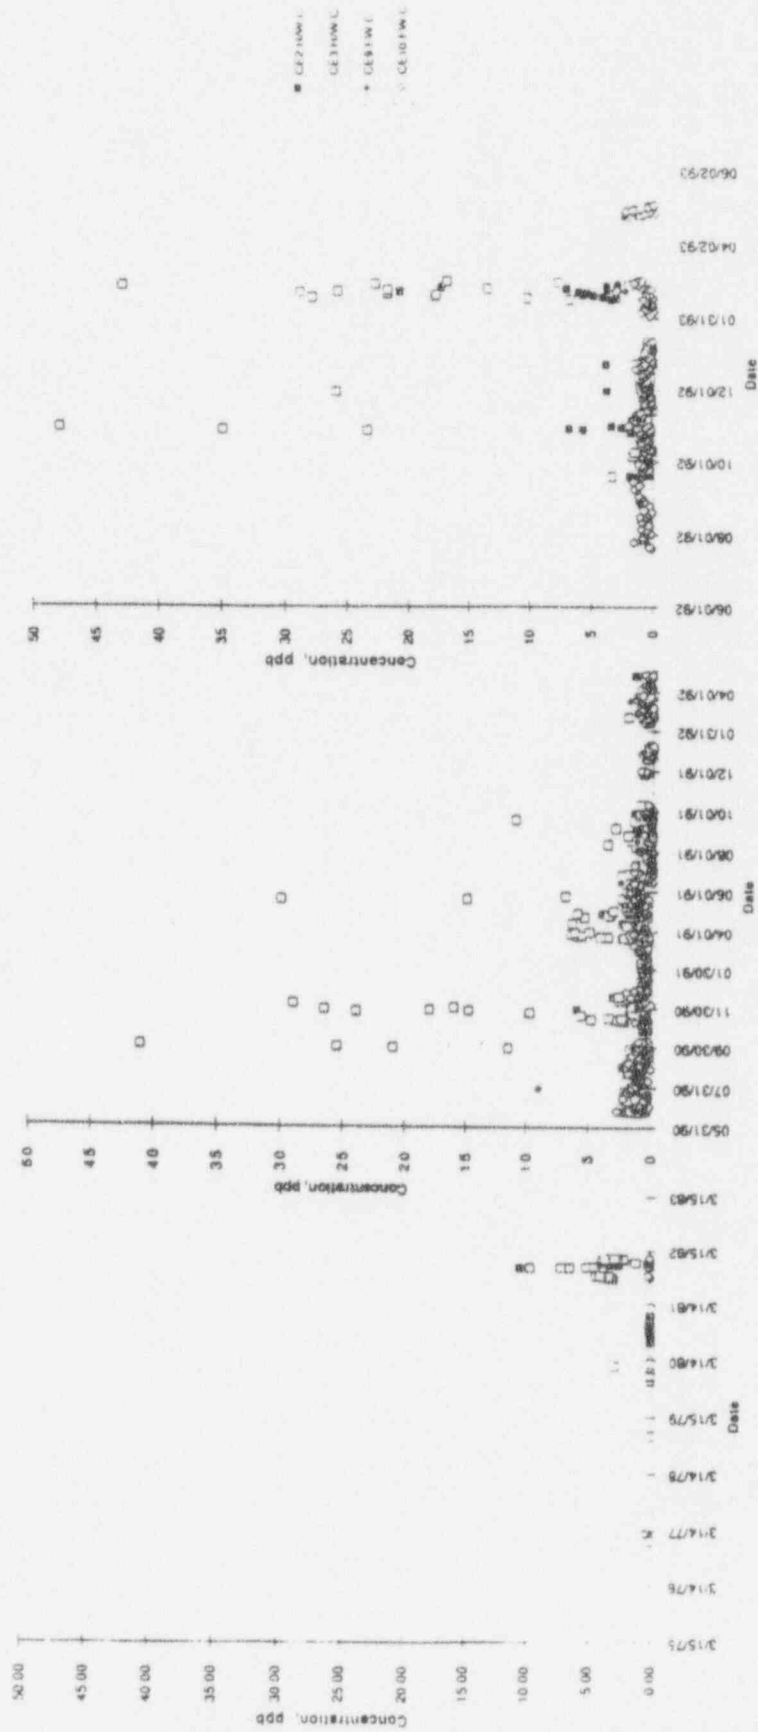
Figure 3-4 illustrates hotwell and feedwater chloride concentrations during the three time periods studied. Hotwell B experienced elevated chloride concentrations in 1982 (1 to 12 ppb) and during much of the 1990 and 1992 time frame (10 to 42 ppb). The condensate polishers were able to maintain feedwater concentrations at less than 3 ppb, except for one sample in June 1990, as shown on the expanded scale of Figure 3-5. It is possible that this anomalous value (9 ppb) was from a contaminated sample.

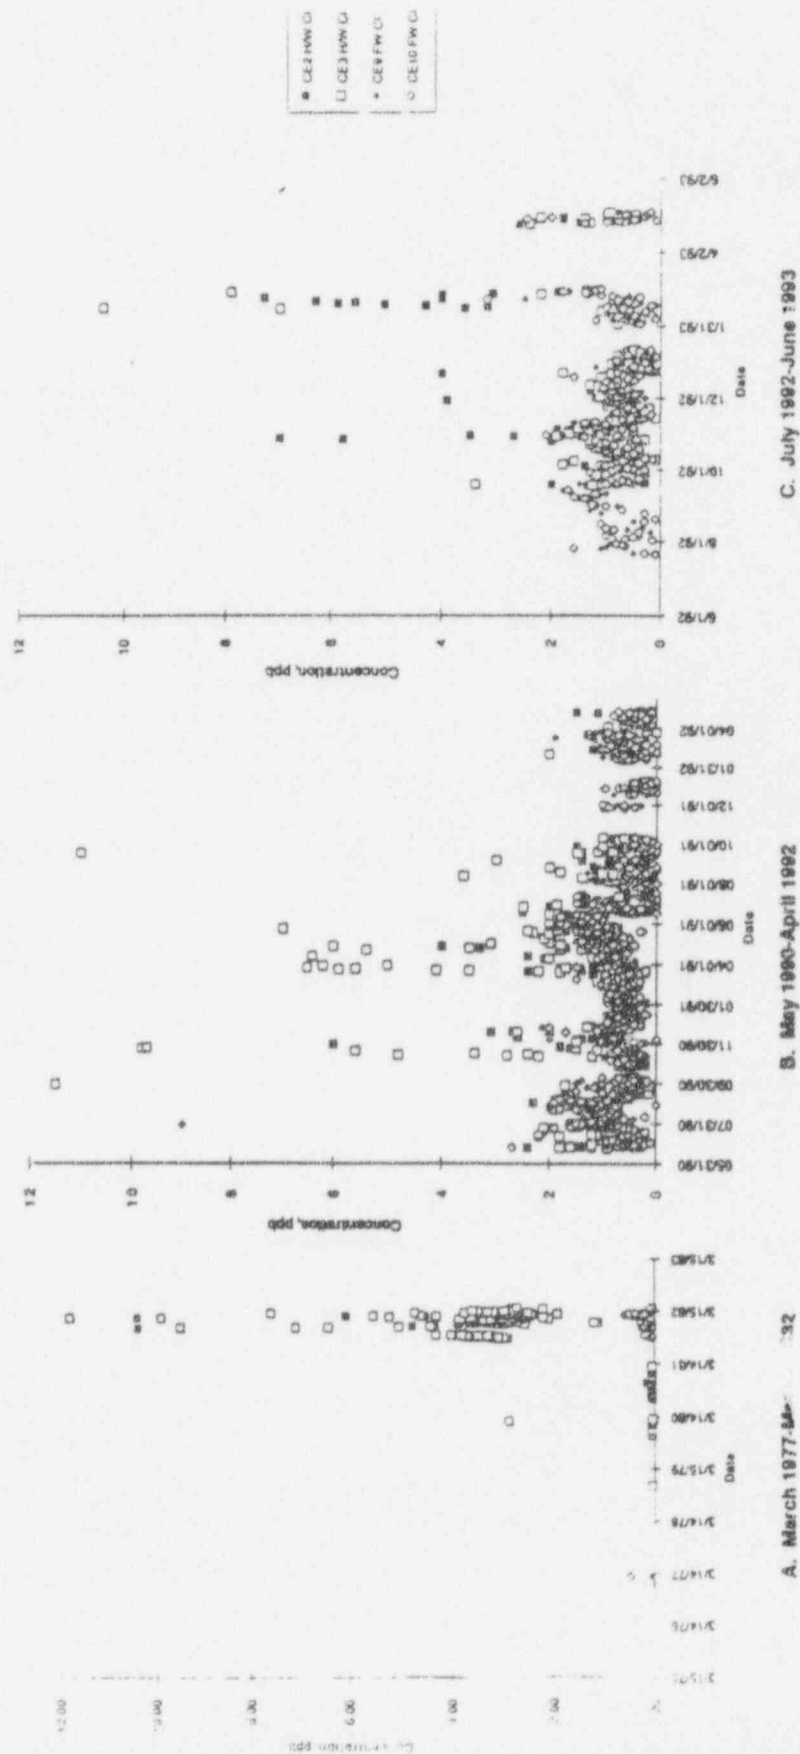
Figure 3-5

A cyclical trend in feedwater chloride is evident in Figure 3-5. Peaks in concentration of approximately 2 ppb occurred in June 1990, December 1990, March 1991, June 1991, August 1991, March 1992, September 1992, November 1992, March 1993, and May 1993. These peaks correspond almost exactly with the cycle peaks for sodium (section 3.1.1).
