Examination of Crystal River Unit #3 Steam Generator Tube Sections

TR-103756

Final Report, January 1994

B&W NUCLEAR TECHNOLOGIES
Special Products & Integrated Services Division
and
THE BABCOCK & WILCOX COMPANY
Nuclear Environmental Services, Inc.

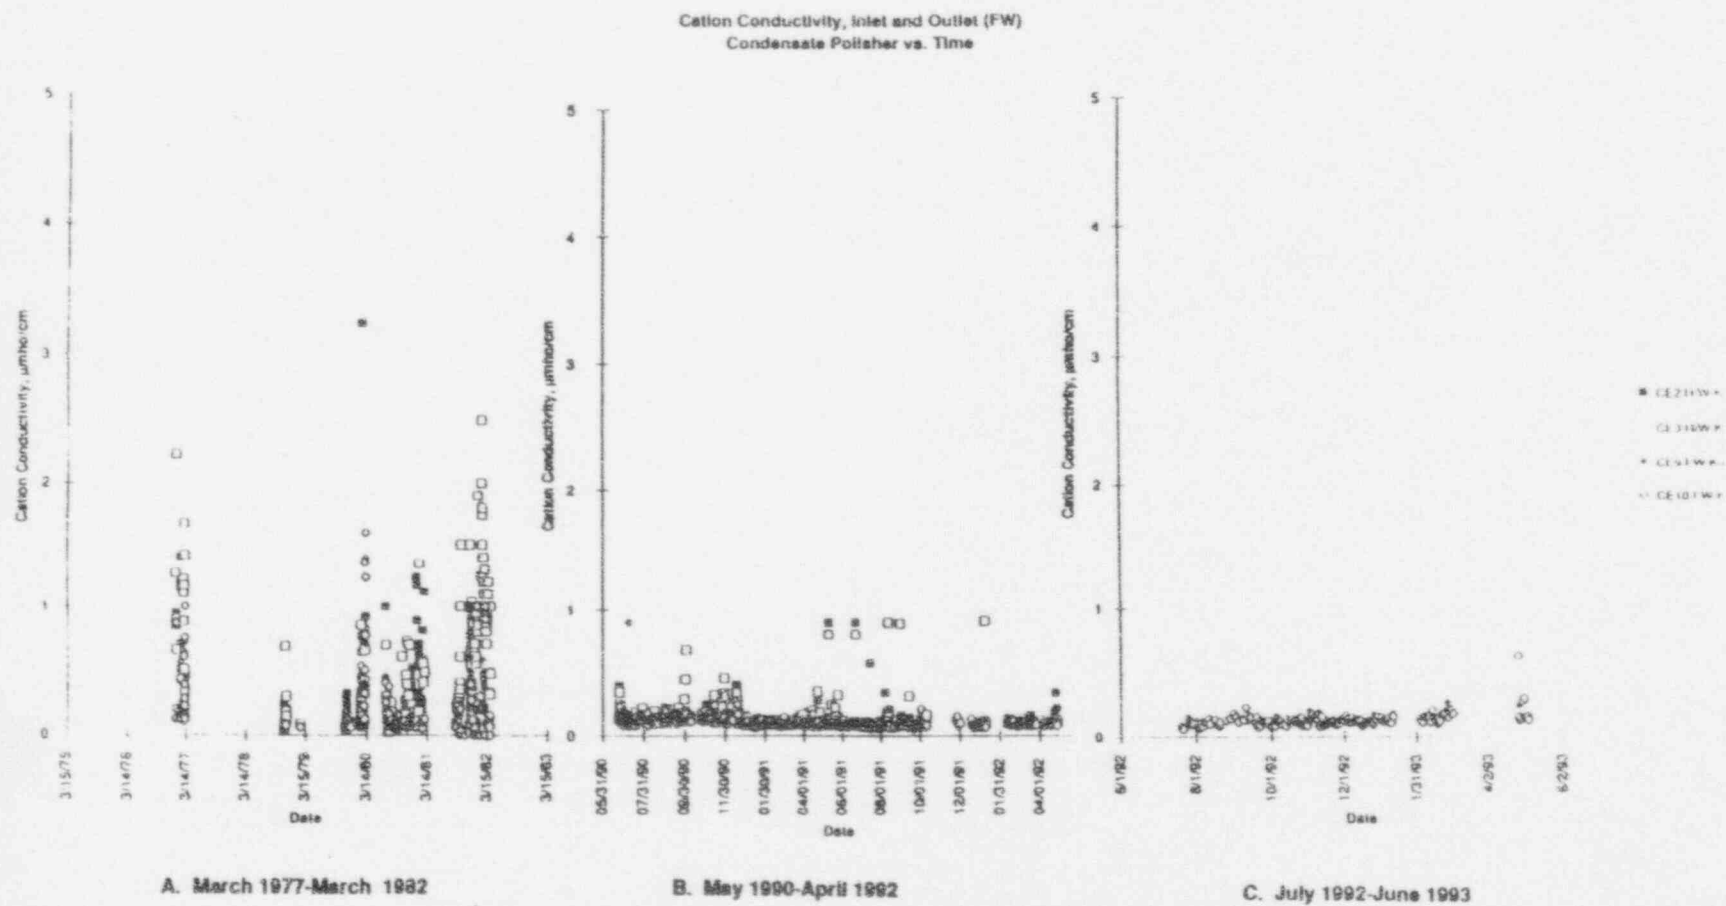
From Figure 3-6 it can be seen that cation conductivity of both hotwells and feedwater has decreased during the life of the plant. (It should be noted that there are no hotwell cation conductivity available for the period, June 1992 through June 1993.) The patterns of hotwell chloride concentrations and cation conductivity observed from Figures 3-4 and 3-6 do not appear to be similar. An examination of feedwater chloride concentrations and cation conductivity on the expanded scales of Figures 3-5 and 3-7 does not indicate a relationship. Therefore, it appears that some non-chloride, acidic species (e.g., sulfate, phosphate, nitrate, and/or organic acids) historically have controlled secondary cycle cation conductivity. It also is apparent that the concentrations of non-chloride, acidic species in the hotwells were highest during early years of plant operation.

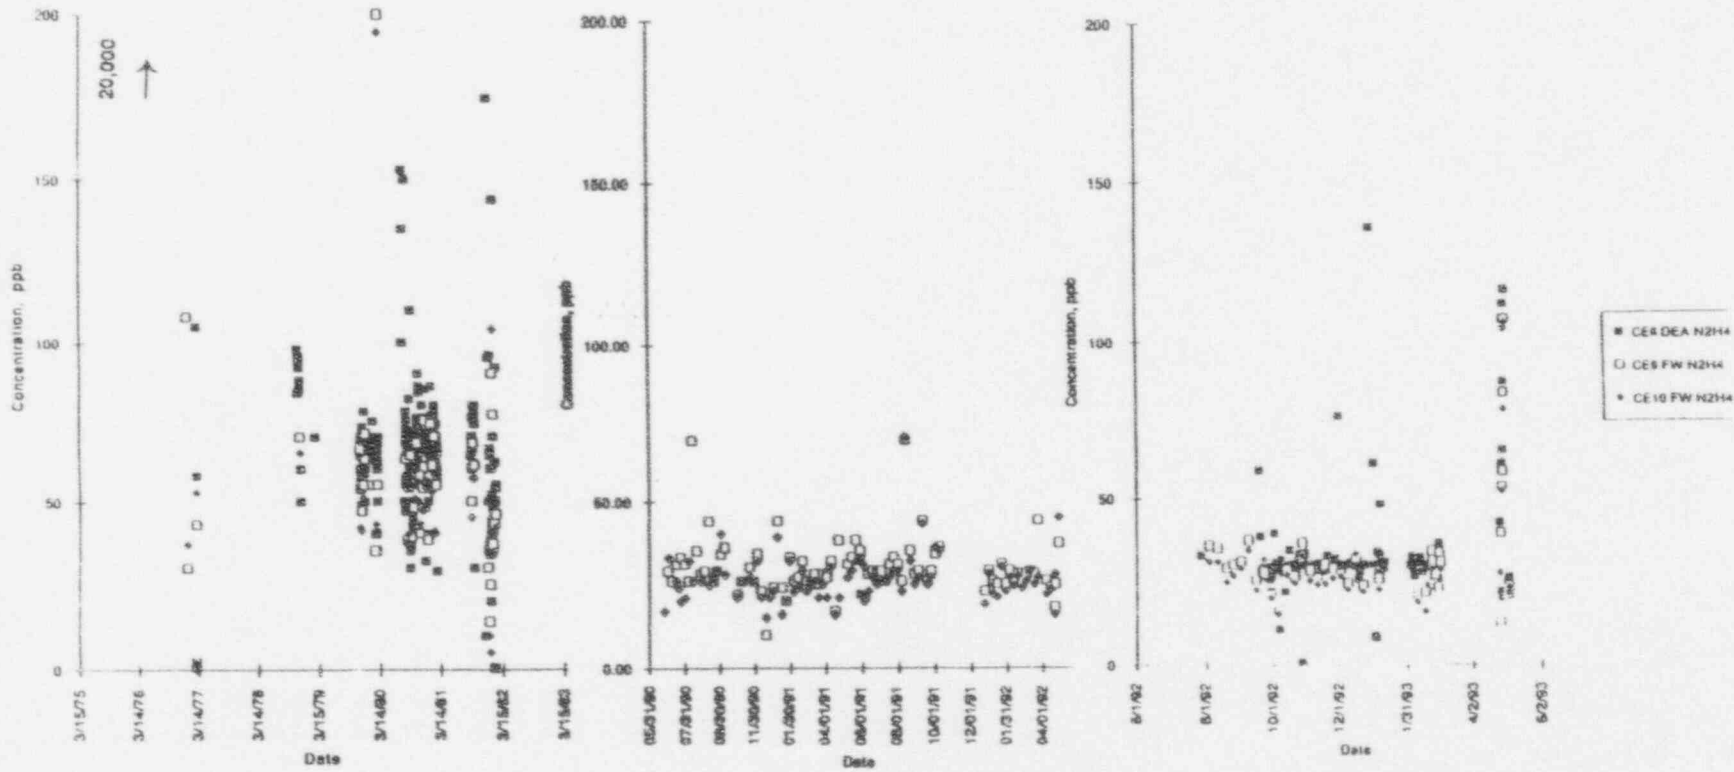
Figure 3-10

Variation of Feedwater and P₁erator Effluent Hydrazine with Time

- Exceptionally high concentrations of hydrazine were present in feedwater at initial plant startup (spikes of 1000 to 20,000 ppb during the period from 1977 through 1982, Figure 3-12, average of approximately 60 ppb, Figure 3-10), without comparable concentrations of oxygen. Therefore, the hydrazine was available for reducing any sulfate present in the steam generators during that period of time.

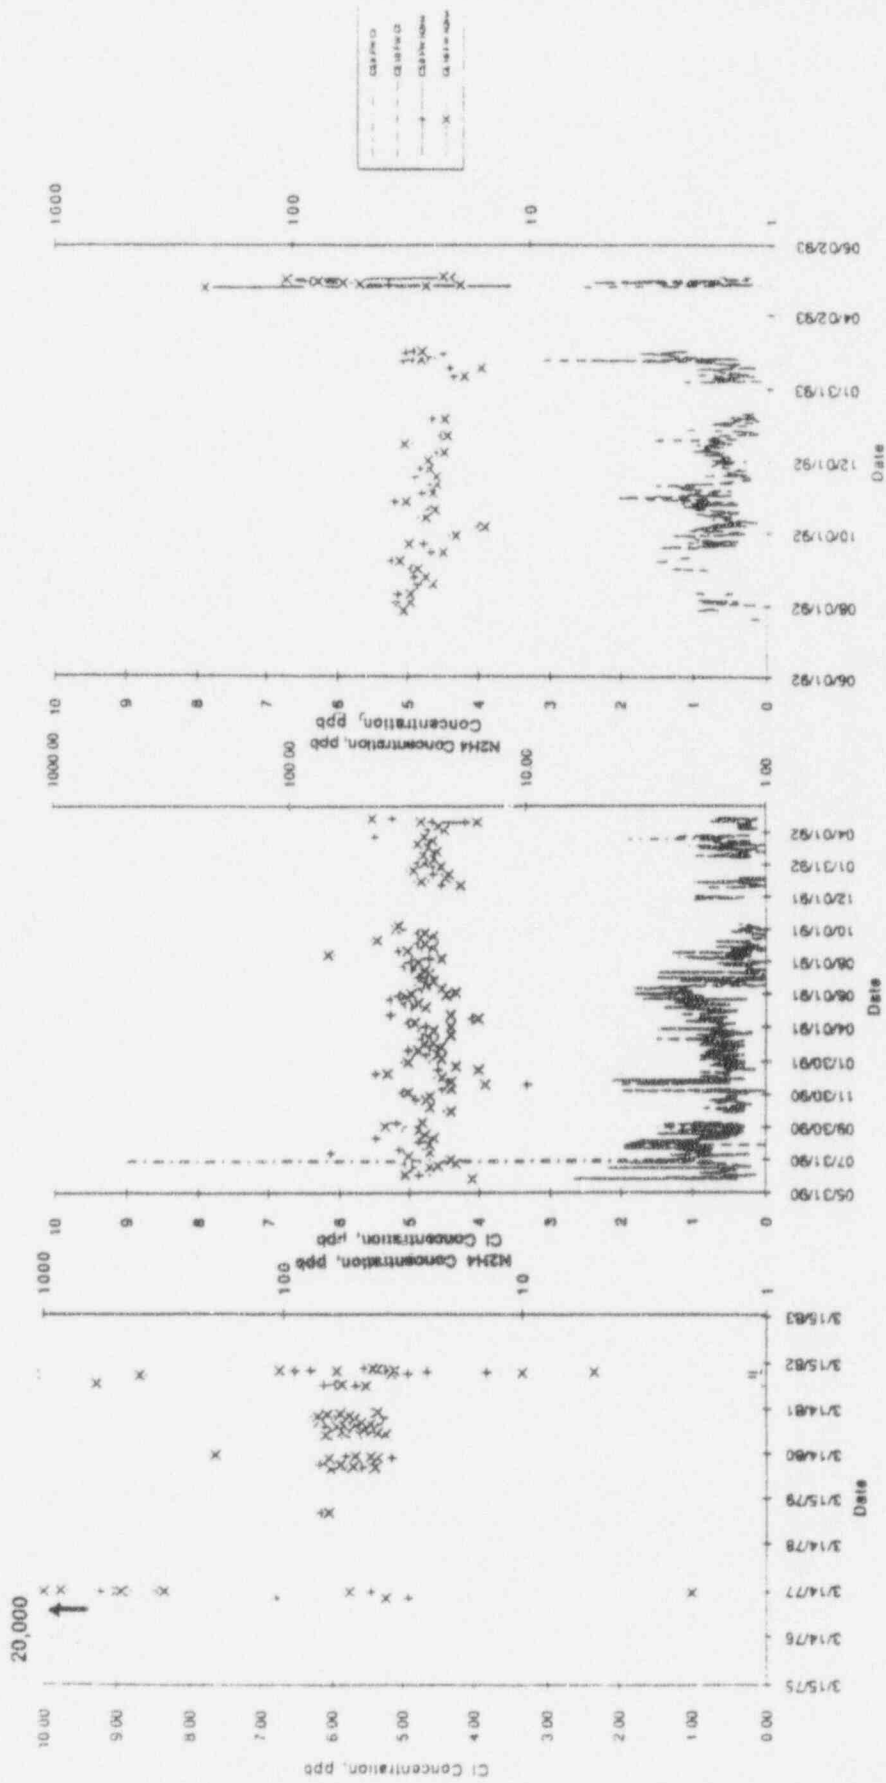
Figure 3-11

Feedwater chloride versus hydrazine concentrations are plotted in Figure 3-11. The general decrease in chloride concentration during the two periods, 1990 through 1992 and 1992 through 1993, does correspond with a decrease in hydrazine concentration. The short-term increase in chloride concentration between January and June 1991 may relate to a slight increase in hydrazine concentration during the same period. However, there is no apparent drop in hydrazine concentration that would correlate with the sudden drop in chloride concentration in July 1991.

Feedwater N₂H₄ and Cl vs. Time

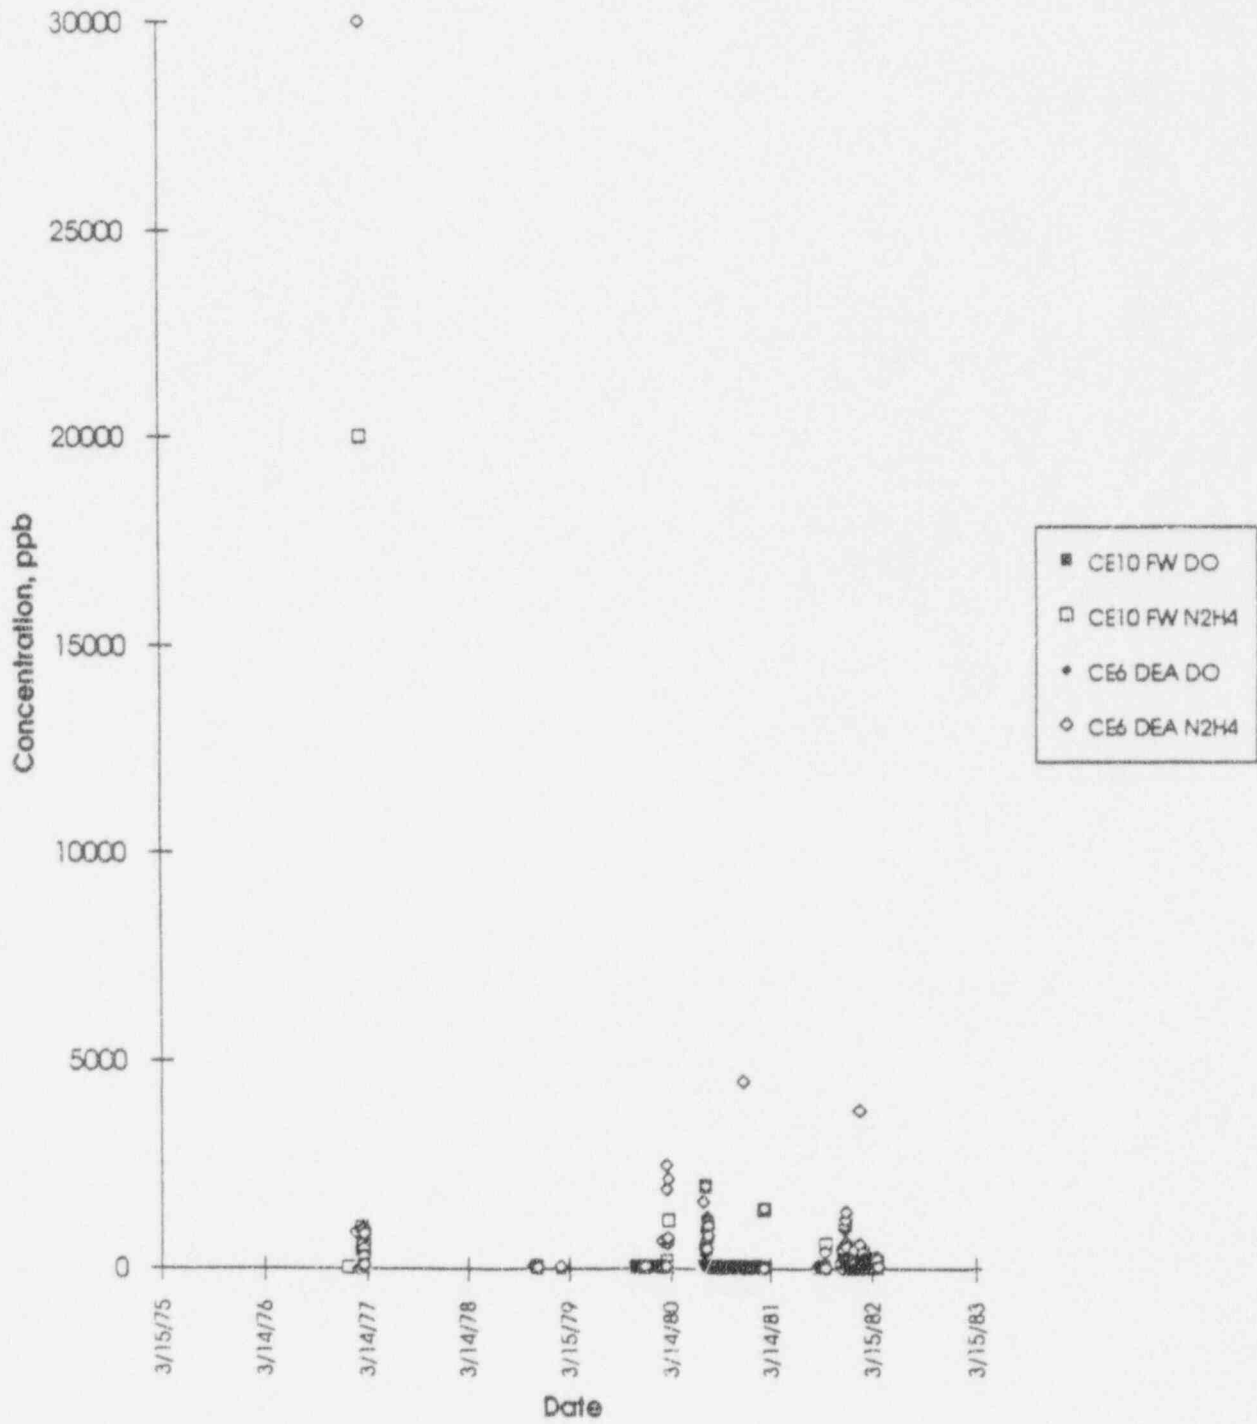
Figure 3-12 shows a comparison of feedwater and deaerator effluent dissolved oxygen and hydrazine. During the 1977 plant startup, the deaerator effectively reduced the dissolved oxygen (filled symbols on Figure 3-12) but the hydrazine level was kept high (open symbols). An expanded plot is shown in Figure 3-13. The high hydrazine concentrations relative to oxygen would have created a very reducing environment in the steam generators, whereby any sulfate species present could have been reduced.

FW and Deaerator Dissolved O₂ and Hydrazine vs. Time

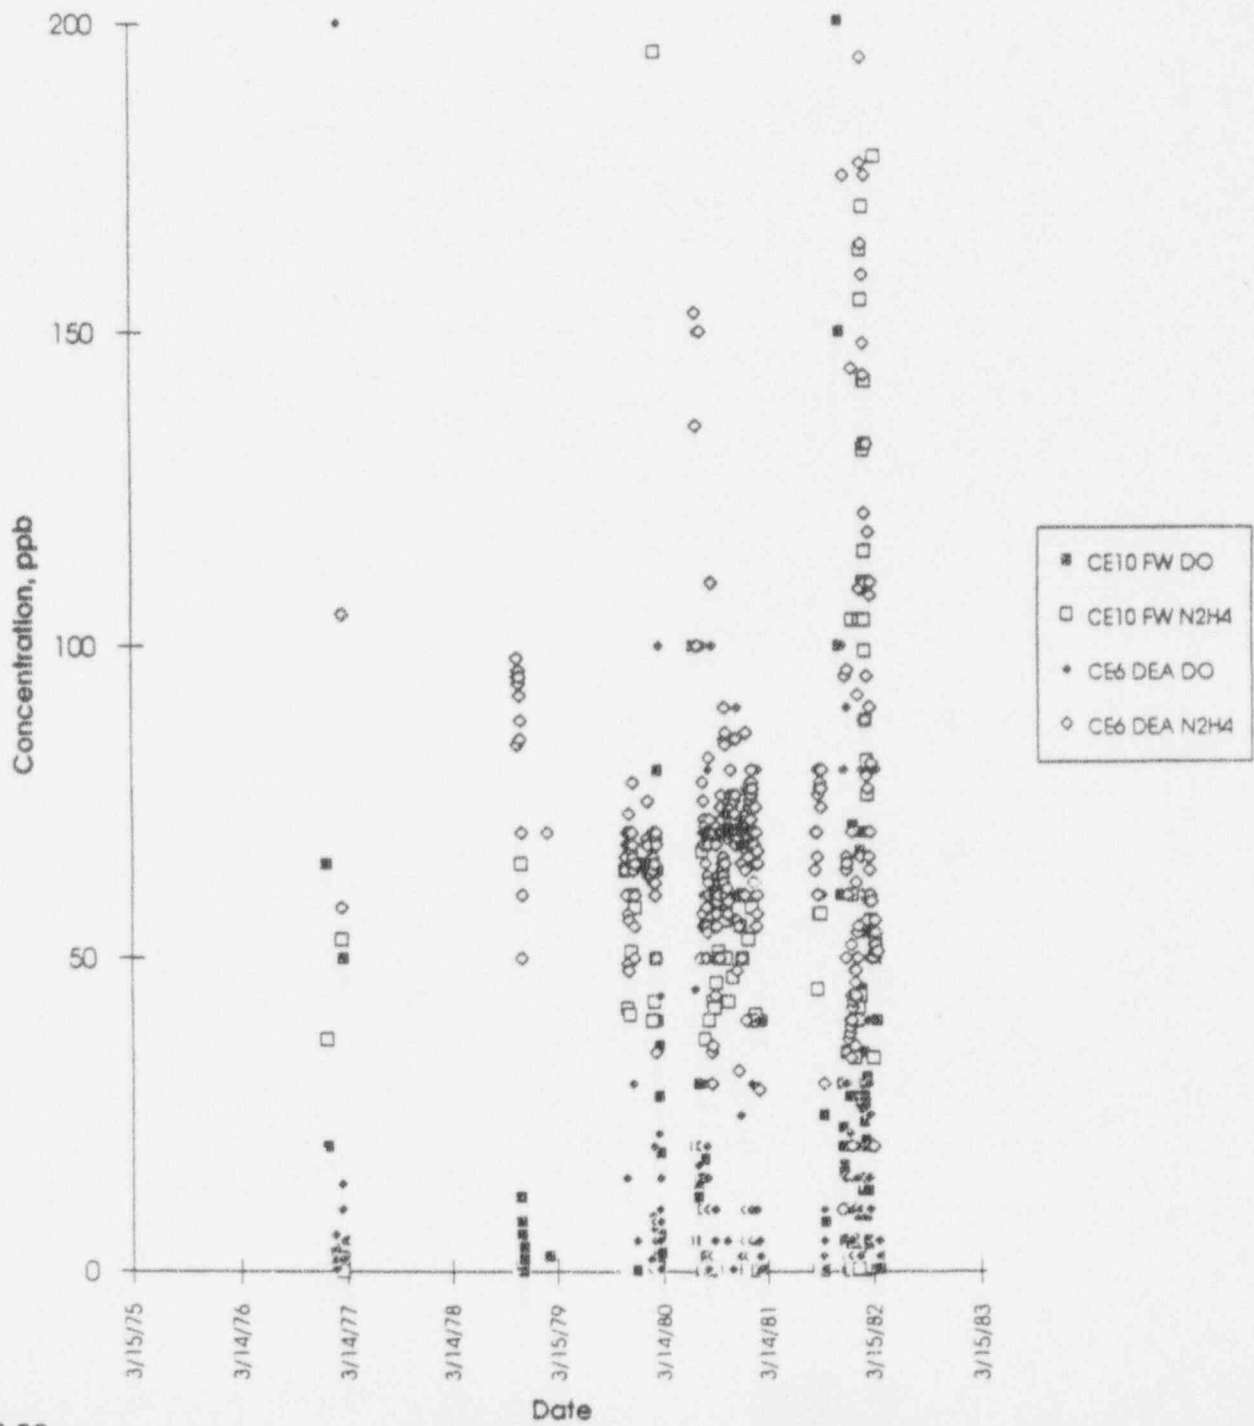
Figure 3-13

FW and Deaerator Dissolved O2 and Hydrazine vs. Time

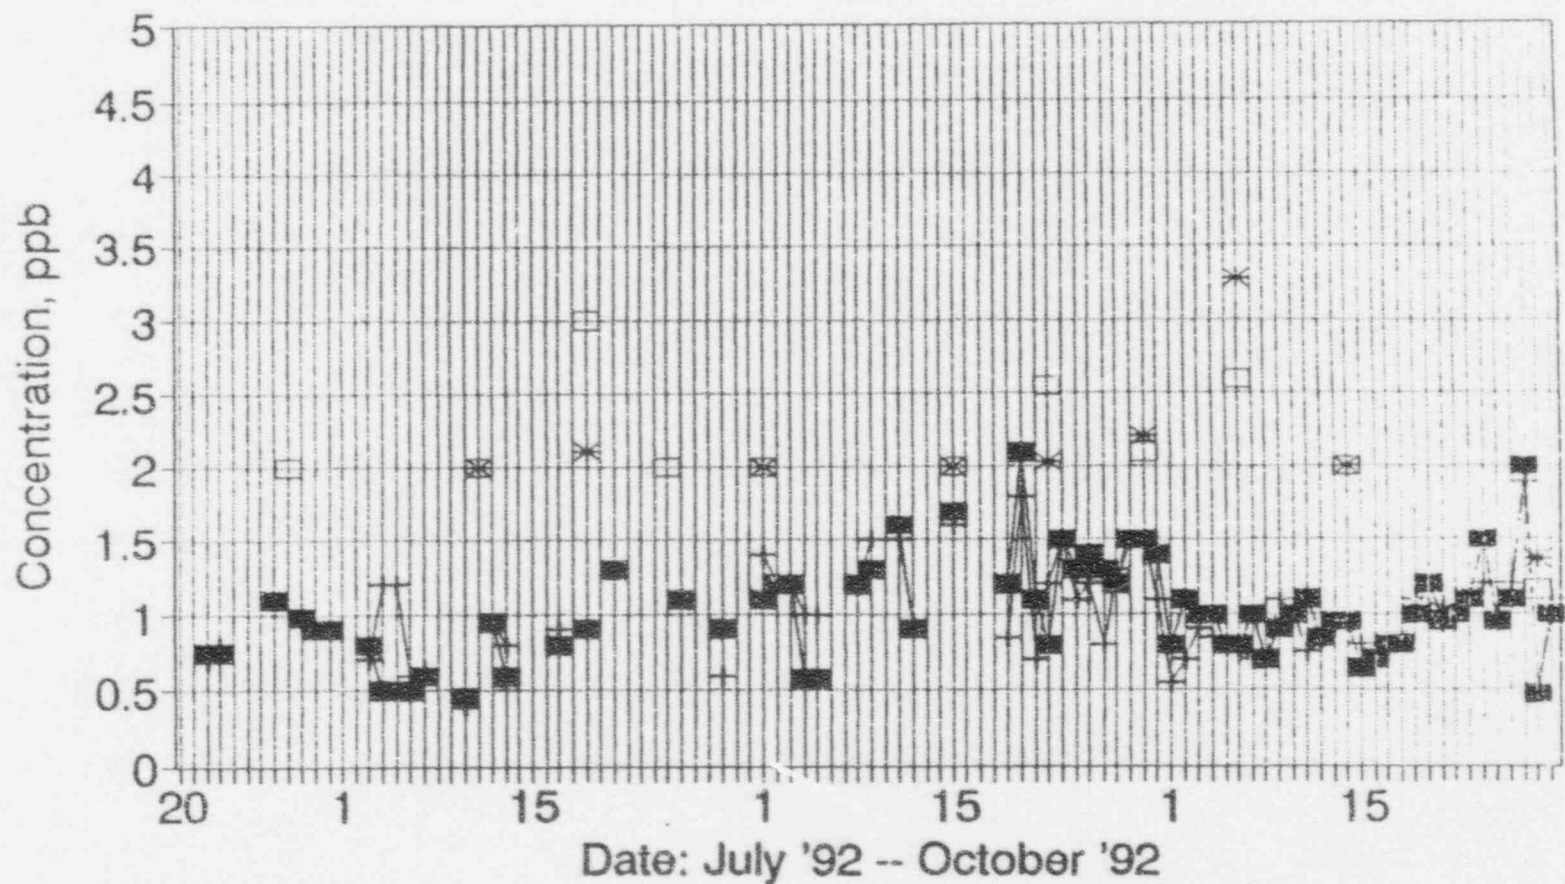
The relatively high levels of sulfate (2-3.3 ppb) observed in feedwater during analysis of recent chemistry transients prompted an investigation of its origin. Operating chemistry data from Cycle 9 were examined to determine if the feedwater sulfate corresponds to condenser leakage. Condenser hotwell samples are not routinely analyzed for sulfate, so Figure 3-14 compares concentration of hotwell sodium with concentration of feedwater sulfate. There is no apparent correlation between those data.

CYCLE 9 Sulfate Trends

Comparison of Hotwell Na and FW SO4

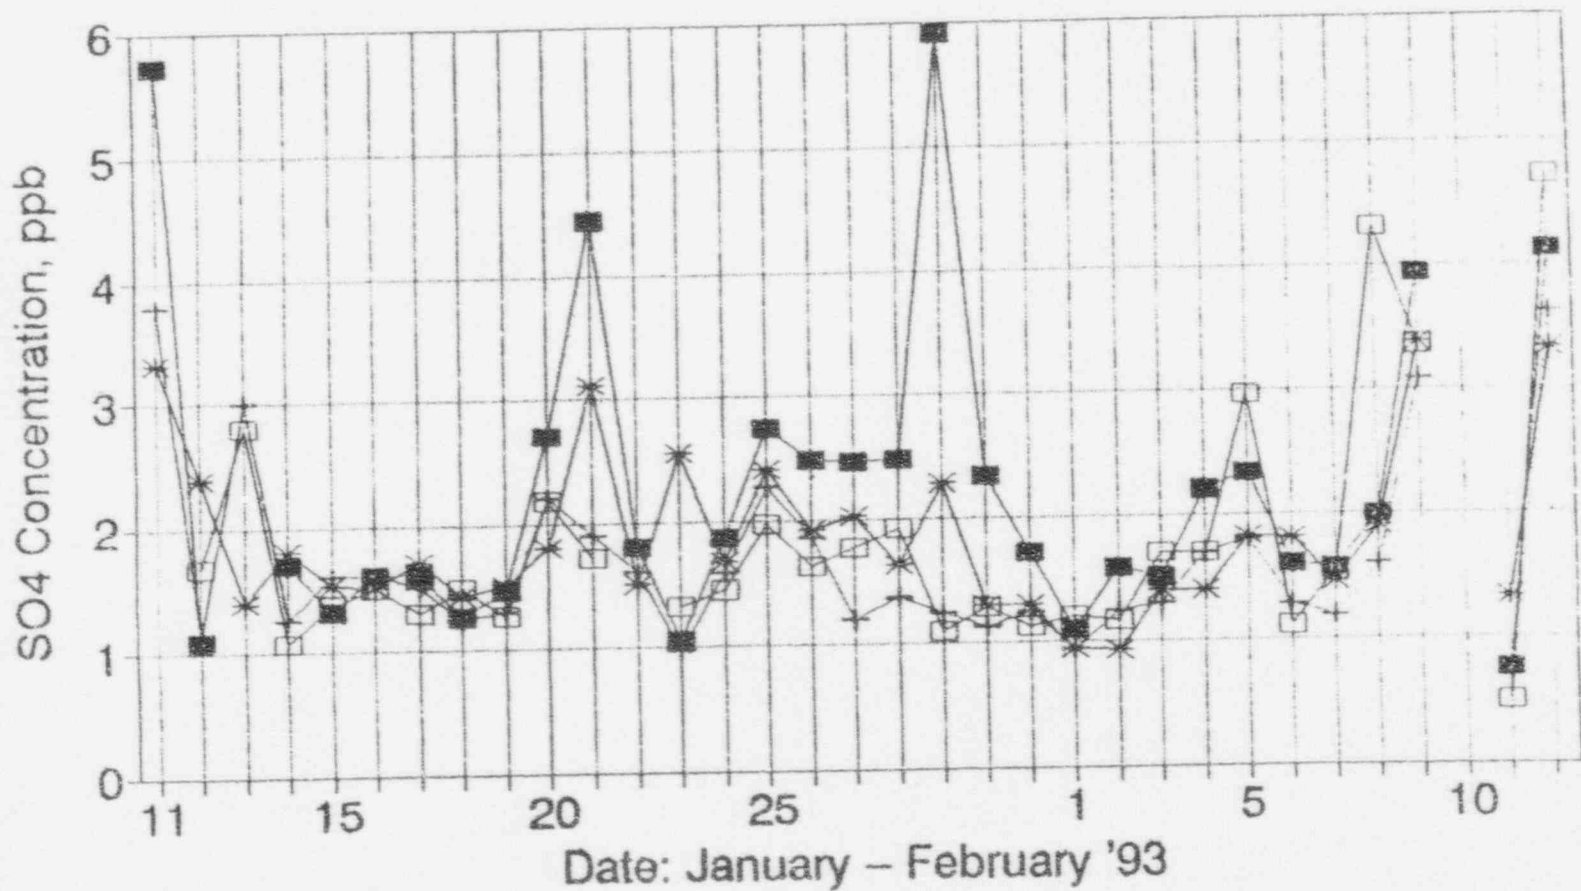
To obtain more detailed and accurate information on the behavior of sulfate in the secondary cycle, a special sulfate analysis test was initiated by Crystal River-3 personnel in January 1993. Figures 3-15 through 3-17 plot data from that test. Figure 3-15 compares concentrations of sulfate in feedwater with those in the hotwells. The measured concentrations track closely, with the "A" hotwell and "A" feedwater train showing similar trends and the "B" hotwell and "B" feedwater train behaving similarly. Plant personnel have commented that this correlation cannot always be observed. It is interesting to note that there is no obvious and consistent bias between hotwell and feedwater concentrations, although the full-flow, deep-bed condensate polishers were in use.

1993 Sulfate Trends

Comparison of Hotwell and Feedwater

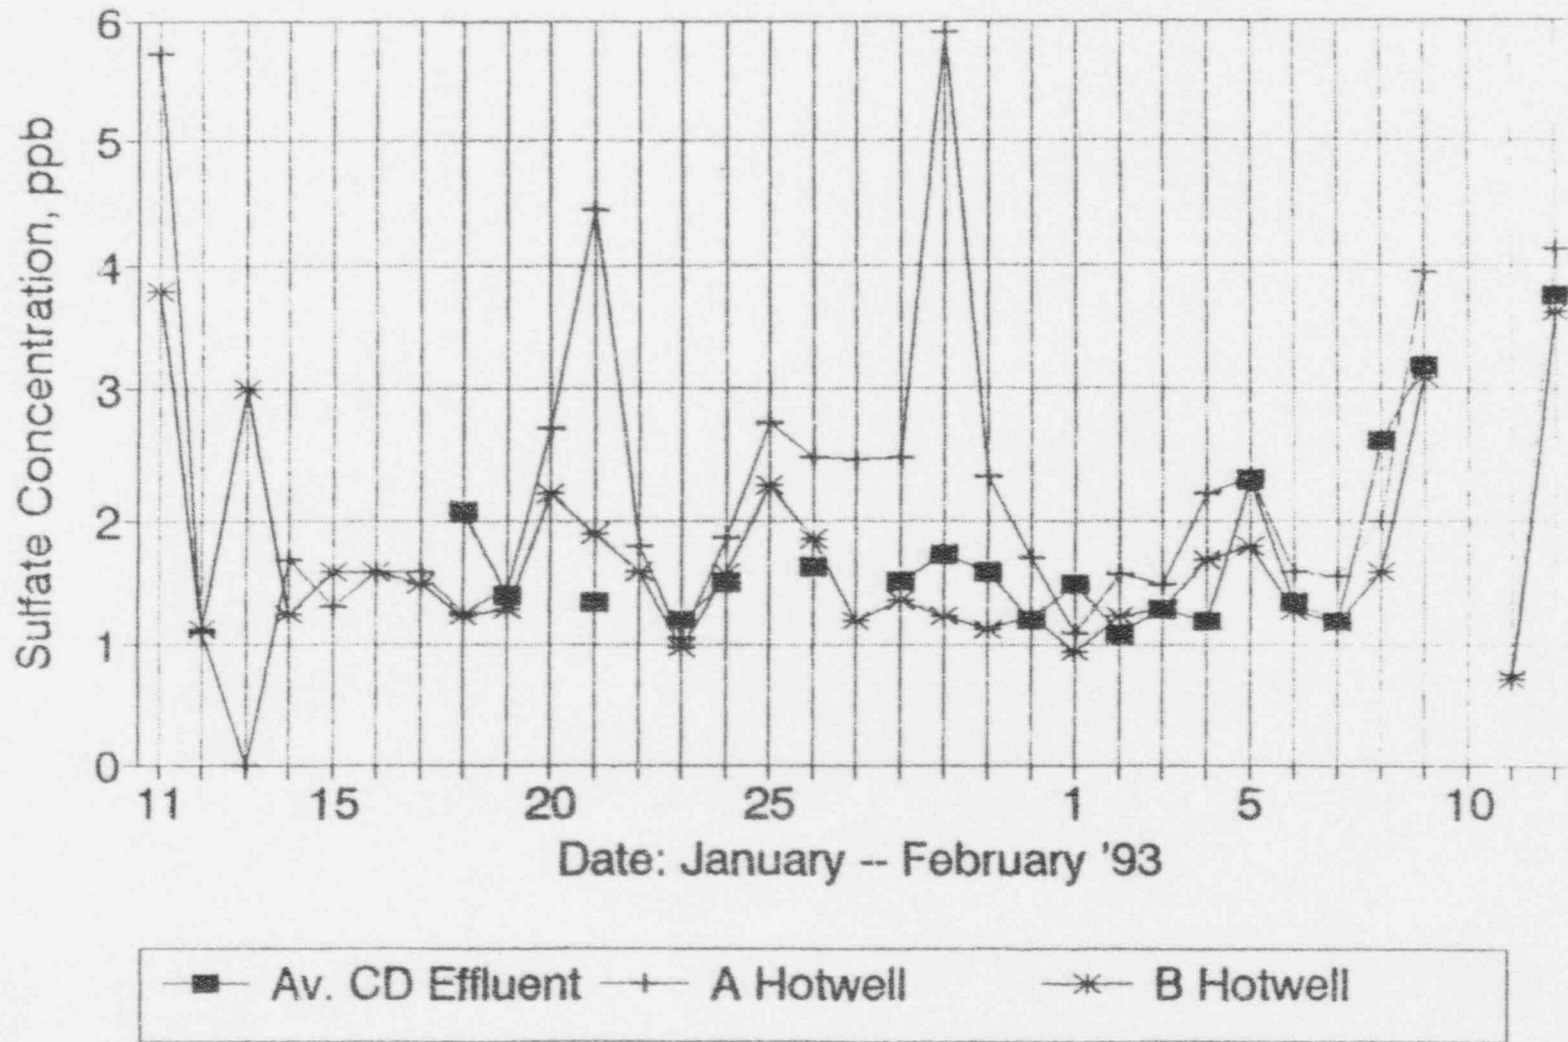
Figure 3-16

Sulfate concentration in the condensate demineralizer effluent header does not trend particularly well with those in the feedwater trains, as can be seen in Figure 3-16. If the header were well mixed, there were no removal of sulfate by the condensate demineralizers, and the sample analyses were accurate and precise, the common condensate demineralizer effluent concentration would always be positioned between the hotwell concentrations.

1993 Sulfate Trends

Comparison of Common CD Effl and FW

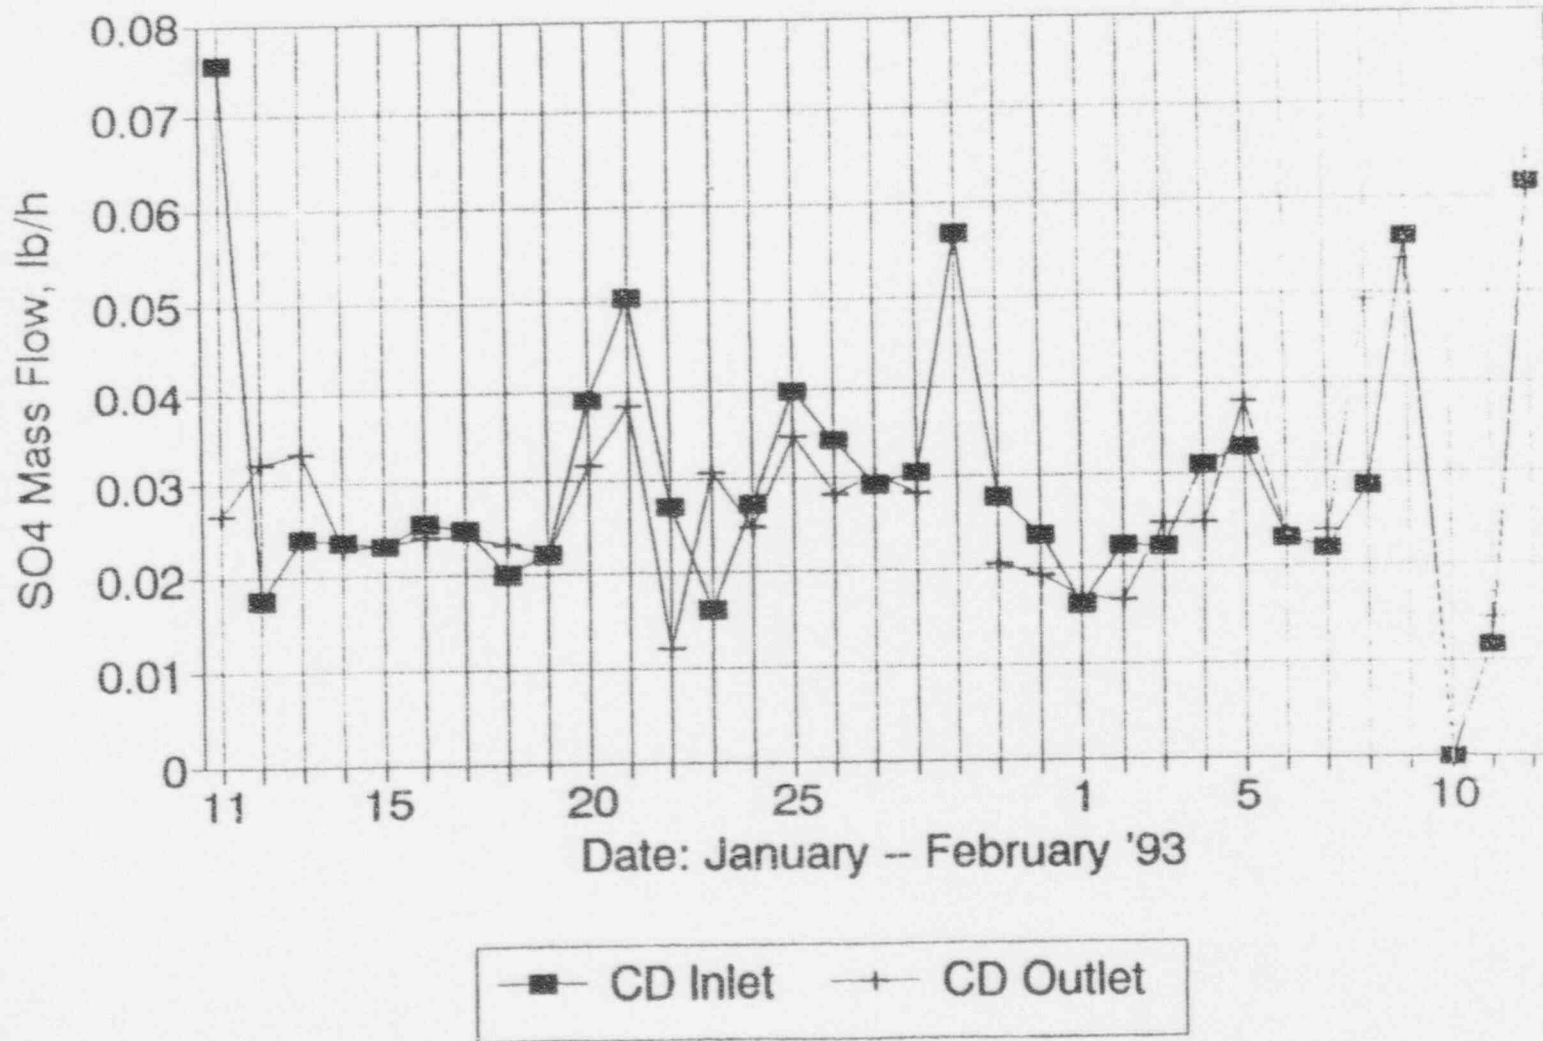
Figure 3-17

To investigate whether the condensate demineralizers were either removing or throwing sulfate, mass flows were determined using hotwell (influent) sample points CE-2 and CE-3 and feedwater (effluent) sample points CE-9 and CE-10. Results are presented in Figure 3-17. It is apparent that during the test period the demineralizers were neither removing nor contributing ionic sulfate. That could indicate that either that the demineralizers were in equilibrium with the condensate with respect to sulfate,

Condensate Demin Sulfate Mass Flows

Comparison of CD Inlet and Outlet

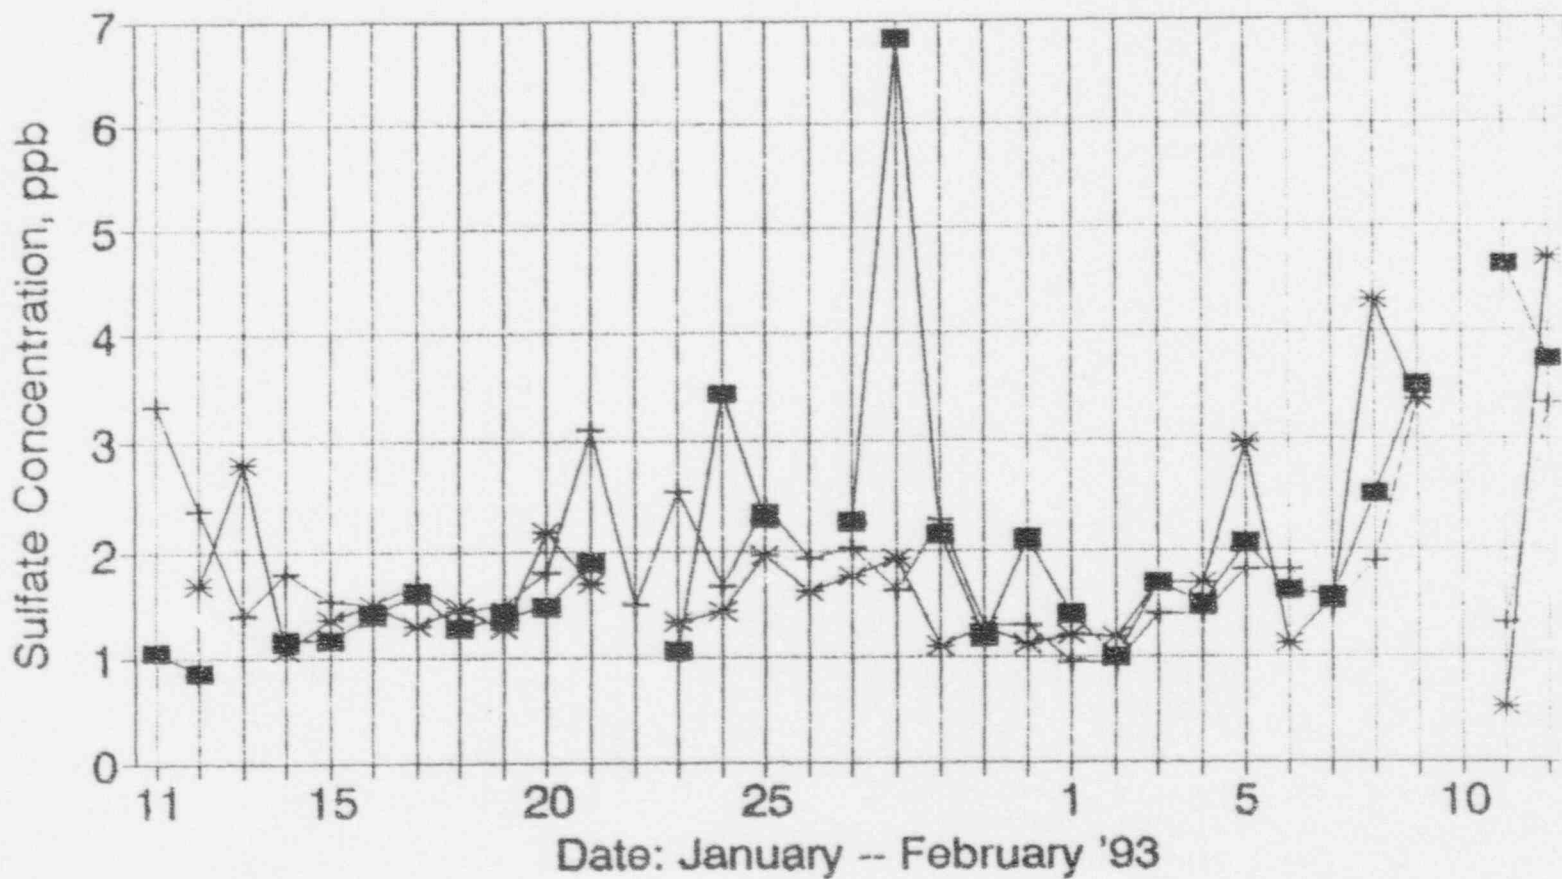
Figure 3-18

To determine whether the demineralizers are throwing colloidal resin particles or soluble sulfonates from resin decomposition, the concentrations of sulfate in high pressure heater drains (condensed extraction steam) was compared with those in feedwater. The results, shown in Figure 3-18, are inconclusive. While there are four peaks in heater drains sulfate concentration that are higher than feedwater concentrations, many of the sample points show concentrations that are slightly lower. This could reflect a routine loss of sulfate by adsorption on secondary plant piping and steam generator surfaces, with periodic throw of organic sulfonates from cation resin. However, this possibility can not be proven with the data.

1993 Sulfate Trends

Comparison of Heater Drains and FW
