NUREG/CR-2932/1 of 2
SAND81-2027/1 of 2

Equipment Qualification Research Test of Electric Cable With Factory Splices and Insulation Rework Test No. 2 Report No. 1

E. E. Minor, D. T. Furgal

This report records the results of tests performed by Sandia National Laboratories to provide the NRC with data for assessing the methods and procedures for environmental qualification tests of electric cable repairs and splices as outlined in IEEE 383-1974.

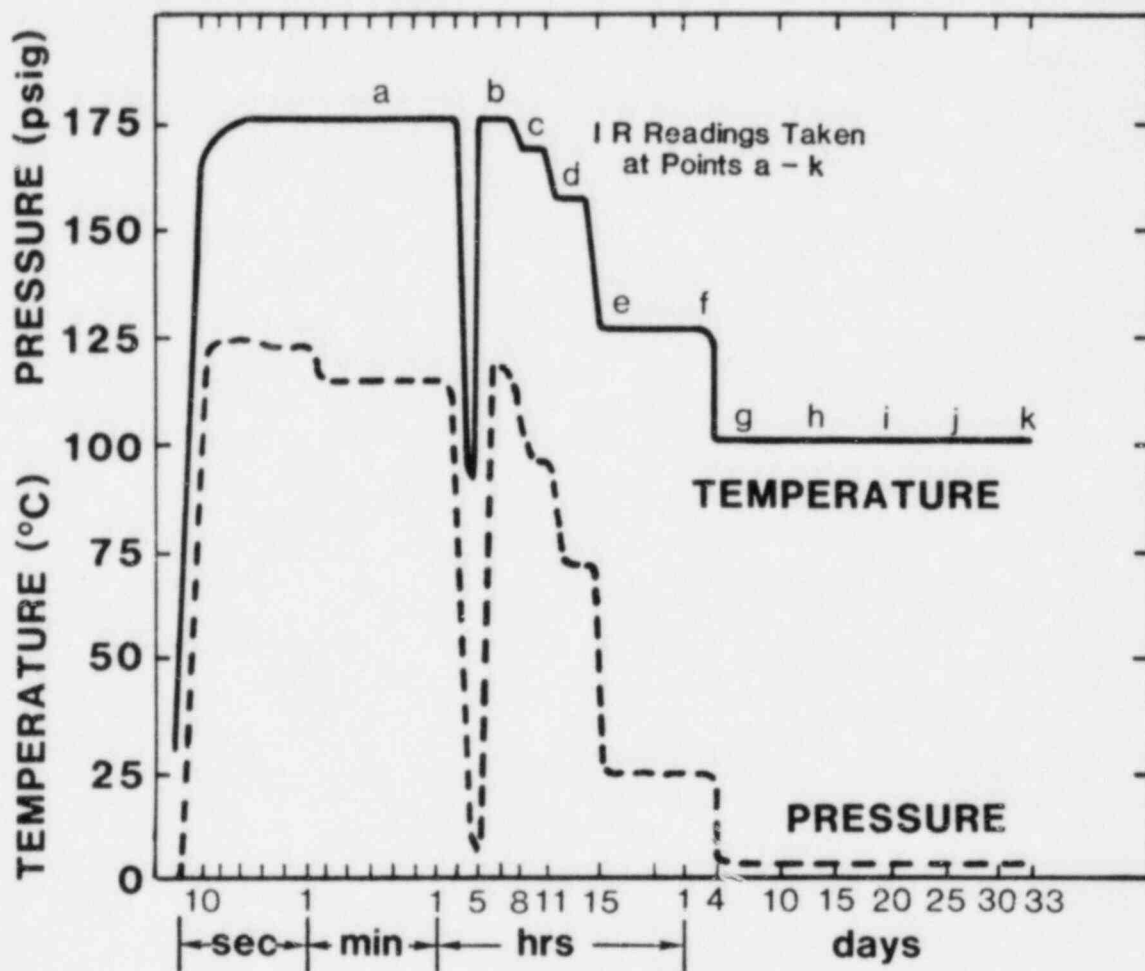
Figure 2-5. Actual Temperature and Pressure Profiles for Steam/Chemical Spray Exposure

Insulation resistance measurements taken during the initial accident profile steam pressure peak (see Figures 2-5 and 2-6, point a) showed significantly degraded readings in the range of 6.0×10^5 and 1.5×10^6 ohms for the No. 6 and No. 12 AWG cables, respectively. Cables 10, 19, 20, 21 and 22 had readings below 5.0×10^5 ohms. At the second pressure peak (Figure 2-5, point b), Cables 17, 18, 24, 25, and 27 had also measured below 5.0×10^5 ohms. Also, during both peaks, eight of the nine No. 6 AWG cables (Cables 19 and 21 through 27) began weeping at the ends of the cables extending from the chamber. This was due to the pressure differential between the chamber and atmospheric pressures. The subsequent visual inspection showed that the weepage occurred both on cables where insulation material handling damage was observed and on cables where no visible damage was apparent. We therefore conclude that some of the weepage may be attributable to thermal softening and expansion of the insulation material or to insulation damage not readily visible to the naked eye. At nine hours into the profile (Figure 2-5, point c), Cable 13 also measured below 5.0×10^5 ohms. At four days into the profile (Figure 2-5, point f), Cables 10, 19, 22, 23, 24, and 27 still measured below 5.0×10^5 ohms. As the exposure continued, insulation resistance readings improved. At the end of the exposure profile, Cables 19, 24, and 27 had readings below 5.0×10^5 ohms.

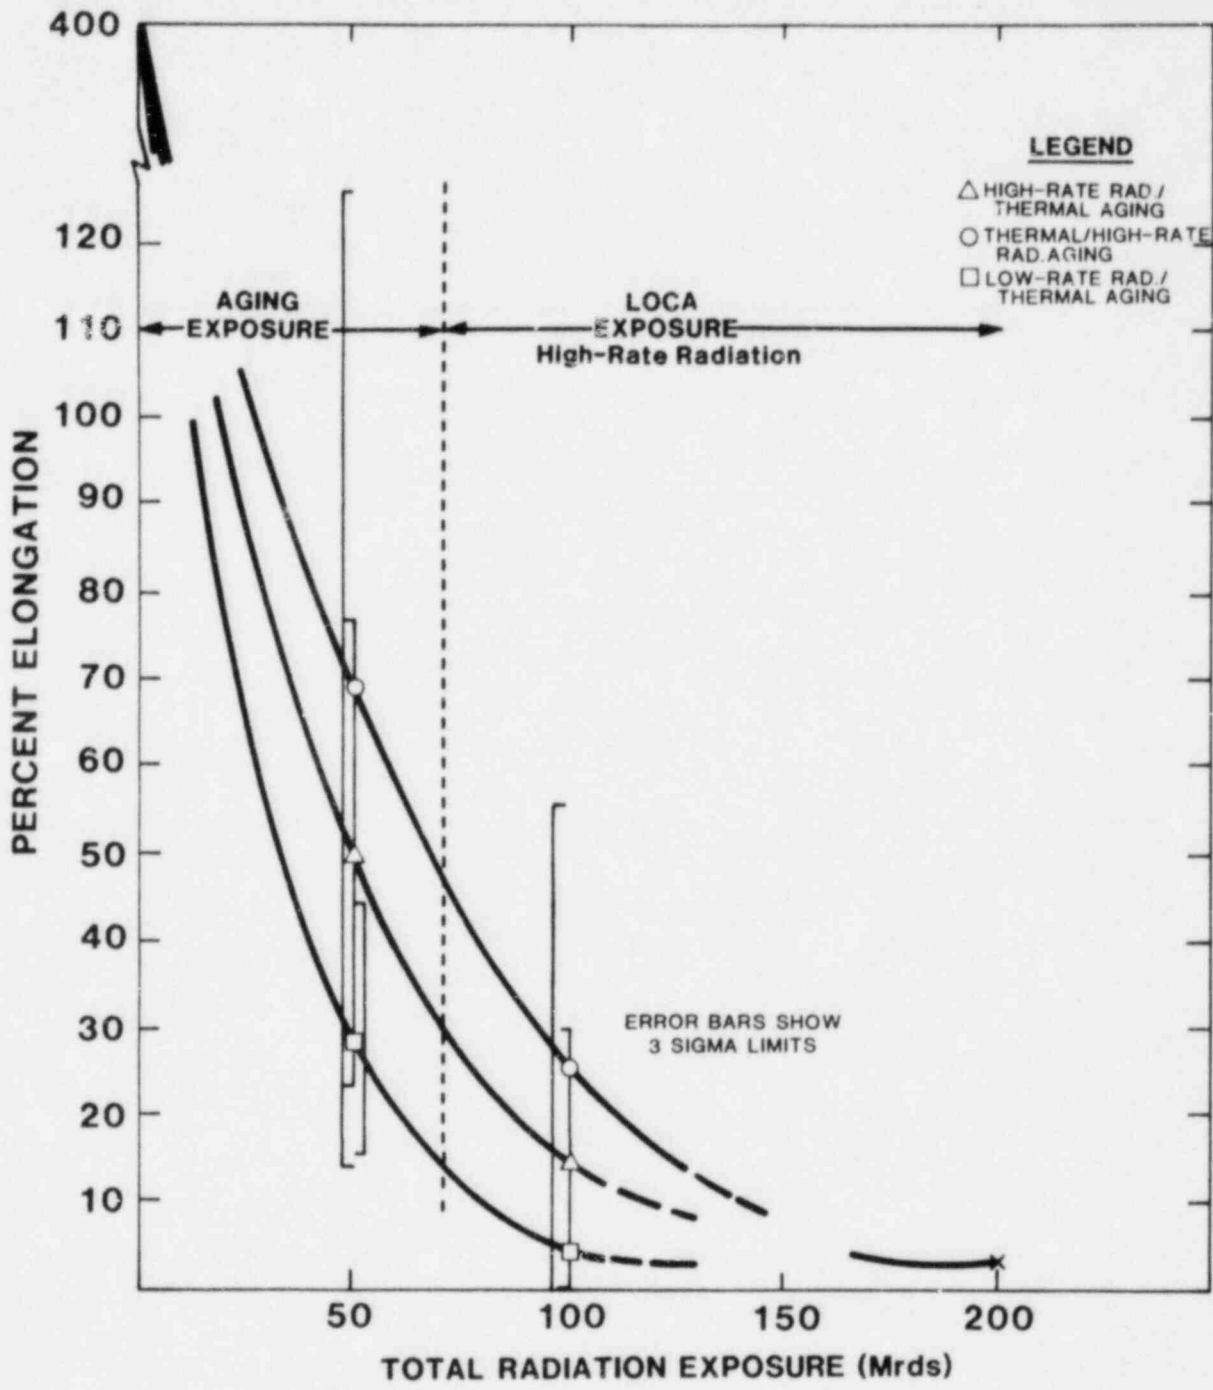
Figure 3-1. Percent Elongation vs Radiation Exposure

Insulation material degradation, on the average, was more affected by dose-rate than by sequence of exposure. The aging sequence of low dose-rate radiation followed by thermal aging, on the average, produced a reduction in elongation and in tensile force when compared with high dose-rate aging sequences. The sequence of thermal aging followed by high dose-rate radiation aging was, on the average, the least severe. The sequence of high dose-rate radiation aging followed by thermal aging, on the average, produced degradation in both elongation and tensile force that was between the most and least severe exposure sequences. However, high data variability, as shown by the error bars shown on Figures 3-1 and 3-2, makes it impossible to positively differentiate between the degradation effects caused by any of the high dose-rate exposures.

After approximately 200 Mrd TID, the test results show that there was very little material life remaining. On the average, the samples had little or no elongation (<10%) remaining and the tensile force required to break them was about one-third of that required originally. Based on the results of the insulation sample tests, it was decided that the cables described in Section 2.0 would be subjected to an aging sequence of low dose-rate radiation aging followed by thermal aging.
