Docket No. 50-213  
B14881

Attachment B  
Haddam Neck Plant  
Walkdown Summary Report  
Replacement Pages

June 1994

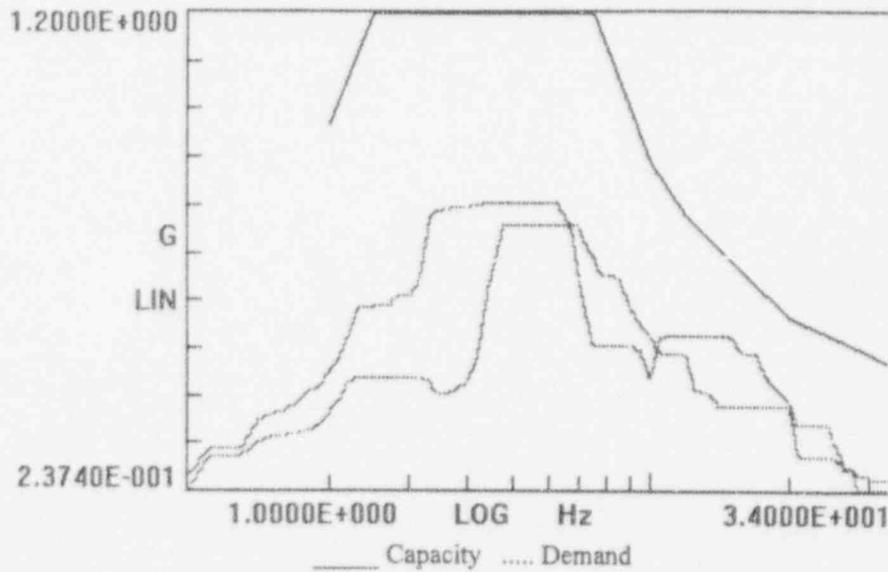
1.	Elevation where equipment receives seismic input	48.50
2.	Elevation of seismic input below about 40' from grade (grade = 0.50)	N/A
3.	Equipment has fundamental frequency above about 8 Hz (est. frequency = )	N/A
4.	Capacity based on:	1.50 * Bounding Spectrum
5.	Demand based on:	1.00 * Conservative Design Floor Response Spectra

File	Record
Capacity	D:\GIP\GIP\spectra.des	Label\Bounding Spectrum
Demand 1	D:\GIP\PROJ0025\spectra.des	UNIT CY BLDG Containment ELEV 40.00 LOC  DIR N/S ID CONT040 T
Demand 2	D:\GIP\PROJ0025\spectra.des	UNIT CY BLDG Containment ELEV 40.00 LOC  DIR E/W ID CONT04 0R
