## AEOD ENGINEERING EVALUATION REPORT

UNIT: Several EE REPORT NO.: AEOD/E91-01  
DOCKET NO: Several DATE: February, 1991  
LICENSEE: Several  
NSSS/AE: Several EVALUATOR/CONTACT: E. J. Brown  
SUBJECT: A REVIEW OF WATER HAMMER EVENTS AFTER 1985  
EVENT DATE: Multiple

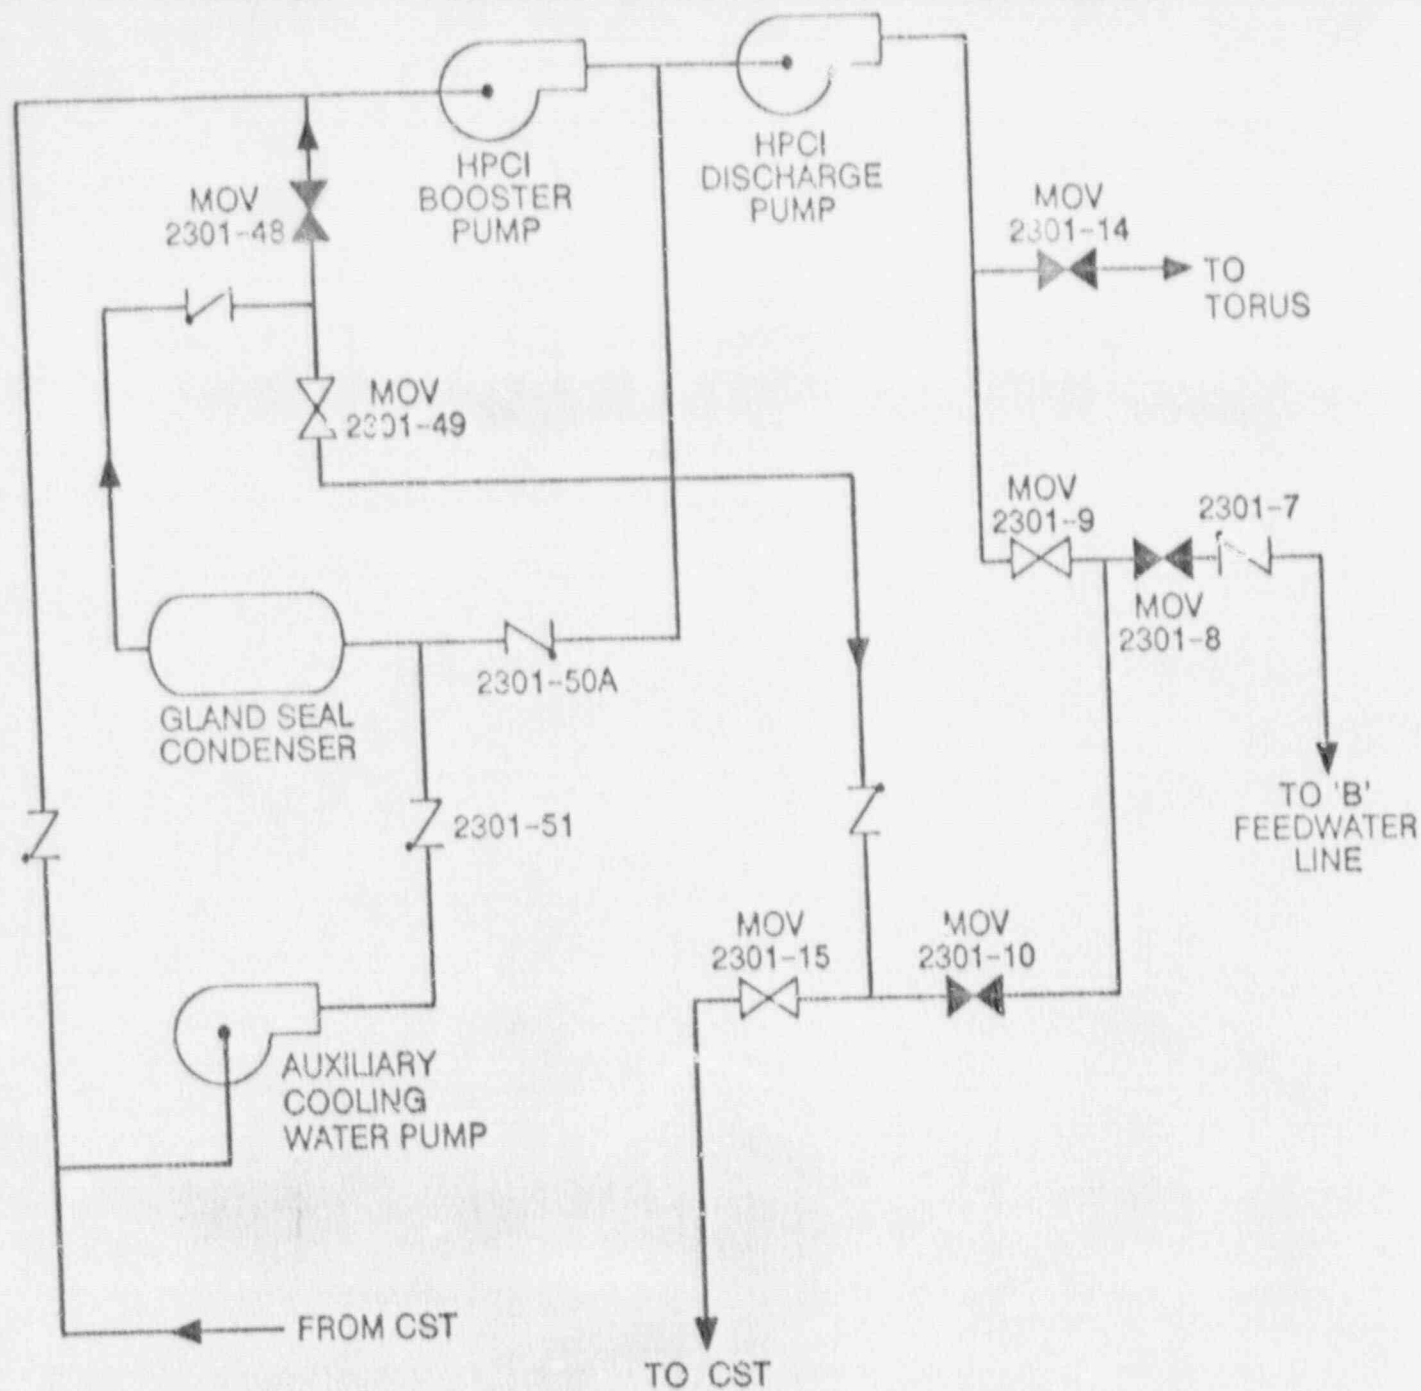
FIGURE B1  
BASIC HPCI SYSTEM (UNIT 3 PRESENTLY)

It was found that check valve 2301-7 (Feedwater/HPCI isolation valve) and MOV 2301-8 (HPCI injection valve) were both back leaking feedwater to the HPCI system piping. A pipe temperature survey conducted on October 23, 1989, revealed HPCI pump discharge pipe temperature was 246° F while the pipe between MOVs 2-2301-8 and 2-2301-9 was 275° F. An evaluation determined that steam voids could form in certain sections of the pipe under these conditions. Subsequent inspections of the Unit 2 HPCI discharge piping supports identified there were deficiencies in 47% (or 16) of the supports. The Unit 2 HPCI system valve lineup was changed (See Figure B2) so that the injection valve function was moved to MOV 2-2301-9 from MOV 2-2301-8. Also, MOV 2-2301-10 became an isolation valve subject to feedwater pressure. Subsequent inspection of Unit 3 HPCI piping found similar elevated temperatures with pipe support deficiencies found in 52% (or 21) of the supports. The Unit 3 inspection also found that other valves in the HPCI system could leak so the valve lineup was changed to that shown in Figure B3.

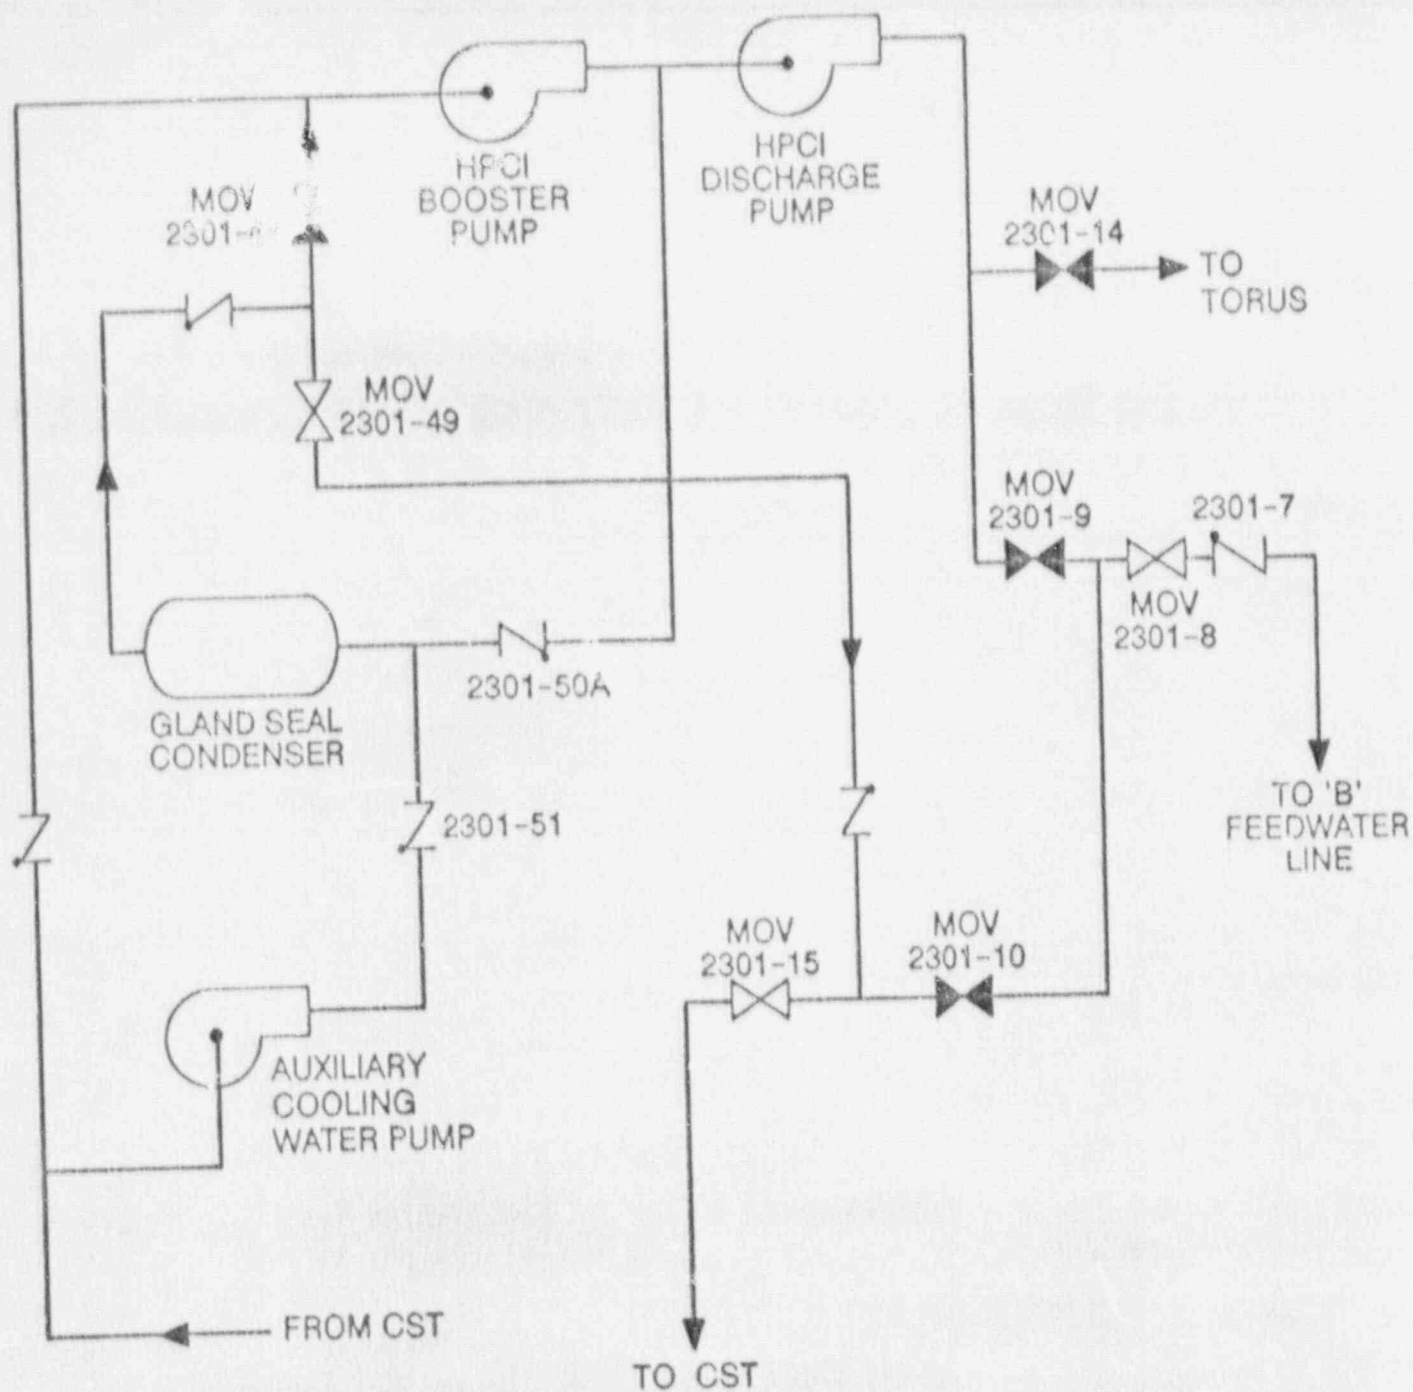
FIGURE B2  
UNIT 2 HPCI ALTERNATE VALVE LINEUP (POST OCTOBER EVENT)

valve manipulation and HPCI pump discharge pipe temperature measurements led the licensee to conclude that feedwater back leakage through the HPCI test return valve 2-2301-10 was the root cause of the event. Based on the investigation, it was postulated that MOV 2-2301-10 did not fully close after one of the manipulations involved in complying with plant Technical Specification required valve and HPCI tests. This valve did not have a seal-in feature to complete the stroke after initiation. In addition, the limit switches were set to provide a torque switch bypass function in the open direction until the valve was 25% open. This limit switch also controlled the valve close light indication in the control room. Thus, a control room operator who removed a closure signal when the control room panel lights indicated the valve was closed could leave the valve approximately 25% open. A procedure was introduced to continue the closure signal 30 seconds after the panel light indicated MOV 2-2301-10 was closed. The HPCI system lineup was revised to that shown in Figure B3.
