NUREG/CR-6187
ANL-94/8
TMIV(93)AL02

Results of Mechanical Tests and Supplementary Microstructural Examinations of the TMI-2 Lower Head Samples

Argonne National Laboratory

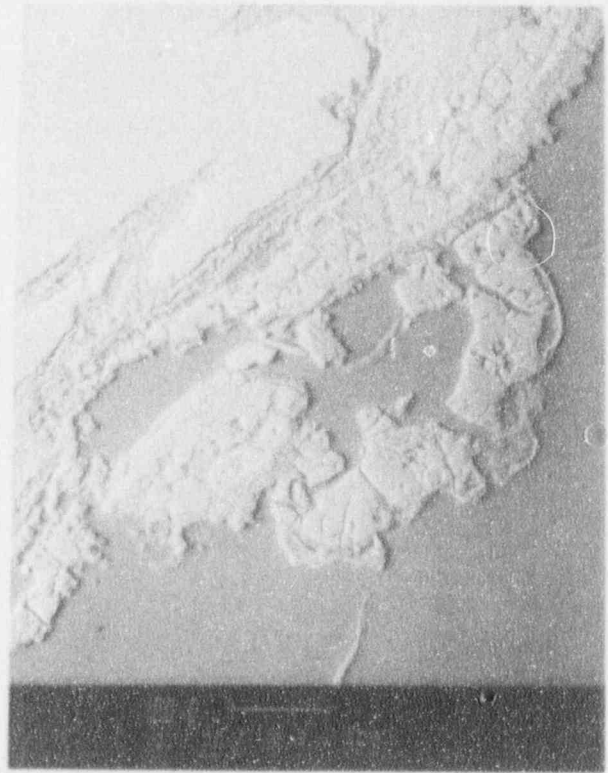
Fuel fragments, such as those shown in Fig. 12, were generally present only atop the adherent surface layers as, apparently, adventitious material trapped somewhat in an Fe-oxide, not as material that had solidified in situ. Some solidified fuel flecks were found in a matrix of other in-situ solidified material in the base of the crack. Some fuel, therefore, was part of the molten material that was on top of the lower head when the cracks were formed. The grain boundaries of the wedge-shaped Fe-oxide in the crack extension into the vessel contained an In-Sn phase, indicating that a liquid was present when this high-temperature columnar-grained oxide was formed. The surface

Fig. 12. SEM-BSE images of multi-layered material on crack surfaces of Sample E-6. (a) Fuel particles (white) on oxide surface (arrow); (b) area outlined in (a); and (c) In-Sn needles in Fe matrix, Ag-Cd spheroids (A), and fuel particle (B).

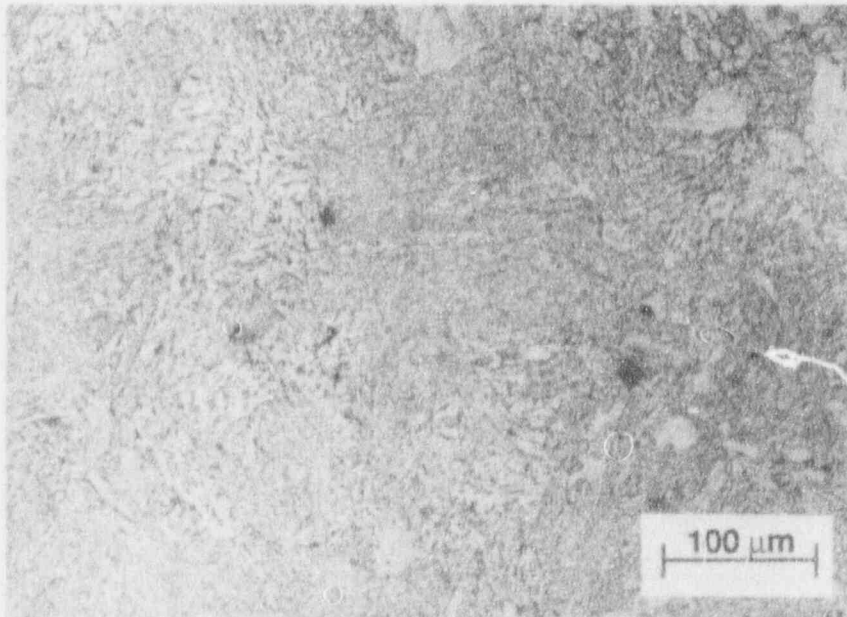
Fig. 18. Metallographic specimen from lower head Sample E-8 showing austenite grain growth in base metal (a) 1 mm below cladding/base-metal interface and (b) 3 mm below interface. (From Ref. 5)

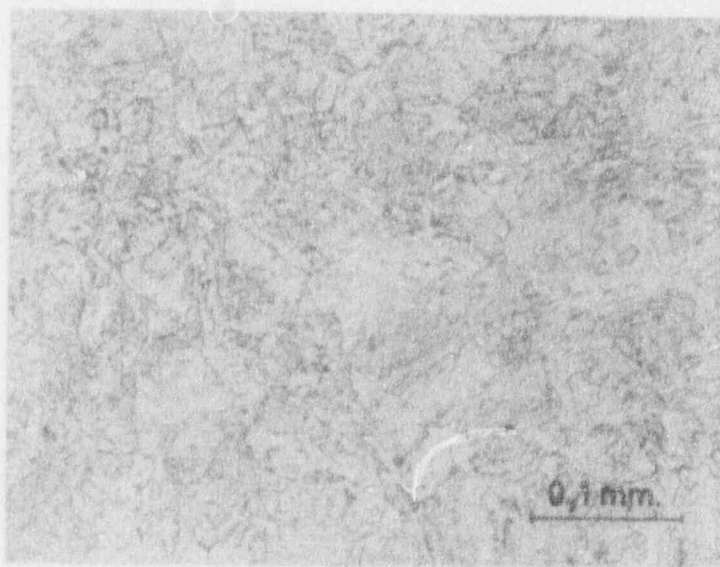
The examination conducted at ENSA in Spain likewise observed the absence of a heat-affected zone in the base metal, the elimination of the thin carbide layer at the interface, the larger prior austenite grain size in the base metal, and a reduction in the amount of delta ferrite in the weld overlay (Fig. 20). From this evidence, they deduced a maximum temperature $>1000^{\circ}\text{C}$.

Fig. 20. Metallographic specimen from lower head Sample E-8 showing (a) absence of carbide layer at cladding/base-metal interface and (b) austenite grain growth in base metal 4 mm below interface. (From Ref. 9)

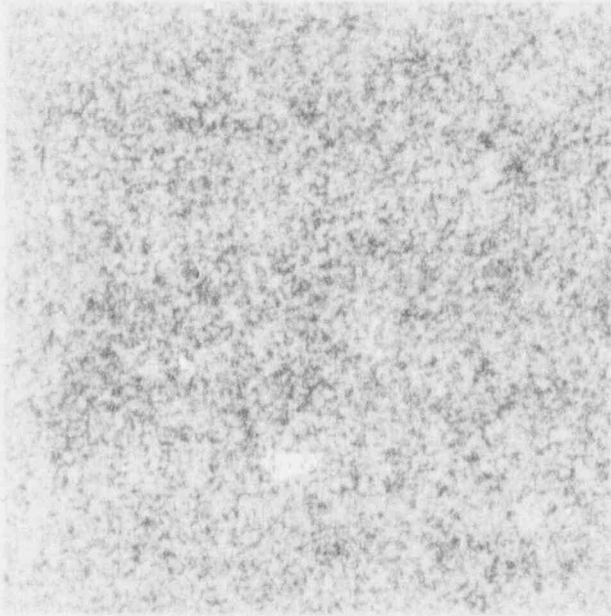
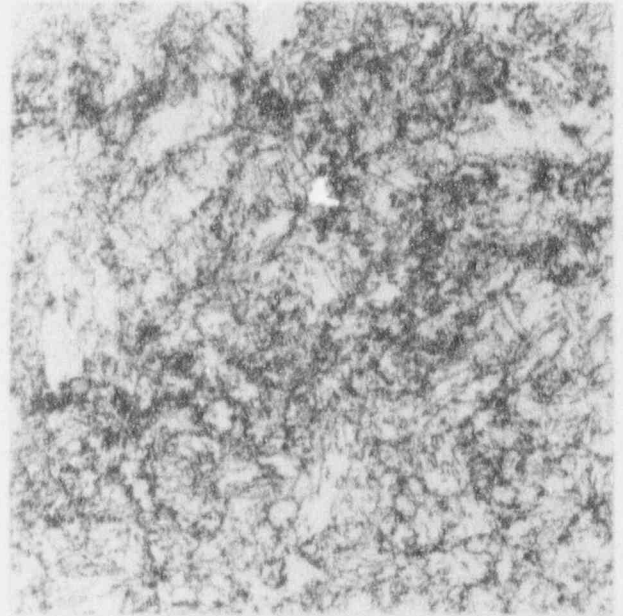
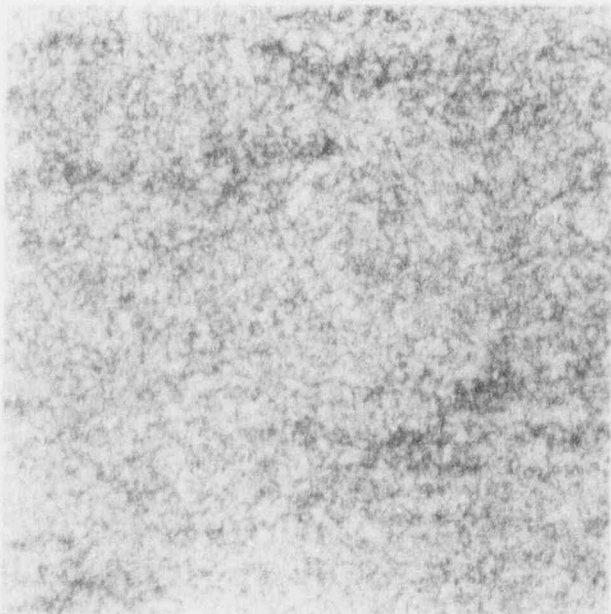
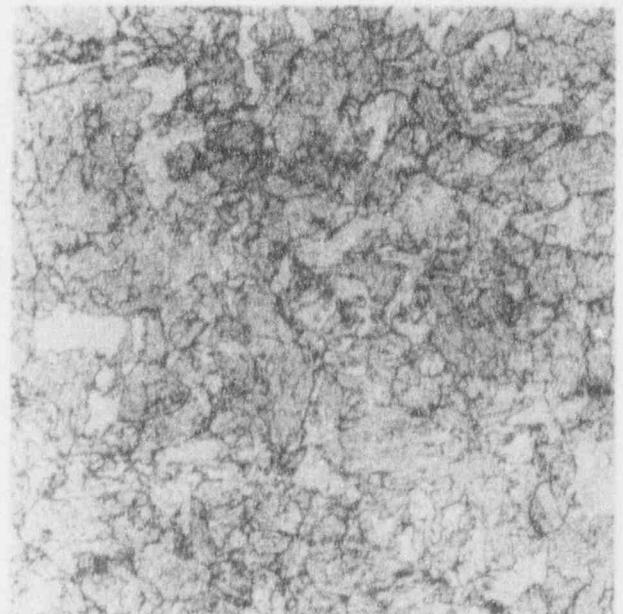
Fig. 22. (Cont'd.)

Investigators at the MPA in FRG noted an increase in hardness of the base metal to a depth of ≈ 15 mm below the interface. They found that the microstructure in this region corresponded to that produced by a partial reaustenitization (Fig. 22), and therefore concluded that the maximum temperature was between ≈ 730 and 850°C (the two-phase ferrite plus austenite region) during the accident.

Fig. 22. Metallographic specimen from lower head Sample F-5 showing evidence of partial reaustenitization of base metal to a depth of ≈ 15 mm below the cladding/base-metal interface. (From Ref. 8)

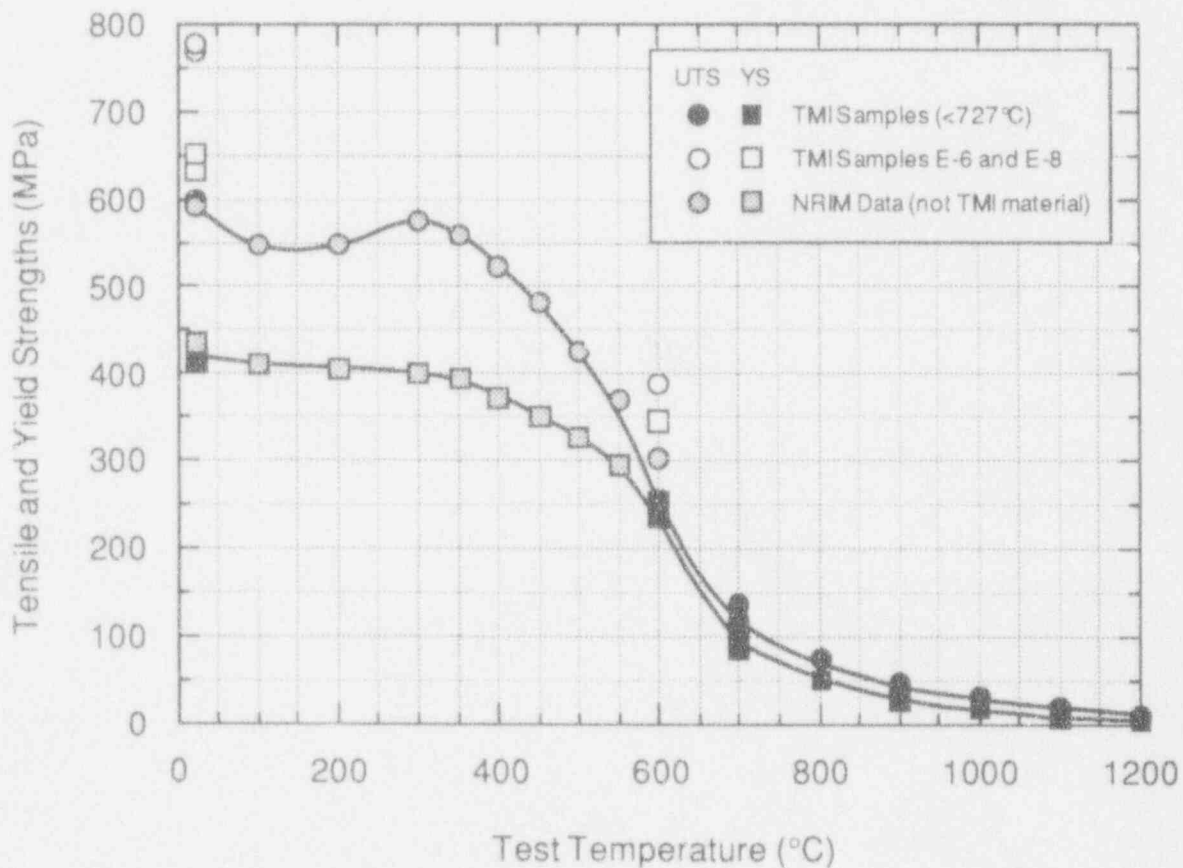
The base-metal tensile and yield strength data of Table 6 are plotted in Fig. 24, together with average values reported by the the Japanese National Research Institute for Metals (NRIM) for five other heats of A533, Grade B steel.¹³ The NRIM data were obtained at a strain rate of $5 \times 10^{-5} \text{ s}^{-1}$ up to yield and $1.25 \times 10^{-3} \text{ s}^{-1}$ for the remainder of the test. The NRIM tensile strength data suggest a strain-aging effect between 100 and 300°C, resulting in a local tensile strength minimum at $\approx 150^\circ\text{C}$. Both the tensile and yield strengths of this alloy are strongly temperature dependent; the room-temperature values are reduced by more than a factor of 2 at 600°C and by more than a factor of 10 at 900°C.

The data for specimens taken from lower head samples E-6 and E-8 are plotted separately in Fig. 24, and these data lie significantly above the best-fit curve to the remaining data. Both of these samples were heated to maximum temperatures of $\approx 1000\text{--}1100^\circ\text{C}$ during the accident, followed by a relatively rapid cooling. The resulting hardening has produced significant increases in strength at both room temperature and 600°C. On the other hand, no perceptible strengthening is seen in specimens from sample M-11, which came from a location where the maximum temperature may have approached or slightly exceeded 727°C near the surface.

Fig. 24. Tensile and yield strengths of TMI-2 lower head material compared with Japanese National Research Institute for Metals (NRIM) data for other heats of A533, Grade B steel.

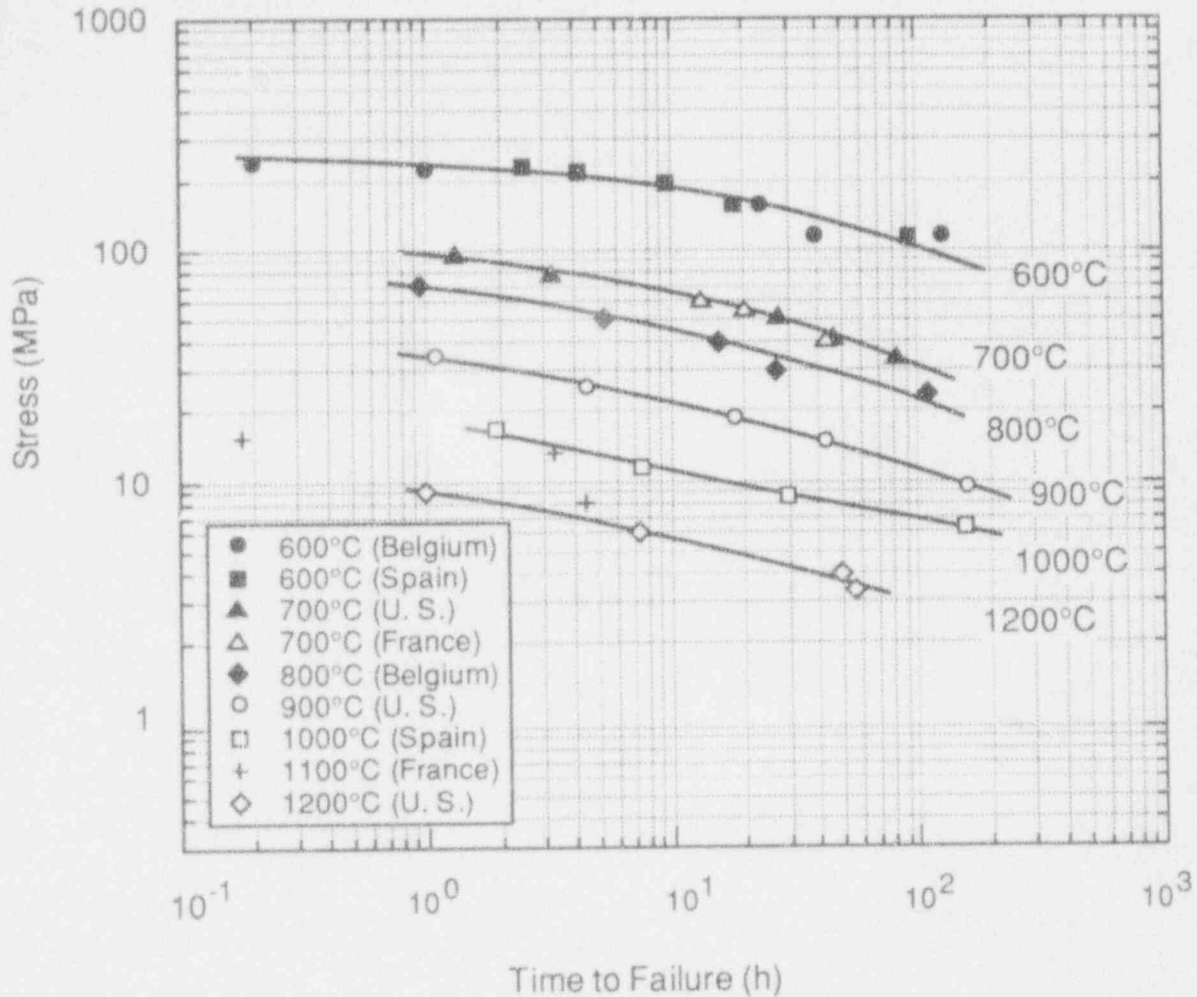
The creep test results are summarized in Table 8 and the stress-vs.-time-to-failure data are plotted in Fig. 25. These tests were carried out at ANL and in Belgium,⁵ France,⁷ and Spain,¹⁴ and they were conducted in general accordance with ASTM Standard E139. The tests were conducted in an Ar or He environment except those conducted by the SCK/CEN in Belgium. All but one of the Belgian tests was conducted in vacuum, as indicated in the table; a single test at 800°C and 30 MPa was conducted in an Ar environment. Strain-vs.-time curves from the creep tests of Table 8 are presented in Appendix B. However, no curves are available for the three creep tests conducted in France at 1100°C.

Materials with slightly different thermal histories were tested at both 600 and 700°C. At 600°C, tests were conducted on specimens from Sample K-13, for which the maximum temperature during the accident did not exceed 727°C , as well as on specimens from Sample F-5, for which the maximum temperature was apparently somewhat $>727^\circ\text{C}$ over a portion of the sample. No significant difference in time to failure is observed in Fig. 25. This lack of an effect may be attributed to the fact that the maximum temperature probably did not significantly exceed the transformation temperature of 727°C in F-5, particularly in the bottom half of the sample from which the creep test specimens were taken. Similarly at 700°C, specimens from Sample M-11, for which the maximum temperature may have approached or slightly exceeded

Fig. 25. Stress vs. time to rupture data from creep tests conducted on TMI-2 lower head material with estimated best-fit curves.

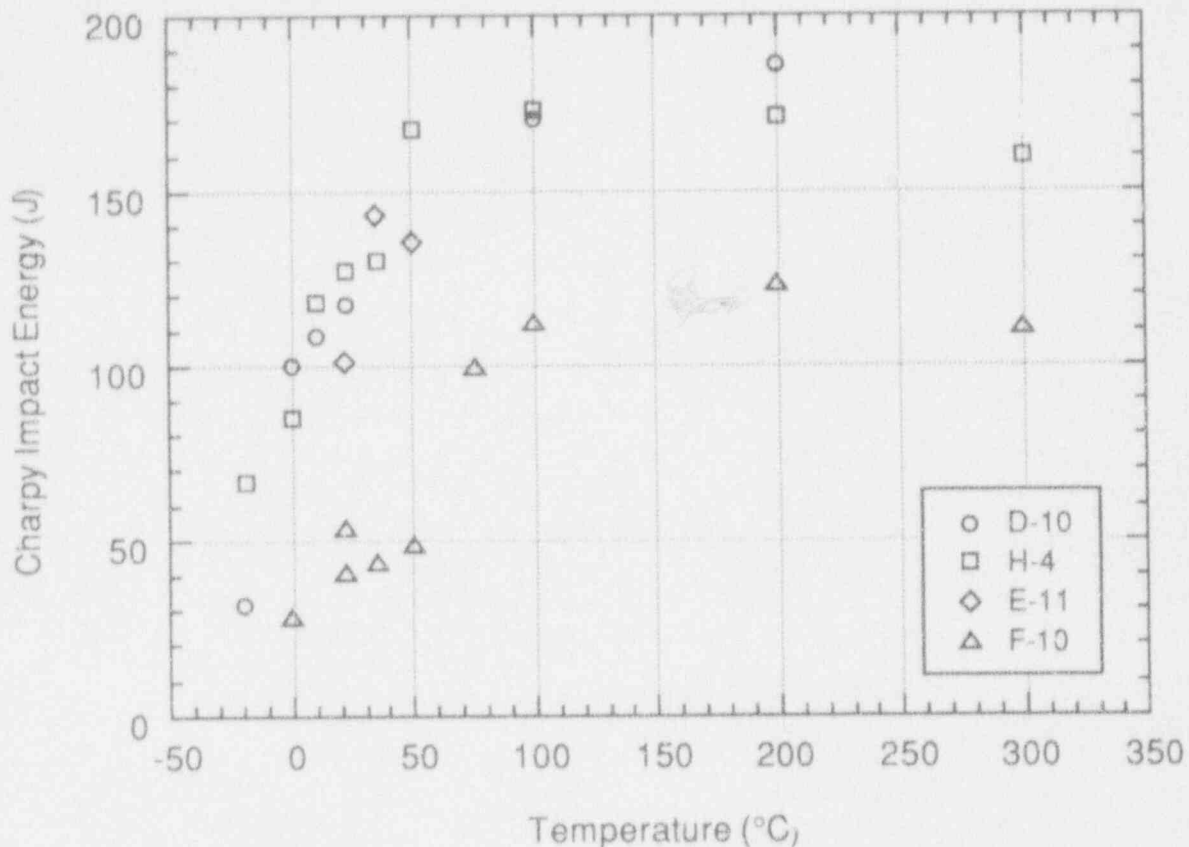
The Charpy V-notch impact data obtained in Italy¹⁷ on specimens from the lower head are summarized in Table 9, and the absorbed impact energy is plotted as a function of test temperature in Fig. 31. The three groups of test specimens for which the maximum temperature did not exceed 727°C show similar behavior, with an upper shelf energy of ~170 J and a transition temperature of the order of 20°C. However, the data from specimens of Sample F-10, for which the maximum temperature was as high as ~1050°C, stand in marked contrast. The F-10 material shows a significantly higher ductile-to-brittle transition temperature of ~70°C, as well as a lower upper-shelf energy of ~120 J. These differences reflect the reduced ductility and impact resistance of that material produced in this material by the high temperatures and relatively rapid cooling associated with the accident.

Fig. 31. Absorbed impact energy vs. test-temperature data from Charpy V-notch impact tests on specimens from TMI-2 lower head.

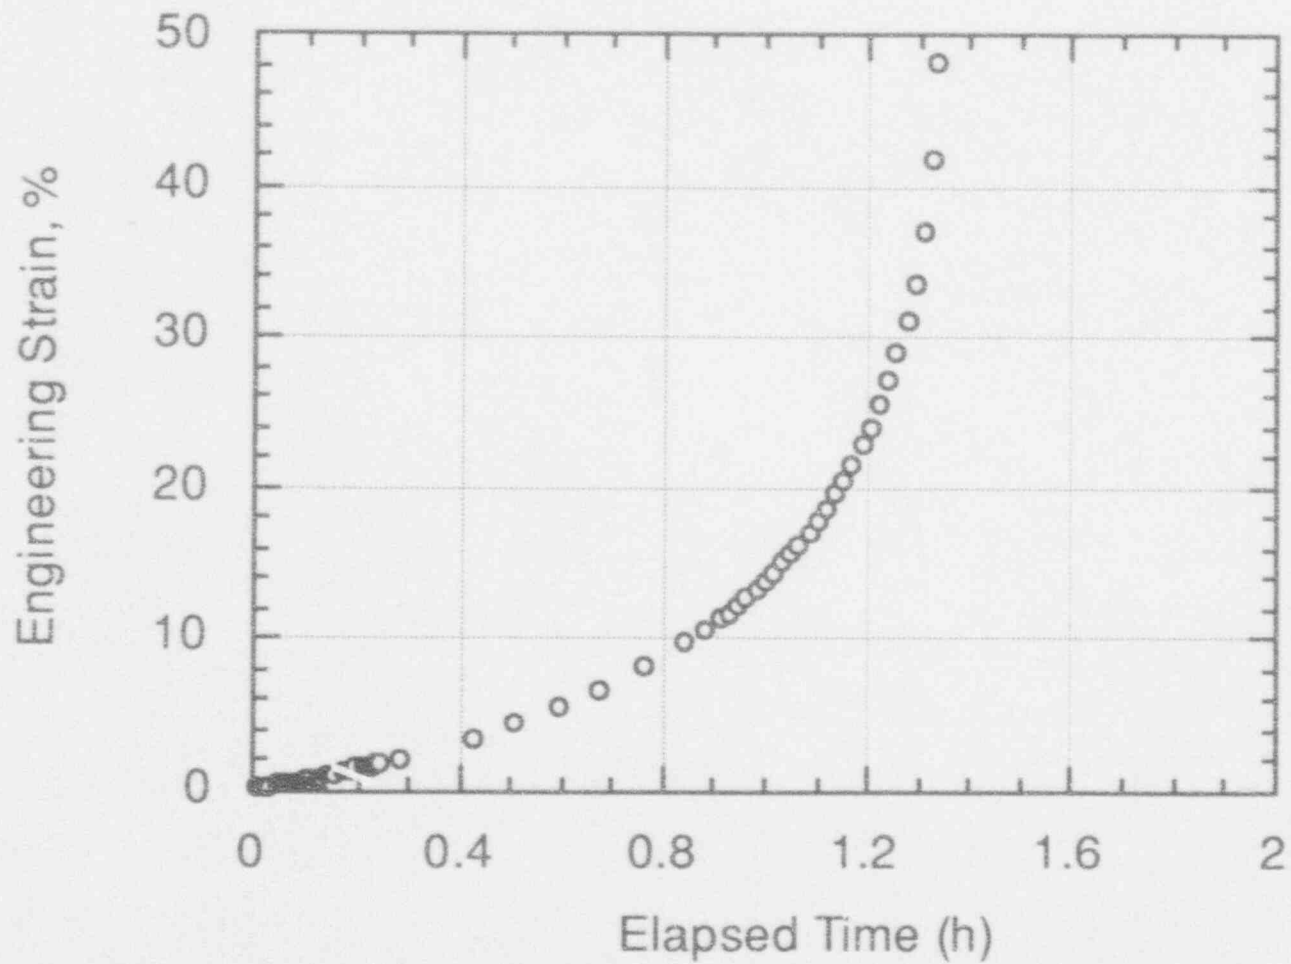
Specimen No.: H-8, t17
Laboratory: ANL
United States

Test Temperature: 700°C
Applied Stress: 95.1 MPa
Time to Failure: 1.34 h

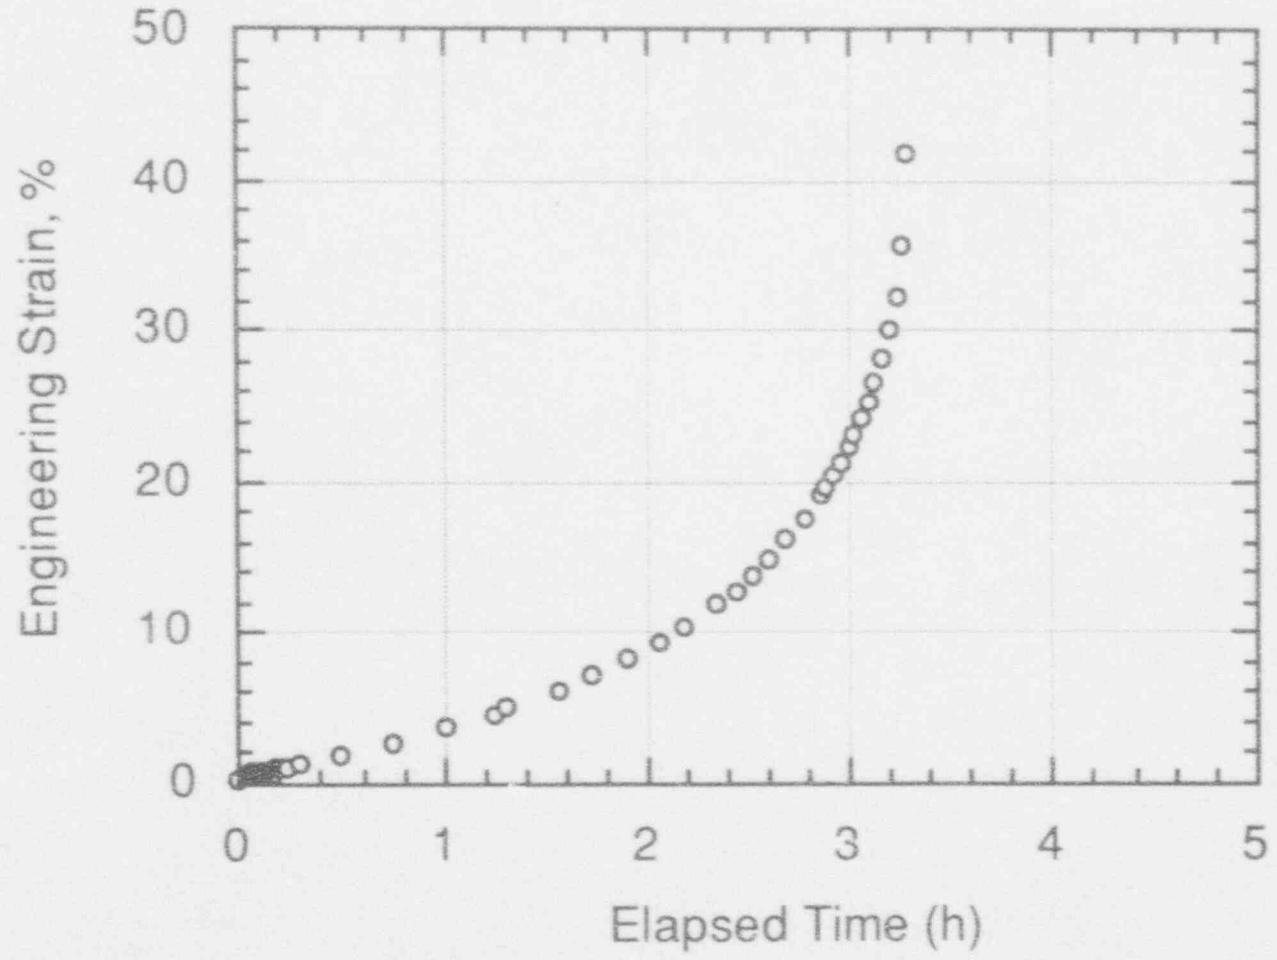
Specimen No.: H-8, t16
Laboratory: ANL
United States

Test Temperature: 700°C
Applied Stress: 80.0 MPa
Time to Failure: 3.27 h

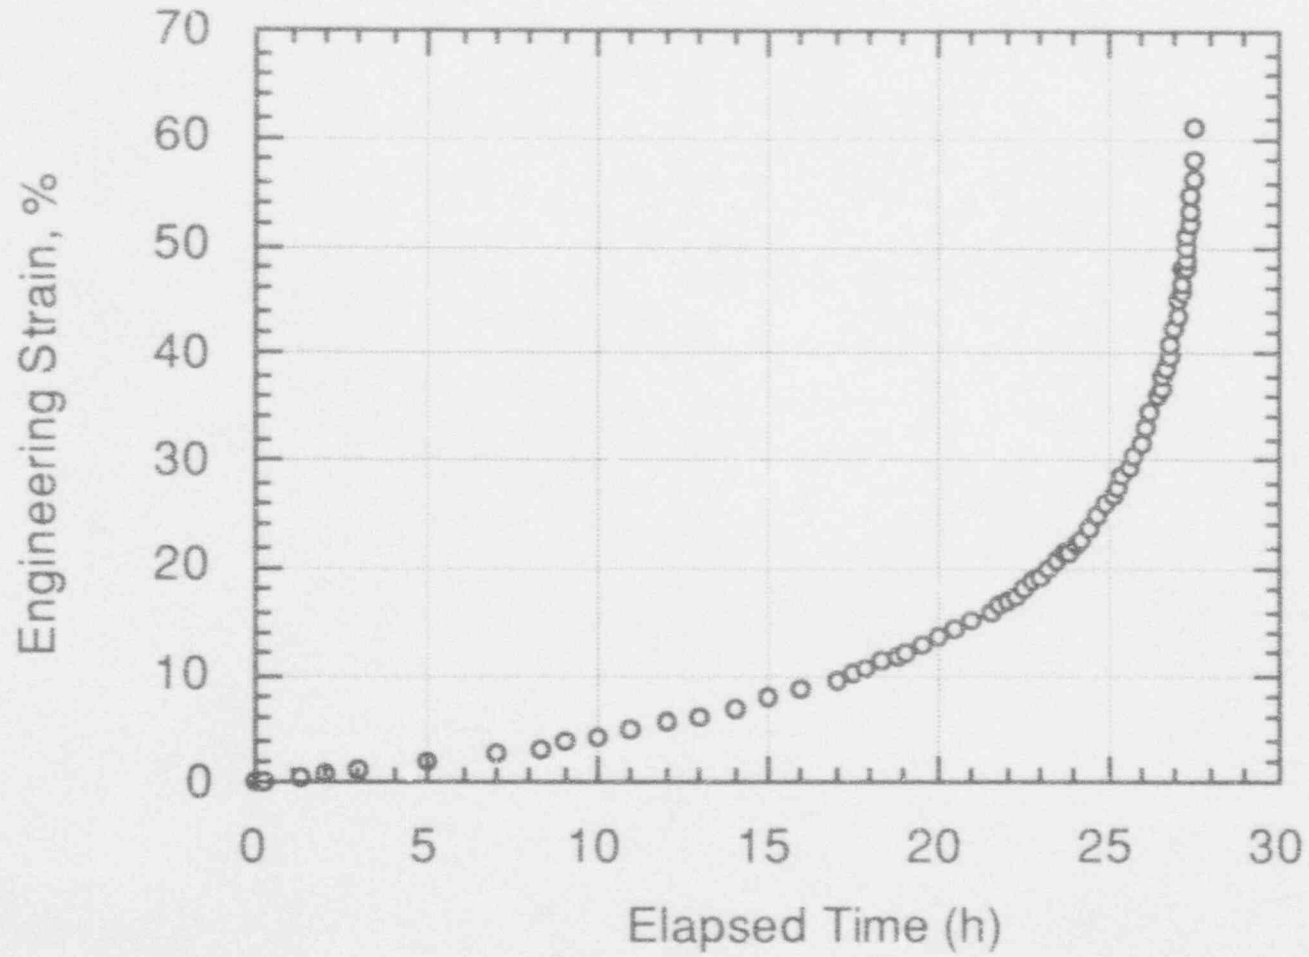
Specimen No.: H-8, t13
Laboratory: ANL
United States

Test Temperature: 700°C
Applied Stress: 52.1 MPa
Time to Failure: 27.6 h

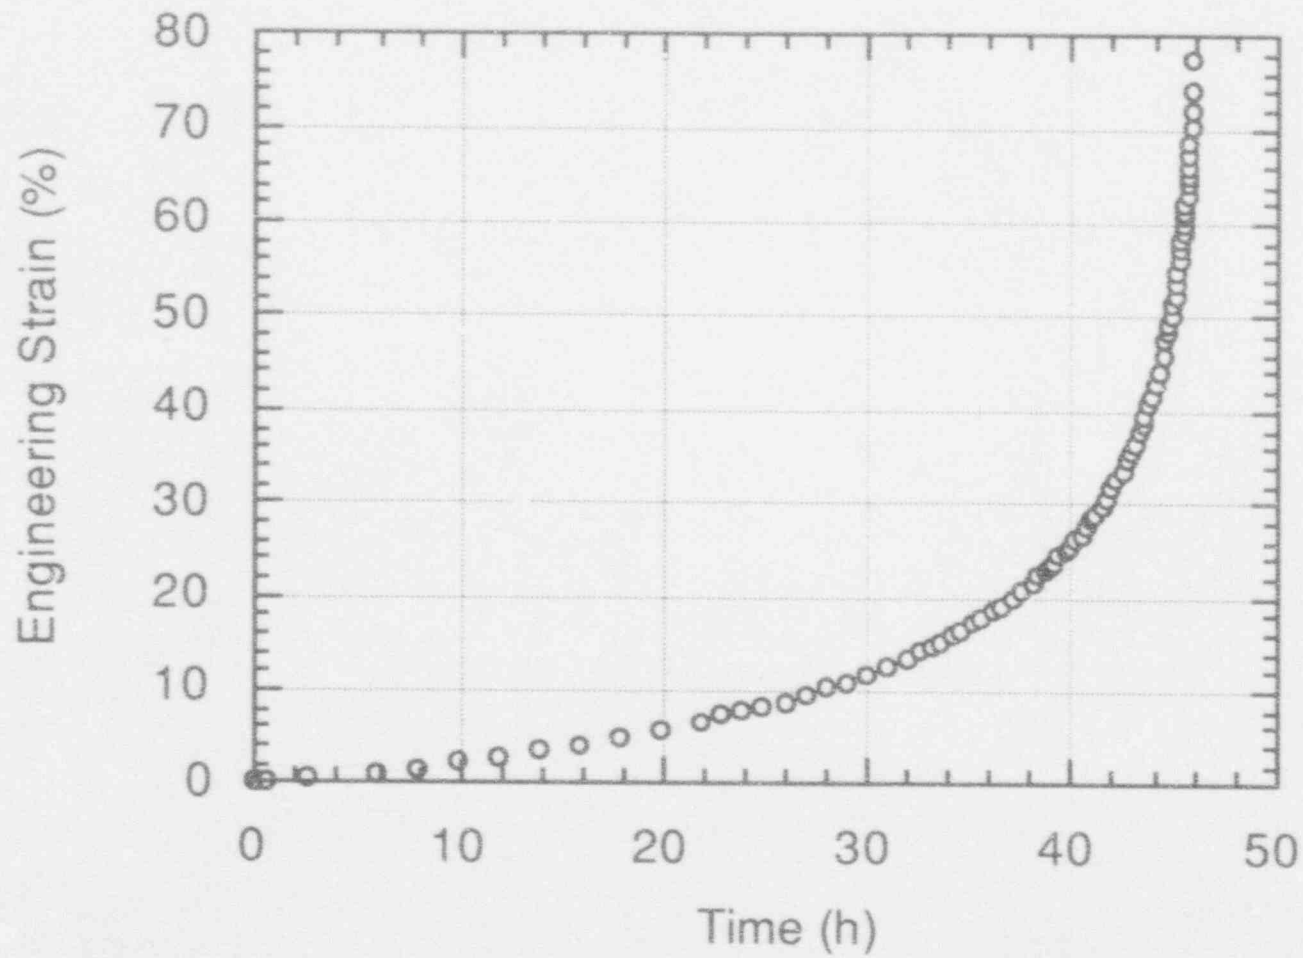
Specimen No.: H-8, t14
Laboratory: ANL
United States

Test Temperature: 700°C
Applied Stress: 41.6 MPa
Time to Failure: 46.0 h

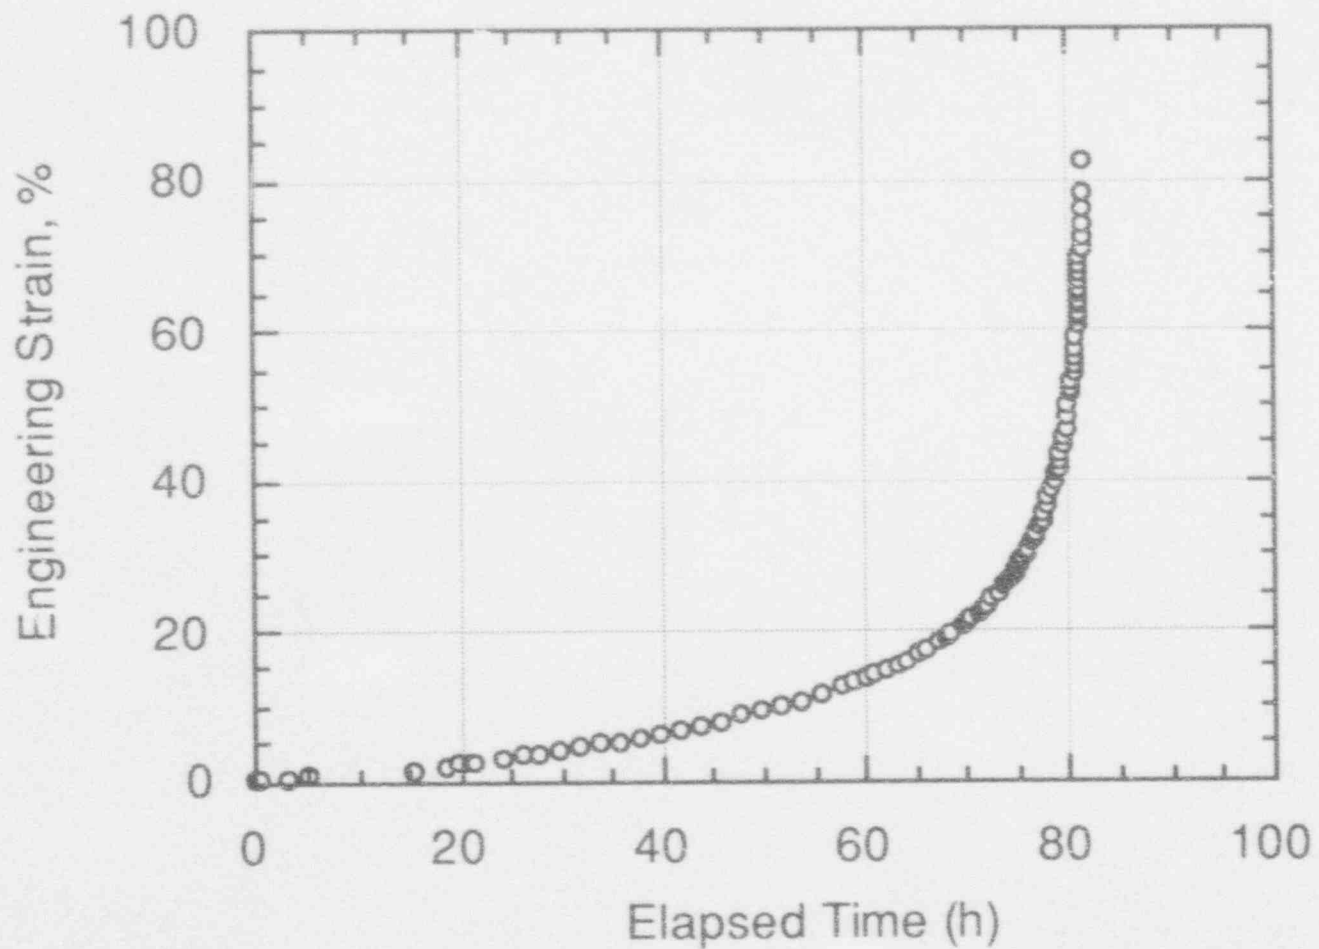
Specimen No.: H-8, t15
Laboratory: ANL
United States

Test Temperature: 700°C
Applied Stress: 34.5 MPa
Time to Failure: 81.6 h

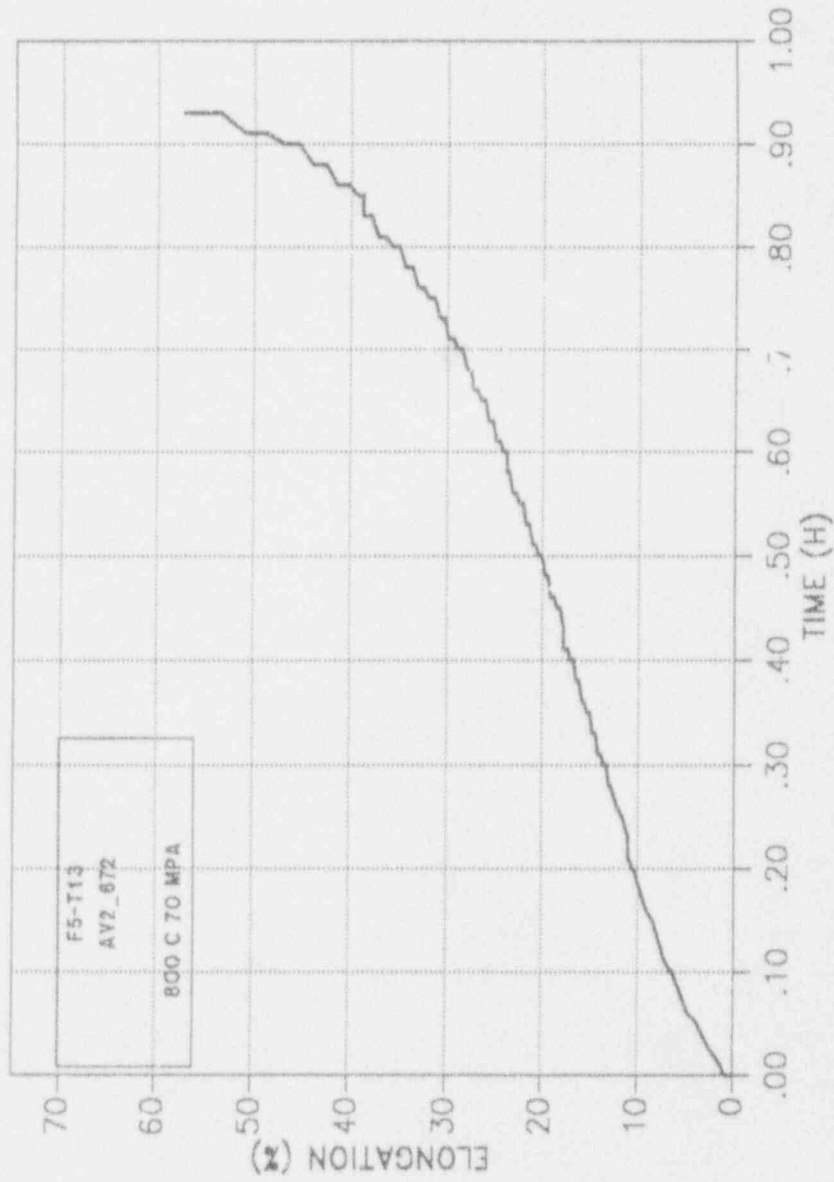
Specimen No.: F-5, t13
Laboratory: V.I.T.O.
Belgium

Test Temperature: 800°C
Applied Stress: 70 MPa
Time to Failure: 0.95 h

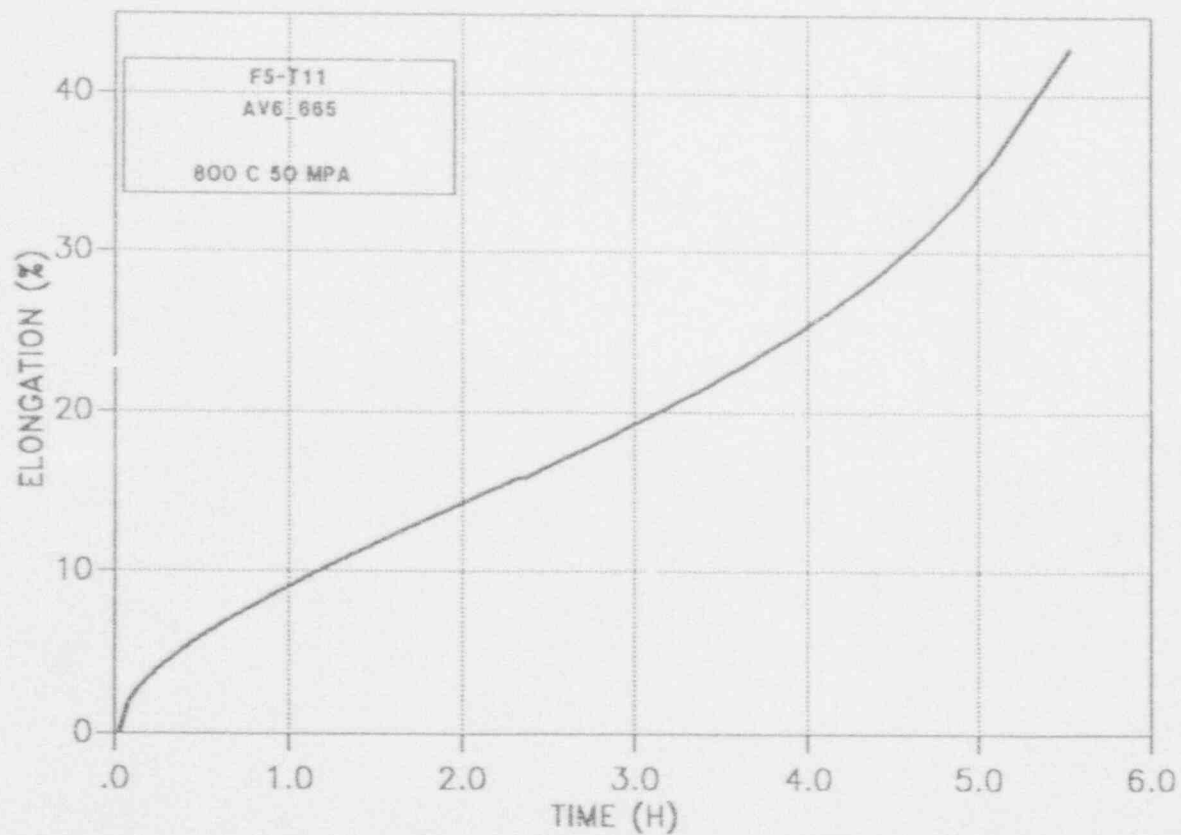
Specimen No.: F-5, t11
Laboratory: V.I.T.O.
Belgium

Test Temperature: 800°C
Applied Stress: 50 MPa
Time to Failure: 5.4 h

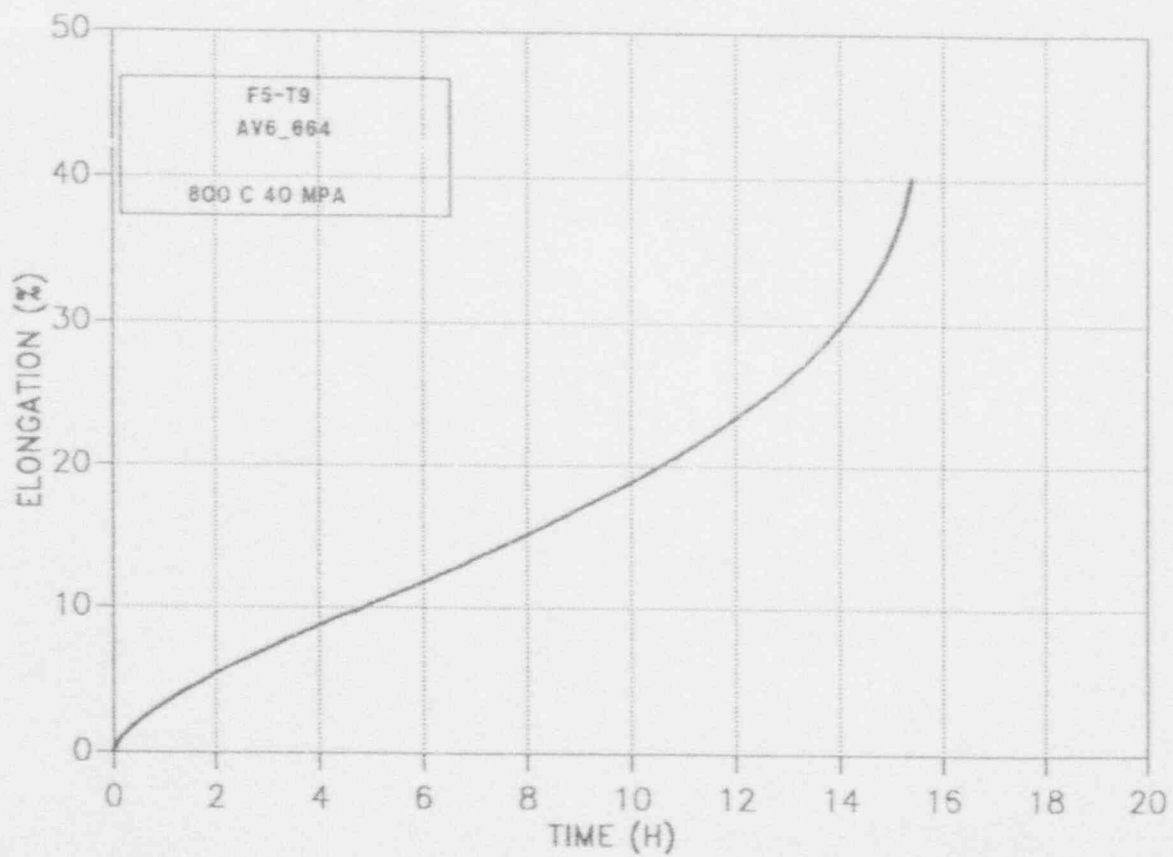
Specimen No.: F-5, t9
Laboratory: V.I.T.O.
Belgium

Test Temperature: 800°C
Applied Stress: 40 MPa
Time to Failure: 15.5 h

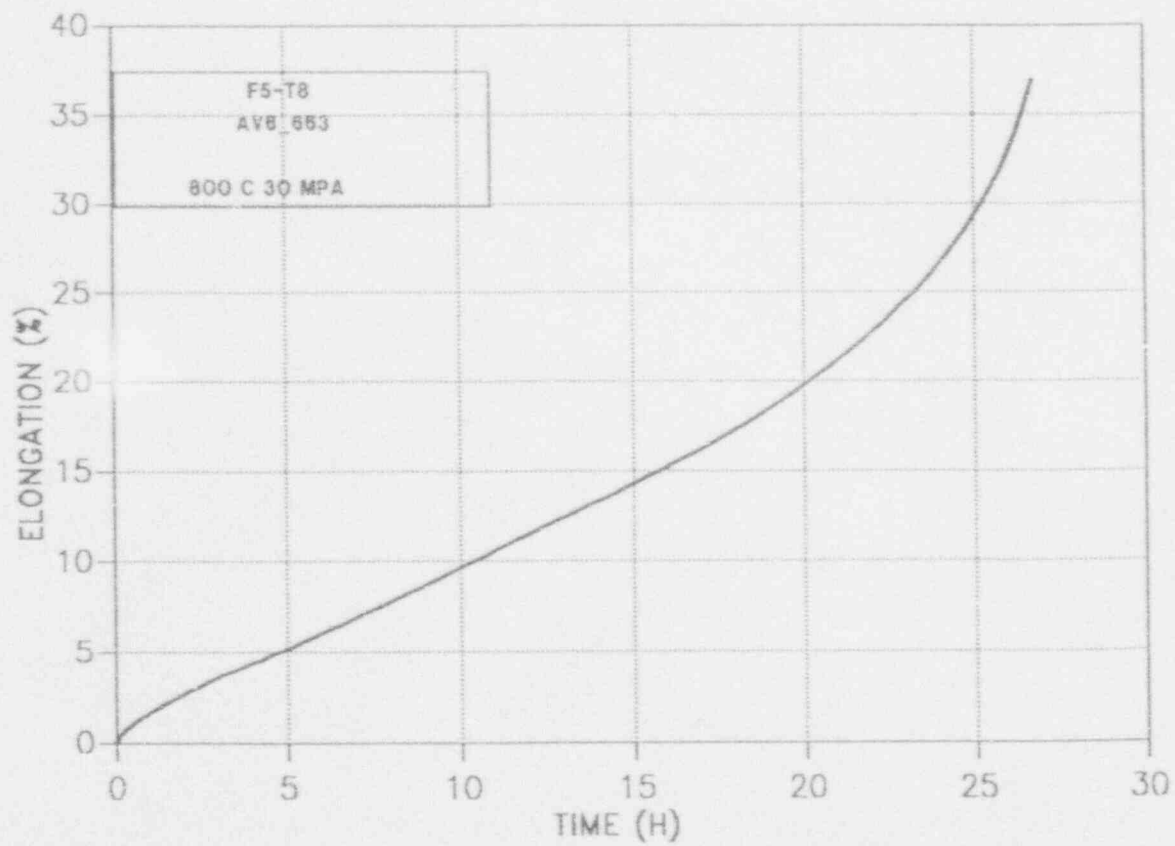
Specimen No.: F-5, t8
Laboratory: V.I.T.O.
Belgium

Test Temperature: 800°C
Applied Stress: 30 MPa
Time to Failure: 27 h

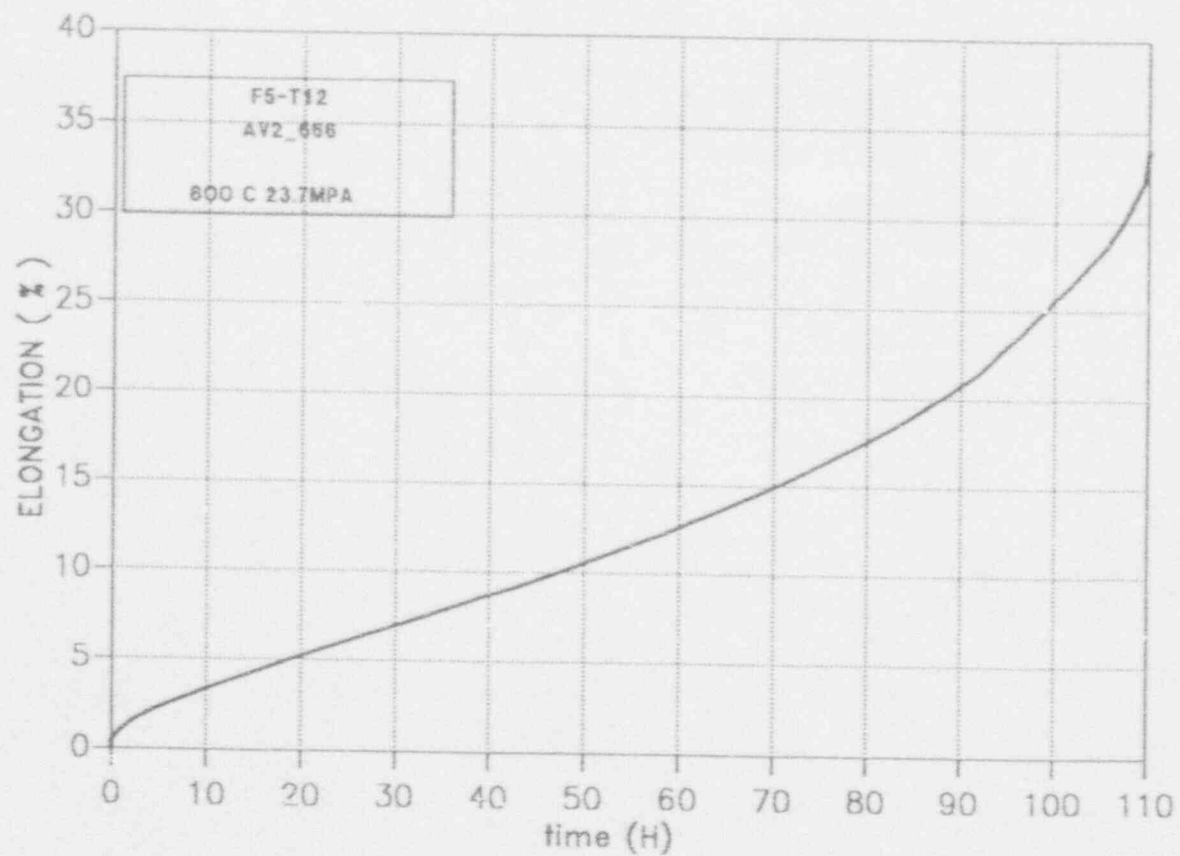
Specimen No.: F-5, t12
Laboratory: V.I.T.O.
Belgium

Test Temperature: 800°C
Applied Stress: 23.7 MPa
Time to Failure: 111 h

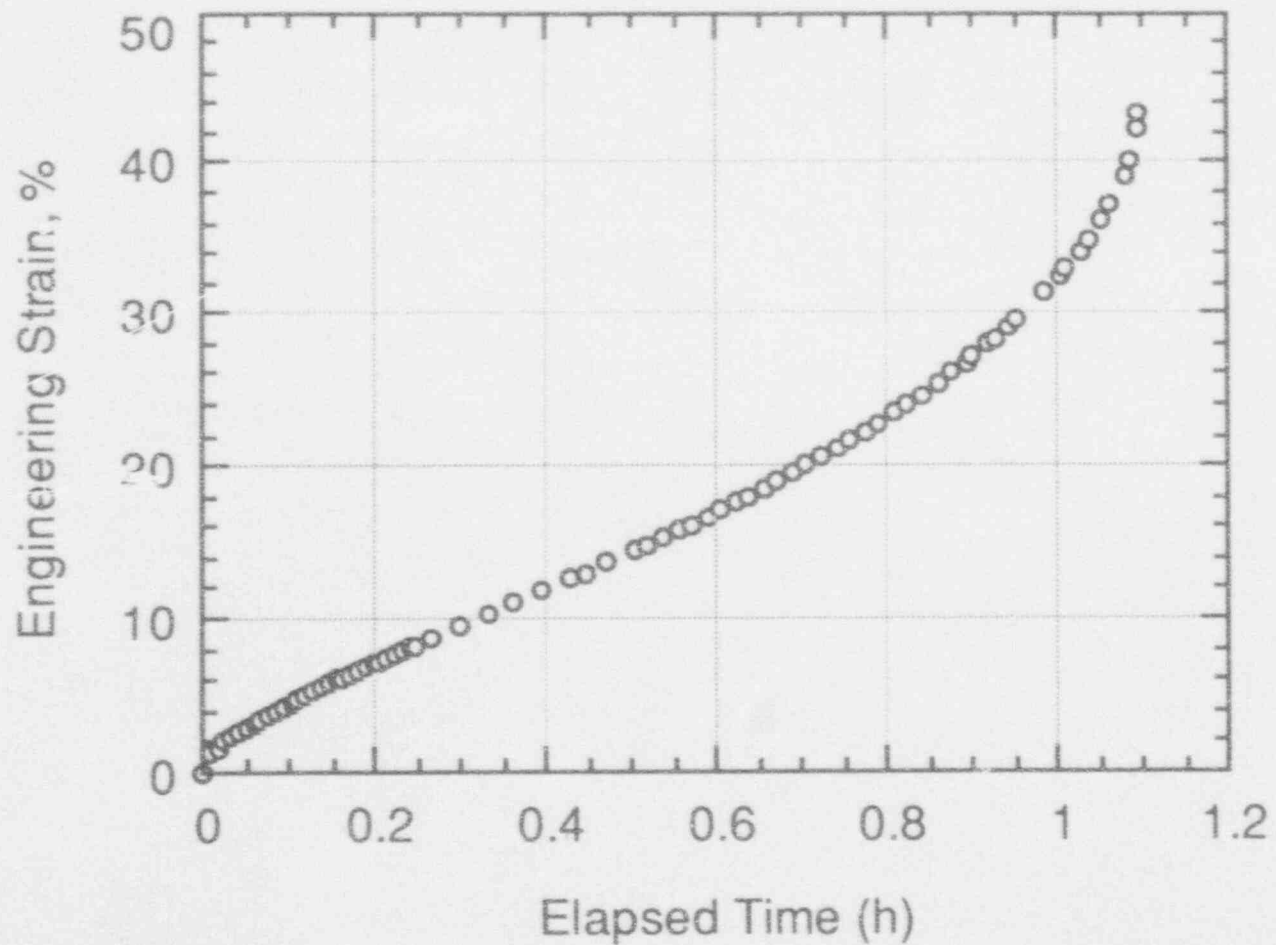
Specimen No.: H-5, t16
Laboratory: ANL
United States

Test Temperature: 900°C
Applied Stress: 35.0 MPa
Time to Failure: 1.09 h

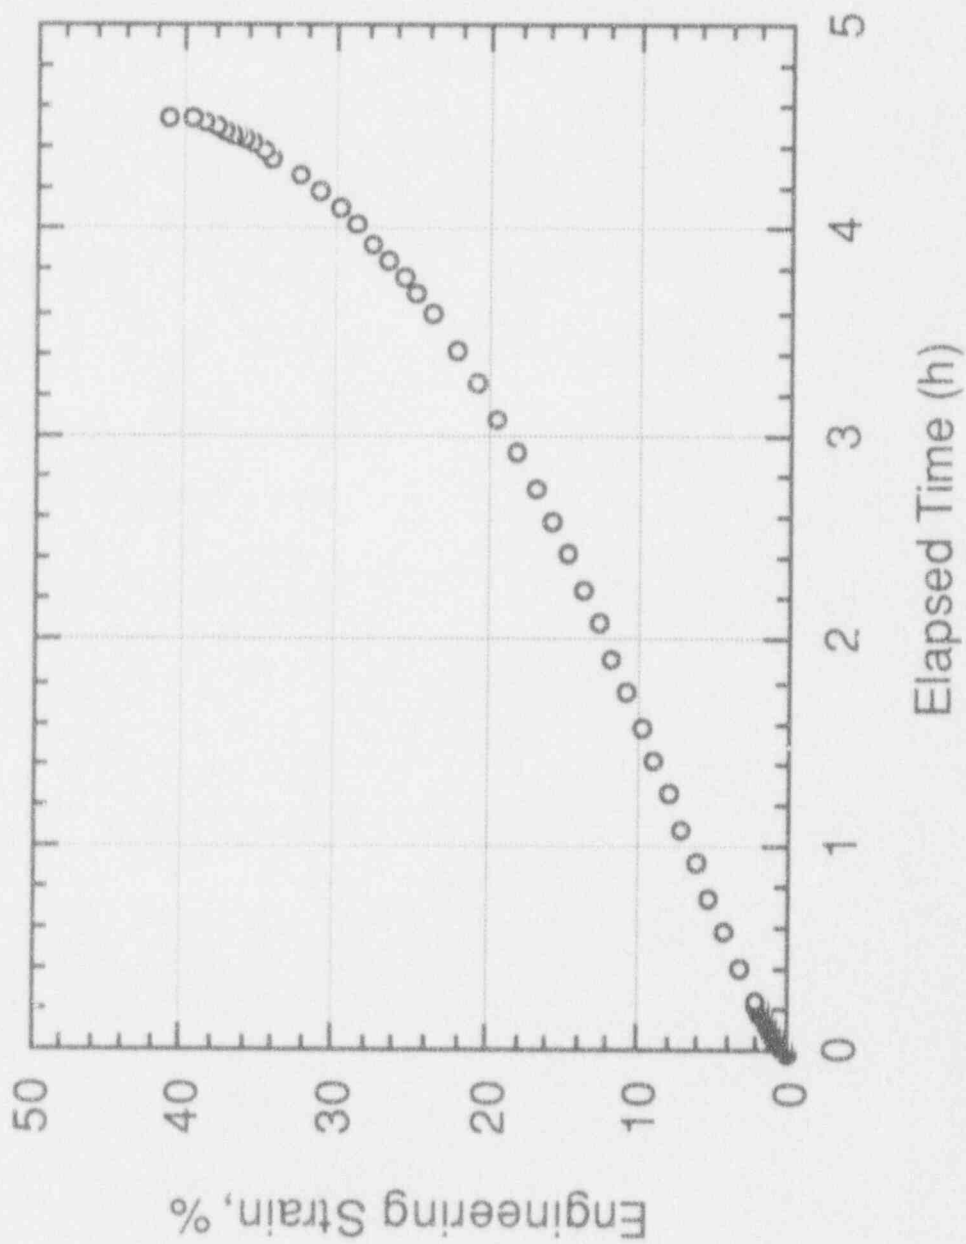
Specimen No.: H-5, 115
Laboratory: ANL
United States

Test Temperature: 900°C
Applied Stress: 26.0 MPa
Time to Failure: 4.55 h
