NUREG/CR-6187
ANL-94/8
TMIV(93)AL02

Results of Mechanical Tests and Supplementary Microstructural Examinations of the TMI-2 Lower Head Samples

Argonne National Laboratory

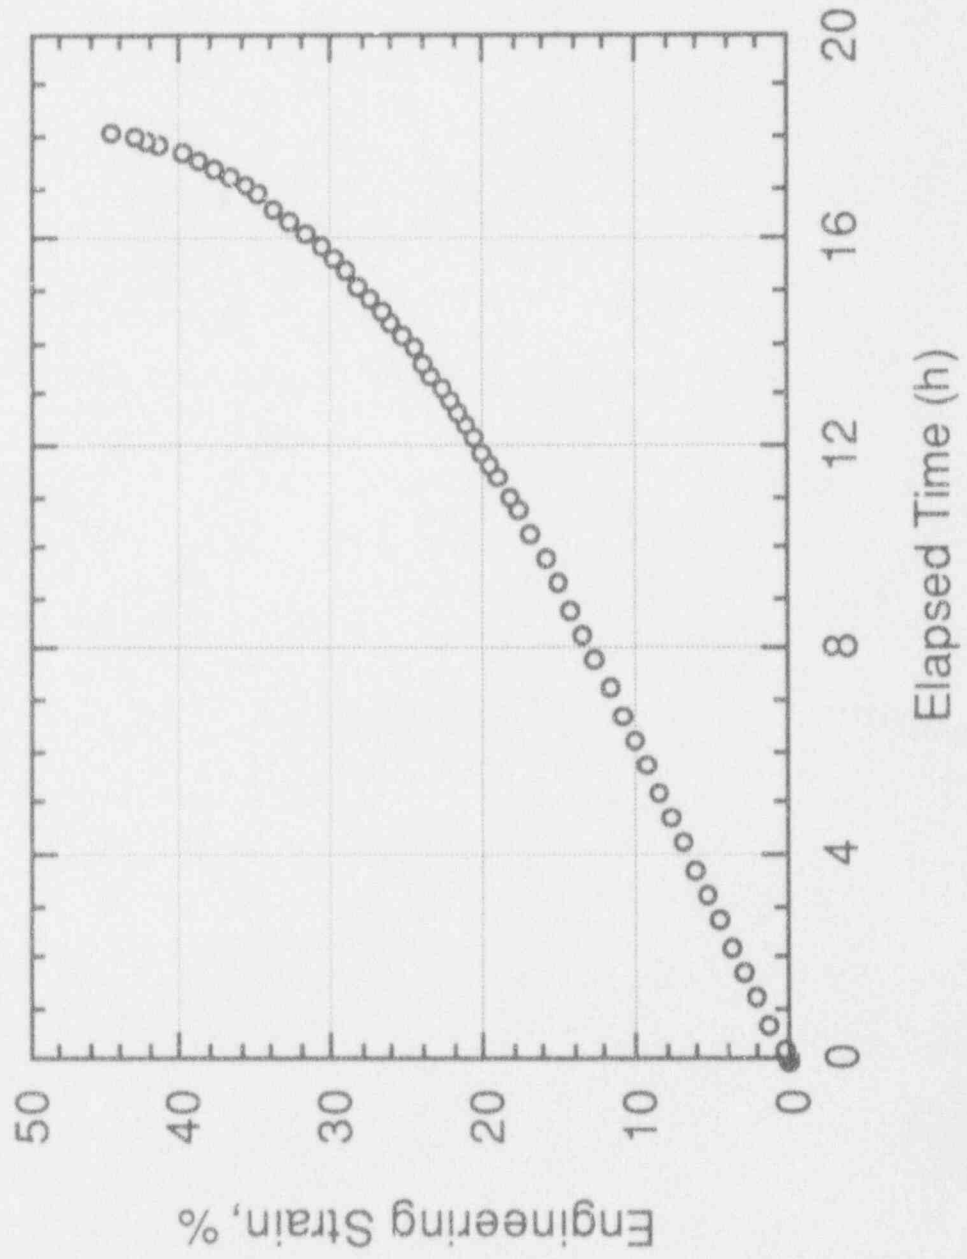
Specimen No.: H-5, t14
Laboratory: ANL
United States

Test Temperature: 900°C
Applied Stress: 19.0 MPa
Time to Failure: 18.1 h

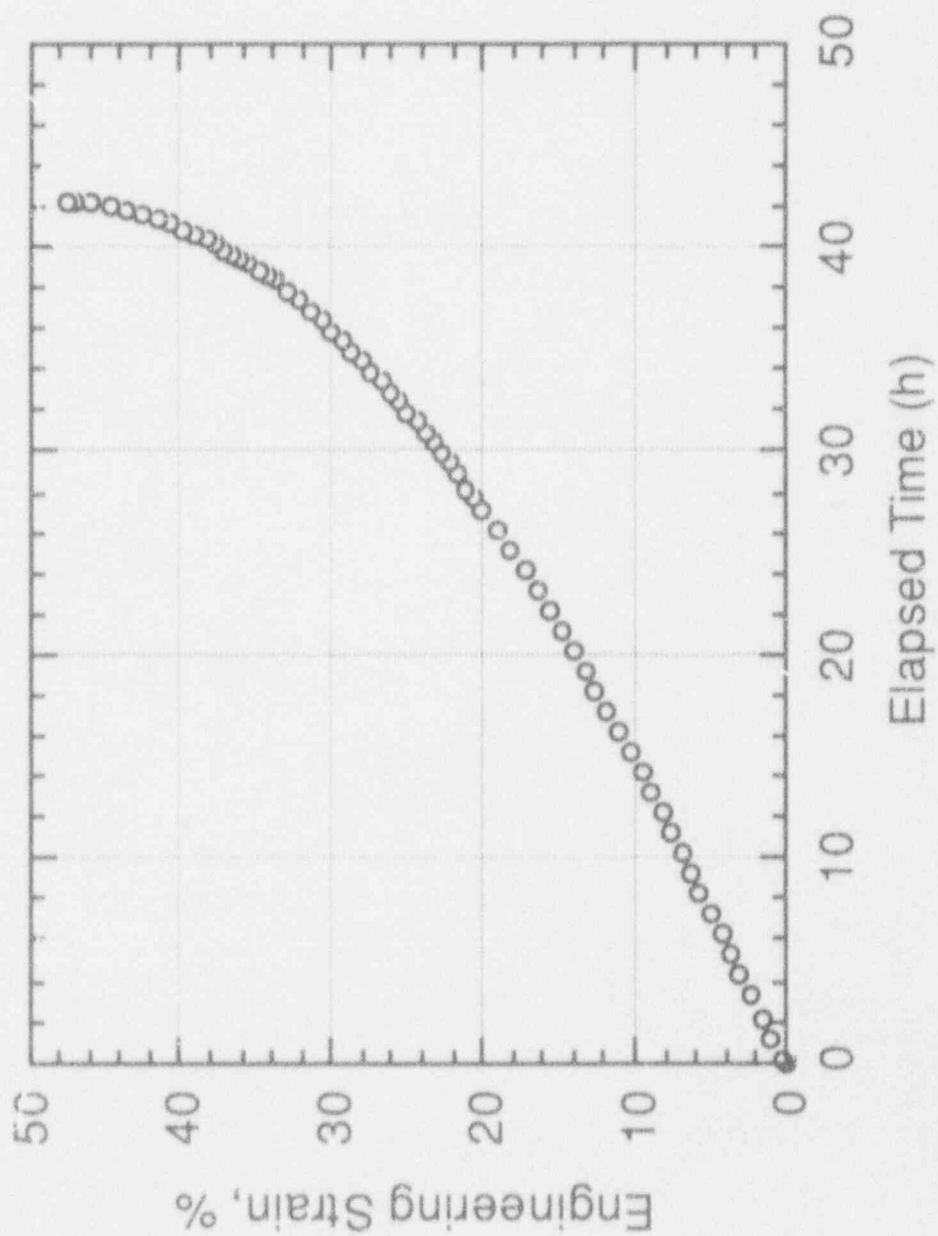
Specimen No.: H-5, t11
Laboratory: ANL
United States

Test Temperature: 900°C
Applied Stress: 14.8 MPa
Time to Failure: 42.3 h

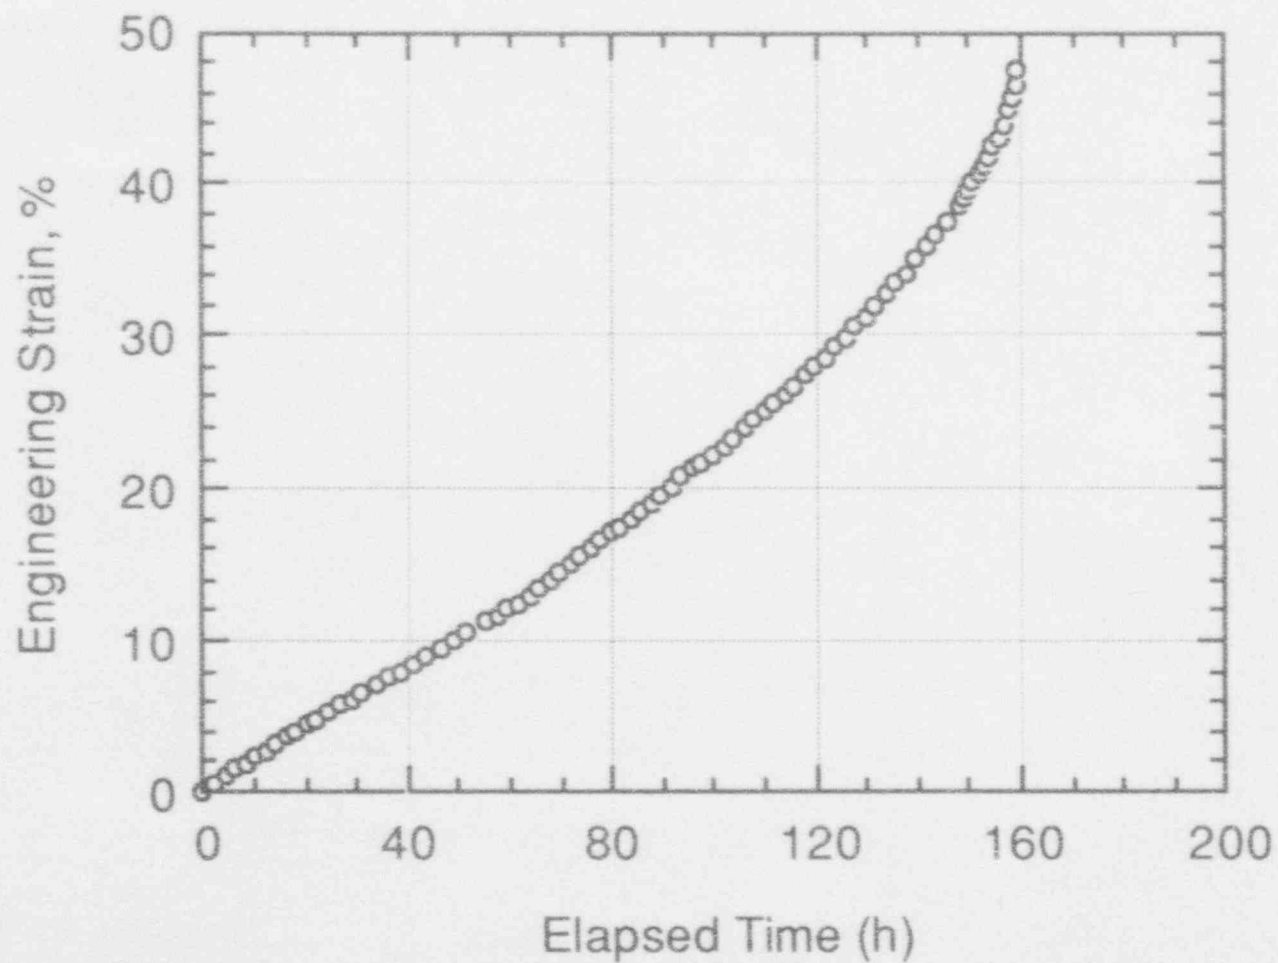
Specimen No.: H-5, t12
Laboratory: ANL
United States

Test Temperature: 900°C
Applied Stress: 9.51 MPa
Time to Failure: 159.5 h

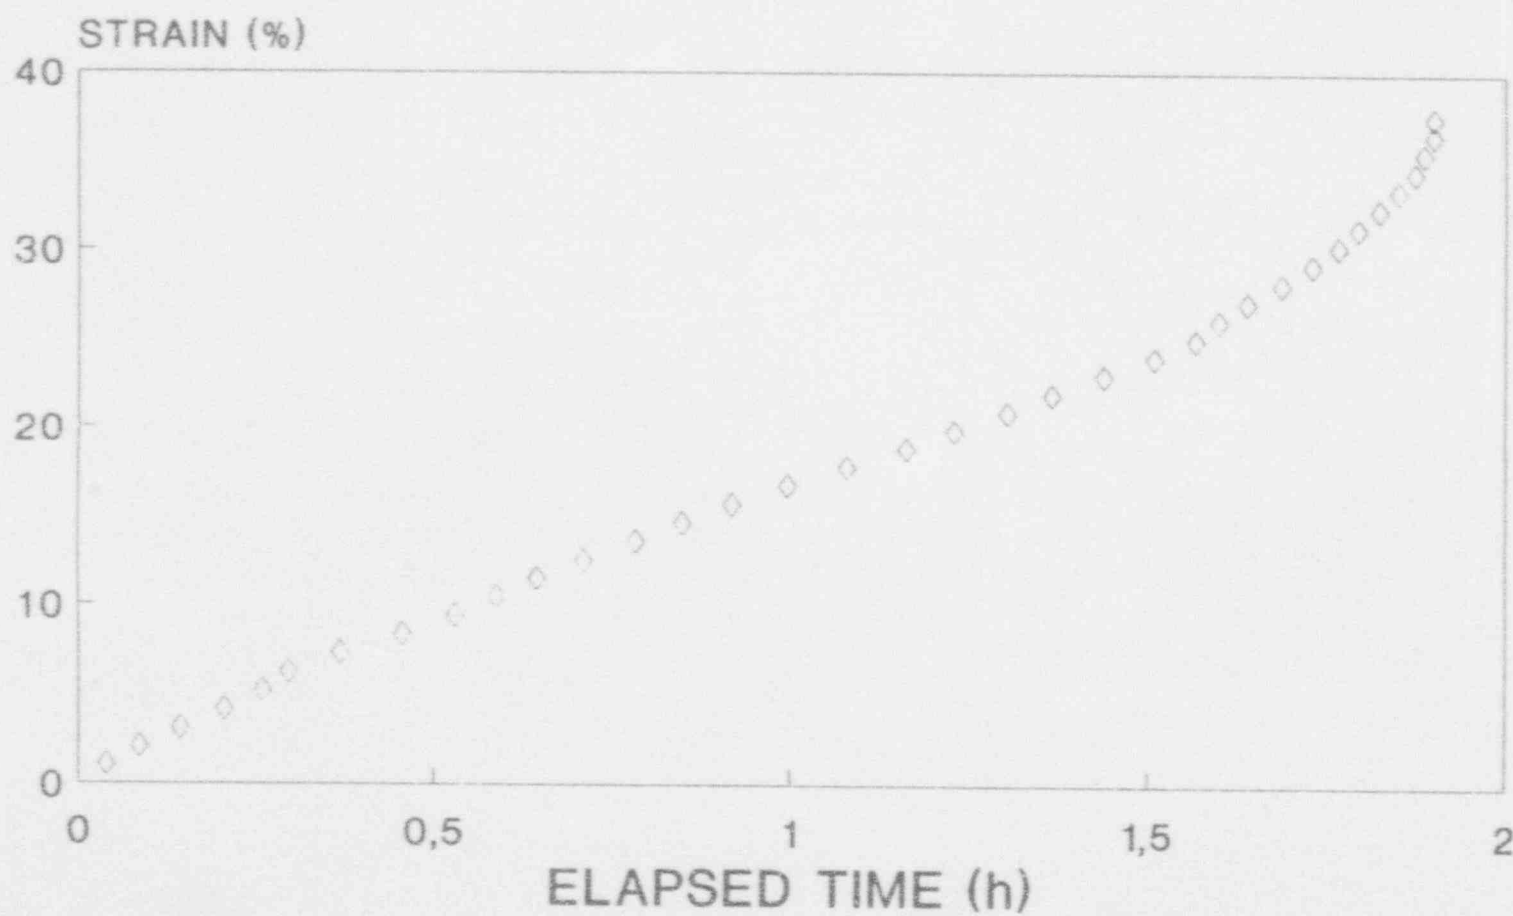
Specimen No.: K-7, t11
Laboratory: tecnatom, s.a.
Spain

Test Temperature: 1000°C
Applied Stress: 16.9 MPa
Time to Failure: 1.90 h

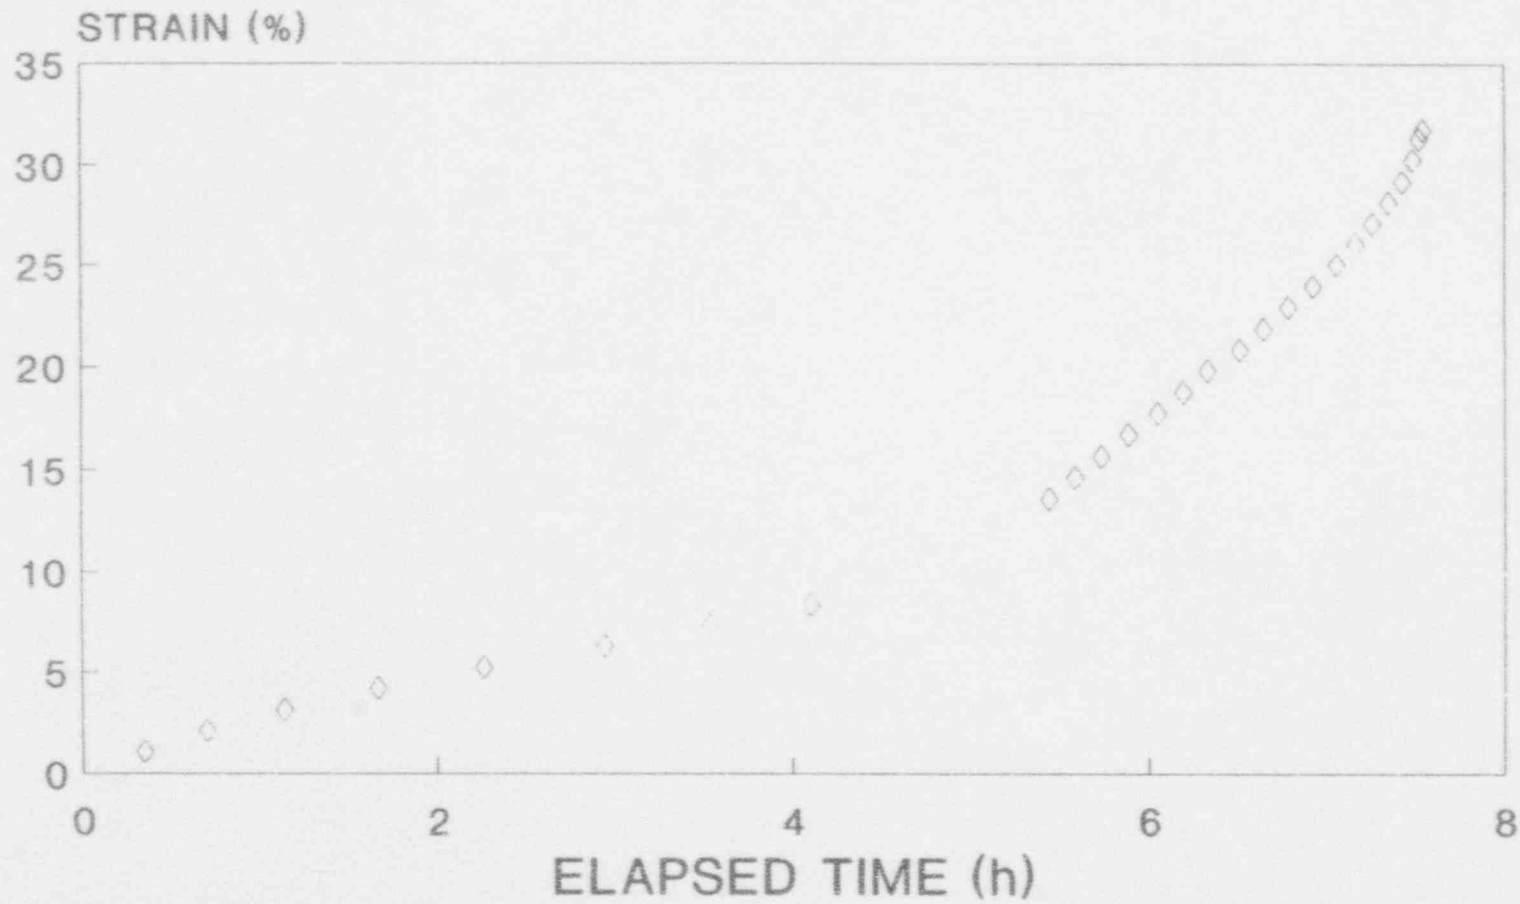
Specimen No.: K-7, t10
Laboratory: tecnatom, s.a.
Spain

Test Temperature: 1000°C
Applied Stress: 11.5 MPa
Time to Failure: 7.54 h

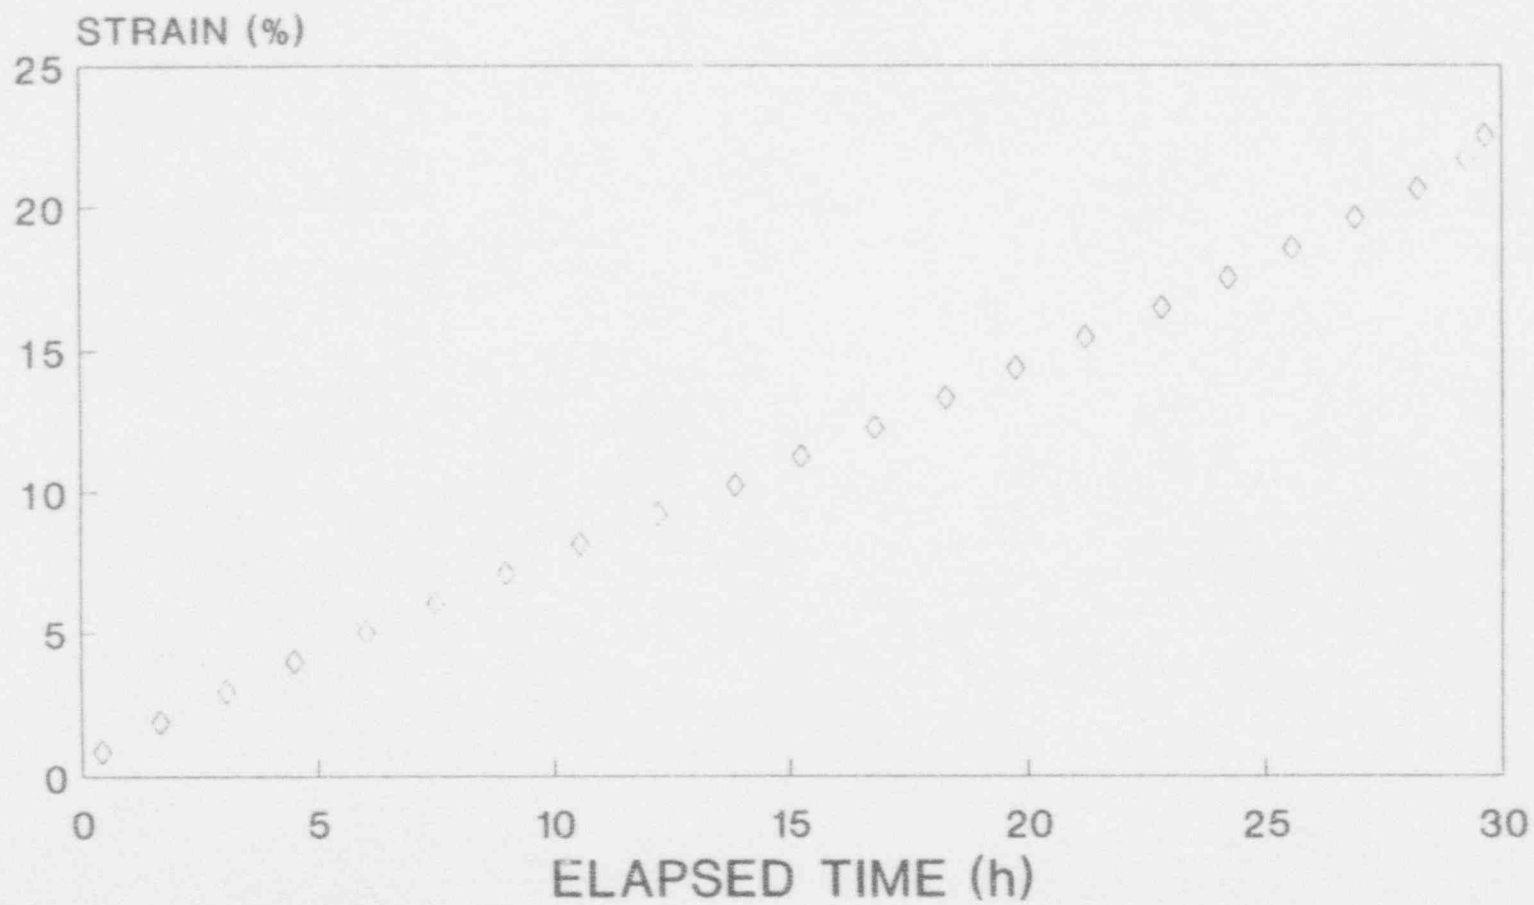
Specimen No.: K-7, t12
Laboratory: tecnatom, s.a.
Spain

Test Temperature: 1000°C
Applied Stress: 8.7 MPa
Time to Failure: 29.64 h

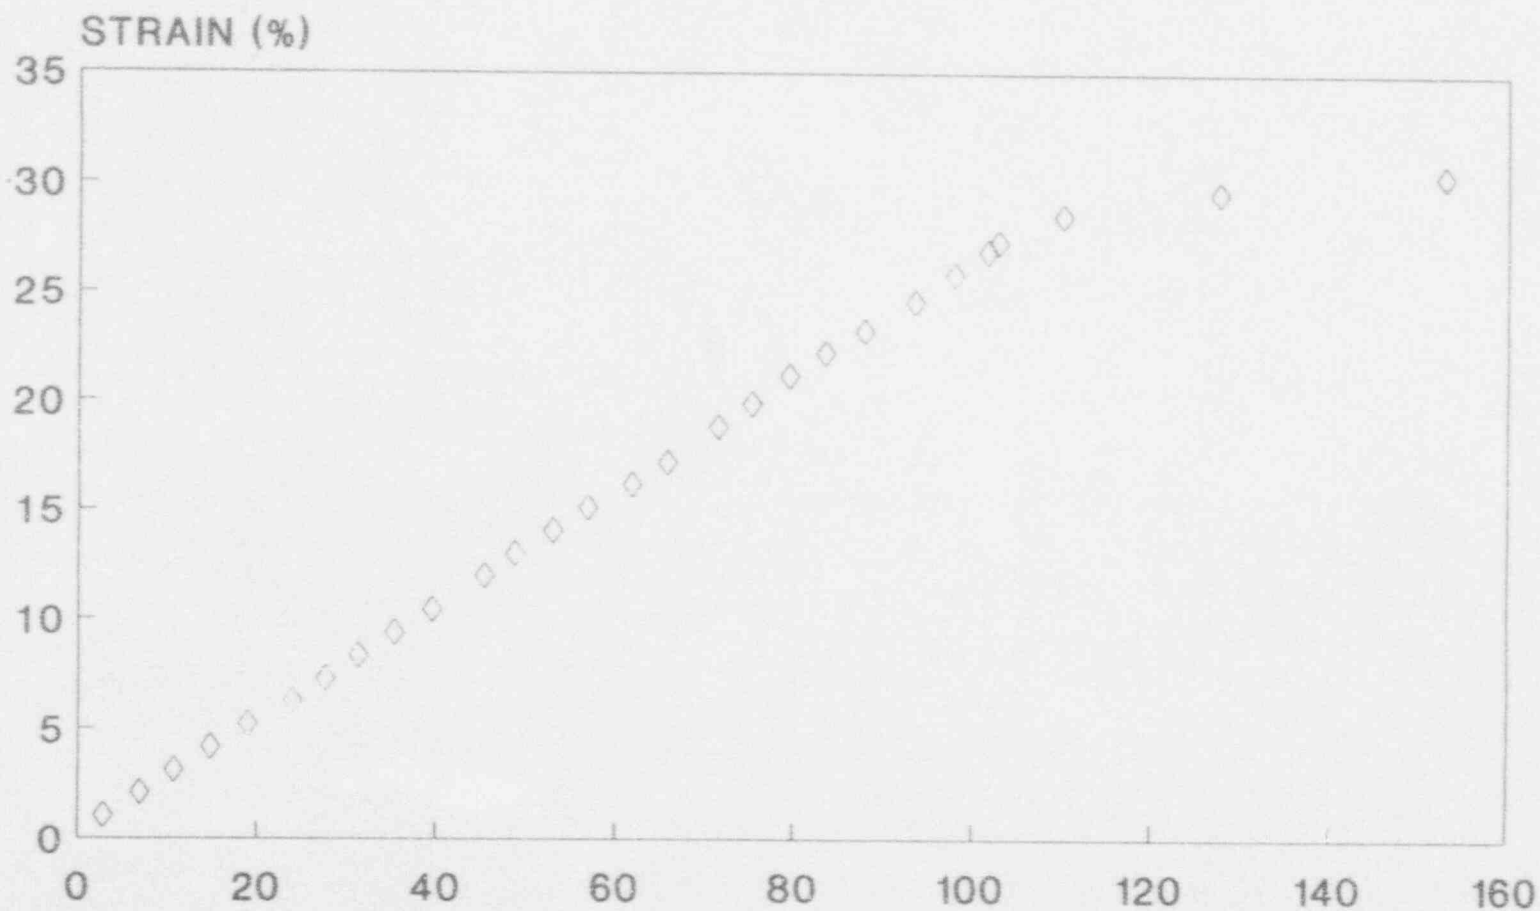
Specimen No.: K-7, t13
Laboratory: tecnatom, s.a.
Spain

Test Temperature: 1000°C
Applied Stress: 6.3 MPa
Time to Failure: 152.8 h

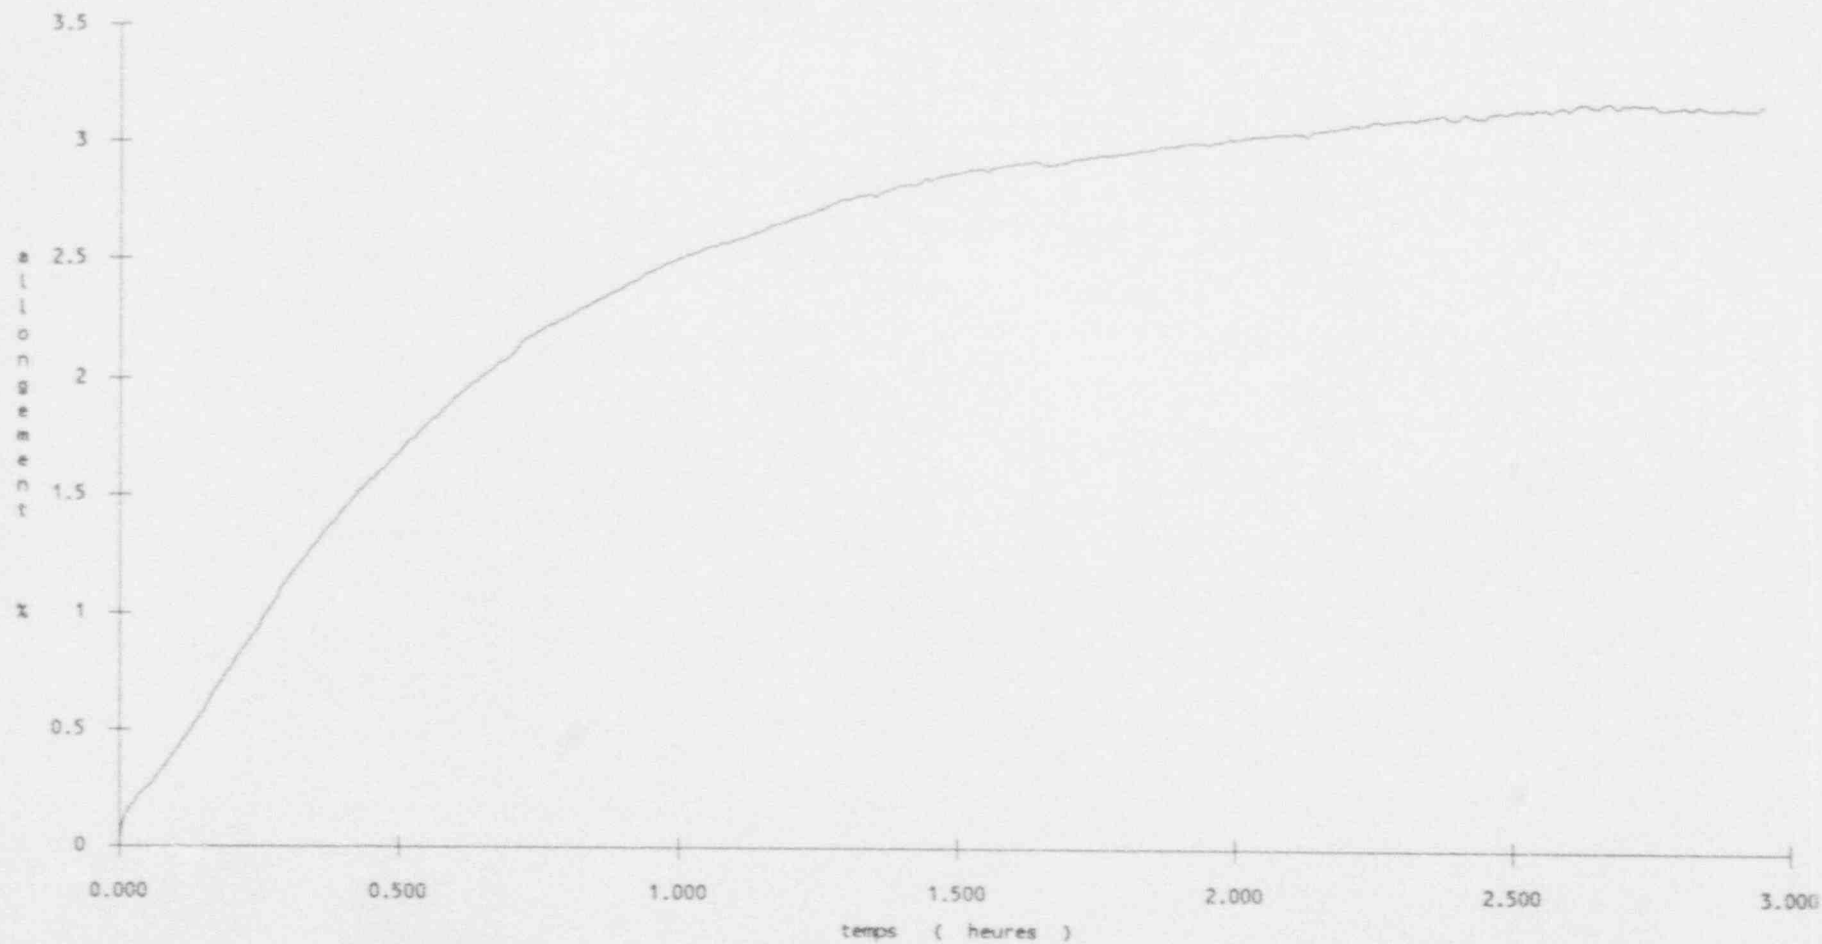
Specimen No.: L-9, 110
Laboratory: CEA
France

Test Temperature: 1100°C
Applied Stress: 8 MPa
Time to Failure: 4.33 h

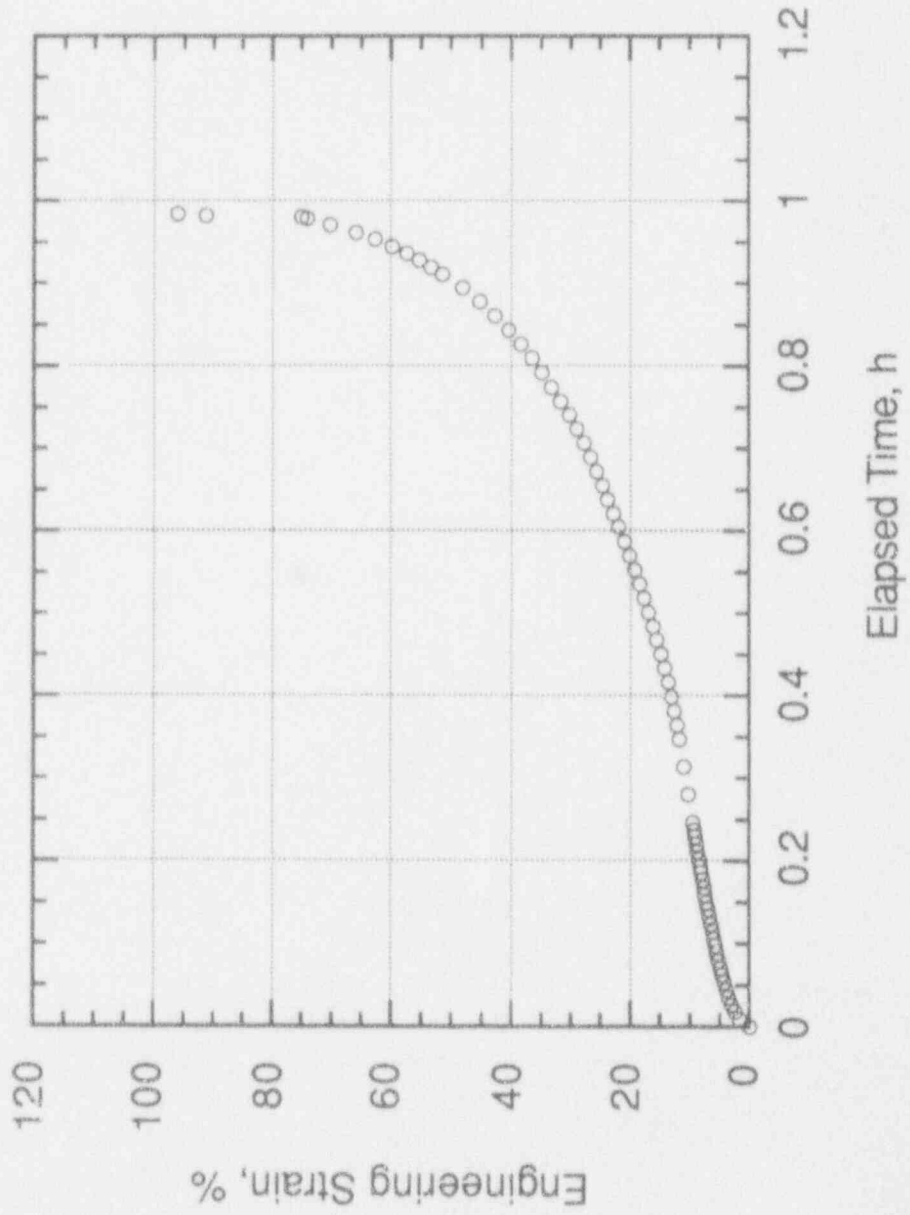
Specimen No.: M-8, t6
Laboratory: ANL
United States

Test Temperature: 1200°C
Applied Stress: 9.0 MPa
Time to Failure: 0.98 h

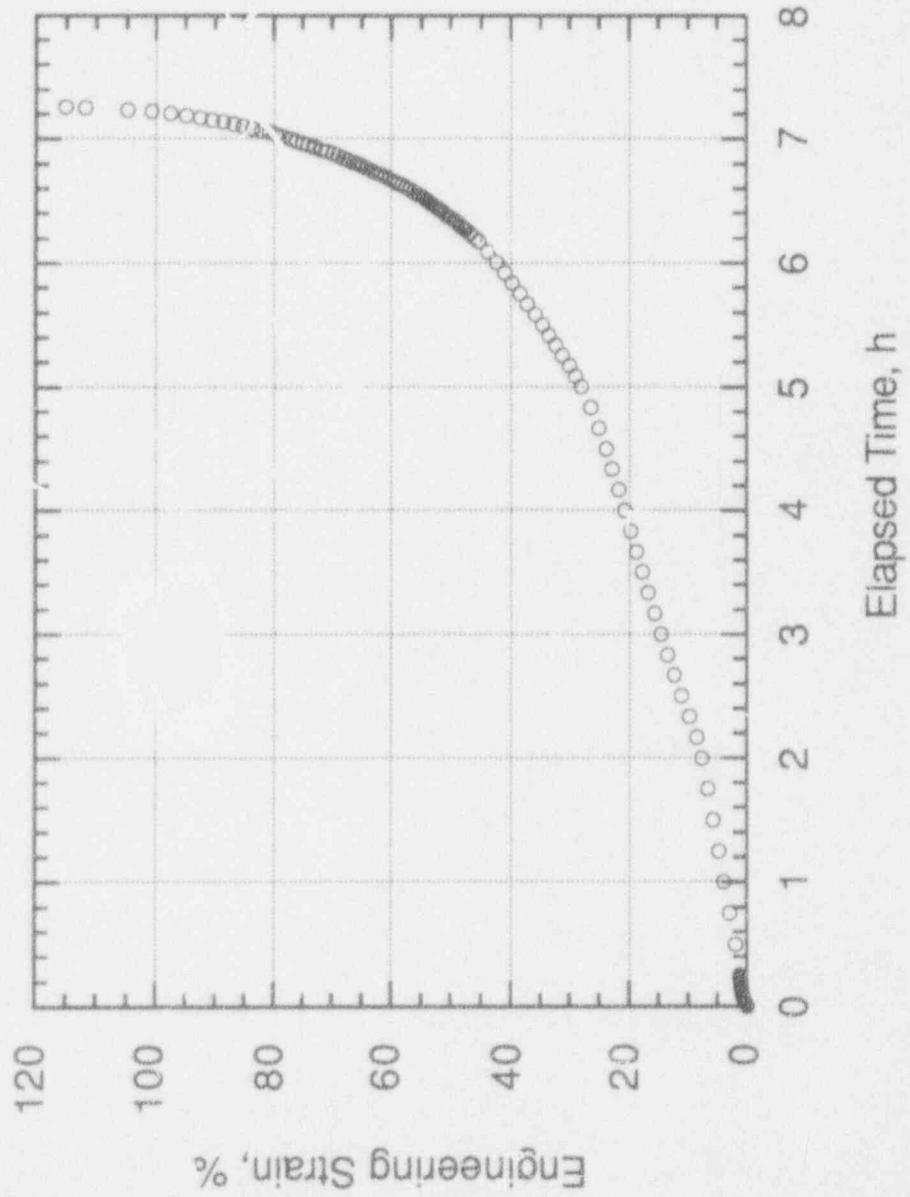
Specimen No.: M-8, t5
Laboratory: ANL
United States

Test Temperature: 1200°C
Applied Stress: 6.0 MPa
Time to Failure: 7.26 h

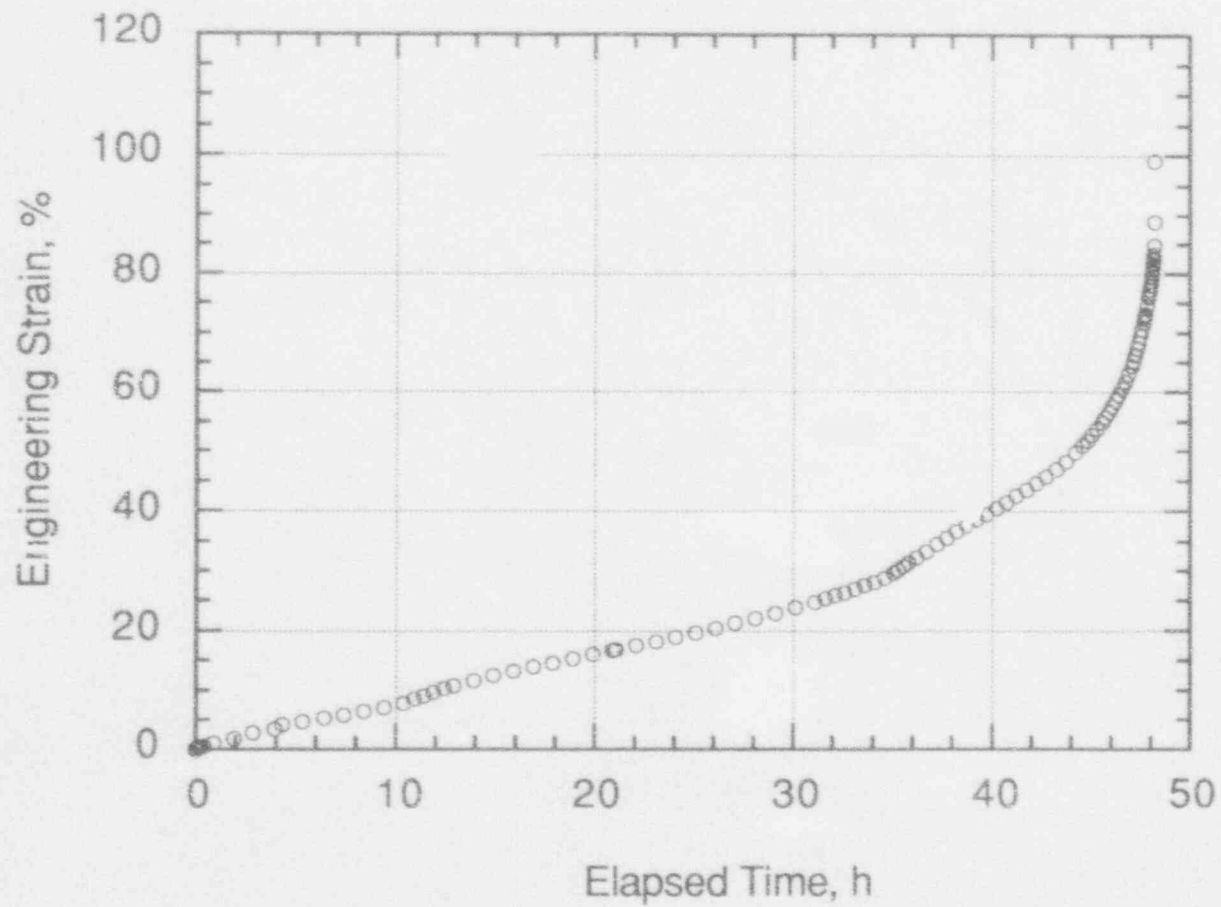
Specimen No.: M-8, t4
Laboratory: ANL
United States

Test Temperature: 1200°C
Applied Stress: 4.0 MPa
Time to Failure: 48.2 h

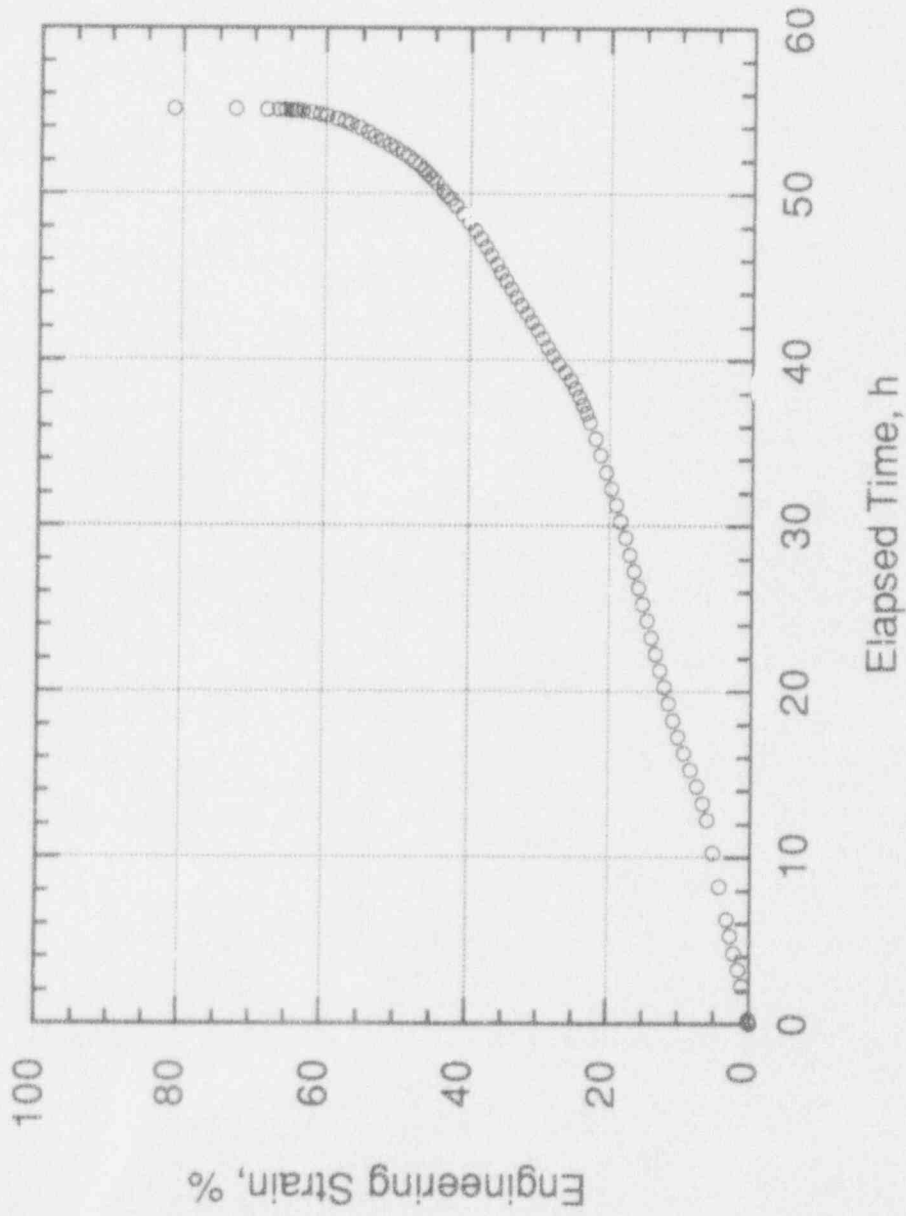
Specimen No.: M-8, t7
Laboratory: ANL

Test Temperature: 1200°C
Applied Stress: 3.4 MPa
Time to Failure: 55.1 h
