SUBJECT: STATUS REPORT - BWR JET PUMP HOLD-DOWN BEAM FAILURES

BWR JET PUMP HOLD-DOWN BEAM FAILURES

NRC INFORMATION NOTICE 93-101: JET PUMP HOLD-DOWN BEAM FAILURE

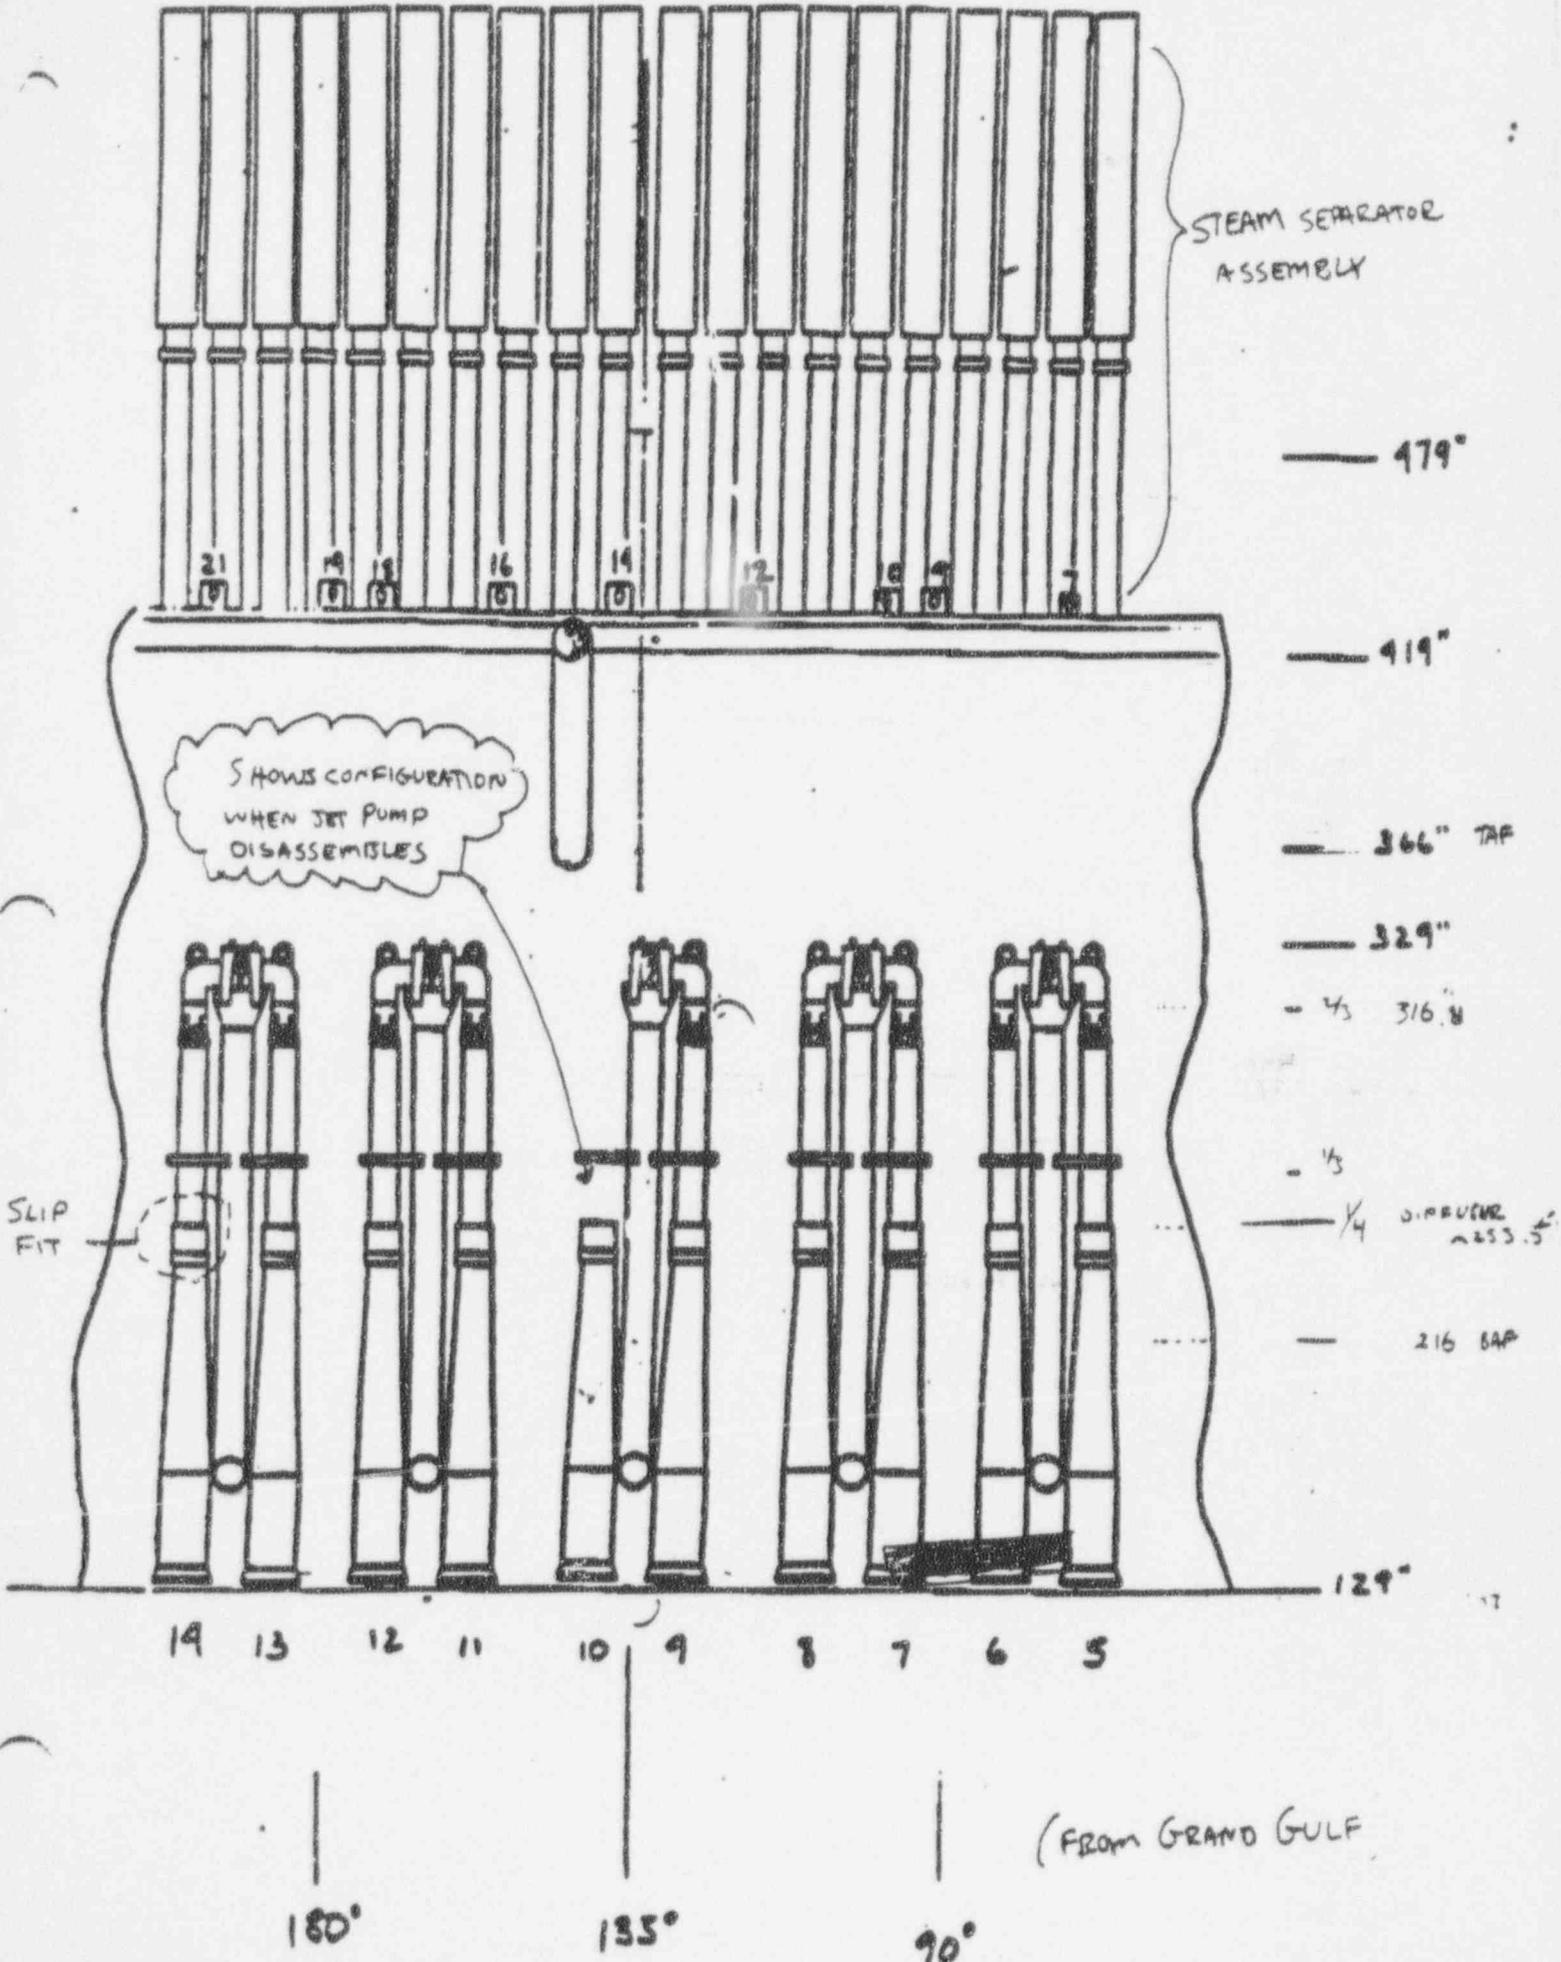
FIGURE 6

The capability of reflooding the core to two-thirds height is dependent upon the structural integrity of the jet pumps. The two-thirds height of the core is at the same elevation that the suction flow enters the mixer throat (See Figure 6.). The elevation at which the mixer interfaces with the diffuser is at approximately 1/4 to 1/3 core height. If the structural system, including the beam holding a jet pump in place, fails, jet pump displacement and performance degradation could occur, resulting in an increased core flow area through the jet pump and a lower core flooding elevation. This could

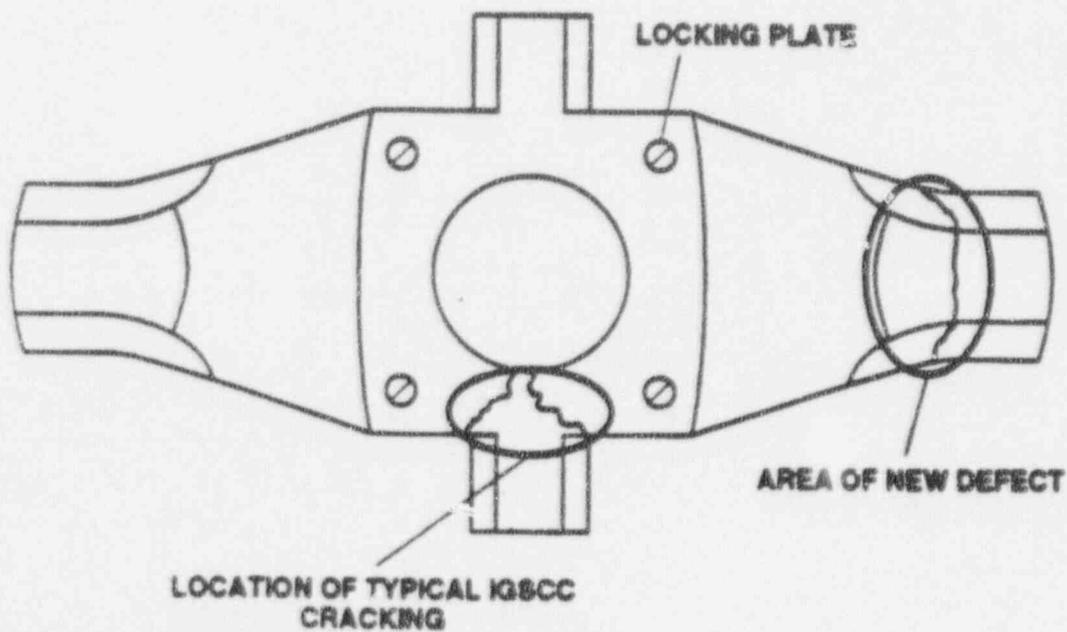
Jet Pump Beam Failure Location

The jet pump hold-down beam failure at the Grand Gulf power station in September 1993 is unlike previous failures in that the hold-down beam for jet pump 10 failed in the transition area between the main body of the beam and the beam end as shown in Attachment 1. There have not been any previous reports of failures in this location. One beam end failed completely, causing the beam to come out of the transition piece, removing the restraint on the jet pump elbow and leading to the disassembly of jet pump 10. There is one hold-down beam for each jet pump assembly. Visual examination of the failed beam showed a crack face covering more than 270° of the cross-section of the intact beam end; the other beam end had cracked in the same location and was missing. The cracks began in an area where a radius machining cut had been made in the forging and led to failure in a location of the beam with a cross-section smaller than the areas that had been affected in previous cases. GE concluded that the probable cause of failure was an intergranular stress corrosion crack that propagated over 80 percent of the fracture surface. Fatigue striations covered the remaining 20 percent of the surface. GE stated that the loss of preload as a result of the intergranular stress corrosion may have induced the fatigue failure.

The licensee conducted ultrasonic examinations on the other inservice jet pump beams and found indications on jet pump 8 and jet pump 21 at the bolt hole area in the center of the hold-down beams. This cracking was consistent with that described in bulletin IEB 80-07. The licensee replaced all the jet pump beams with spare beams available on site.
