**TMI-1**  
**OTSG Status Review**

**April 7, 1982**

TMI-1 OTSG STATUS REVIEW

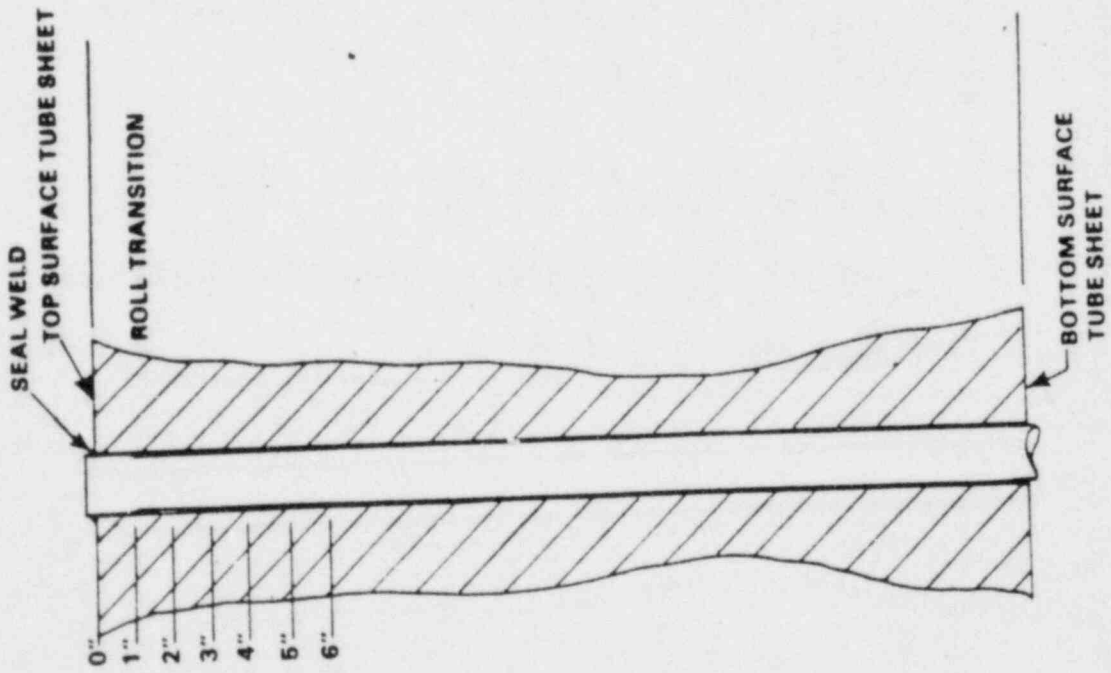
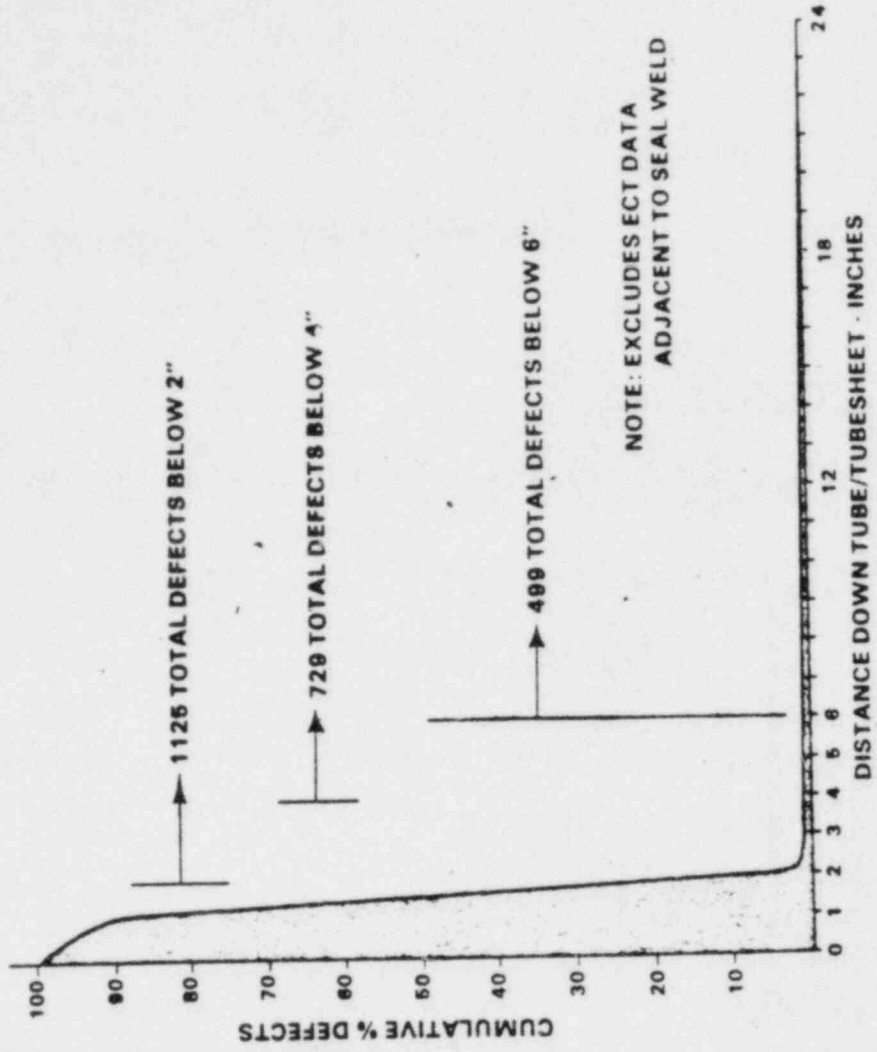
# TMI-1 Steam Generator Tube Cracking

Potentially Defective Tubes  
(Projection of Eddy Current Data)

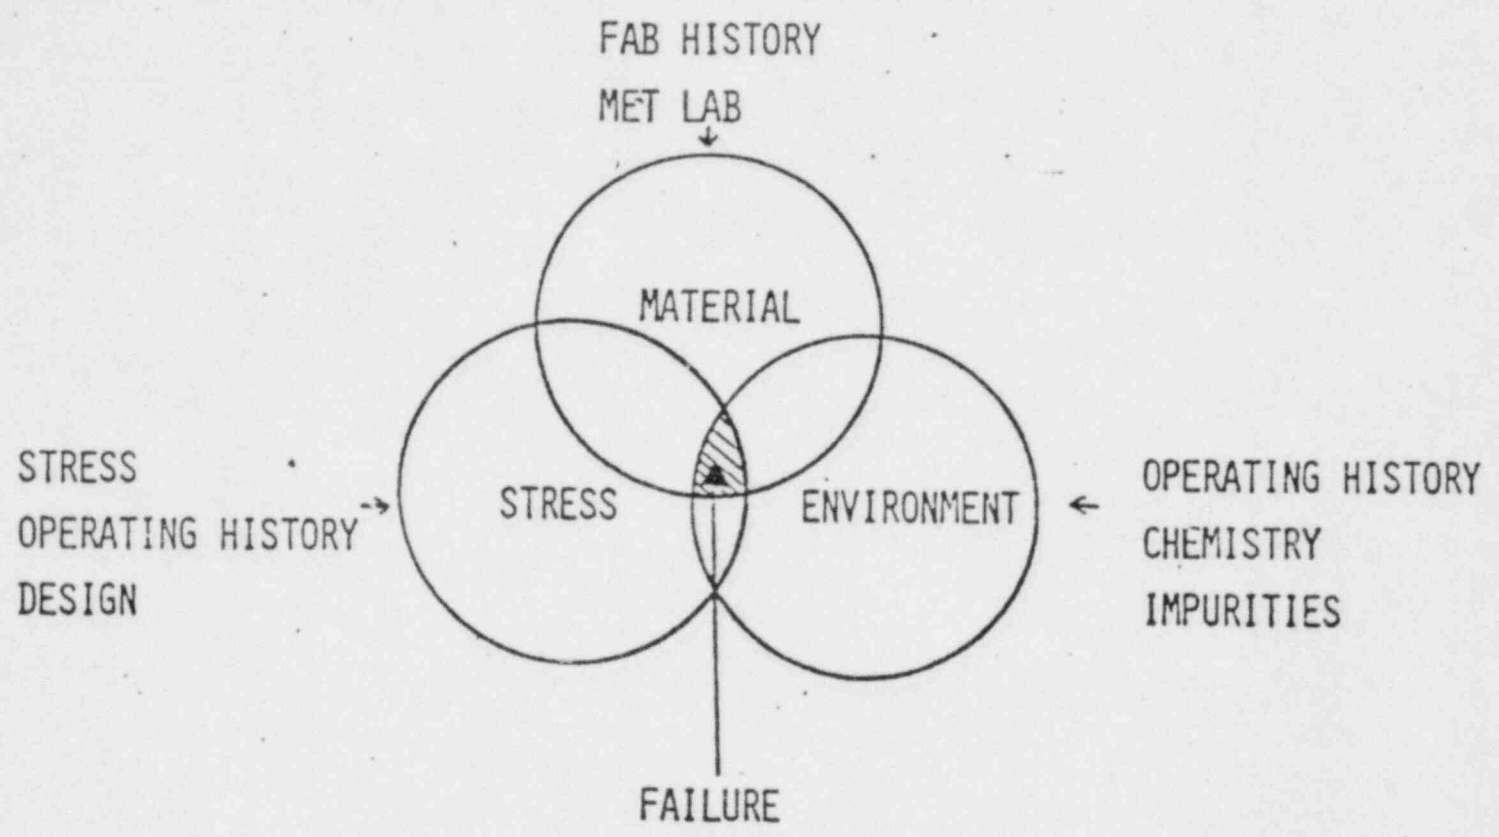
GENERAL INTERGRANULAR STRESS CORROSION CRACKING

- MUST EXPLAIN - TIMING OF CRACKING
- MATERIAL FAILURE MODE, I.E., INTERGRANULAR
  - CONTAMINANT SOURCE FORM
  - AXIAL/RADIAL CRACK DISTRIBUTION

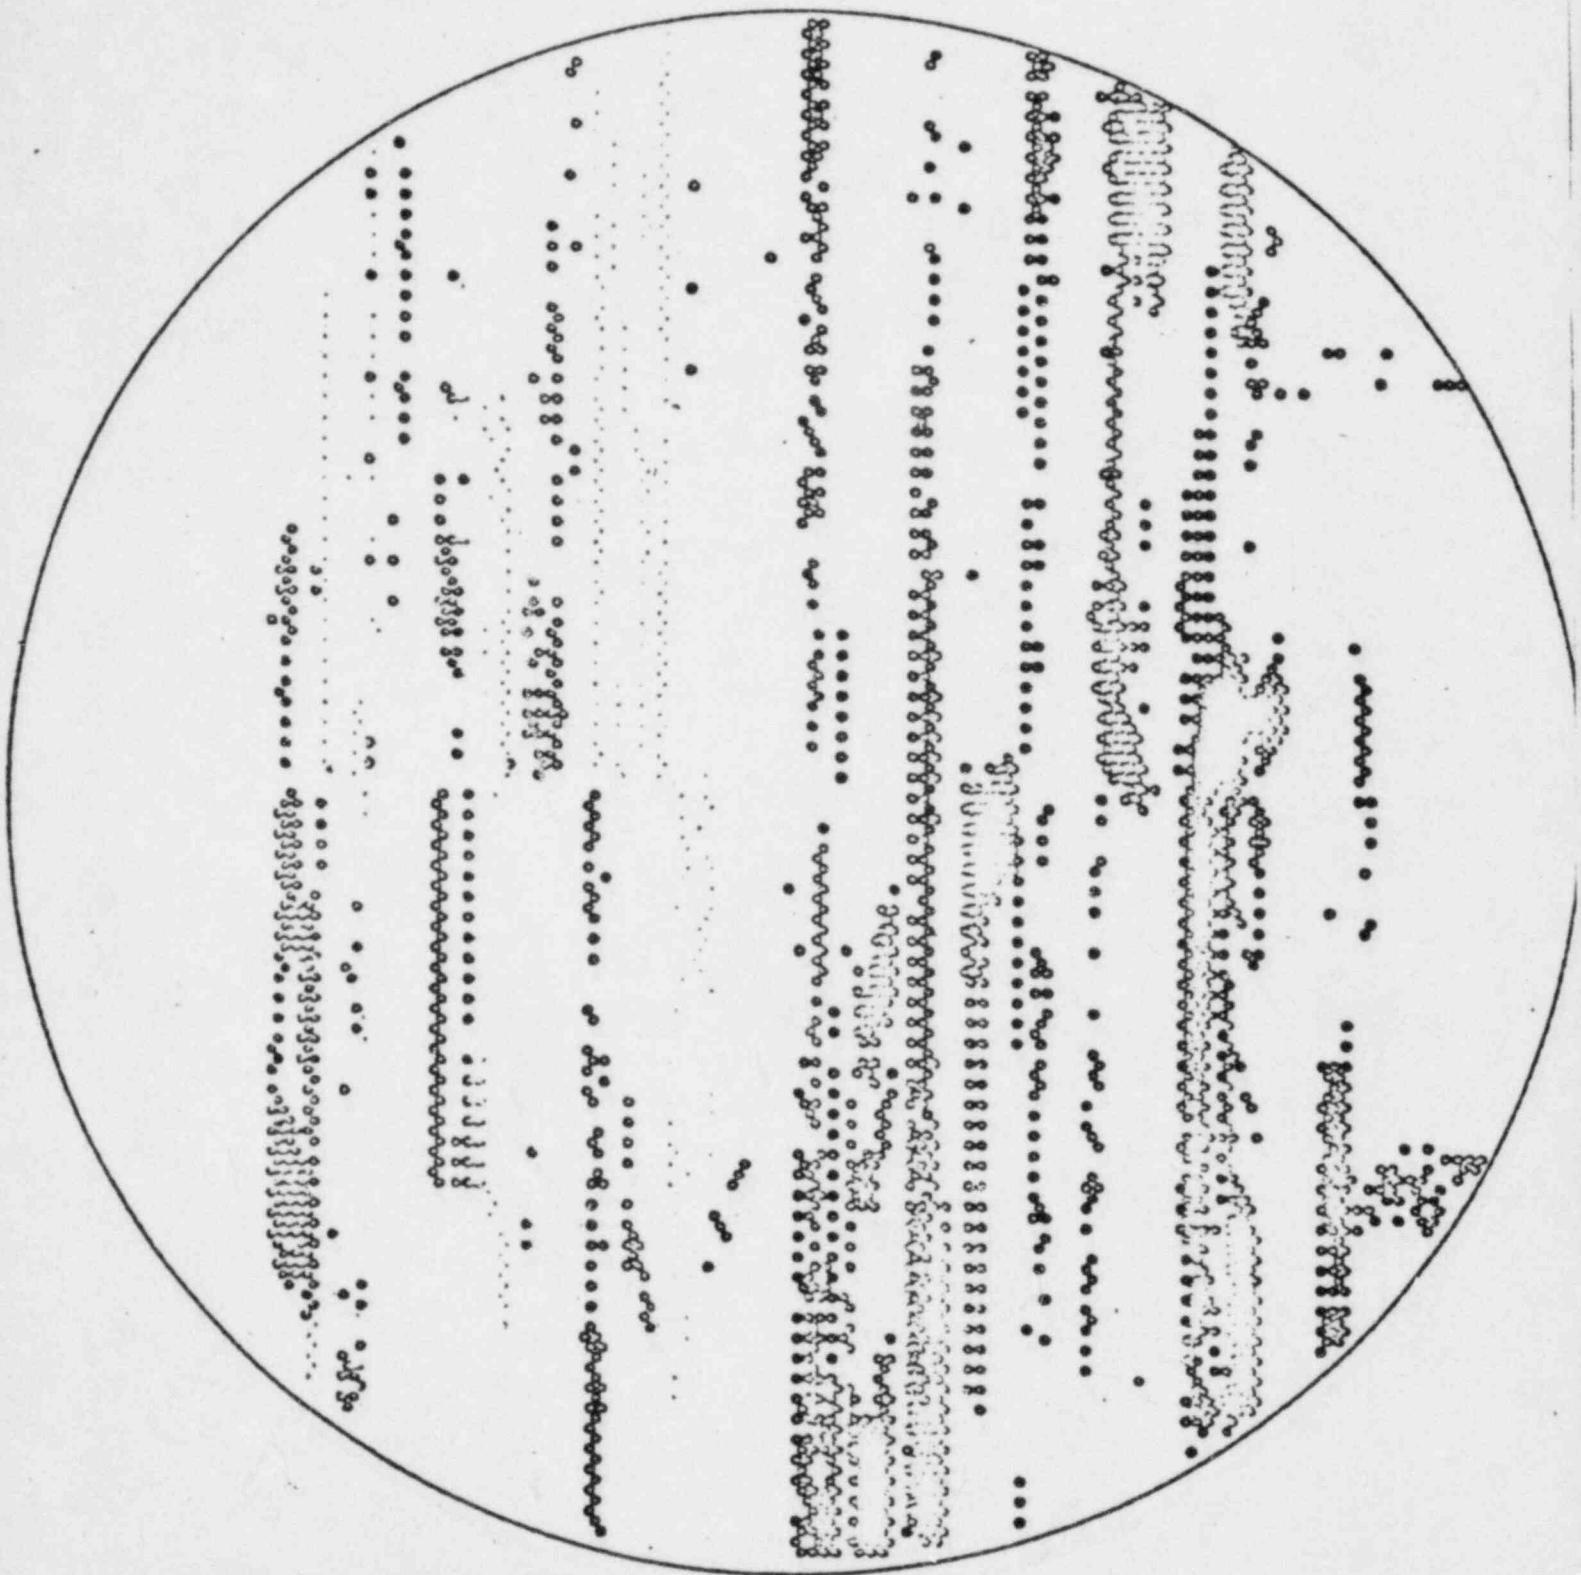
THREE MILE ISLAND NUCLEAR  
GENERATING STATION  
UNIT 1 STEAM GENERATOR A

TUBE LOCATIONS OF ALL TUBES  
FOR TUBE HEAT NUMBERS  
M2328  
M2345  
M2582

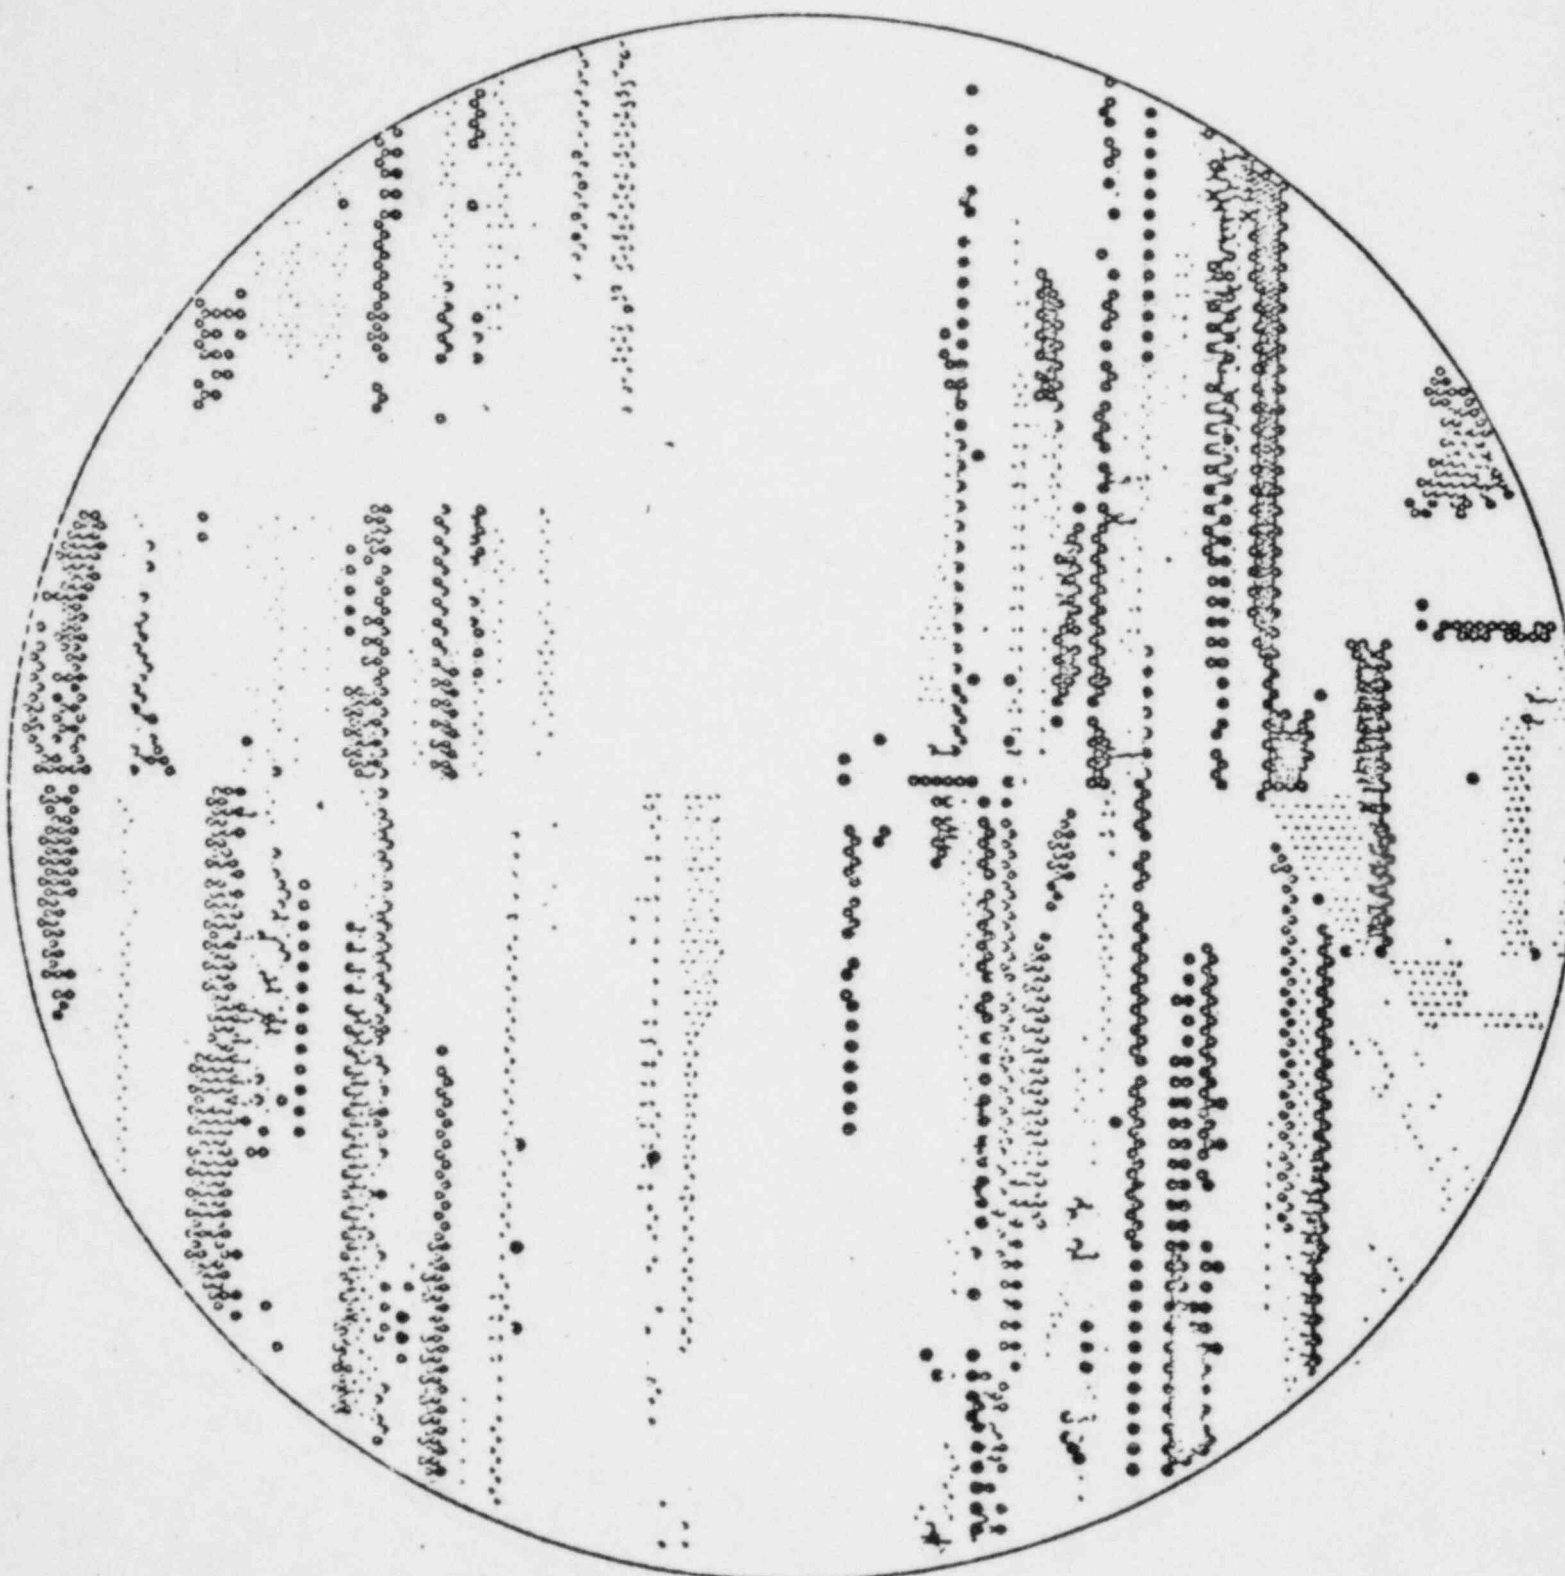
THREE MILE ISLAND NUCLEAR  
GENERATING STATION  
UNIT 1 STEAM GENERATOR B

TUBE LOCATIONS OF ALL TUBES  
FOR TUBE HEAT NUMBERS

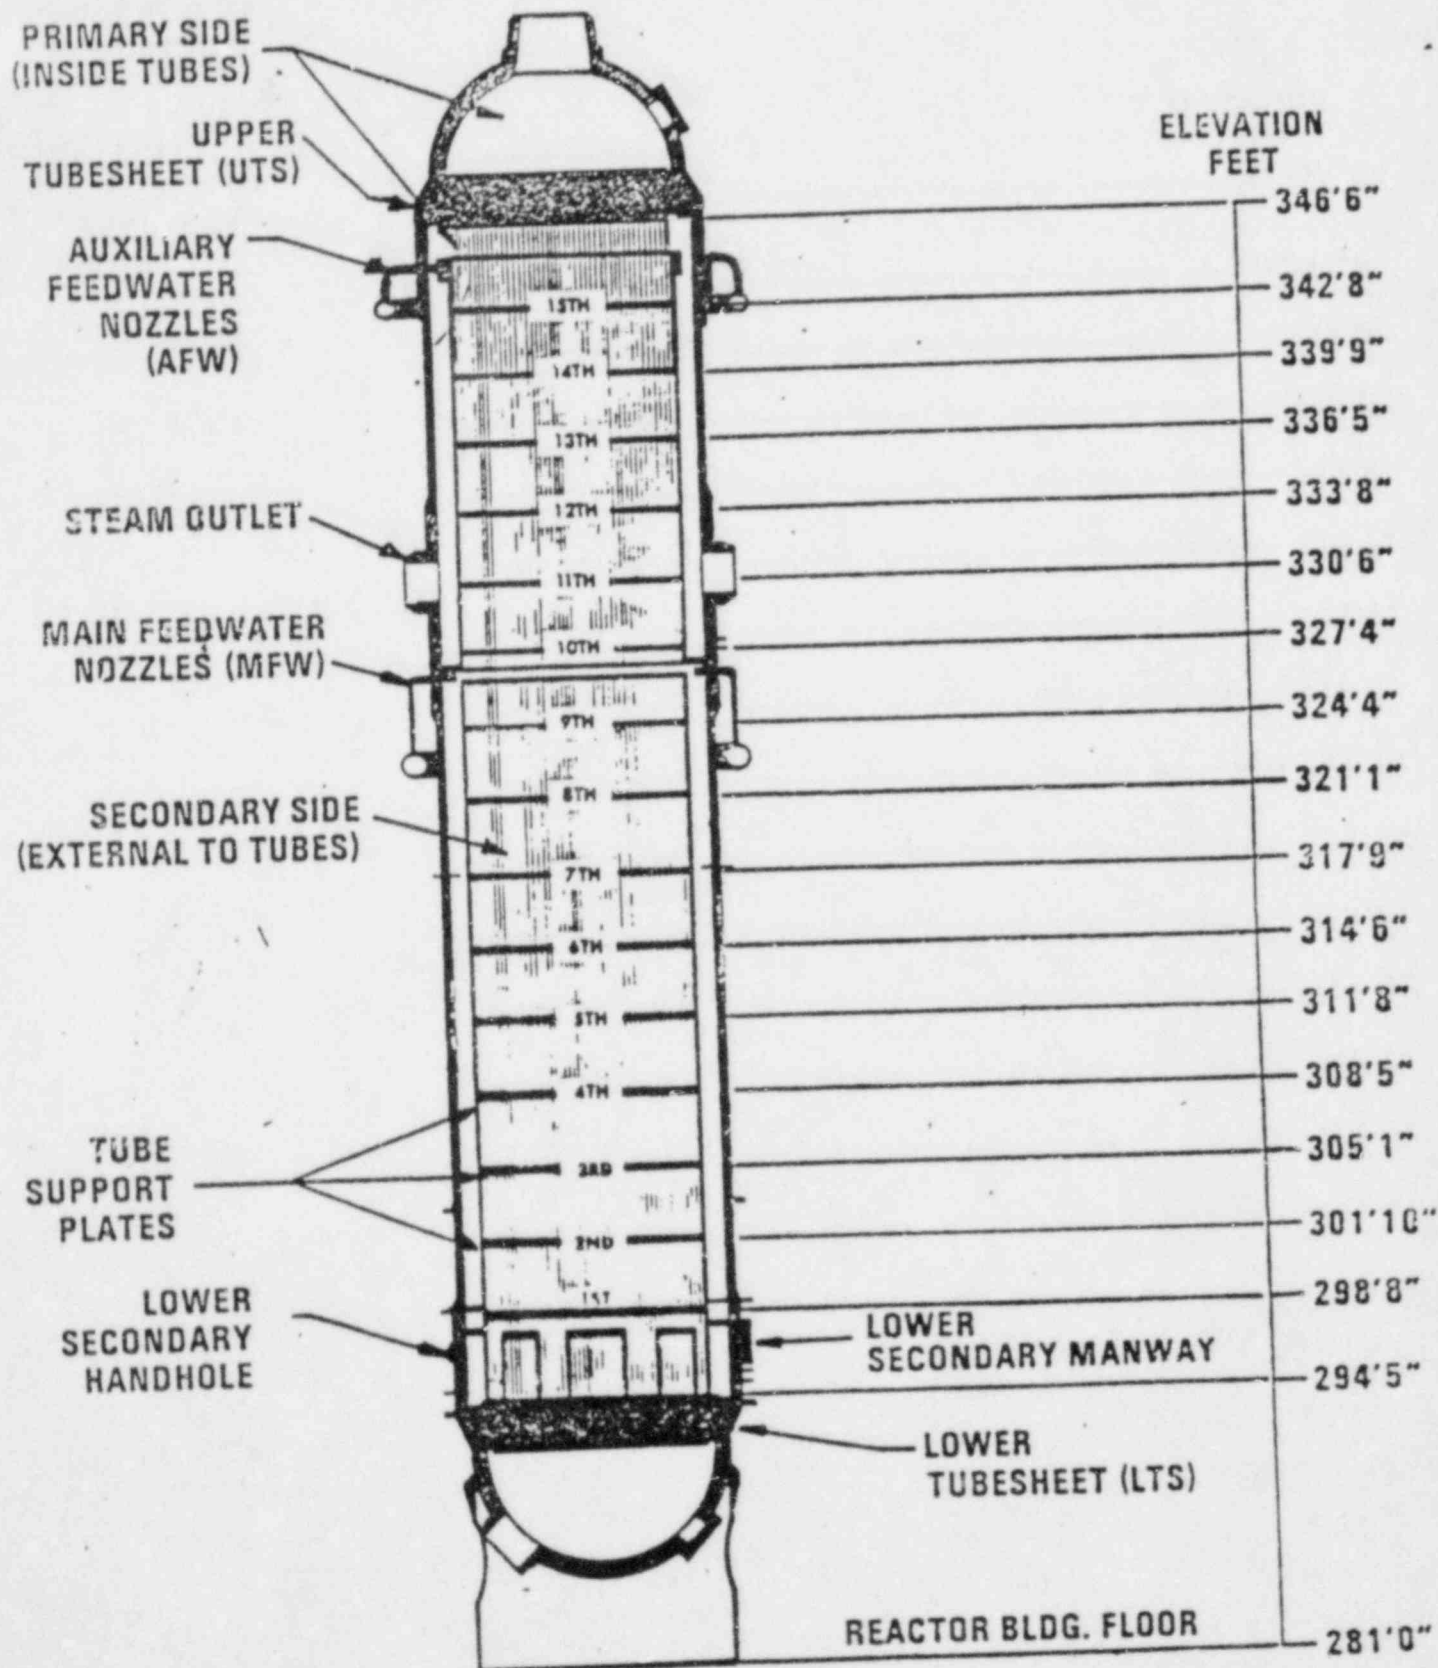
# OTSG Longitudinal Section Elevations (Typ.)

- STRESS MAXIMUM IN ROLL TRANSITION AREA,  $\sim 34 \text{ KSI} \pm$
- STRESS MAXIMUM ON OUTER EDGE OF GENERATORS
- STRESS EXPECTED TO BE QUITE VARIABLE IN ROLL TRANSITION AREA
- MAXIMUM STRESSES ARE AXIAL
- STRESSES SAME IN UPPER AND LOWER TUBESHEET
- STRESSES MAXIMUM DURING COOLDOWN, COLD
- AT OPERATING TEMPERATURE - HOOP STRESS  $>$  AXIAL STRESS

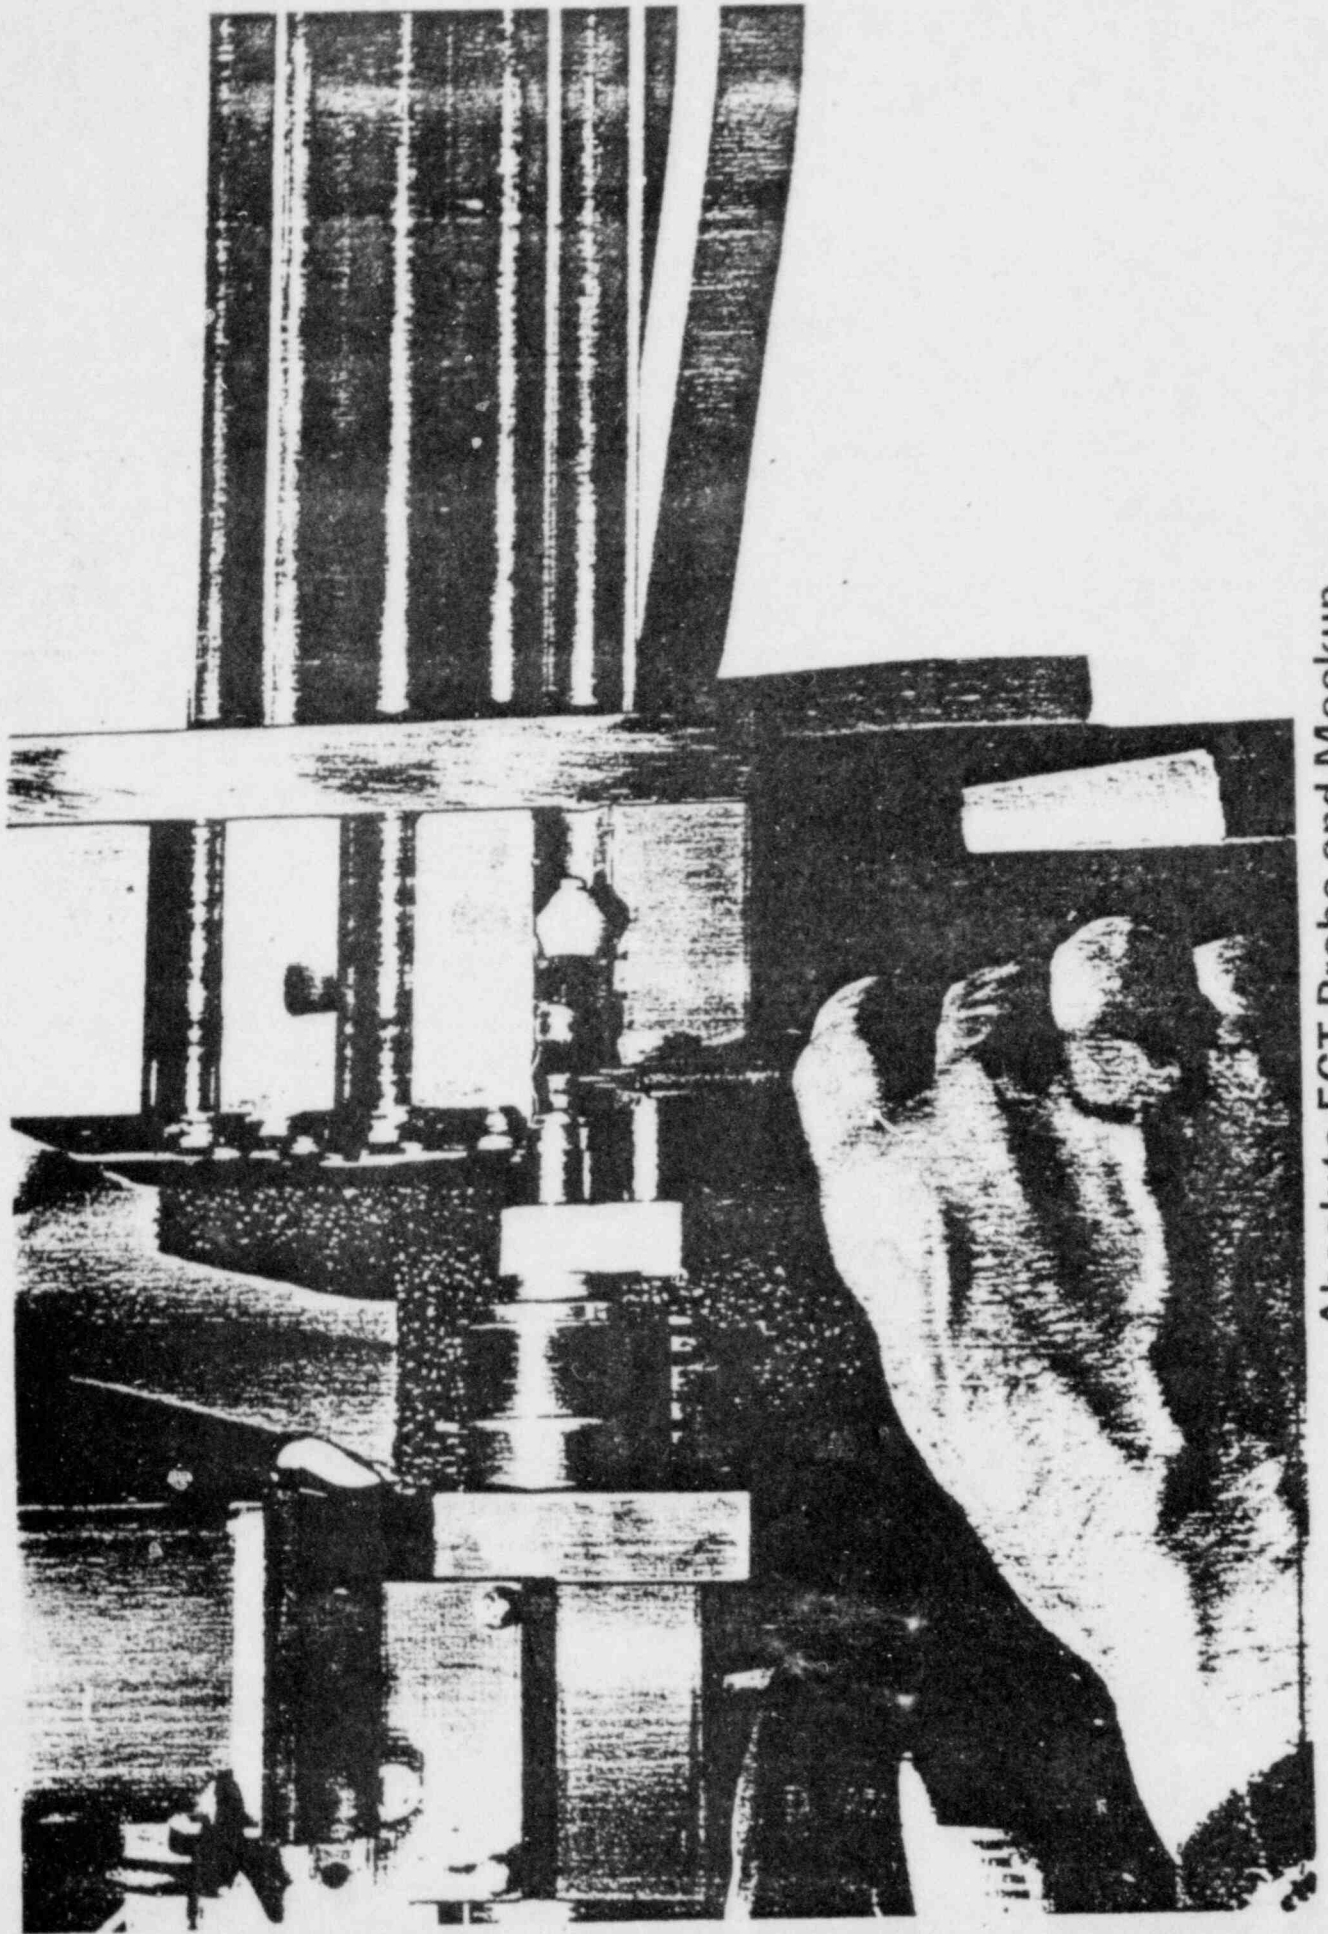
Absolute ECT Probe and Mockup

- Defects # 1 thru 5 (D1 – D5) are ID defects located as shown
- Extent of defects varied from 20% thru 100% of tubing wall thickness – defects are 3/16 inch long (EDM notches)
- 40% and greater defect depths were detected
