B&W OWNERS GROUP

BOLTING TASK FORCE

SUMMARY REPORT OF
NUCLEAR REGULATORY COMMISSION/
BABCOCK & WILCOX OWNERS GROUP
MEETING ON
REACTOR VESSEL INTERNALS BOLTING
MAY 6, 1983

SUMMARY REPORT OF
NUCLEAR REGULATORY COMMISSION /
BABCOCK & WILCOX OWNERS GROUP
MEETING ON
REACTOR VESSEL INTERNALS BOLTING
MAY 6, 1983
BAW 1784

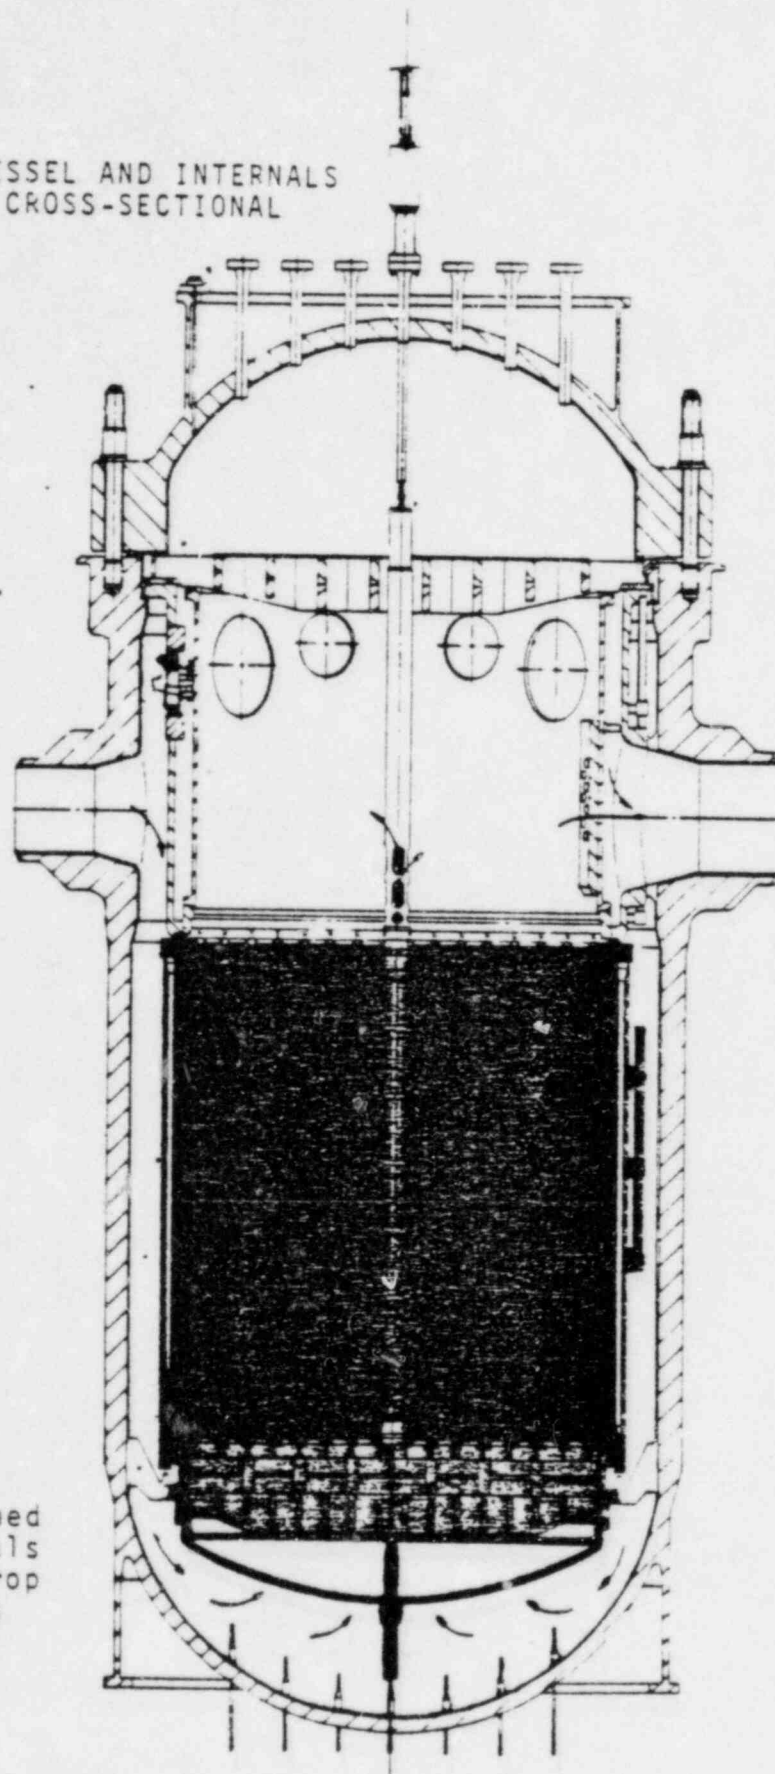
REACTOR VESSEL AND INTERNALS
ELEVATION CROSS-SECTIONAL

With UCB Joint
failure blackened
part of internals
and the core drop
onto guide lugs

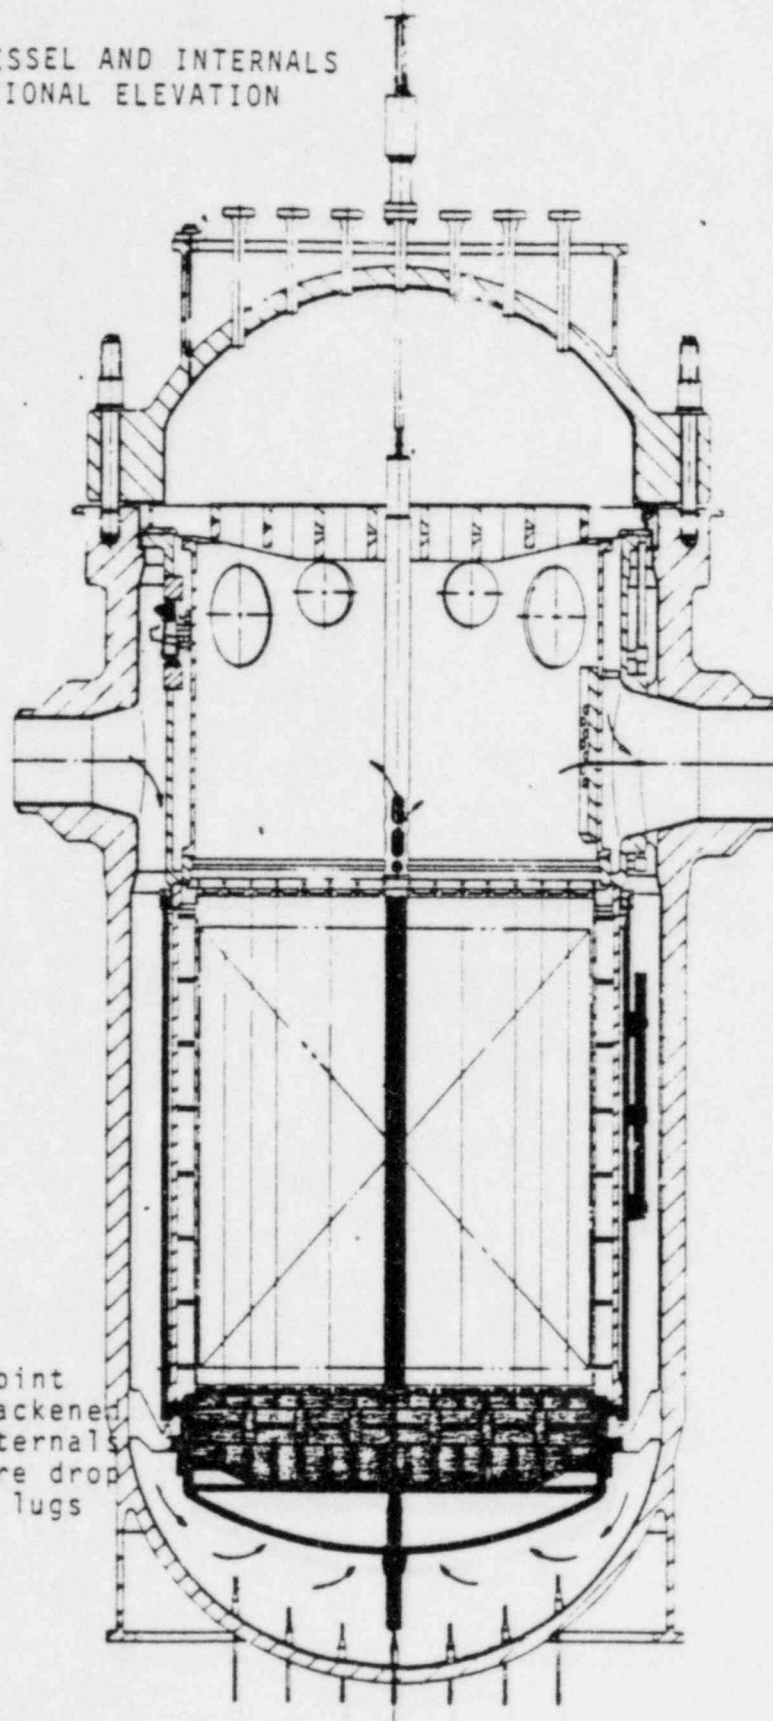
REACTOR VESSEL AND INTERNALS
CROSS-SECTIONAL ELEVATION

With LCB Joint
failure blackened
part of internals
and the core drop
onto guide lugs
