LICENSEE: BALTIMORE GAS & ELECTRIC COMPANY (BG&E)

FACILITY: Calvert Cliffs Units 1 and 2

SUBJECT: SUMMARY OF A FEBRUARY 24, 1983 MEETING HELD WITH BG&E TO DISCUSS RECENT PROBLEMS WITH THE CALVERT CLIFFS ENGINEERED SAFETY FEATURES ACTUATION SYSTEM (ESFAS).

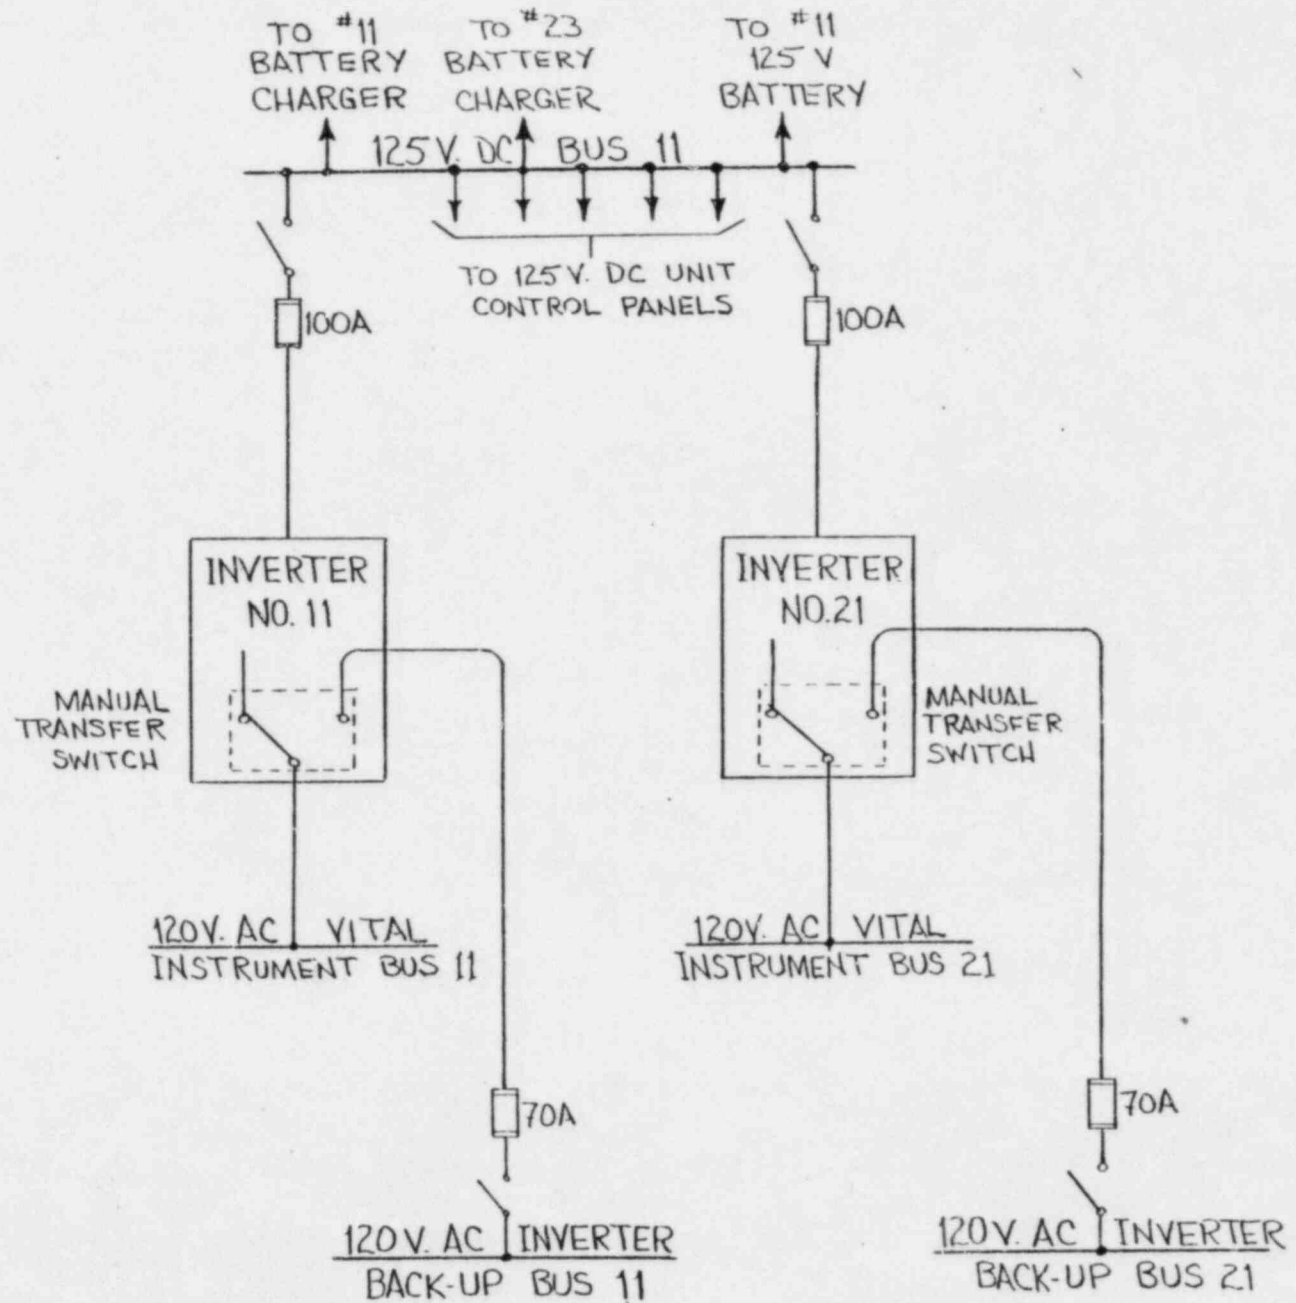
①

VITAL 120V.AC & 125V.DC SINGLE LINE DIAGRAM (TYP. OF 4)

1. BLOWING DC INPUT FUSE TO INVERTER BUT NOT OUTPUT FUSES ON LOAD WHERE FAULT OCCURS.
2. INVERTER PROTECTED FROM FAULT CURRENTS BY CURRENT LIMIT FEATURE.
3. UNNECESSARY ESFAS ACTUATION.

1. FOLLOW MANUFACTURER'S RECOMMENDATIONS TO USE PROPER FUSE TYPE AND SIZE.
2. REMOVE CURRENT LIMIT FEATURE FROM INVERTER.

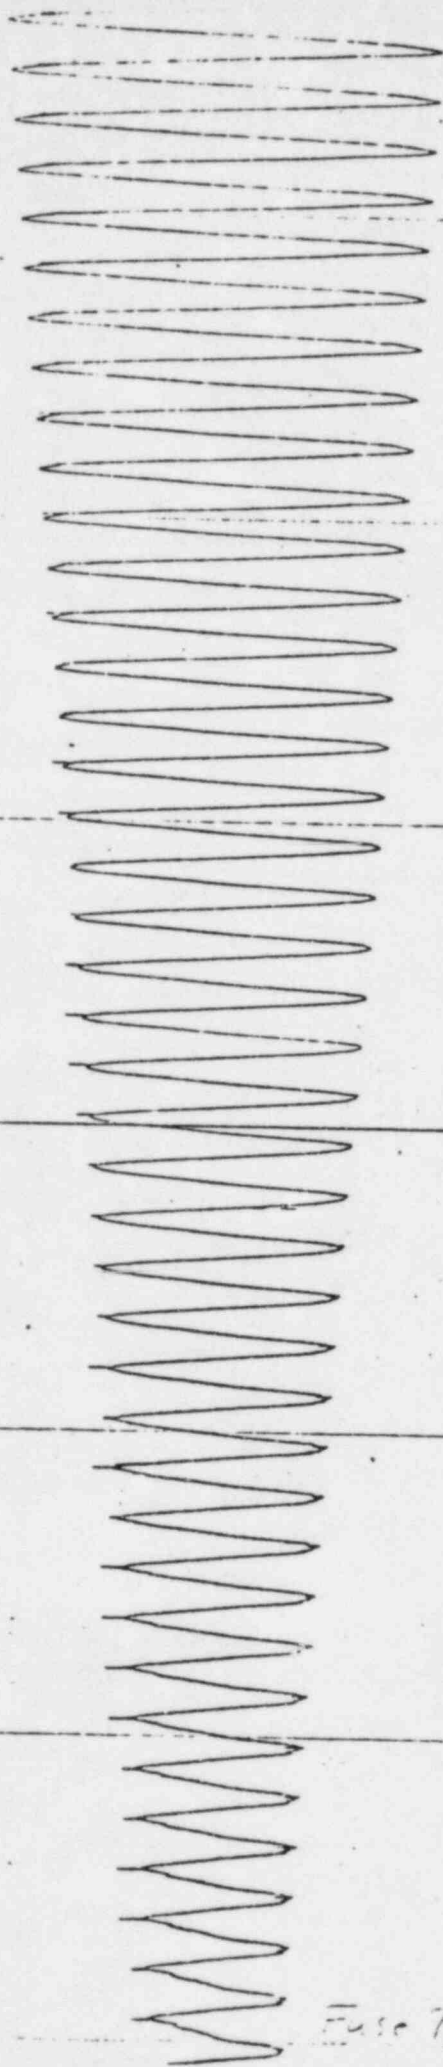
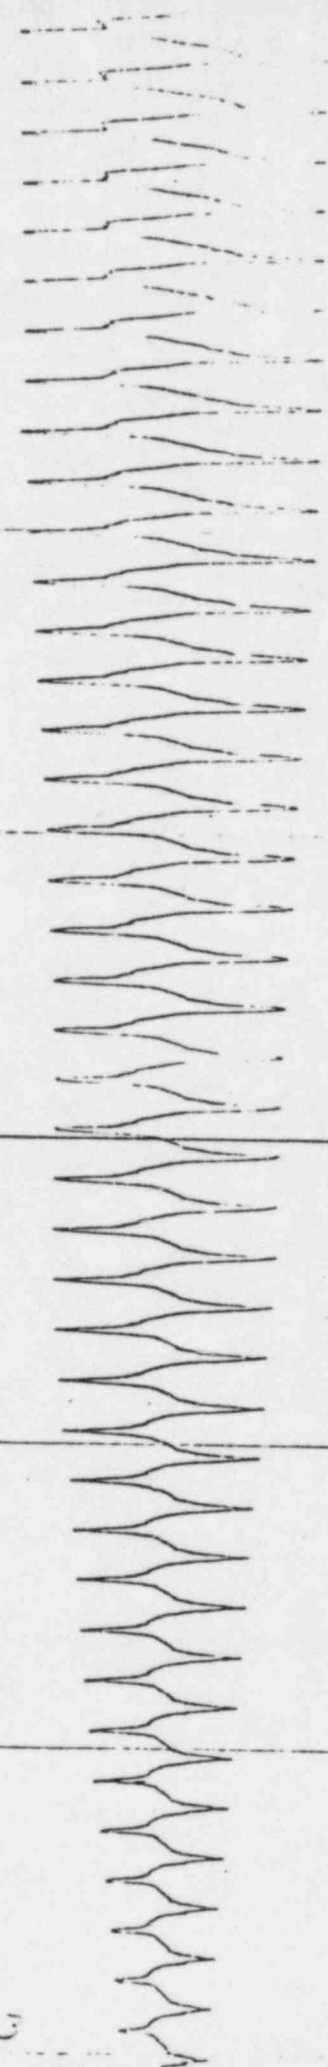
14

Fuse Test #2 - Sheet 3

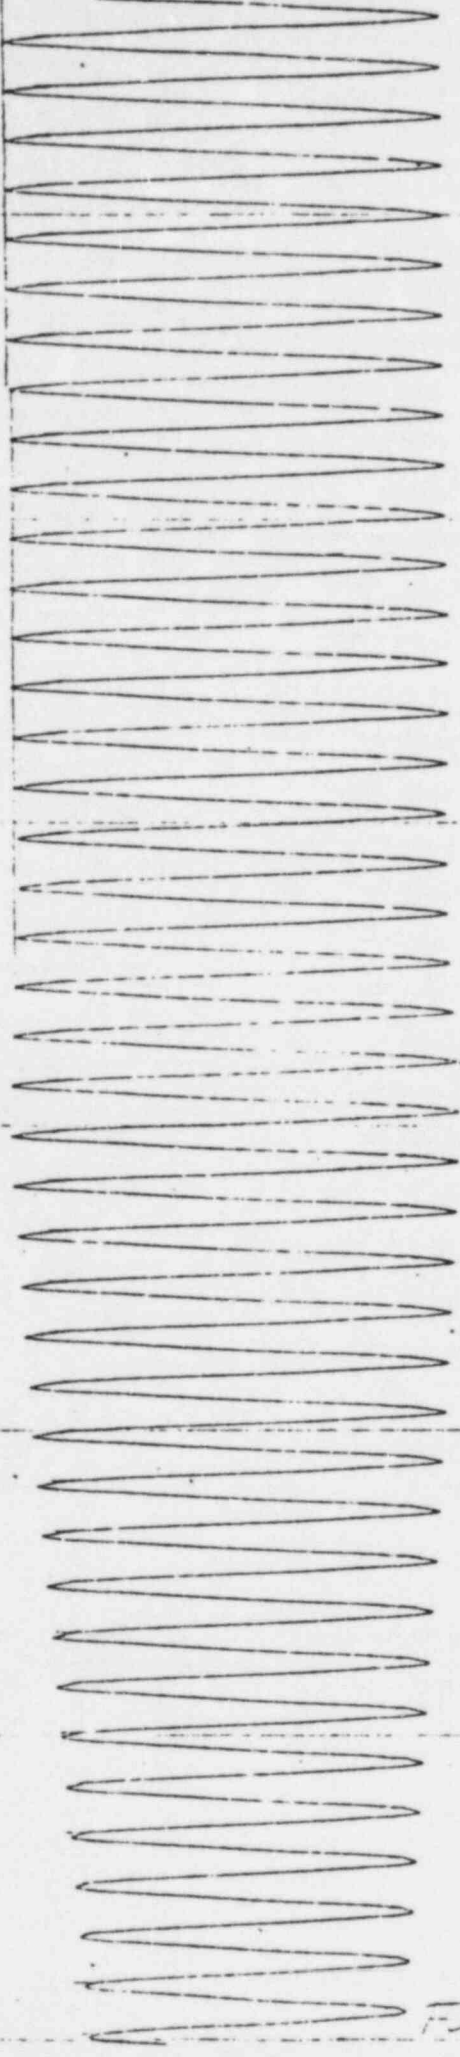
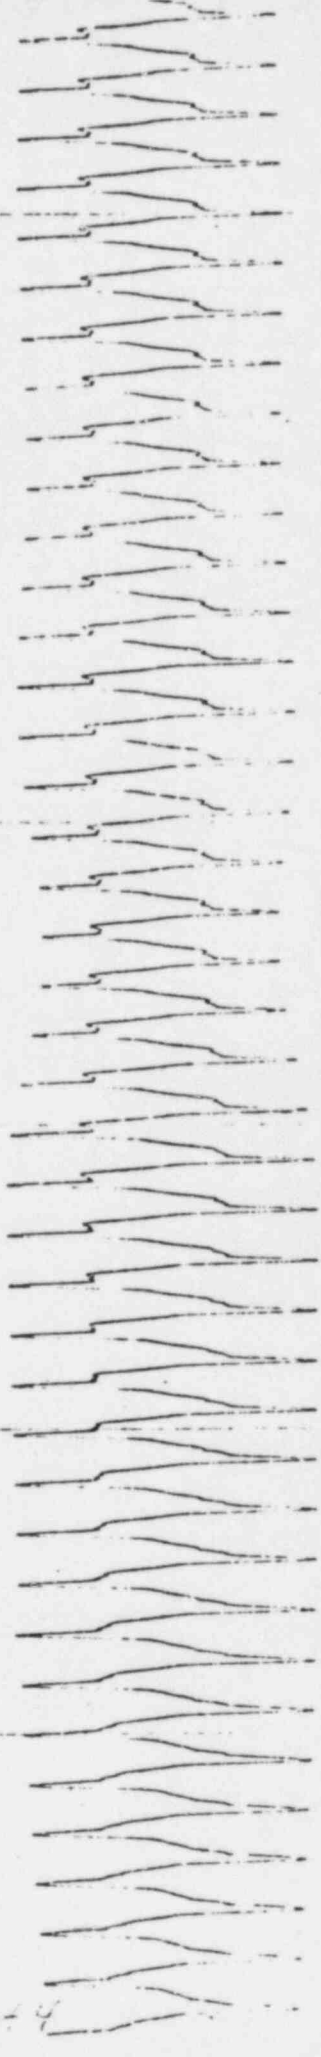
15

Phase Test For sheet 4

INVERTER RESPONSE TO SHORT CIRCUIT WITHOUT CURRENT LIMITING.

1. REMOVE CL FEATURE - ALLOWS FAULT TO CLEAR (VIA LOAD FUSES) AND PREVENTS VOLTAGE DROP.
2. MEET MANUFACTURER'S RECOMMENDATION FOR PROPER FUSING.
3. ESFAS POWER SUPPLIES WILL NOT SEE VOLTAGE DROP IF FAULT OCCURS.
