PRESENT STATUS AND PROJECTED FUTURE PROGRESSION OF STEAM-  
GENERATOR TUBE CORROSION/DEGRADATION AT POINT  
BEACH UNIT NO. 1, WISCONSIN ELECTRIC  
POWER COMPANY, TWO CREEKS,  
WISCONSIN

James R. Myers, Ph.D., P.E.  
JRM Associates  
Consulting Corrosion/Metallurgical Engineers  
4198 Merlyn Drive  
Franklin, Ohio 45005

Public Service Commission  
State of Wisconsin  
4802 Sheboygan Avenue  
Madison, Wisconsin 53707

June 8, 1983

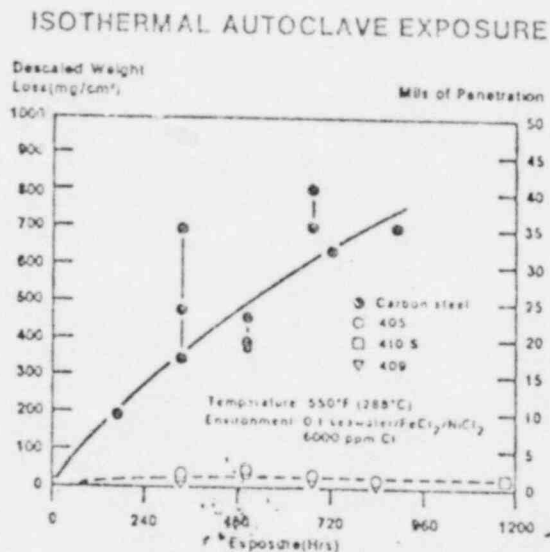
Concern for the potential denting problem would be even further reduced if the steam generators were replaced. For example, the tube support plates in the Model 44F steam generators will be fabricated from Type 405 stainless steel instead of carbon steel. Compared to carbon steel, Type 405 stainless steel has significantly improved resistance to the chloride-induced, occluded-cell corrosion which causes denting (Figure 1).<sup>(10,11)</sup>

Figure 1 - An unusually-aggressive, simulated-occluded-cell, environment does not cause appreciable corrosion to Type 405 stainless steel in laboratory environments.<sup>(10)</sup>

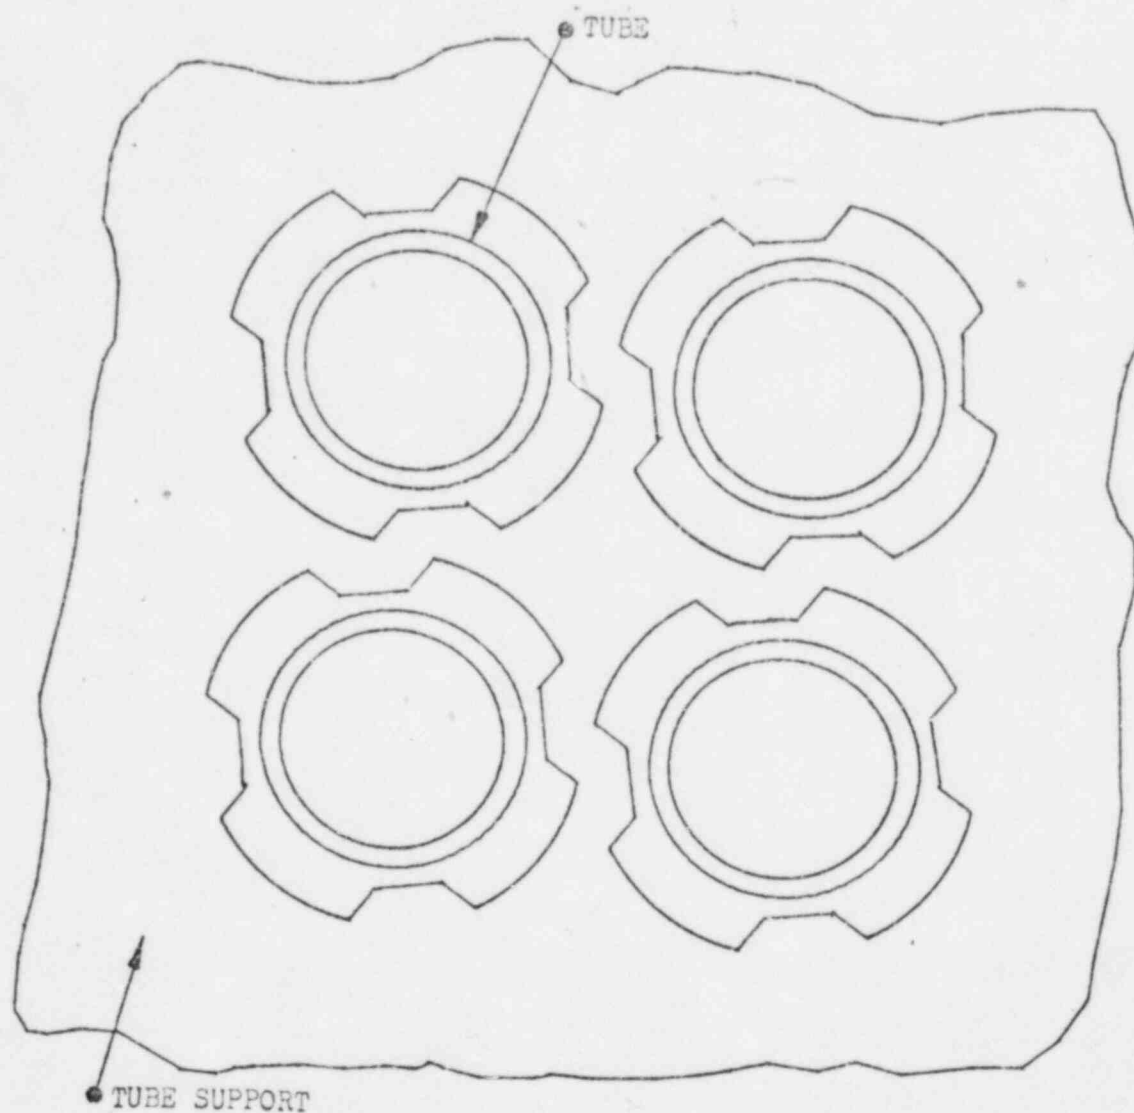
foil tube-passage design for the tube support plates (Figure 2).<sup>(5)</sup> Improved secondary-side water flow at the tube-TSP interfaces will essentially eliminate the occluded cells (i.e., prevent the localized concentrating of chloride ions) which are required for denting.

Figure 2 - The quatrefoil-tube-passage design for the Model 44F steam generator TSPs essentially precludes the existence of the chloride-concentrating occluded cells which are required for denting. (5)

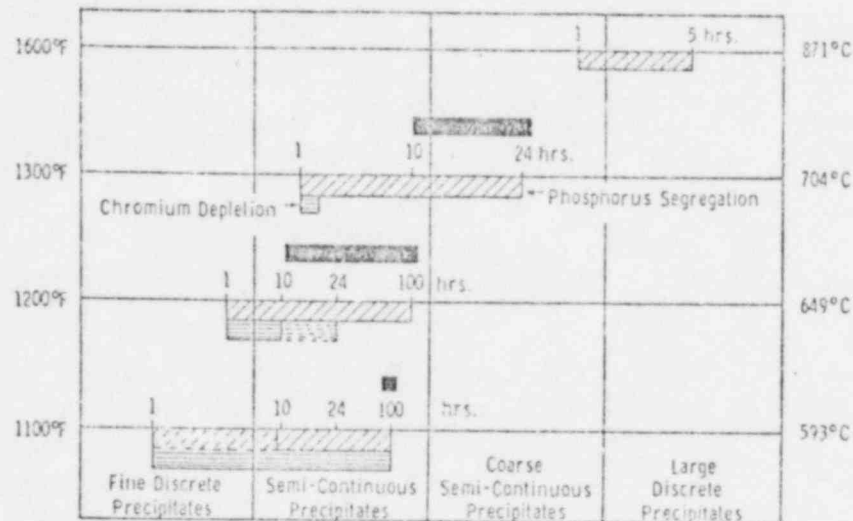
2. Maximum resistance to caustic-induced intergranular/stress corrosion is associated with Inconel-600 which has a semicontinuous, grain boundary carbide precipitate (Figure 3). (18)

Figure 3 - Summary of grain boundary microstructure in thermally-treated Inconel-600. Dotted lines represent minor grain boundary segregation or chromium depletion. Solid bars correspond to maximum improvement in caustic-induced intergranular/stress corrosion. (18)

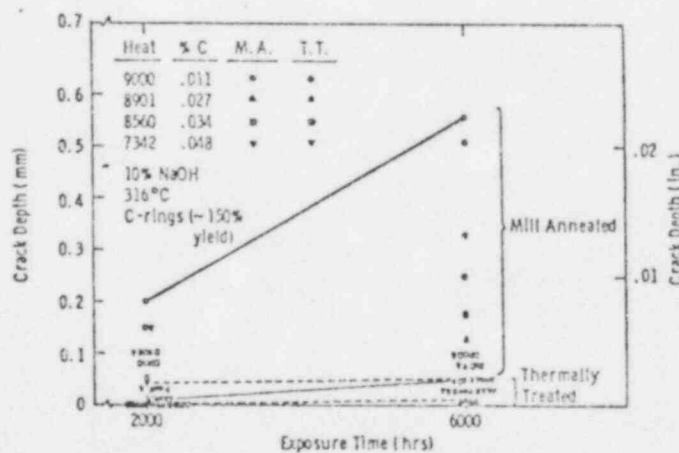
3. For plastically-deformed C-ring specimens exposed to deaerated, 10% sodium hydroxide solutions at 600 °F, thermally-treated (15 hours at 1300 °F) Inconel-600 has resistance to intergranular/stress corrosion which can be as much as ten times (or more) greater than that exhibited by the mill-annealed product. (Figure 4). (20)

Figure 4 - Crack depth as a function of exposure time for mill-annealed and thermally-treated Inconel-600 exposed to deaerated, 10% caustic solutions at 600 °F. (20)

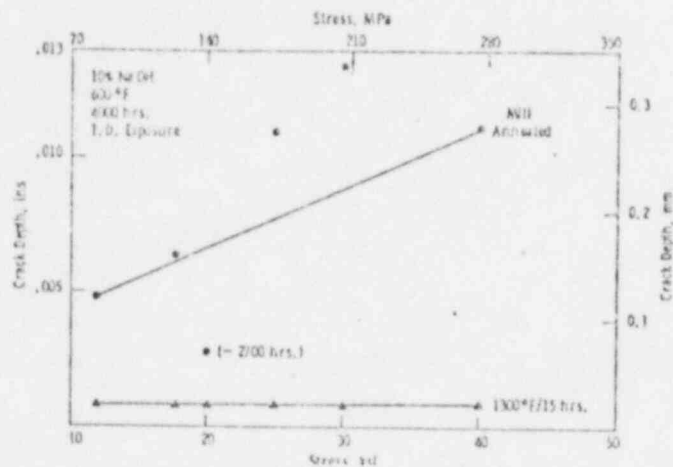
4. For specimens stressed in tension at values up to 40,000 psi and exposed to deaerated, 10% sodium hydroxide solutions at 600 °F for 4,000 hours, the cracks in thermally-treated (15 hours at 1300 °F) Inconel-600 had propagated only one or two grain depths into the alloy whereas relatively deep cracks existed in the mill-annealed product (Figure 5). (20)

Figure 5 - Crack depth as a function of stress and material condition (i.e., mill-annealed and thermally-treated 15 hours at 1300 °F) for Inconel-600 exposed to deaerated, 10% sodium hydroxide solutions at 600 °F for 4,000 hours.

The relative improvement in the intergranular/stress corrosion resistance of thermally-treated Inconel-600 is evident from the data presented in Figures 5 and 6. Assuming thermally-treated Inconel-600 is stressed in tension at 20,000 psi and continuously exposed to deaerated, 10% sodium hydroxide solution at 600 °F, the cracks would be expected to propagate no more than one or two grain diameters/depths into the alloy (i.e., about 0.002 inch) in 8,000 hours. For comparison, the cracks in mill-annealed Inconel-600 exposed to the same tensile stress and environ-

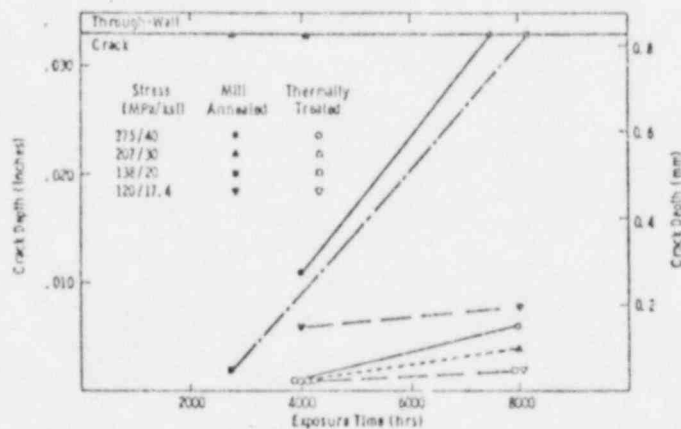
5. For thermally-treated (15 hours at 1300 °F) Inconel-600 specimens stressed in tension at 17,000 to 30,000 psi and exposed to deaerated, 10% sodium hydroxide solutions at 600 °F, the crack propagation rate for intergranular/stress corrosion is so slow that it cannot be meaningfully measured. For mill-annealed specimens stressed at 20,000 psi and exposed to the same environment, the crack propagation rate is approximately 0.050 inch per year (Figure 6). (20)

Figure 6 - Crack depth as a function of time, stress level, and material condition (i.e., mill-annealed and thermally treated) for Inconel-600 exposed to deaerated, 10% sodium hydroxide solutions at 600 °F.
