# Design, Operating and Inspection Considerations to Control Stress Corrosion of LP Turbine Disks

**AMERICAN POWER CONFERENCE**

CHICAGO, ILLINOIS, APRIL 18-20, 1983

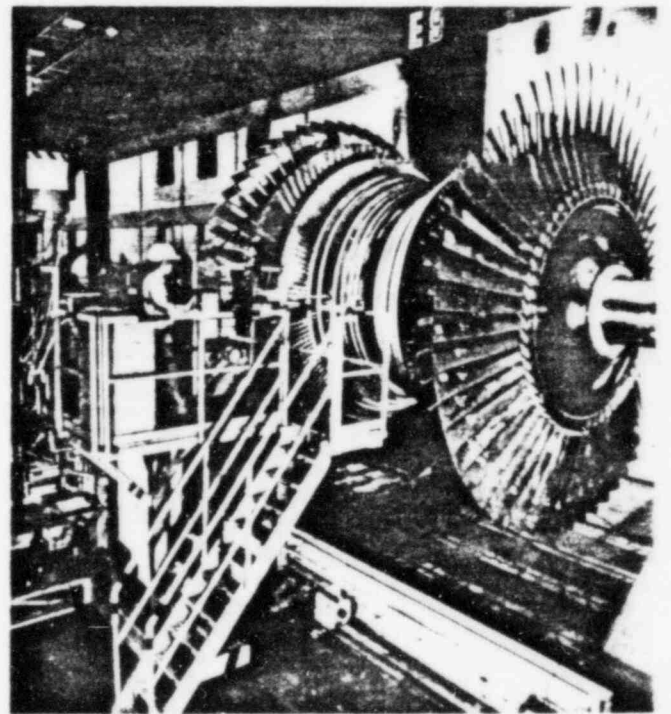
**Fig. 12 In-service Inspection of Fully Bladed LP Rotor.**

This newly developed system was applied for the first time to inspect an LP rotor after roughly 76,000 service hours in a German PWR nuclear power plant. The 100% volumetric inspection of the hub bores and keyways was performed on a completely bladed LP rotor. The ultrasonic testing showed a maximum indication of a 3.3 mm (0.13 in.) equivalent flat bottom hole over a maximum axial distance of 100 mm (4 in.) in one of the ten disks at the shrink fit.

As part of the development program of this specific LP rotor test all disks were removed from the shaft after the ultrasonic inspection. The ultrasonic indication on the aforementioned disk was found to be caused by score marks with a maximum depth of 0.5 mm (20 mils). The score mark configuration clearly indicated that scoring had occurred during the shrink-on and not the shrink-off process (**Fig. 14**). All the shrunk-off disks were closely inspected without indication of any stress corrosion after approx. 76,000 hours of operation.
