**NRC/INEL Radiation Therapy
Event Investigation Team
Report 9501**

NRC/INEL RADIATION THERAPY EVENT INVESTIGATION TEAM REPORT 9501

A two-position, solenoid-operated valve on the hydraulic system of a gamma knife unit failed during a recent treatment. The valve (valve 20) that failed controls the direction of bed movement. The valve was inspected by personnel from Elekta Instruments, Inc., the U.S. distributor of the gamma knife, and then sent to the valve manufacturer for analysis. Elekta has attributed the failure to a particle of metal that either caught between the valve spool and valve body or scored the spool, in either case essentially locking the valve in the 'bed in' position. The behavior of the device and the system response when valve 20 was replaced leave no doubt that a malfunction of this valve precipitated the event.

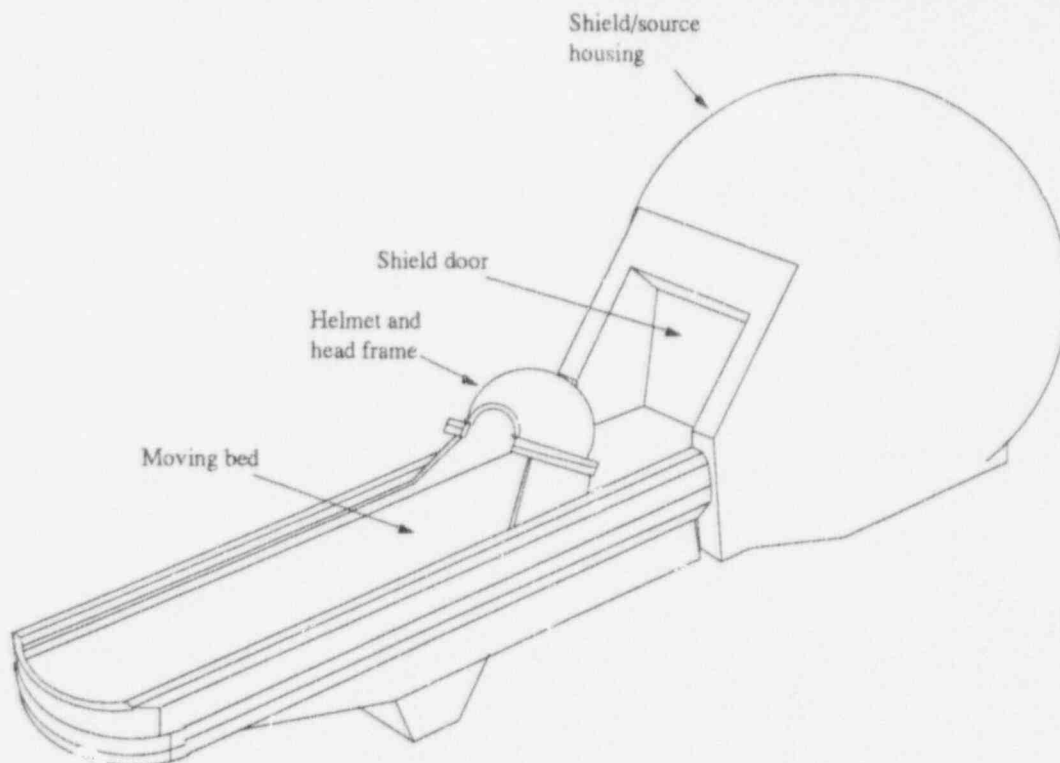
Figure 1: Line drawing of gamma-knife

The gamma-knife's sources are located in the shield/source housing (See Figure 1) and are collimated to form an isocenter near its center. The bed moves into and out of the "face opening" of the housing. A hydraulically operated door is shut when the machine is idle to provide shielding and security.
