# New Hampshire Yankee

NYN-91157

Subject: Supplemental Submittal for the Radiograph Reinterpretation Program Completion Report

ENCLOSURE 1 TO NYN-91157  
SUPPLEMENTAL SUBMITTAL FOR THE RADIOGRAPH  
REINTERPRETATION PROGRAM COMPLETION REPORT

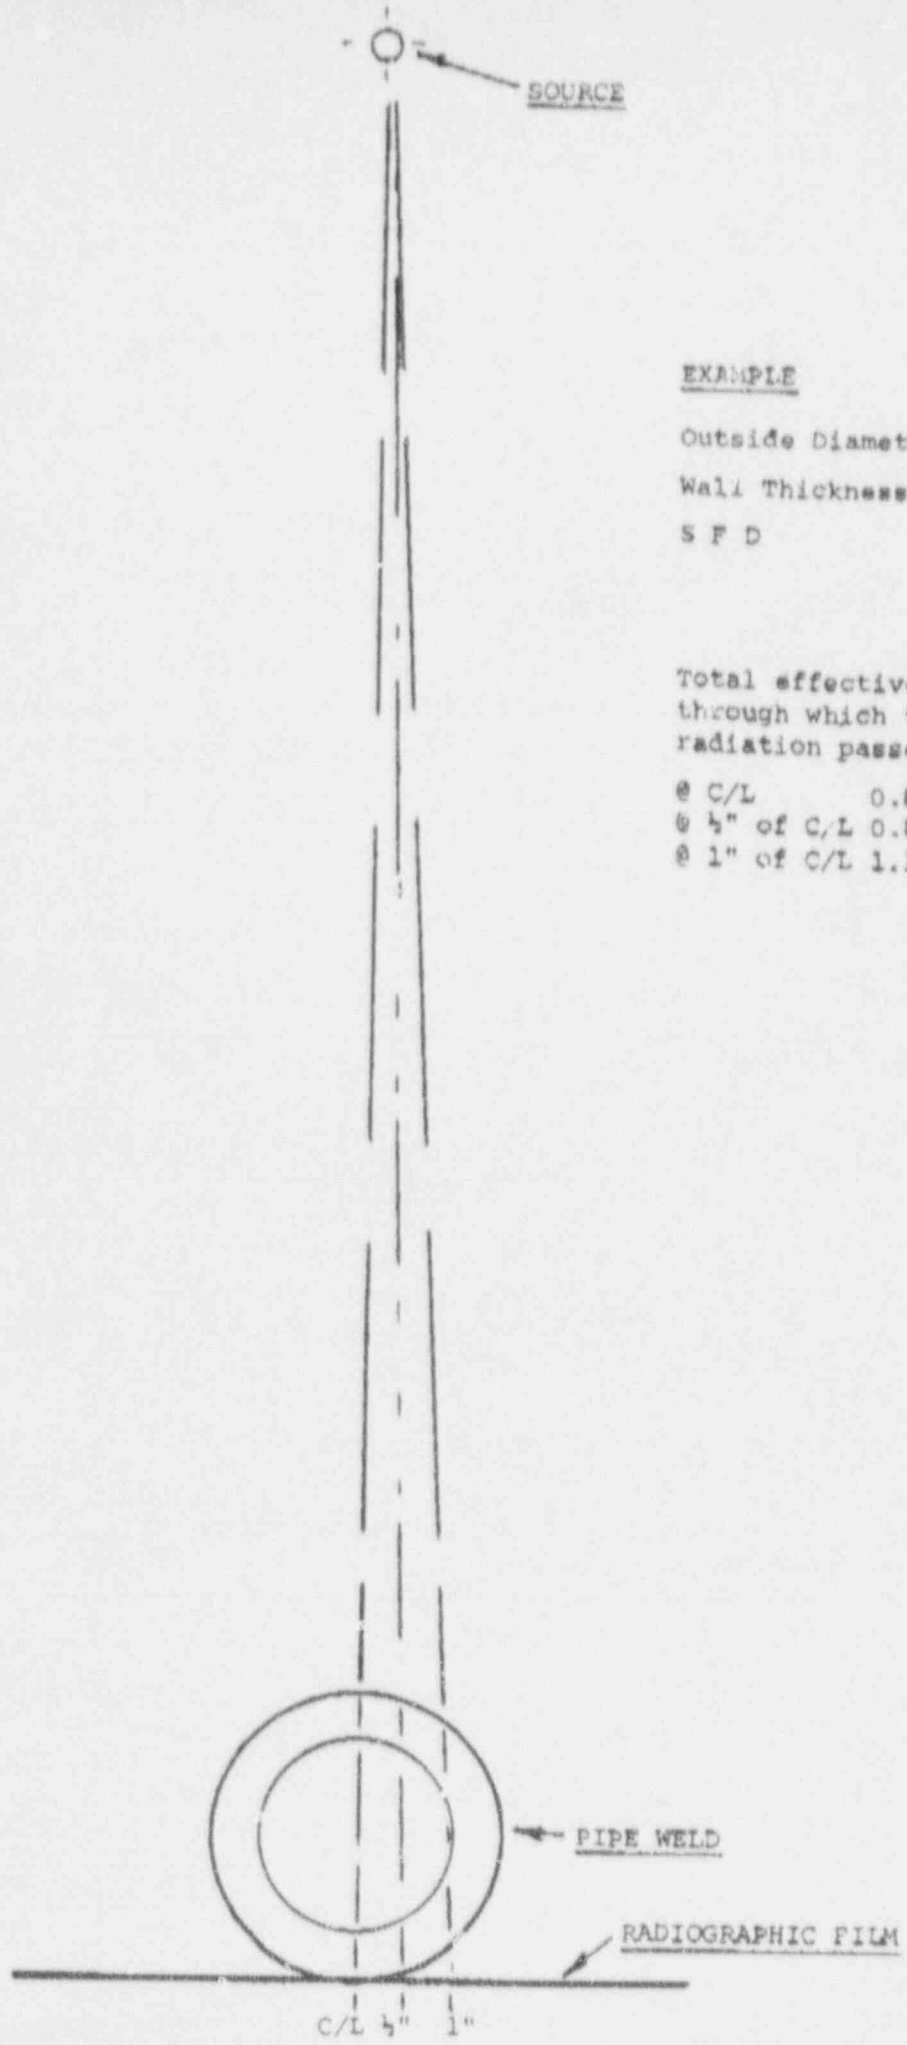
FIGURE #1

When pipe welds with relatively small diameters are radiographed using the double wall exposure and double wall view technique, (either elliptical or superimposed image) the effective composite through wall path the radiation passes through, radically changes as the distance away from the pipe center increases. (See Figure # 1).
