ACRS FLUID DYNAMICS SUBCOMMITTEE
MEETING MINUTES
DECEMBER 8, 1983
WASHINGTON, DC

Purpose: The purpose of the meeting was to discuss the recent flow-related incidents at the Palo Verde Unit 1, St. Lucie, Unit 1, and Millstone Unit 2 reactors that resulted in equipment damage to the plants' primary systems.

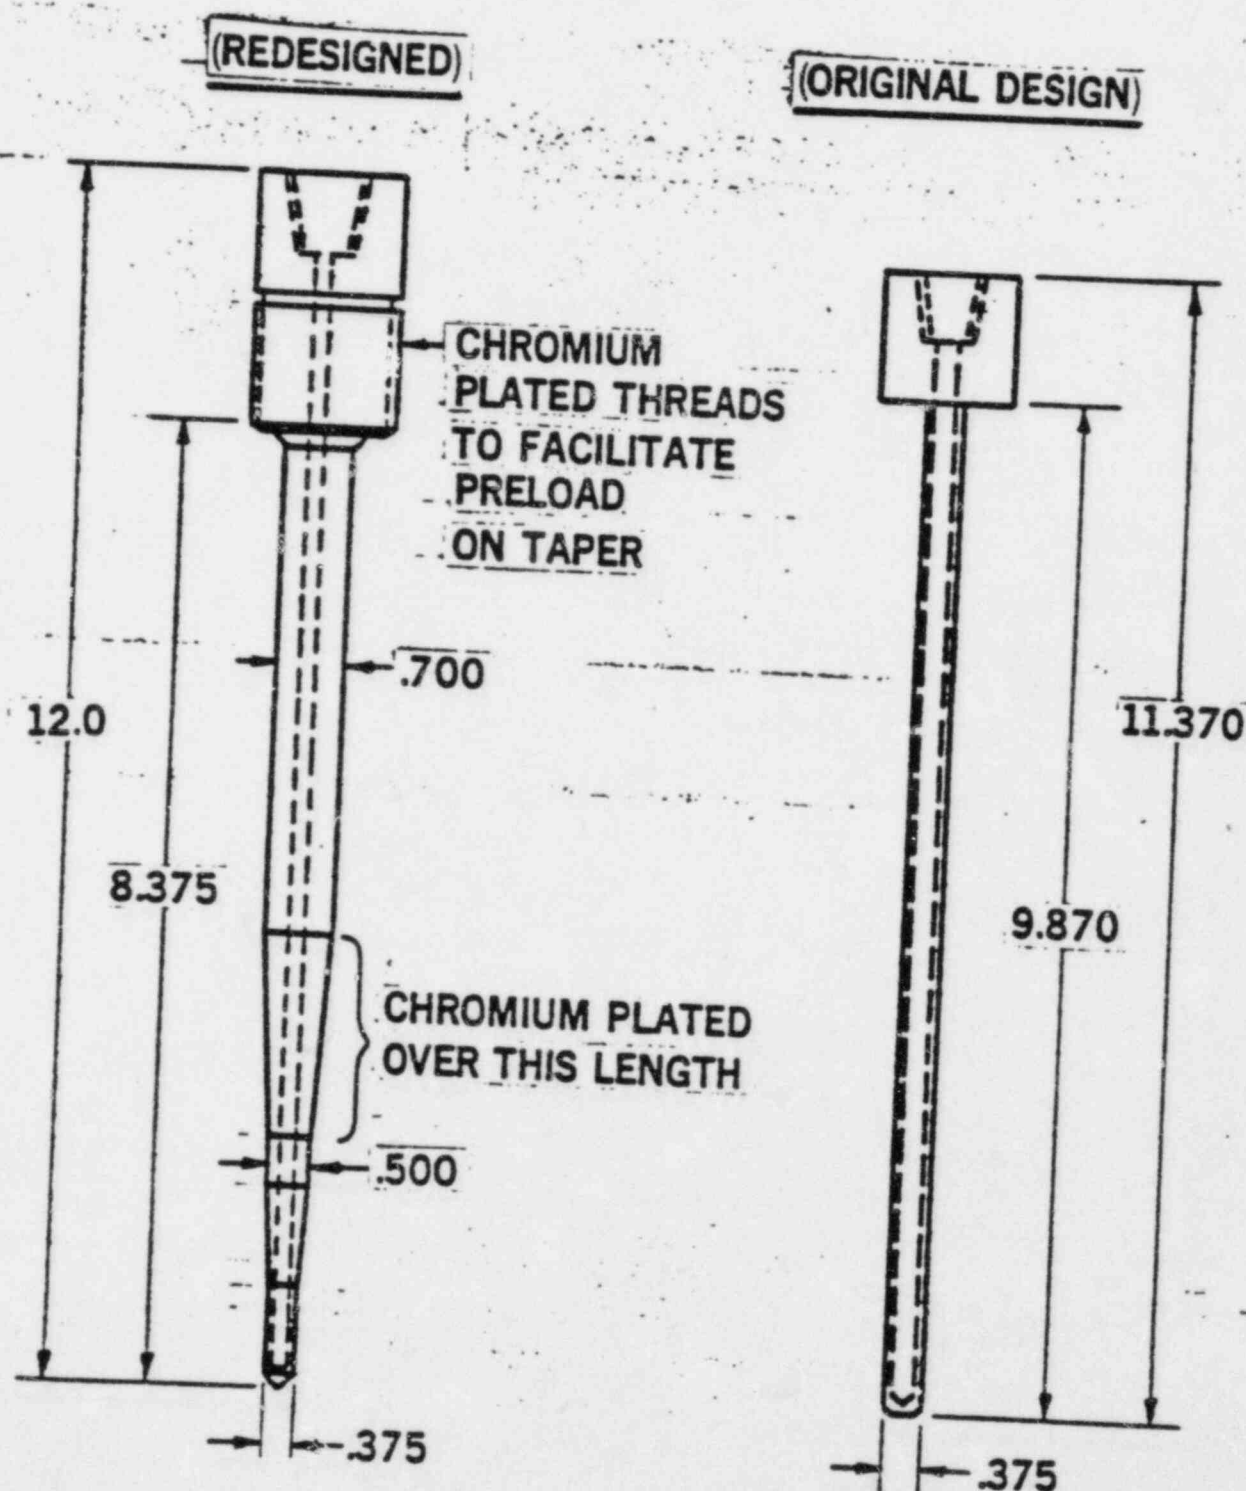
Fig. 1

The original RTD installation with the failure locations is shown on Figure 1. These failures showed up during the pre-core hot functional tests. The failure mode is as follows: (1) the thermowells experienced high cycle vibration, (2) the vibrations were in a plane perpendicular to the flow direction, indicative of vortex shedding, (3) failure was initiated by fatigue, and (4) extensive wearing was found on the thermowell at the annular interface between the inconel thermowell and the inconel pipe nozzle. All failures were seen in the cold leg RTDs. Figure 2 shows the redesigned RTD thermowell. The redesign increased the natural frequency from 1000 to 2800 cps, putting it well out of the region of potential excitation from plant operating conditions. Figure 3 shows the modified pipe nozzle fitting.

ANPP-1 THERMOWELL DESIGN COMPARISON

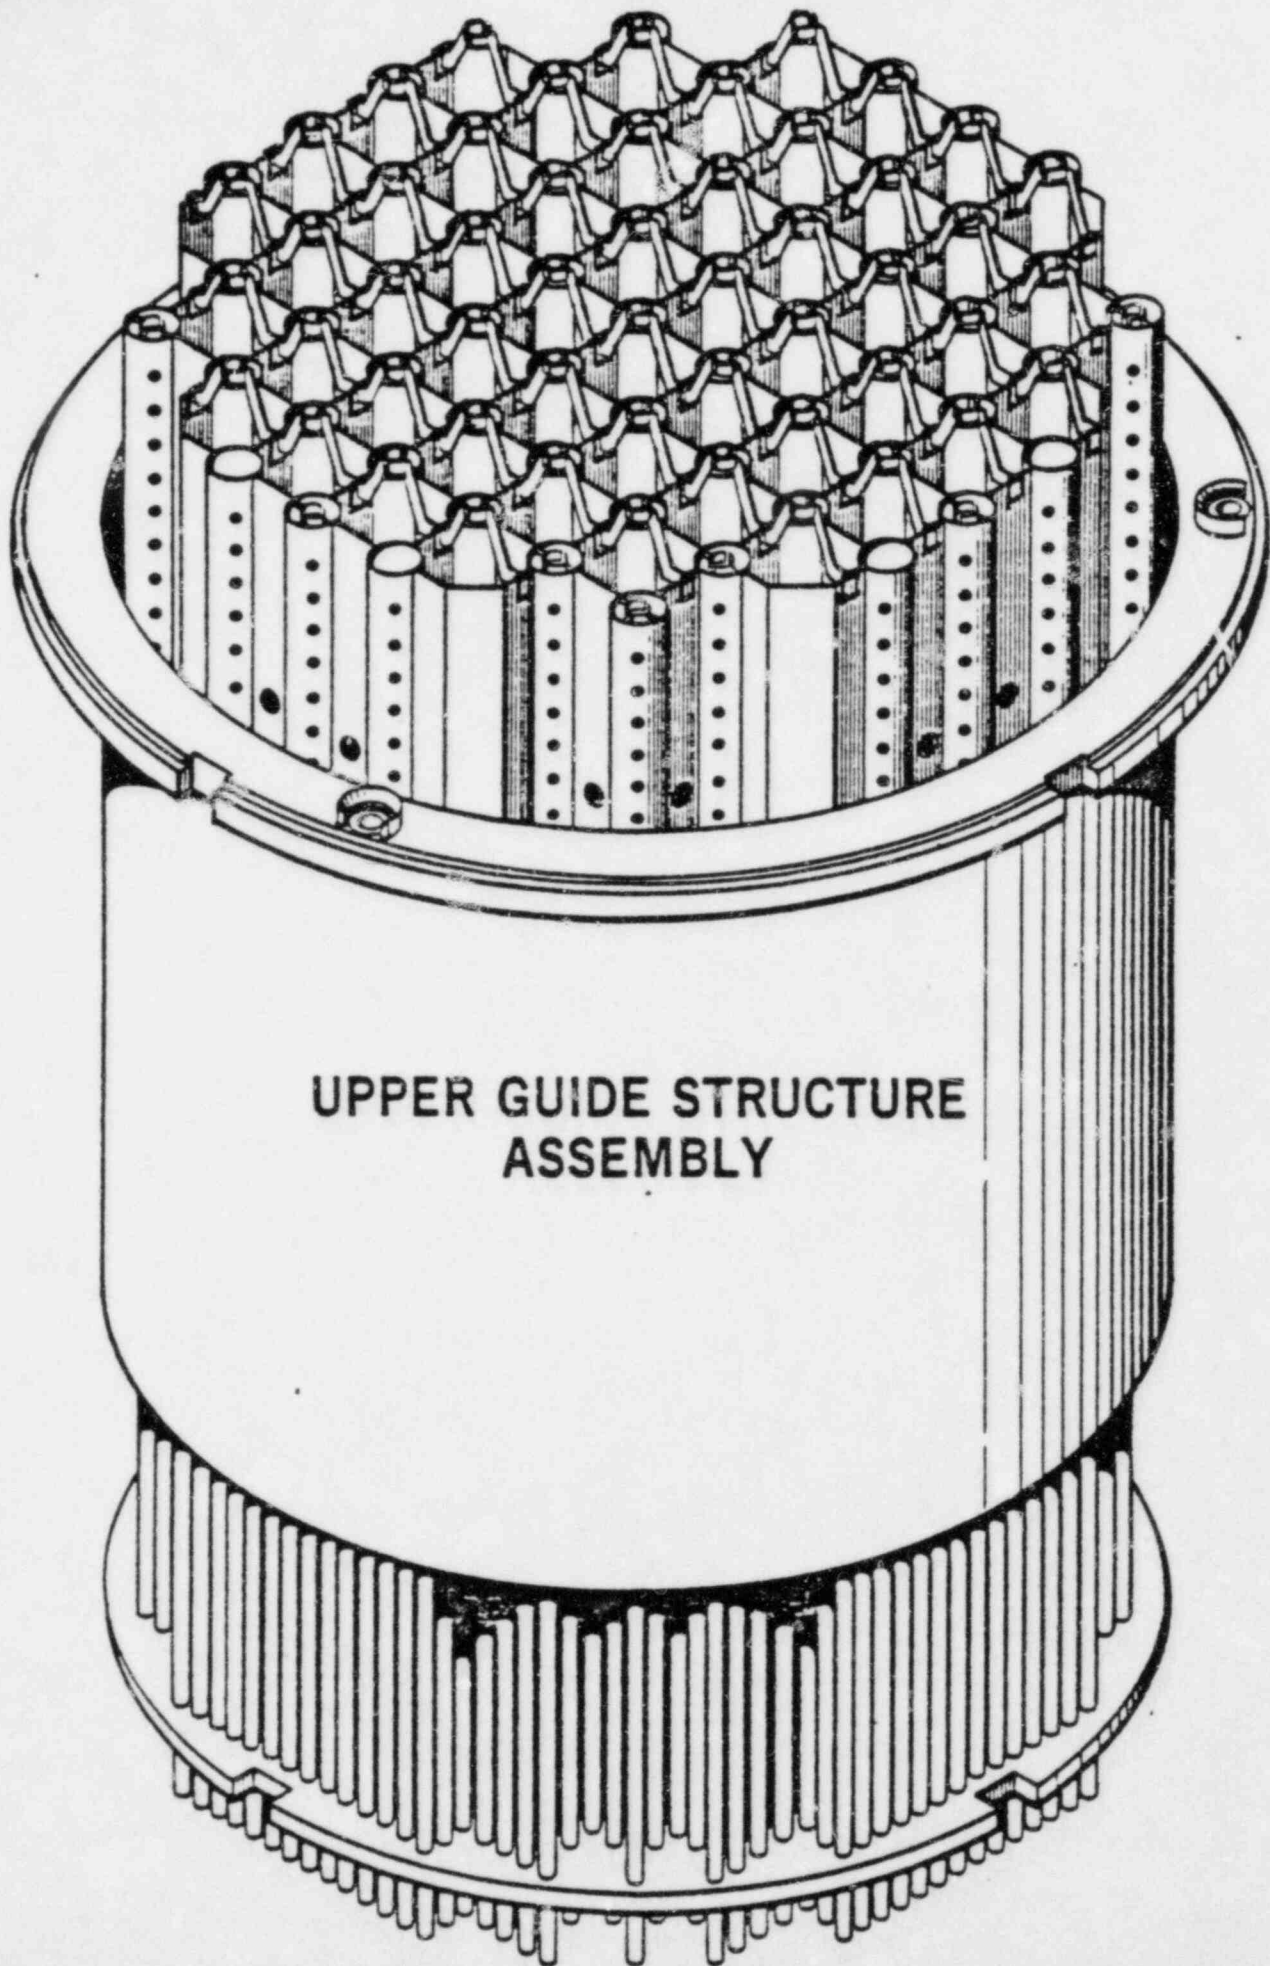
FIG. 8

CE discussed the cracking seen in the upper region of the CEA shroud assembly. Figure 8 shows the shroud and the upper guide structure and Figure 9 shows the location of the cracking in the upper structure

TOP CRACK SUMMARY

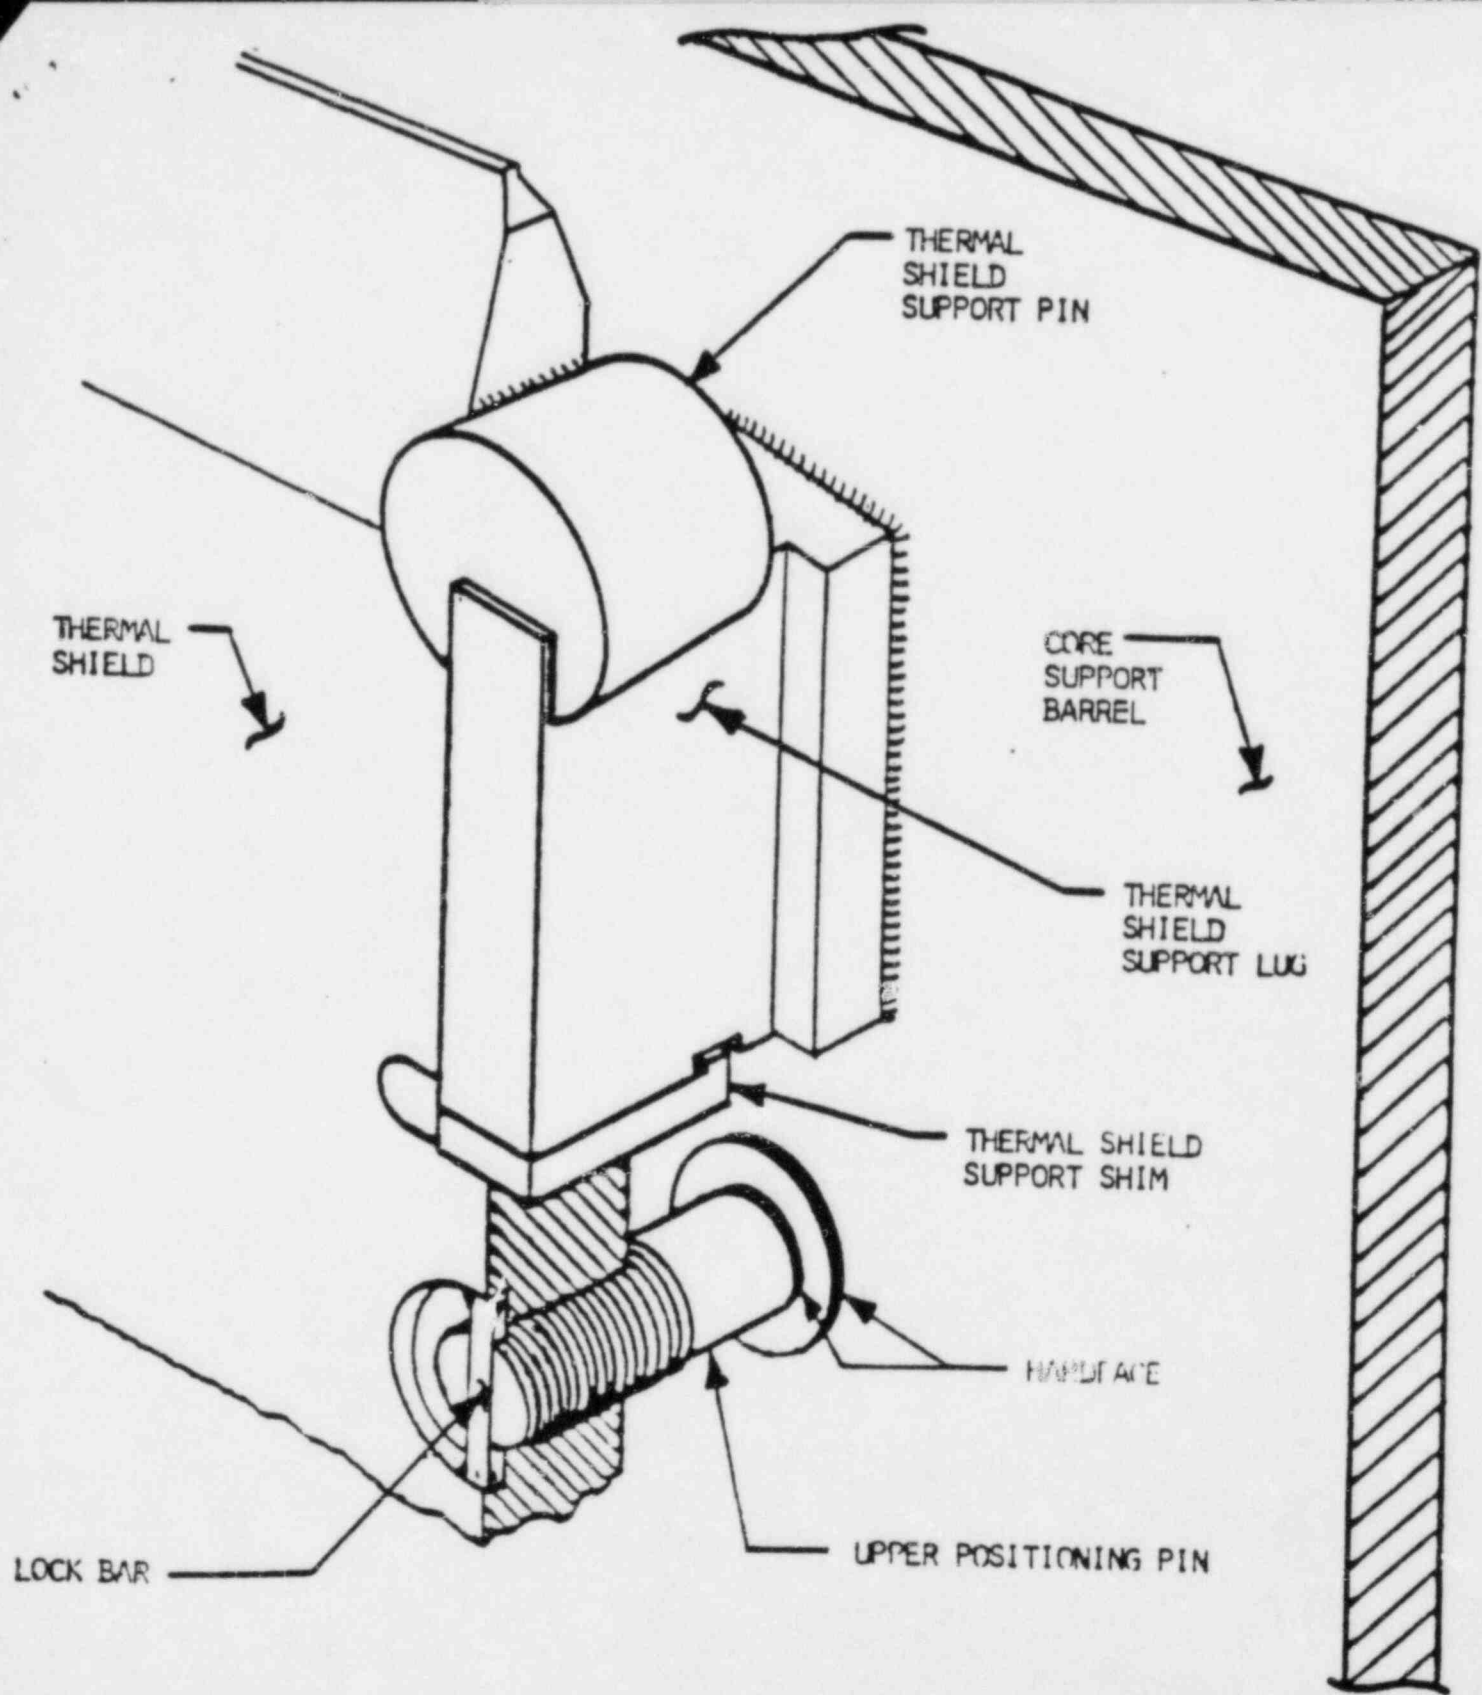
THERMAL SHIELD CONNECTION
