Inspection of Jacket Water Pumps  
from Transamerica Delaval Diesel  
Engines, SNPS, FaAA No. PA07396  
Shoreham Nuclear Power Station - Unit 1  
W.O. 44430/48923

FAILURE ANALYSIS REPORT - EF-3060

## FAILURE ANALYSIS - ROTOR POLE 7; ROTOR 17404267

ANALYSIS OF THE REPLACEMENT CONNECTING ROD BEARINGS  
FOR EMERGENCY DIESEL GENERATORS, FATIGUE LIFE PREDICTION  
SHOREHAM NUCLEAR POWER STATION

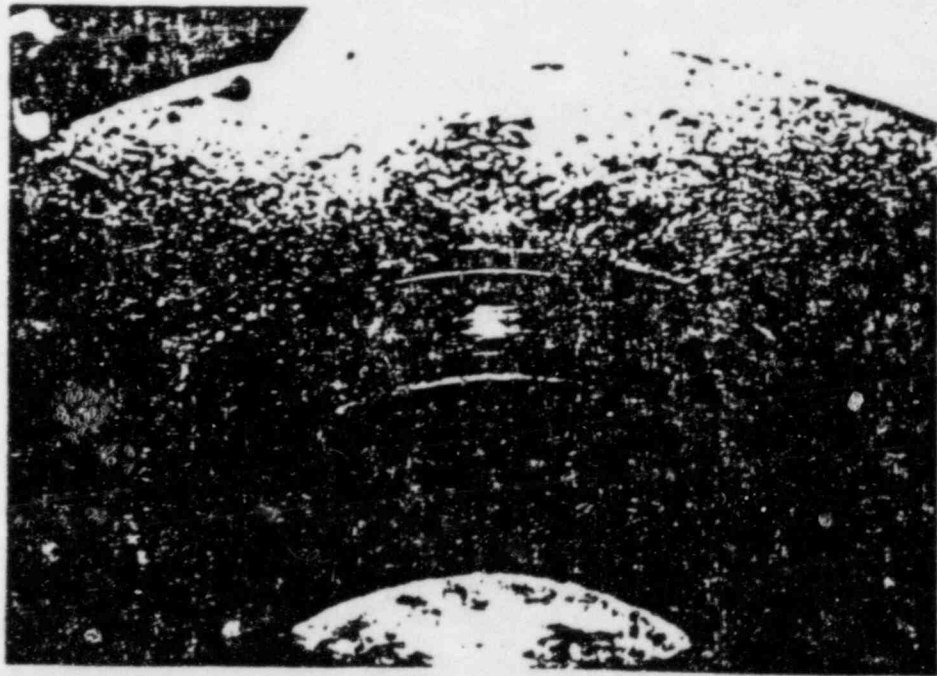
PHOTOGRAPH 17

The shaft taper surface was in excellent condition with no evidence of scoring, wear or relative rotation between impeller and shaft (Photograph 17). The only evidence of wear on any component of this pump was at the wear ring of the suction flange. This ring showed wear over approximately 120° of the circumference as shown in Photograph 18. There does not appear to have been any contact over the remaining portion of the wear ring circumference.
