TRANSFORMER REPORT
ON
EVENTS AT NORTH ANNA POWER STATION

June 16, 1983

POWER TRANSFORMER DIVISION
WESTINGHOUSE ELECTRIC CORPORATION
GREENTREE, PA 15220

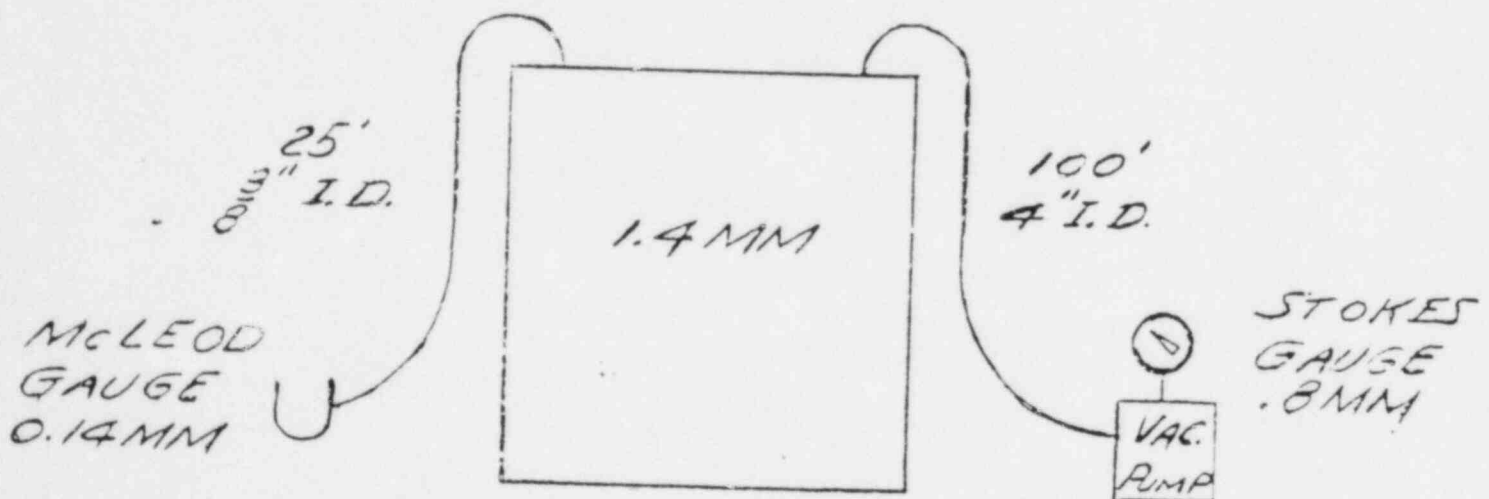
Calculation of Tank Pressure - HAM707

Because of the configuration of the reprocessing system and the fact that a McLeod gauge measures only partial pressure of the non-condensables, the pressure within the tank is different than measured by either gauge. Tank pressure can be calculated based on the Stokes gauge reading and conductance of the 100 feet of 4" vacuum hose.

This calculation (Appendix D) shows that the internal tank pressure was 1.4 mm Hg which is greater than the specification limit of 1.0 mm maximum (per Westinghouse Instruction Leaflet 48-668) prior to oil filling; although the vacuum meets the specification for pressure during oil filling, 2 mm maximum. The 20 hours during which the vacuum pump was on prior to oil filling is sufficient time to evacuate the tank completely and reach equilibrium.

Although the 1.4 mm absolute pressure is greater than the specification requirement prior to oil filling, the insulation should have been effectively impregnated and dried because of circulating hot, de-gassed oil through the system prior to energizing. Moisture in the oil during processing and prior to energization was within specification, 10 ppm maximum. There was very little difference in processing characteristics between 7001994 and 7001965. Unit 7001994 failed in December, 1982, and unit 7001965 did not show any irregular tendency during operation.

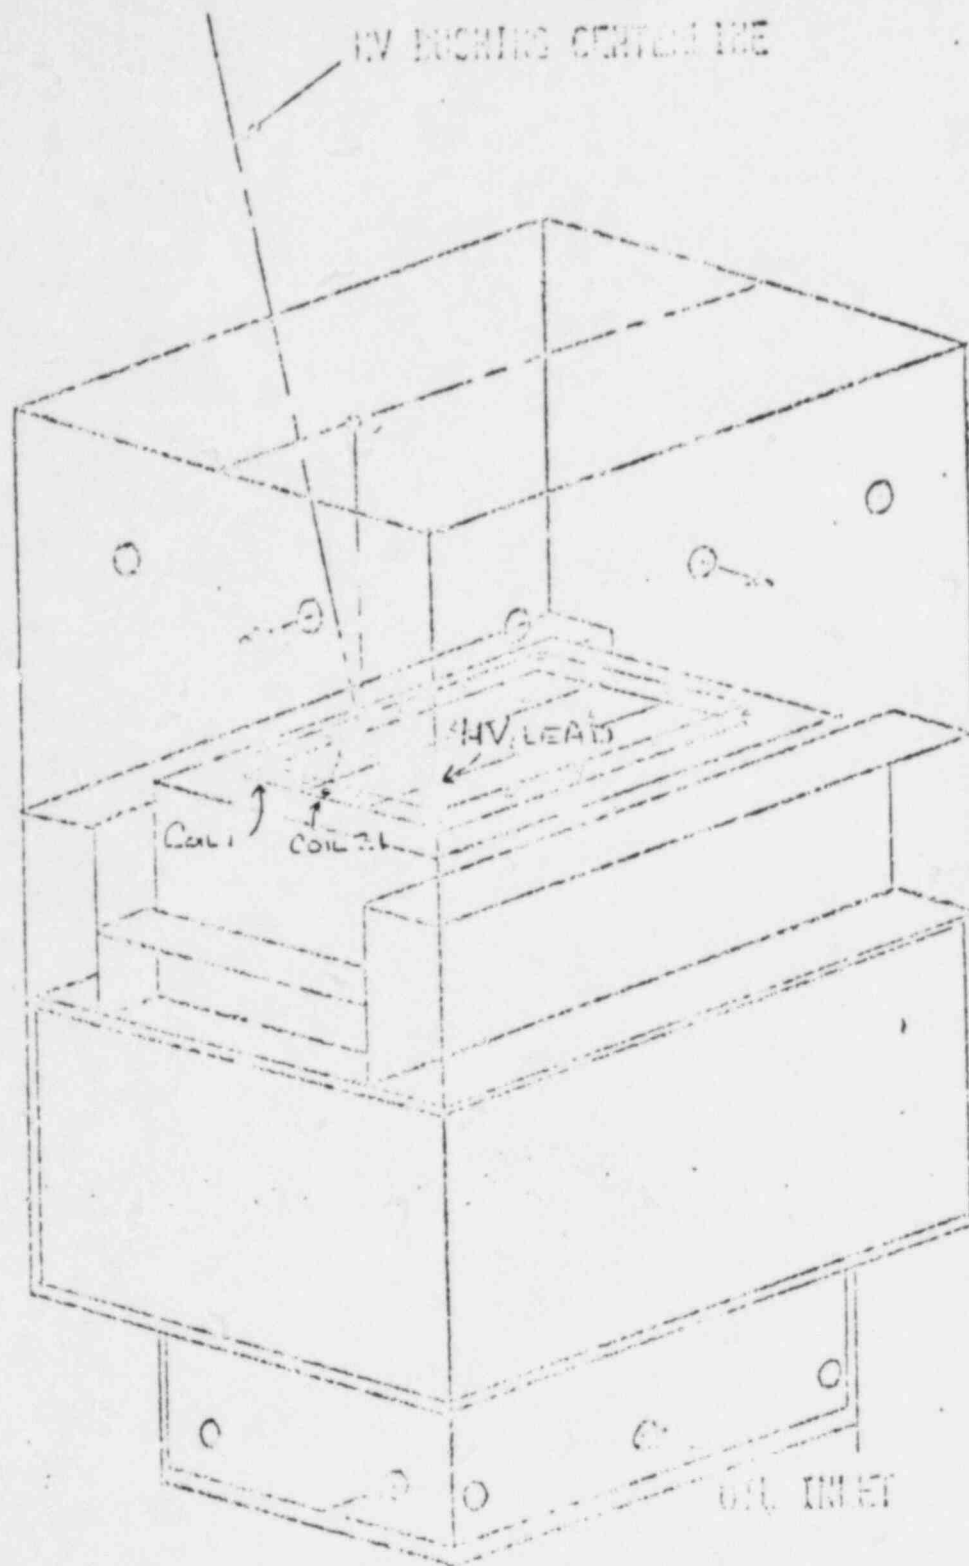
- . On turning on the pumps no bubbles were noticed in the circulating oil.
- . When bubbles were purposely injected through one of the pumps, they were found to progress straight up through the windings and then straight-up through the bridge structure.
- . The quantity of injected bubbles were at least twice as great around the core and coils as opposed to through the coils.
- . Calculations indicate that a given volume of gas, if present, will take seven minutes to complete one cycle through the main tank and cooling system.
- . Reference data indicates that if the bubble size is greater than 1/4" in diameter, it would not dissolve in the oil before one cycle of circulation.

Figure 6 - Relative Position of Winding Coils and Lead

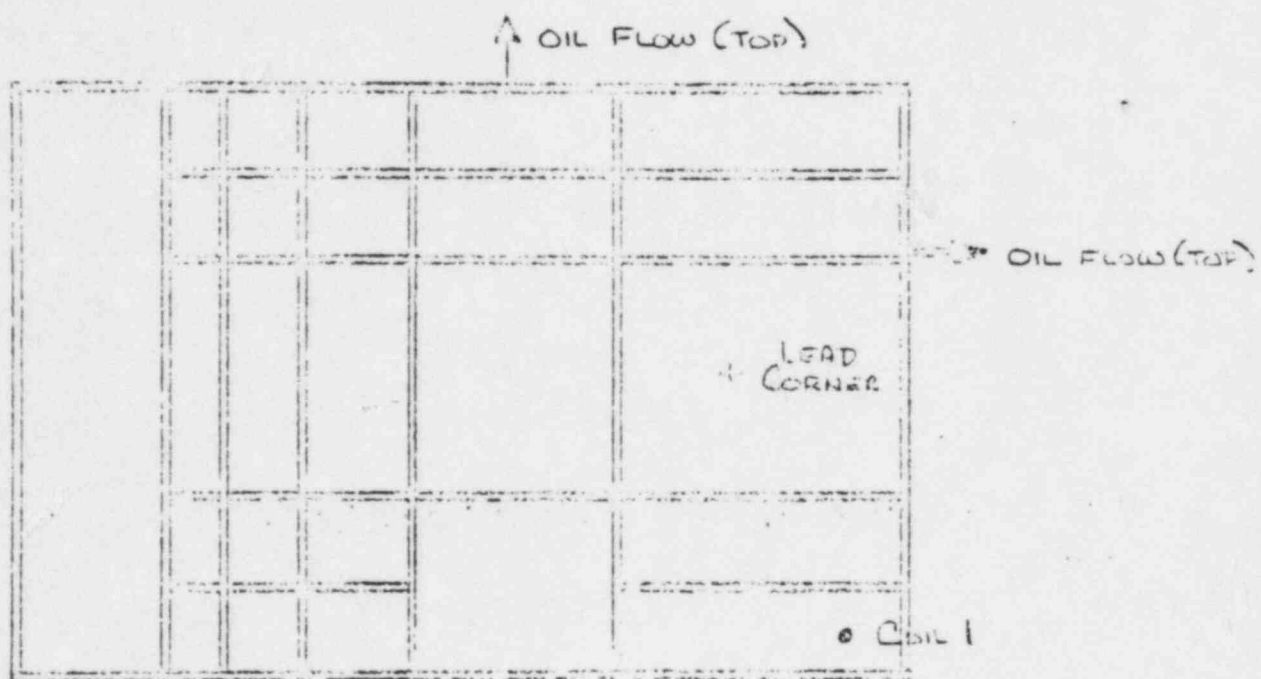
It was not likely that a bubble generated at coil #1 would approach the HV lead unless it was circulated through the cooling system and then come up through the HV lead bridge section.

Figure 7 - Bridge Structure

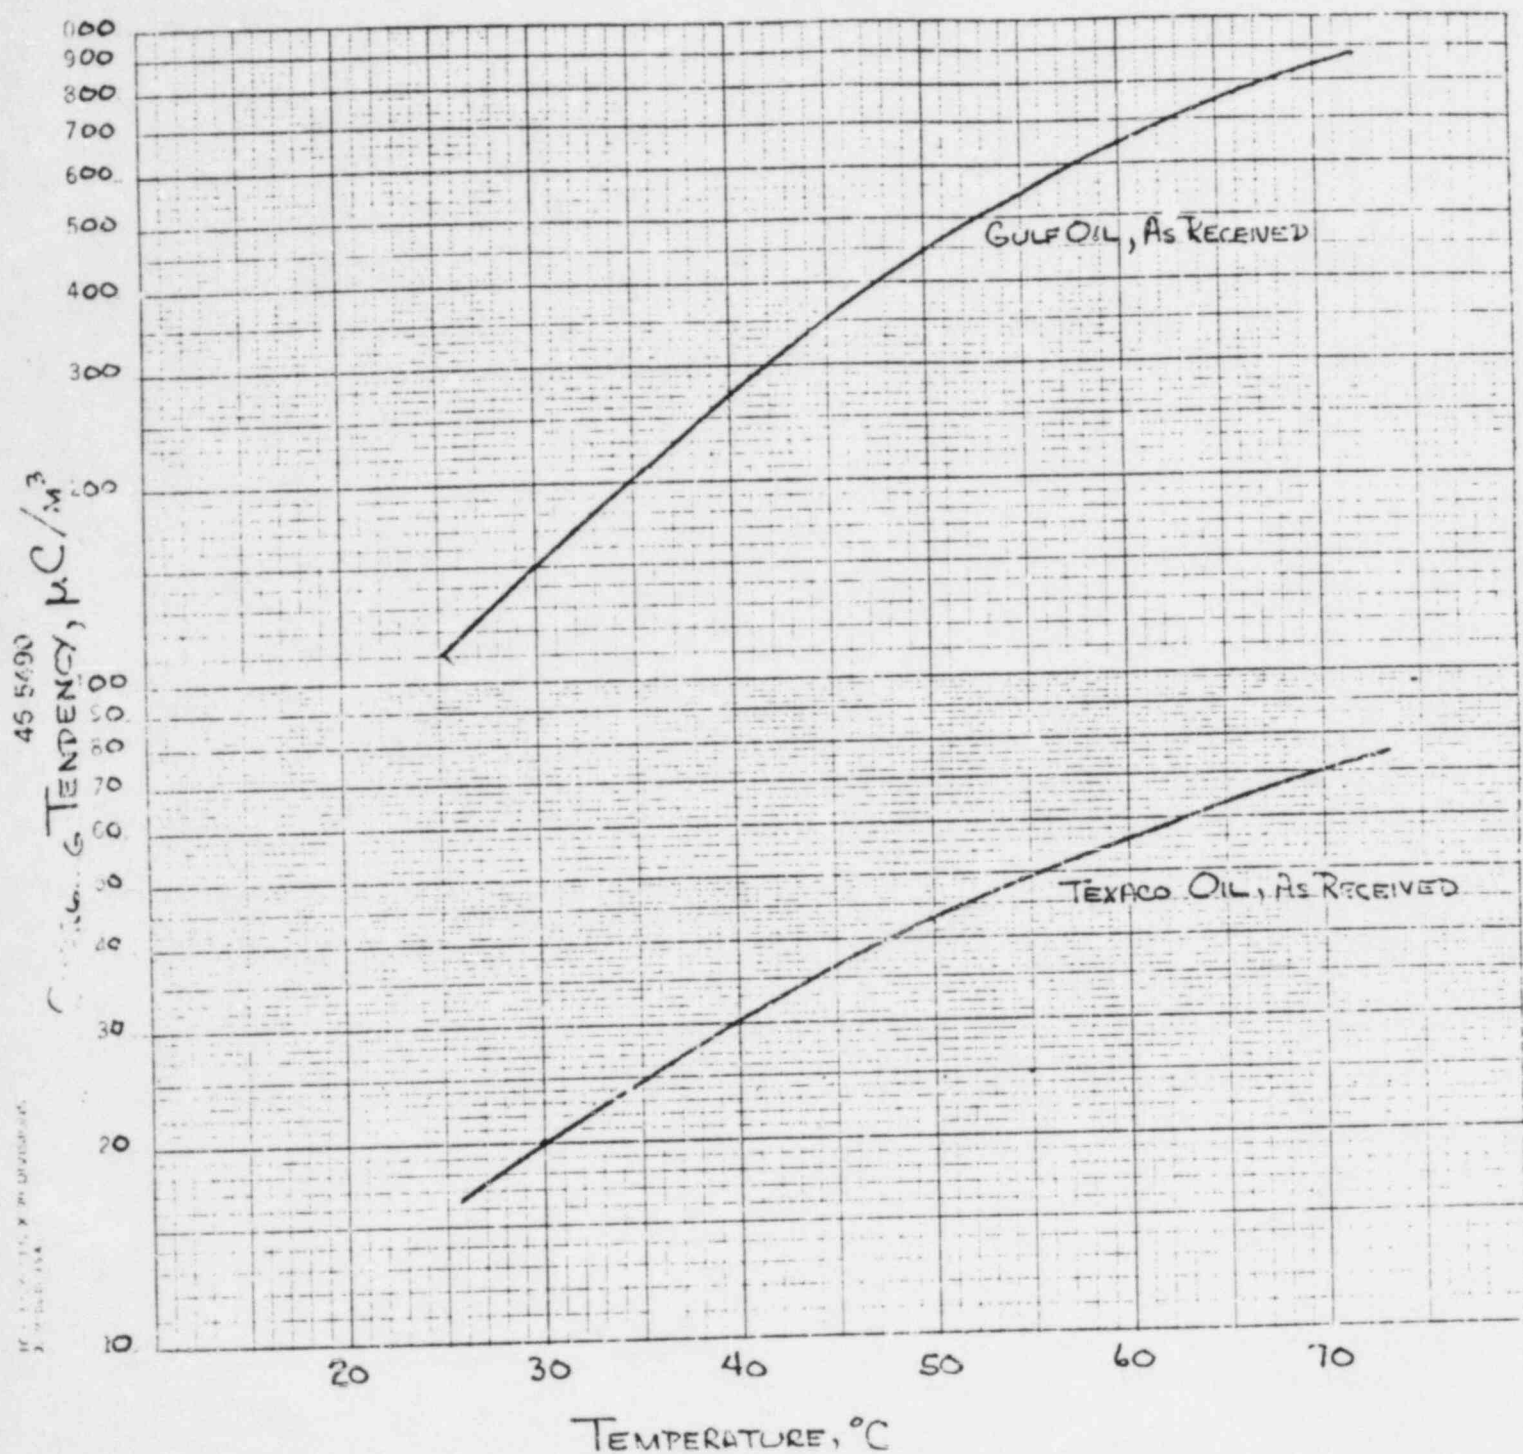
In experiments conducted at Muncie in 1982, various commercial sources of transformer oil were analyzed for charging tendency with the Exxon mini-static tester. The investigation was initially to determine if hydro-refined oil had greater charging tendency than acid refined oil. (Texaco the last and only domestic supplier of acid refined oil is a chief source of supply for the Muncie plant.) The results of the investigation did not show correlation between acid or hydro-refined oil and charging tendency, but it did show that one source of supply (Gulf Trancrest H) exhibited significantly greater charging tendency than any other source, Figure 9.

Figure 9 - Charging Tendency of Gulf and Texaco Transformer Oils

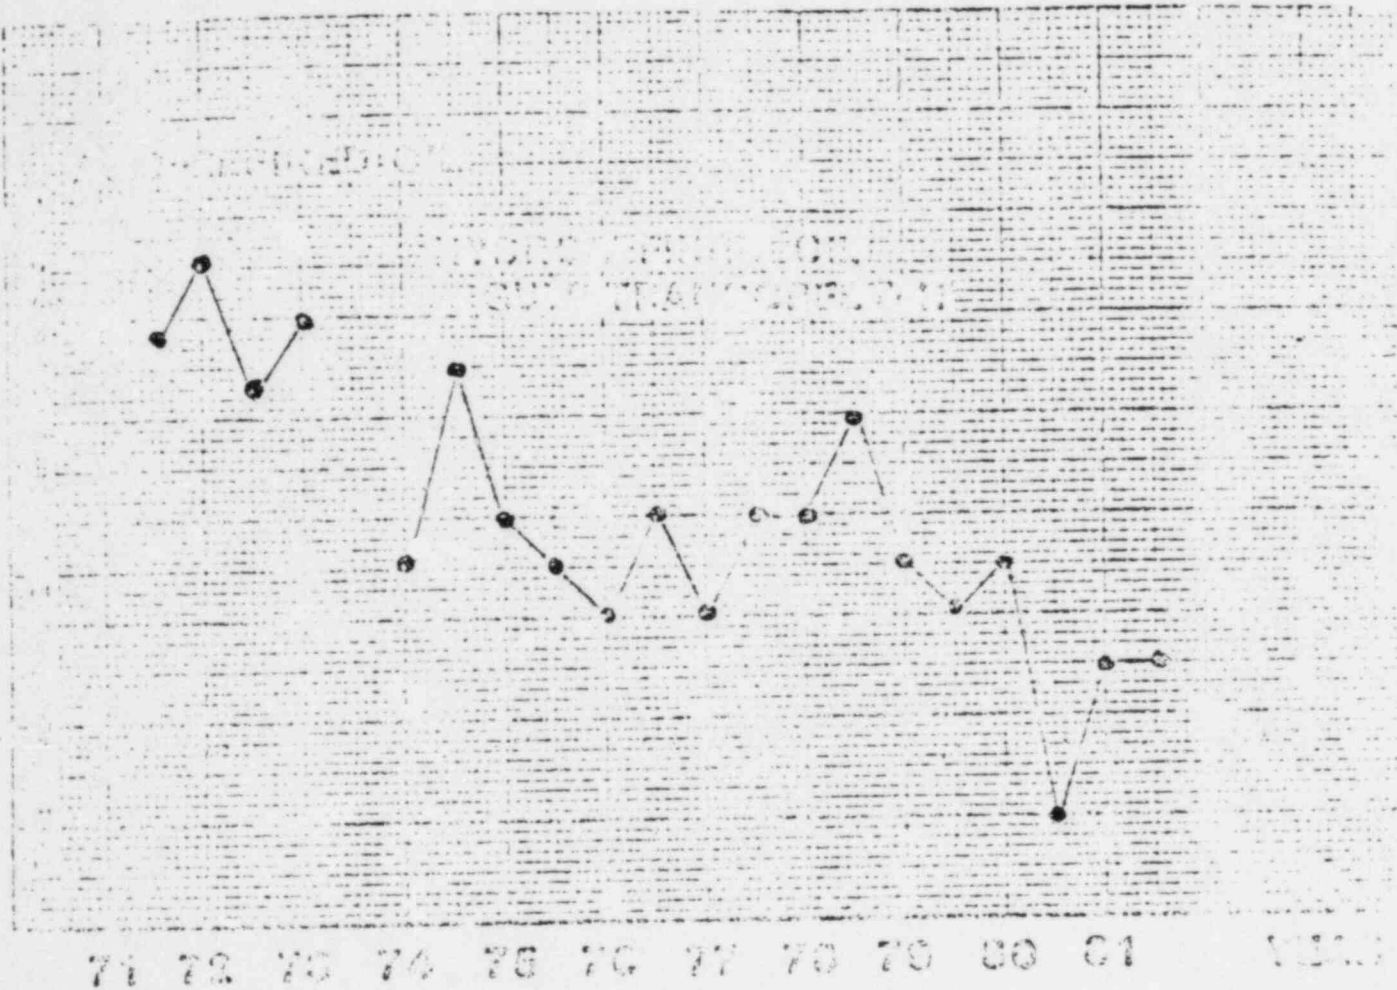
Figure 10 illustrates the trend of Gulf Trancrest H IFT (interfacial tension values) as measured by the semi-annual Doble oil survey. Although the degree of contamination required to provide significant charging tendency may not lower the IFT below the specification limit (40 dynes/cm), it would lower IFT somewhat. Figure 10 shows that the IFT values of Trancrest H dropped significantly after changing to the hydro-refining process, and an indication of a drop in IFT also occurs in mid-1980 through 1981. Oil produced in this time period was likely to have been used during factory testing or field filling some of the North Anna units.

Figure 10 - IFT Values for Gulf Oil, 1971-81 taken from Doble Semi-Annual Oil Survey

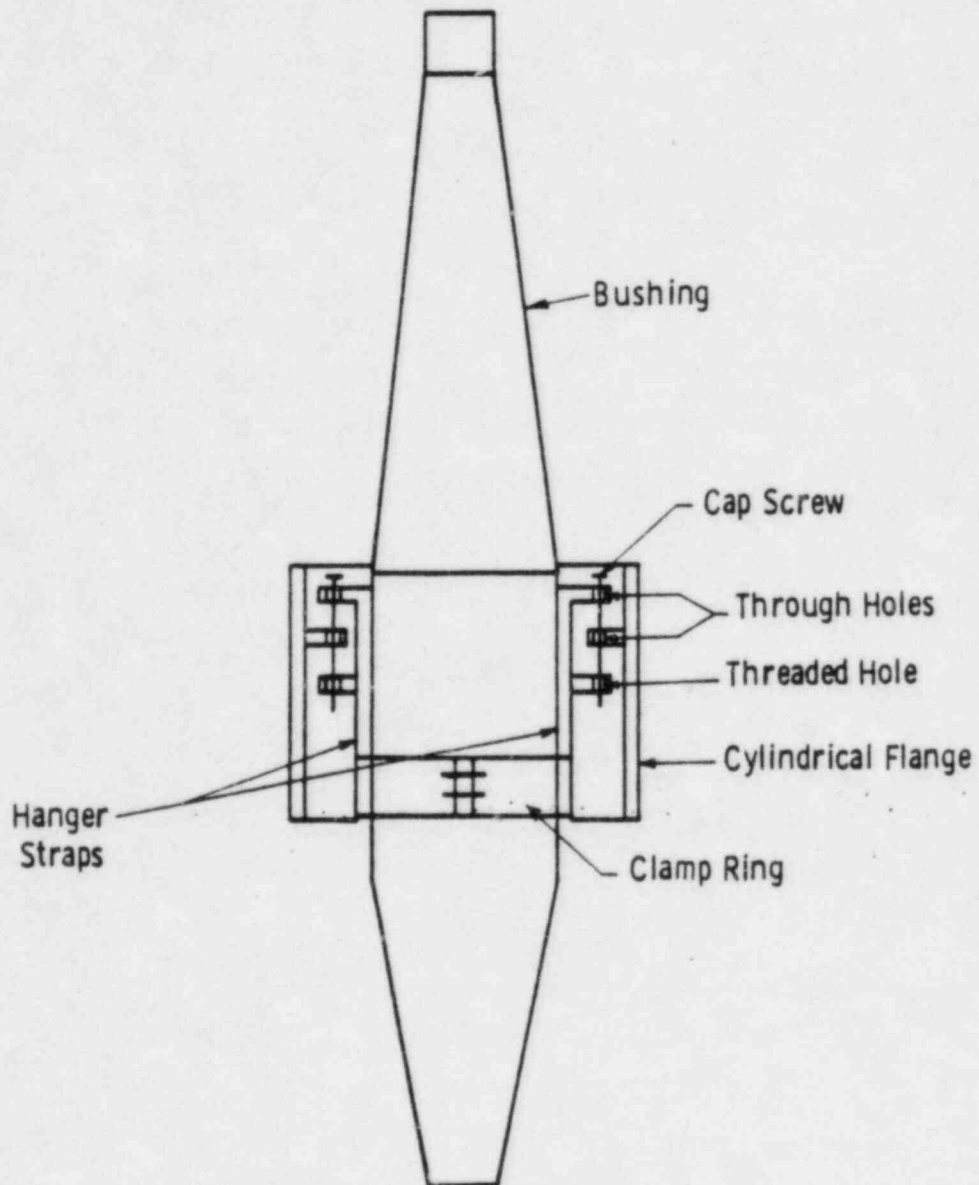
Fig. 1 - Schematic sketch showing the location of the two cap screws in the bushing support assembly. Not to scale.

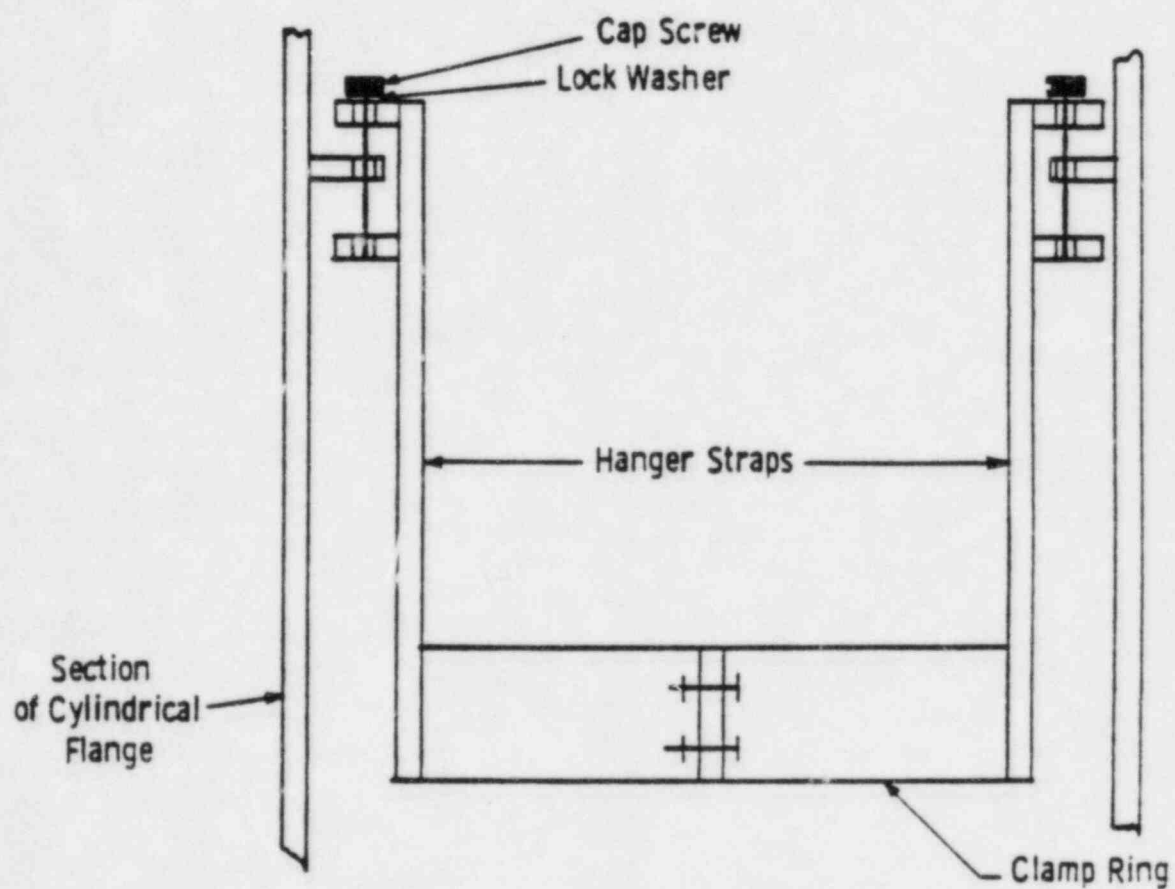
Fig. 2 — Schematic sketch showing the central detail from Fig. 1 . Not to scale

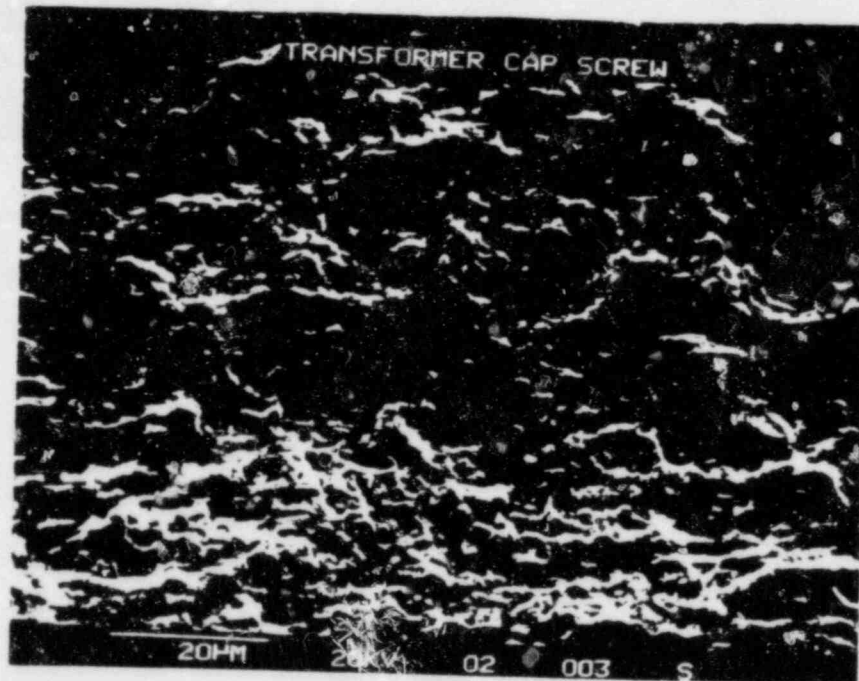
Figure 10. Area 1 from Fig. 9. Some of the primary fracture origins.

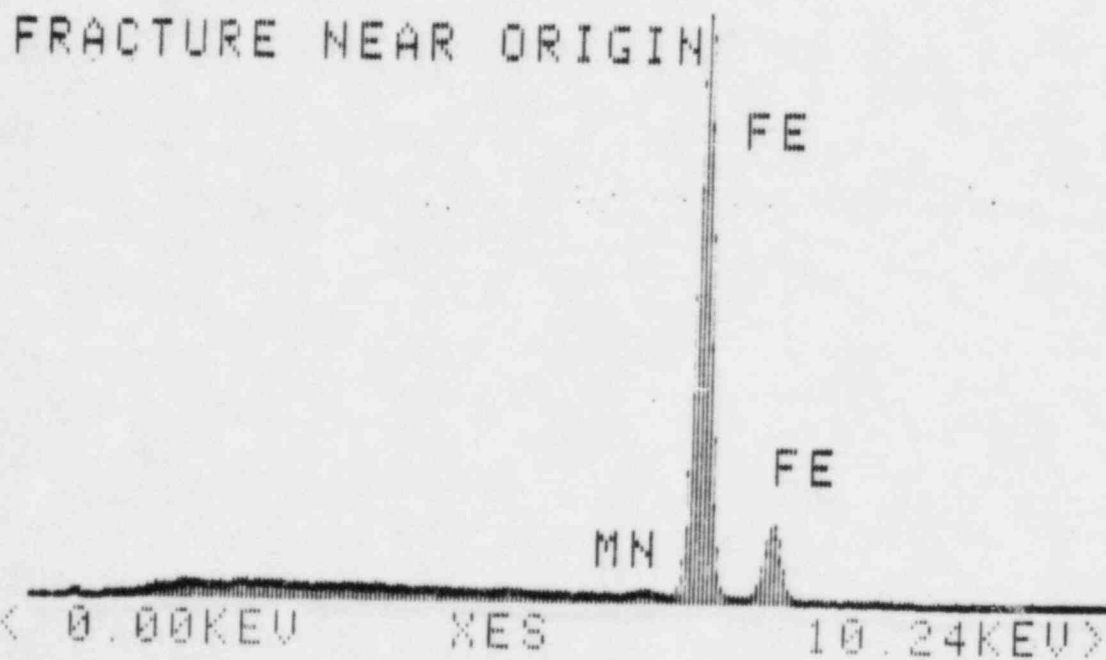
Figure 11. Energy-dispersive x-ray spectrum (EDS) of the fracture area 3 from Fig. 10, next to one of the origins. Numerical results of this analysis are shown in Fig. 12.

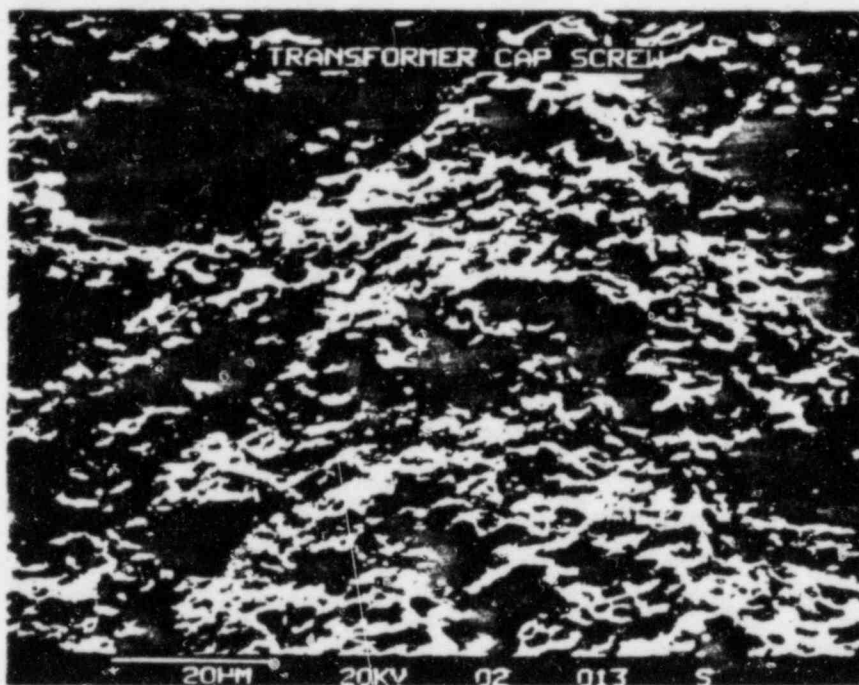
Figure 18. Fracture area 13 from Fig. 17.

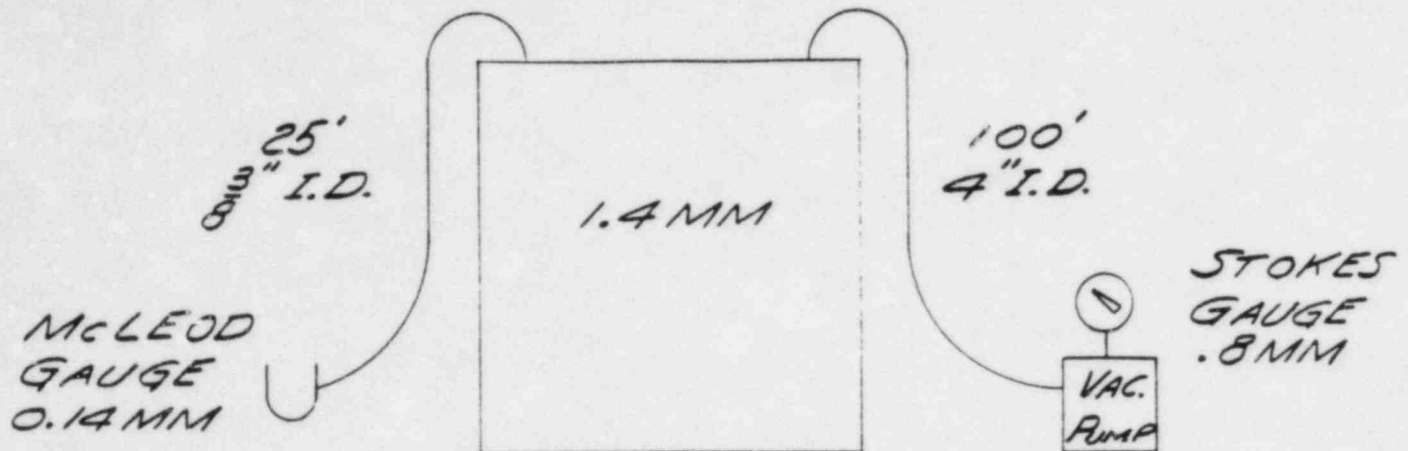
Calculation of Tank Pressure - HAM707

The single phase transformer, HAM707, (retrofitted with a COPS unit) was evacuated to prepare for vacuum filling. During this process, two pressure readings were taken (1) at the vacuum pump and (2) by a McLeod gauge separated from the tank cover by approximately 25 ft. of 3/8 inch I.D. tubing. The question has been raised, what is the total pressure within the tank.
