EXAMINATION OF OTSG TUBES
B73-8 AND B112-19 FROM ANO-1
— FINAL REPORT —

RESEARCH AND DEVELOPMENT DIVISION
LYNCHBURG RESEARCH CENTER

SPONSORED BY
ARKANSAS POWER AND LIGHT

June 10, 1983

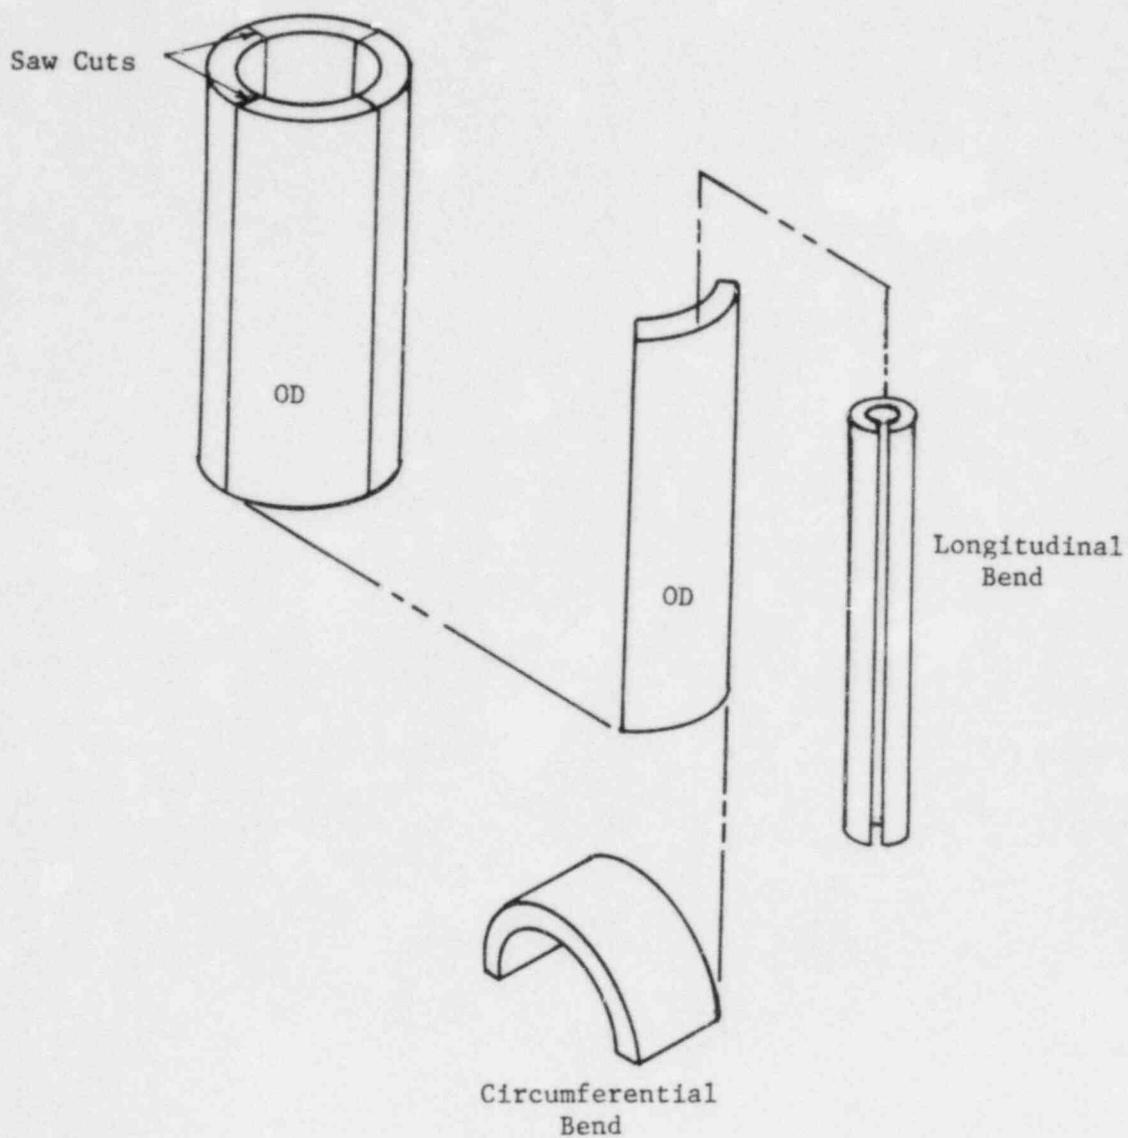
Figure 2-10. Tube Sectioning and Bending Technique

Sectioning tube samples into longitudinal strips and bending the strips has proven to be very effective in opening tight intergranular cracks.(2,3) Figure 2-10 is a schematic of the two bend techniques used during this examination. Both the circumferential and longitudinal bend techniques place the surface of the tube in tension to open circumferentially or longitudinally oriented cracks, respectively. Since the EC inspection indicated that the tube defects were OD initiated, the tubes were bent with the OD surface in tension. Some of the tube samples were chemically cleaned either before or after bending to remove deposits and further evaluate the tube surface features.

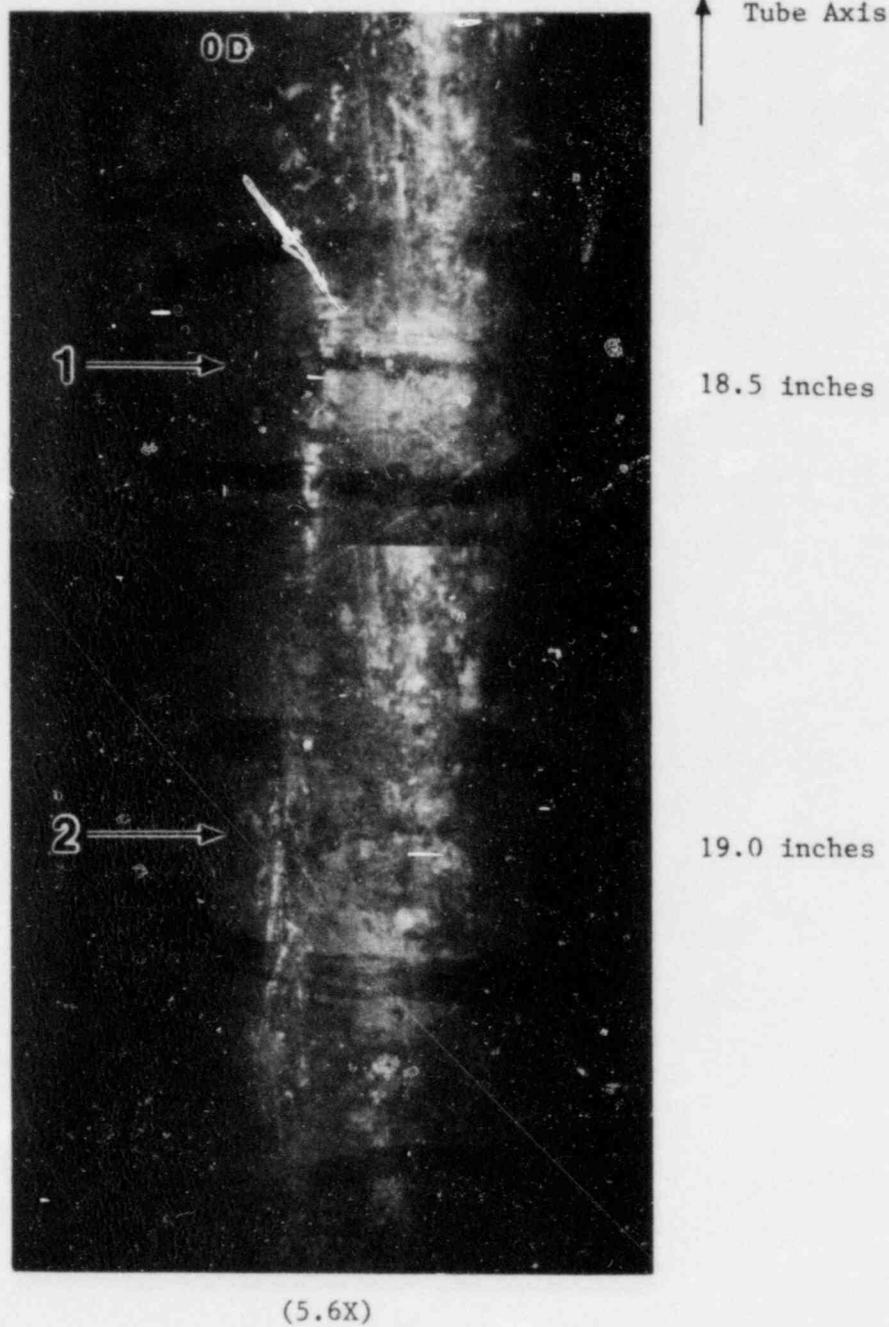
Figure 2-11. OD Surface of Tube B73-8 Defect Indication Areas

OD surface micrographs of defect indication areas are shown in Figures 2-11 through 2-14. The approximate extent of the indications was circled with black ink during the EC inspection. Heavy black OD surface deposits in these areas prevented an accurate confirmation of defect presence during the visual inspections. Areas 1, 2, and 3 did have circumferential crack-like features, but nothing anomalous was visible in Areas 4 and 5. A 100% through-wall hole was visible in Area 6, with unusually large axial extent on the OD surface, and is shown in Figure 2-14. Areas 7 to 12 were inspected using other techniques and not examined by stereo macroscopy.

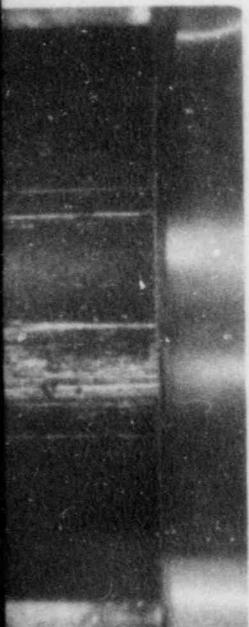
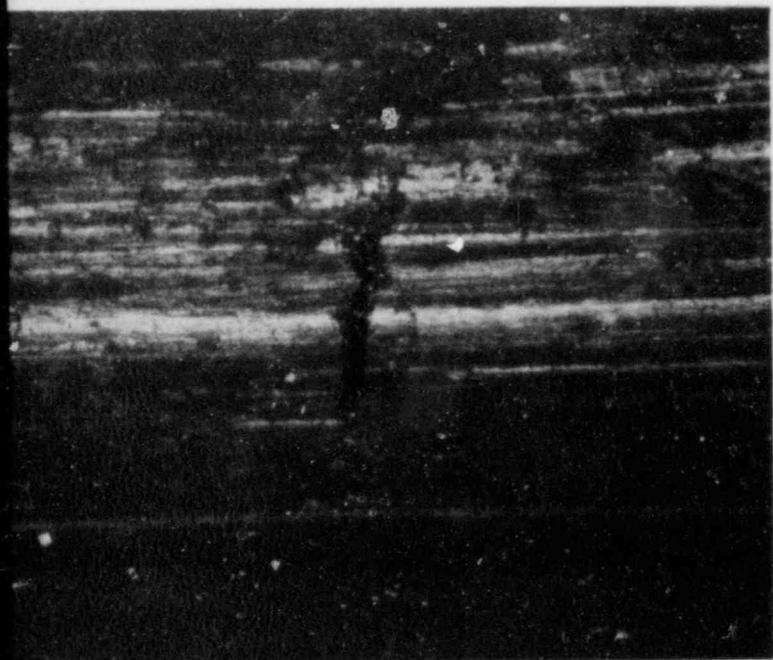
Figure 2-15. ID Surface of Tube B73-8
in Areas 2 and 3

Inspection of the ID surfaces revealed a circumferential crack in Areas 2 and 3. Figure 2-15 shows these cracks, which appear to have been "stretched" at the crack tips, thus opening them slightly in the axial direction. This probably occurred during tube removal, since large (approximately 2,700 pounds) axial forces were applied, and may have contributed to the larger depth estimates of the laboratory EC indications. The ID surface of the sample removed from Areas 4 and 5 appeared normal with no defects visible. The axial scrapes visible on the ID surface were caused by the insertion and removal of EC probes and tube removal devices and are typical for OTSG tubes removed from service.

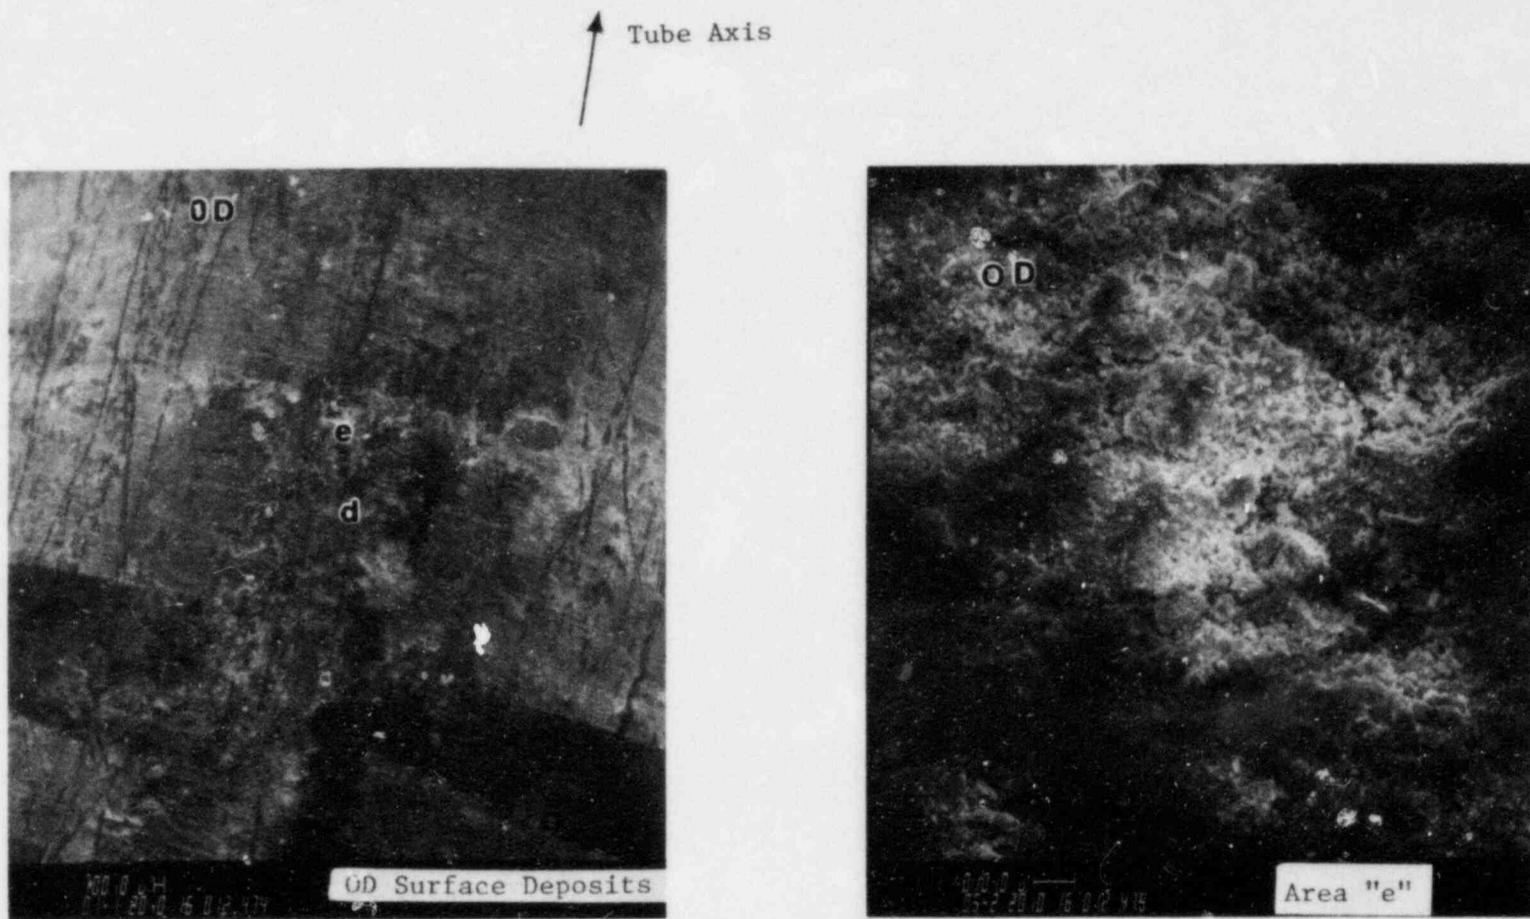
Figure 2-16. OD Surface of Tube B112-19 Defect Indication Area

The OD surface of Area 1 revealed a substantial amount of mechanical damage. This damage consisted of axially oriented scrapes and "plowed-up" metal and is shown in Figure 2-16. Since the overall OD surface was dark in this region and the damage was shiny, this implies that the damage was not service related. No obvious defects or cracks were visible on either the ID or OD surfaces of Area 1 which could be attributed to the site EC defect

OD Mechanical Damage
After Cleaning with
Inhibited HCl

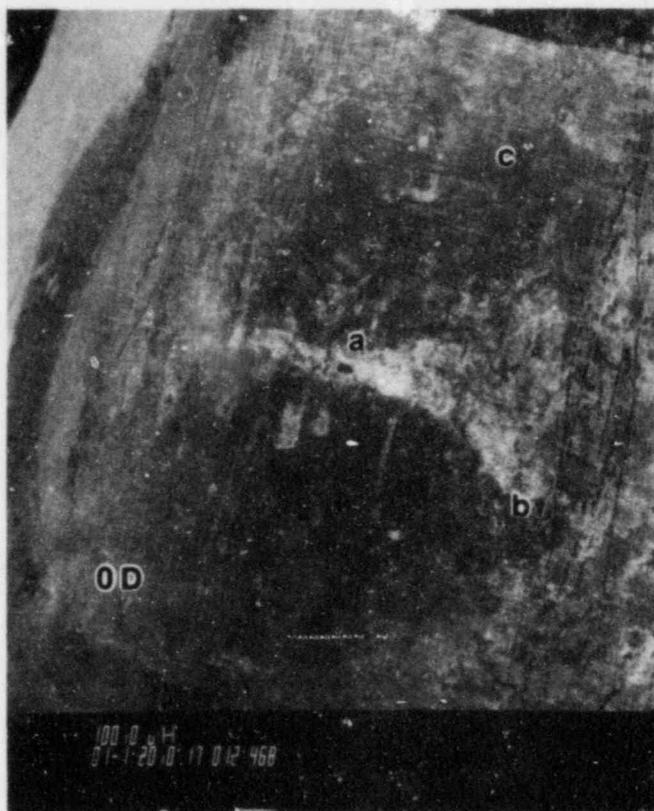
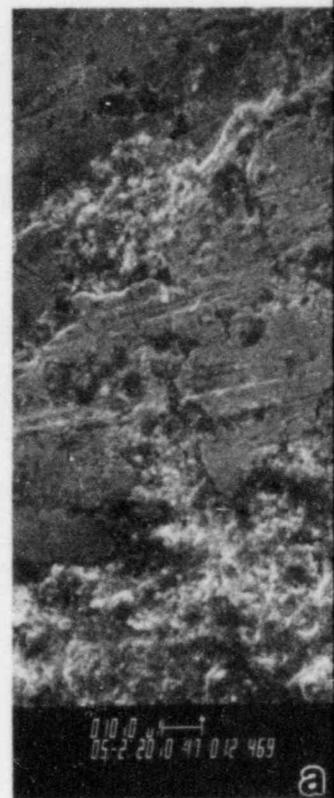
Figure 2-17. SEM Micrographs of Tube B73-8 Area 2

Micrographs of the OD surfaces of the samples from Areas 2 and 3 of tube B73-8 are shown in Figures 2-17 through 2-19. No cracks were visible in either area, but heavy surface deposits were present which would have covered any cracks. An EDX spectrum from the surface deposit in Area 3 shown in Figure 2-19 on which significant peaks (>2 wt. %) of magnesium (Mg), silicon (Si), sulfur (S), and zinc (Zn) were visible. These elements are in addition to chromium (Cr), iron (Fe), and nickel (Ni), the major alloying constituents of Inconel 600.

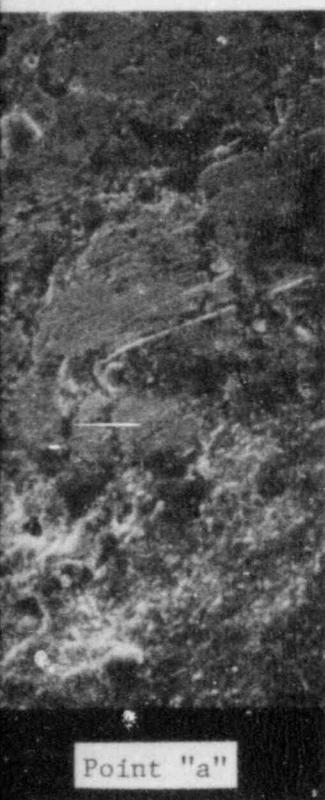
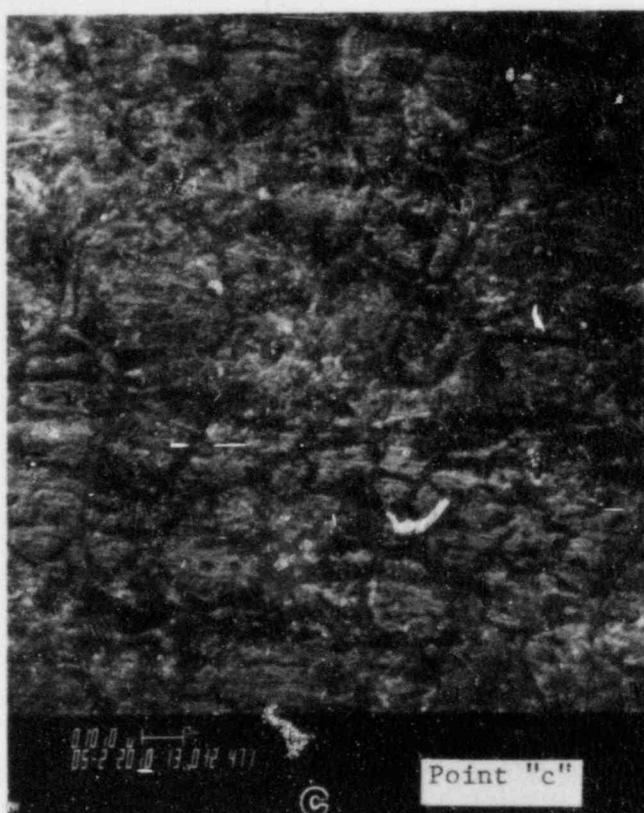
Figure 2-18. SEM Micrographs of Tube
B73-8 Area 3

OD Surface Deposits

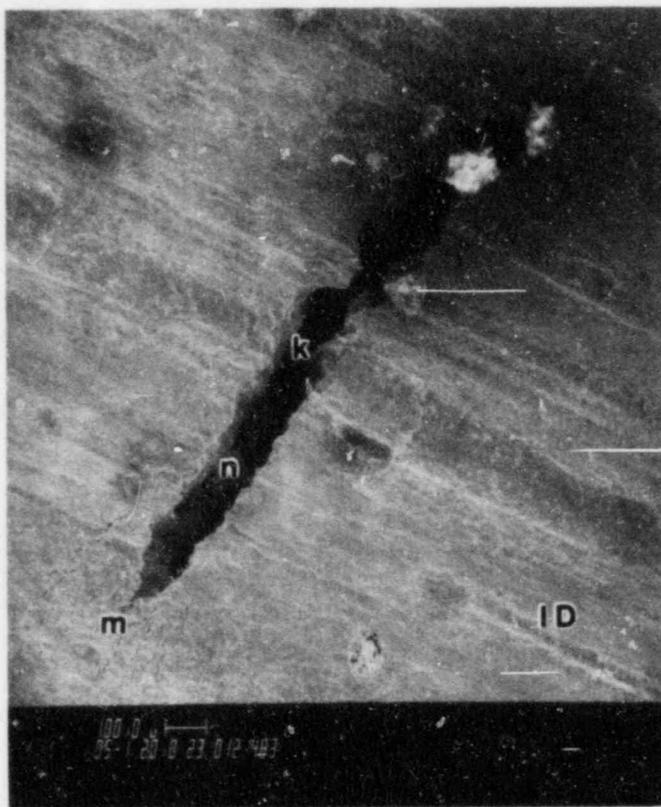
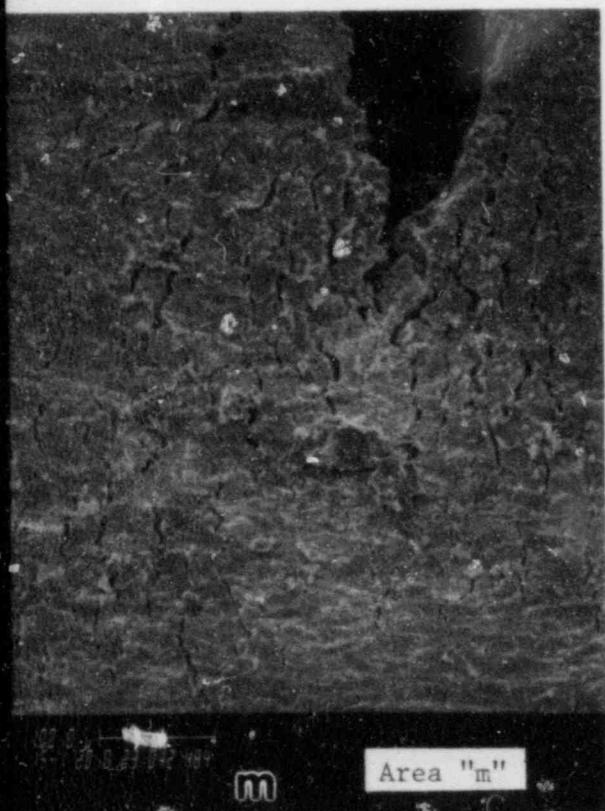
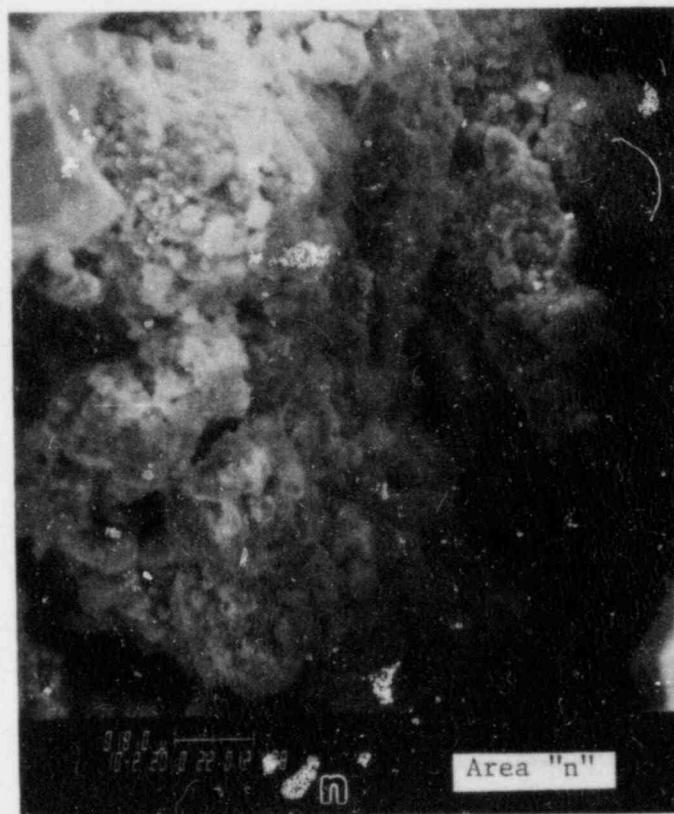
Figure 2-21. SEM Micrographs of Tube
B73-8 Area 5

While examining the ID surfaces of Areas 2 and 3, the circumferential cracks seen during the macroscopic inspection were studied. Both cracks were intergranular in nature and relatively free of heavy deposits on the portion of the crack surfaces nearest the ID. Figures 2-20 and 2-21 show micrographs of these two cracks. Observations made during the macroscopic inspection were confirmed, in that the crack tips appear to have been "stretched". These observations support the theory that the cracks were "stretched" during the tube removal operation and, thus, may be a partial explanation as to why the laboratory defect indication depth estimates are slightly greater than those made from the site EC data.

ID Intergranular Circumferential Crack

Crack Surface Deposits

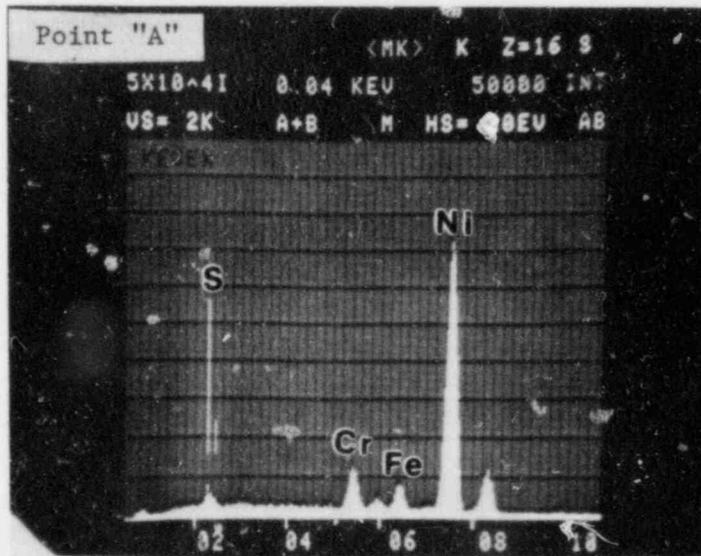
Figure 2-22. SEM Micrographs of Tube B73-8 Area 4

The OD surface of Areas 4 and 5 appeared very similar, with heavy deposits in both areas. A typical micrograph of deposits, which contained detectable sulfur using EDX, is shown in Figure 2-22. Area 5 did, however, have a circumferential crack-like feature visible under high magnification and is shown in Figure 2-23. An accurate depth estimate could not be made using the SEM, therefore it was not determined whether or not the cracking was limited to the surface deposits. The EDX spectrum in Figure 2-23 showed silicon and sulfur to be present in the deposit cracking in Area 5. The ID surface of Areas 4 and 5 appeared typical of OTSG tubes removed from service and a micrograph is also shown in Figure 2-23.

OD Surface Deposits

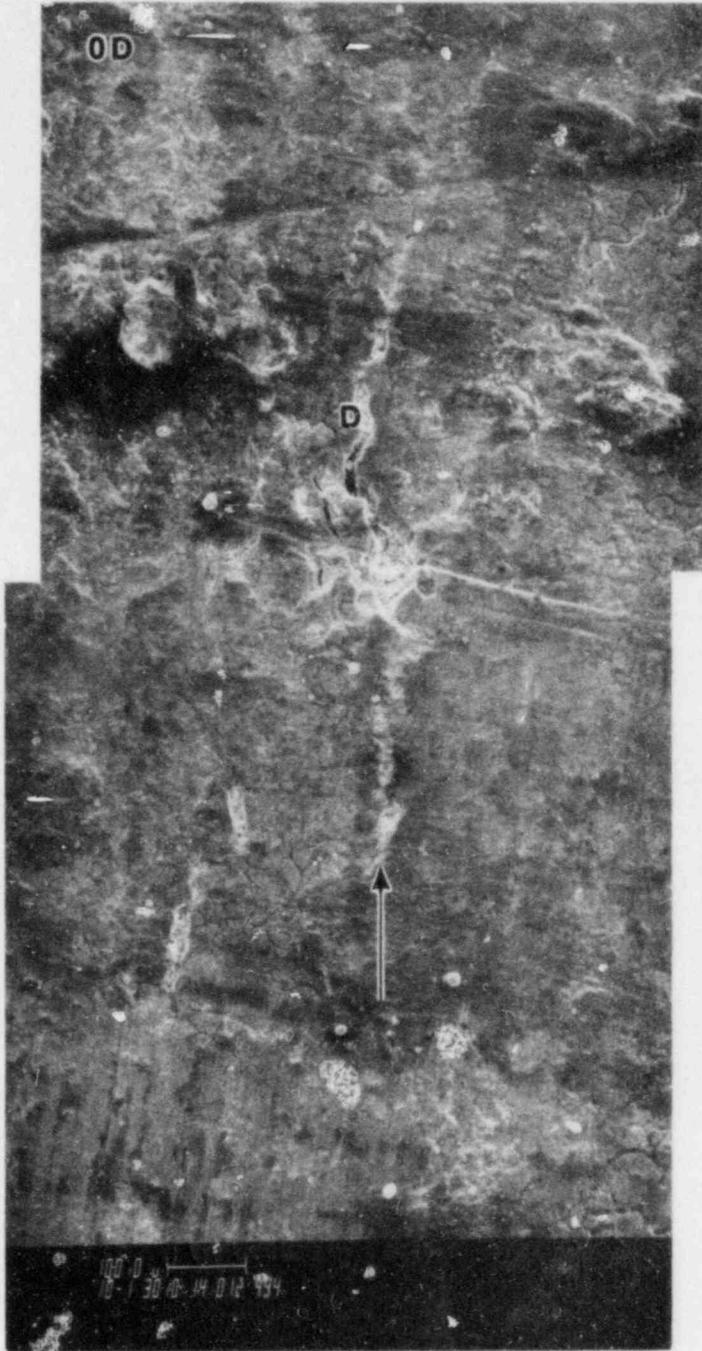
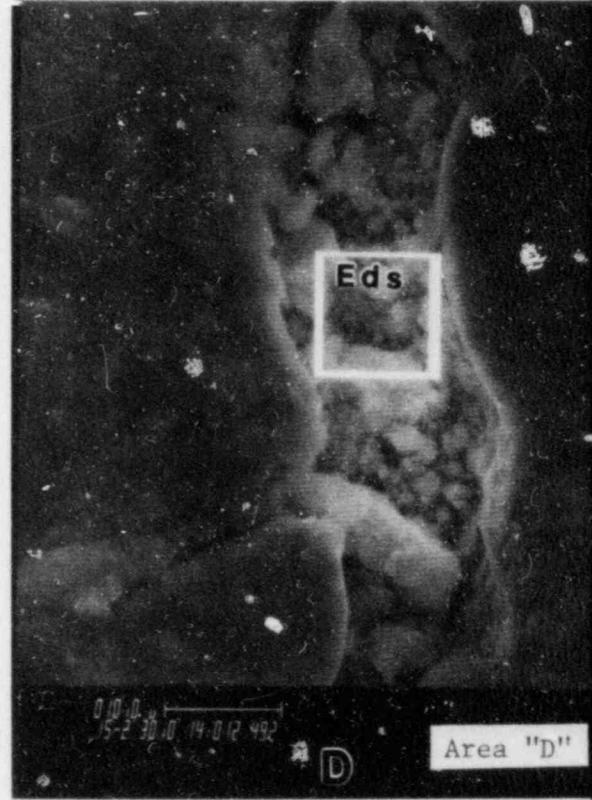
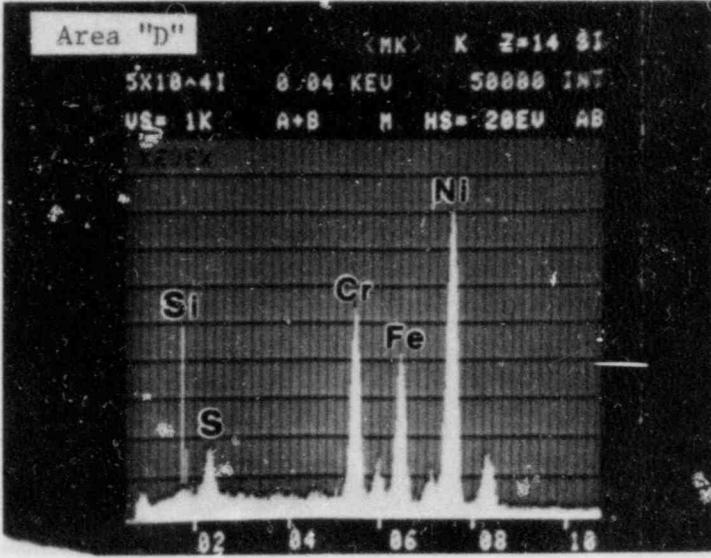
Figure 2-23. SEM Micrographs of Tube B73-8 Area 5

Crack-like Feature on OD Surface

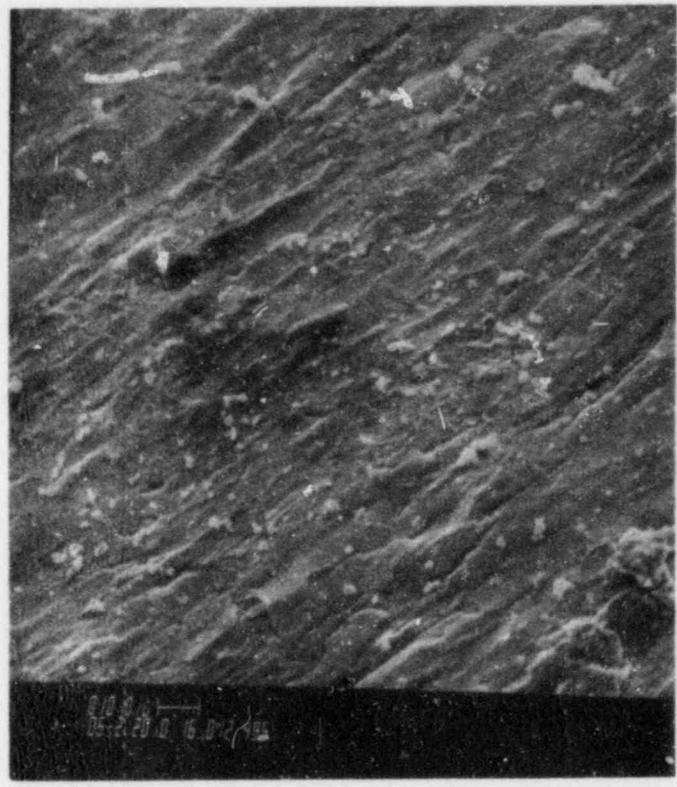
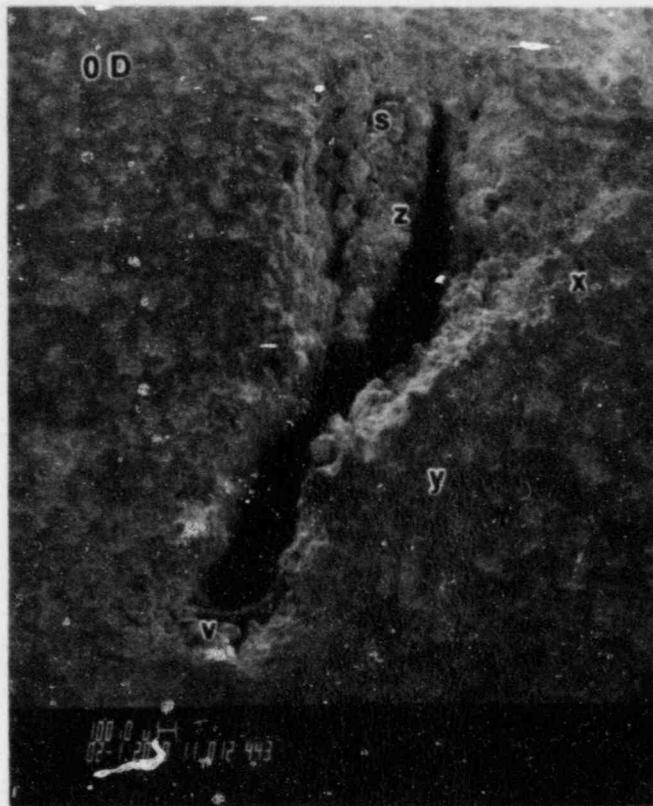
Area 6 of B73-8 contained the 100% through-wall circumferential hole seen during the macrovisual inspection. Micrographs of the OD surface are shown in Figures 2-24, which identify its intergranular nature. The IGA was rather extensive on the OD surface, which produced its hole-like appearance. The entire crack surface was covered with deposits, which indicates its exposure to a corrosive environment during OTSG service. The EDX spectrum from a portion of the crack surface revealed a trace amount of sulfur and large quantities of silicon, and is shown in Figure 2-24.

100% Through-Wall Circumferential Intergranular Hole

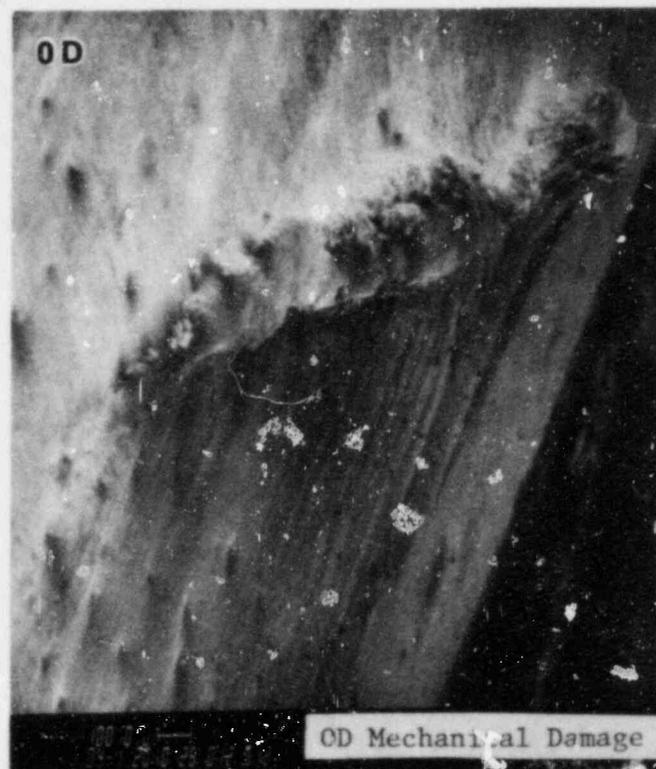
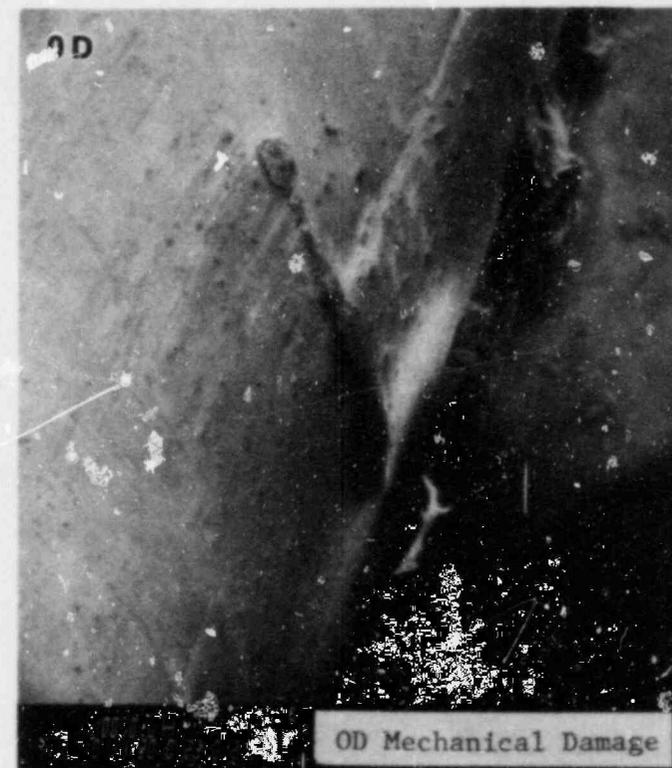
Figure 2-25. SEM Micrographs of Tube B112-19 Area 1

The area of tube B112-19 with the 63% site EC indication (Area 1) was examined using SEM to try to determine the cause of the indication. Figure 2-25 shows micrographs of areas of mechanical damage on the OD surface of the sample (also visible during the macroscopic inspection). Nearly all of the scrapes and scratches were into the base metal and axially oriented, indicating axial forces resulted in the metal being pushed and "plowed-up." In attempts to further characterize this damage, the sample was cleaned in an ultrasonic bath of inhibited HCl solution (500 ml 6N hydrochloric acid plus 1g hexamethylene tetramine) at ambient temperature to remove the OD surface deposits. The sample was re-examined using SEM and the micrographs are shown in Figure 2-26. As is clearly evident at higher magnifications, the base metal was "smeared" in the axial direction, indicating that this may have occurred during the site tube removal operation.

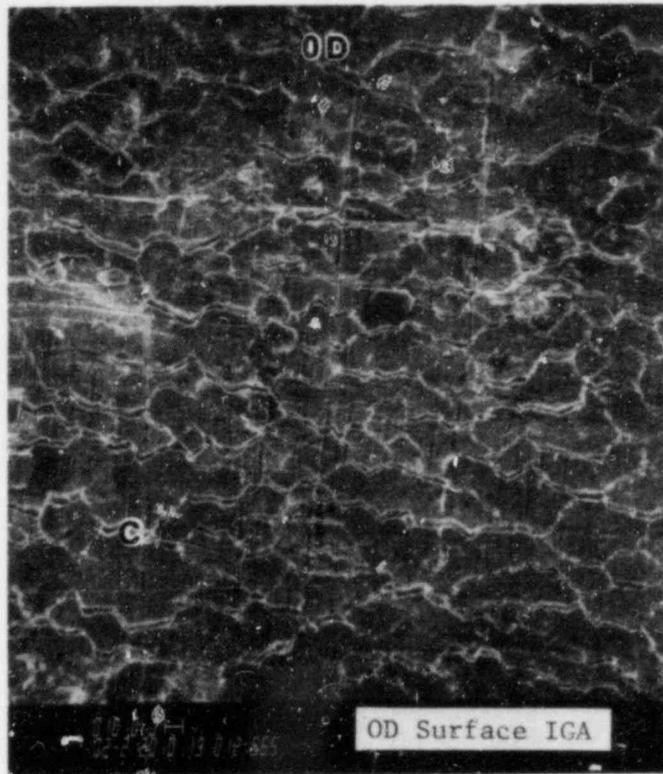
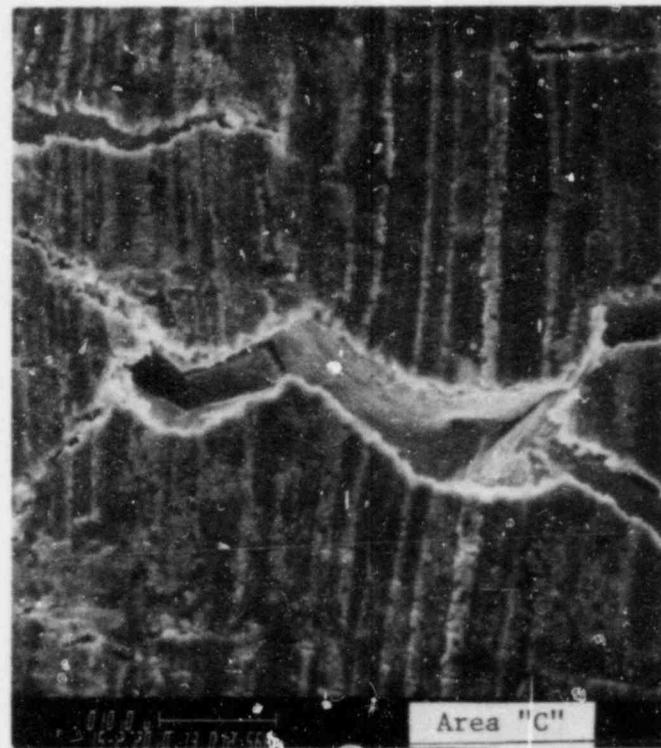
Figure 2-29. SEM Micrographs of Tube B73-8 Area 8 (After Bending)

The bend samples on which SIGA was detected during the SEM examination were examined to quantify the depth and also check for undetected (subsurface) defects. Figure 2-47 shows micrographs which reveal the maximum observed depth of the penetrations in this area to be approximately 0.007-inch. The sections shown are polished longitudinal surfaces through the region of IGA in Figure 2-29 and represent the deepest SIGA penetrations detected during this examination.

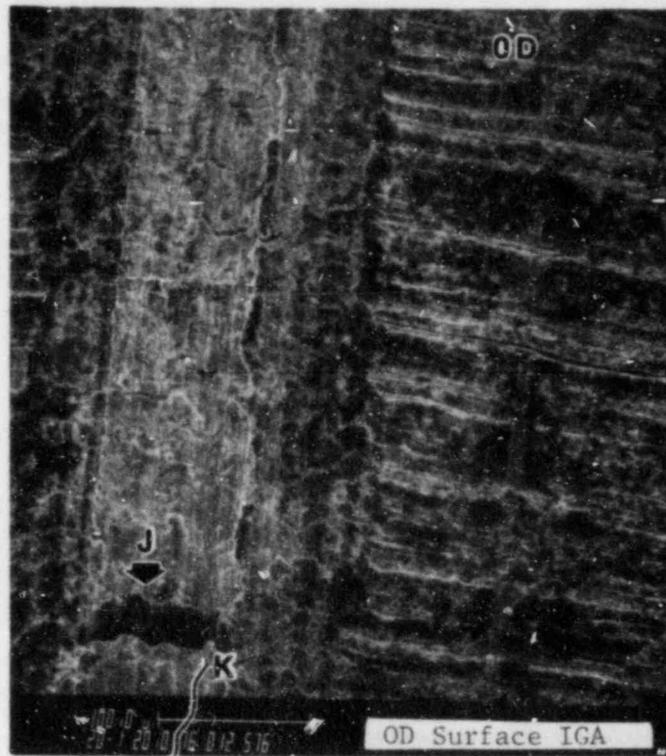
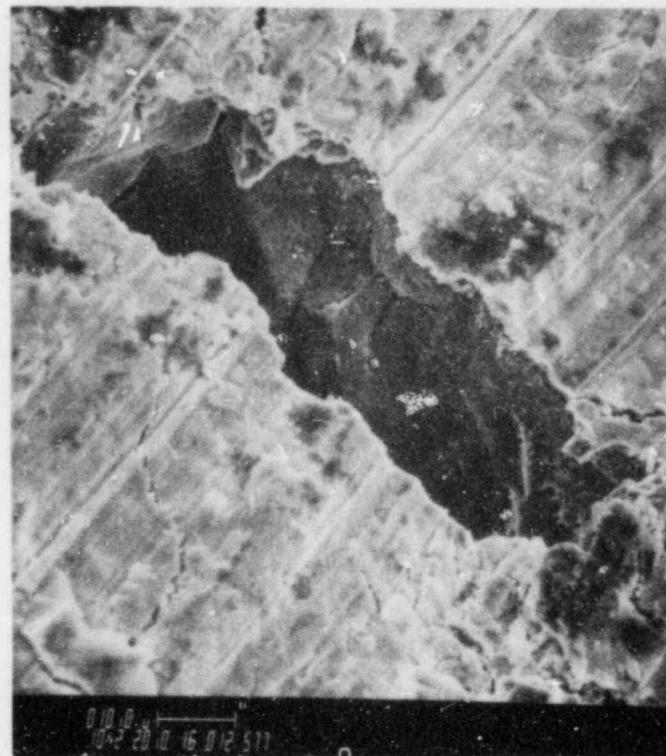
Figure 2-36. SEM Micrographs of Tube B112-19 Area 4 (After Bending)

Strip samples from midspan 16 were bend tested and examined, and similar SIGA was detected. Figure 2-36 shows typical micrographs of these samples, showing the larger openings in the axial scrapes. Metallography was subsequently performed.

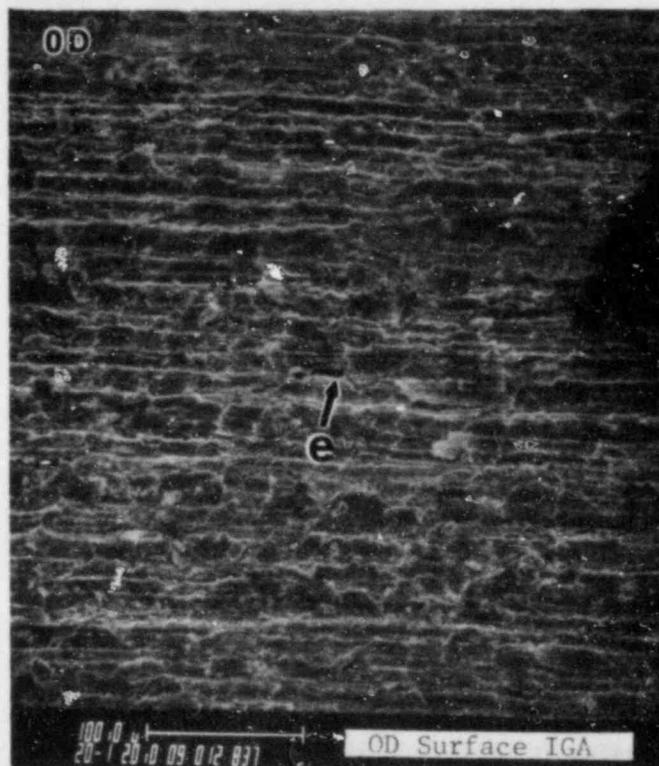
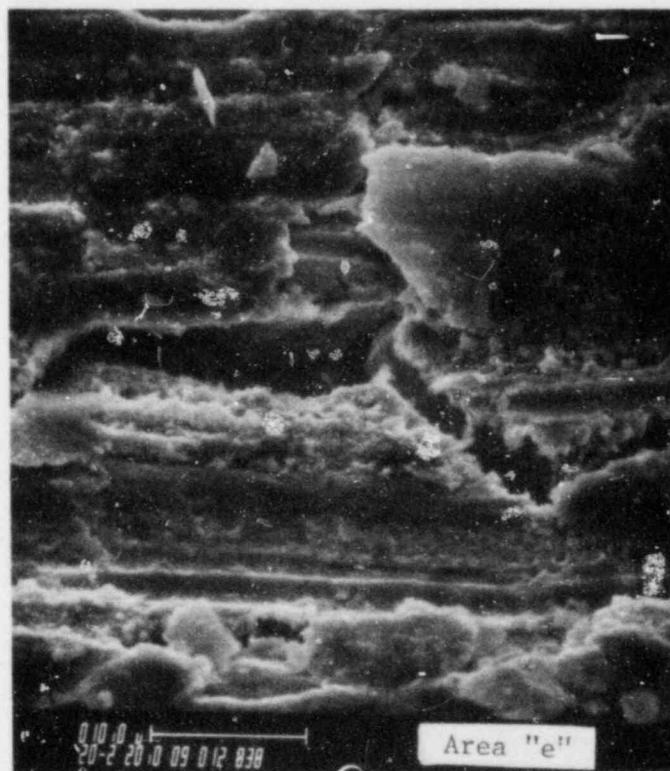
Figure 2-37. SEM Micrographs of Tube B112-19 Area 5 (After Bending)

Similar SIGA was opened by bending strip samples from just above the UTS secondary face. Figure 2-37 shows micrographs of this area. Metallography was subsequently performed.

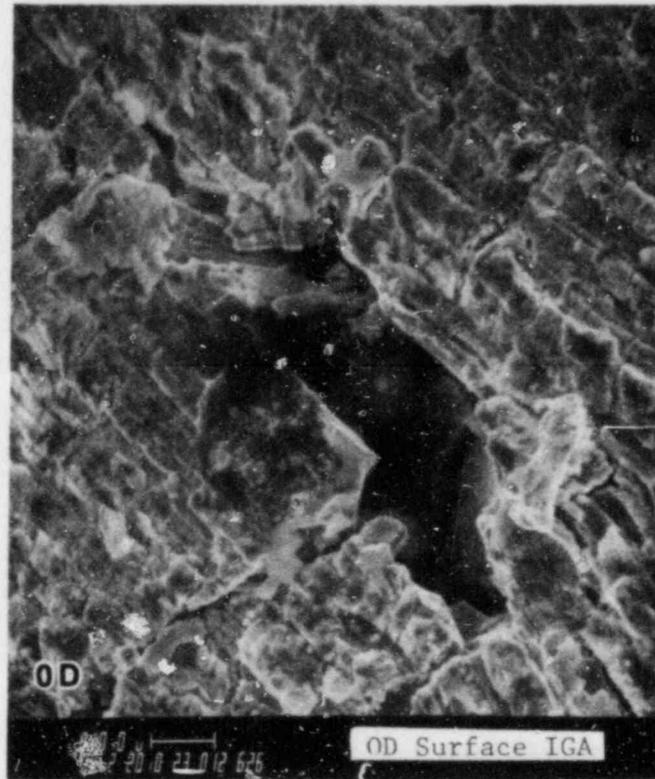
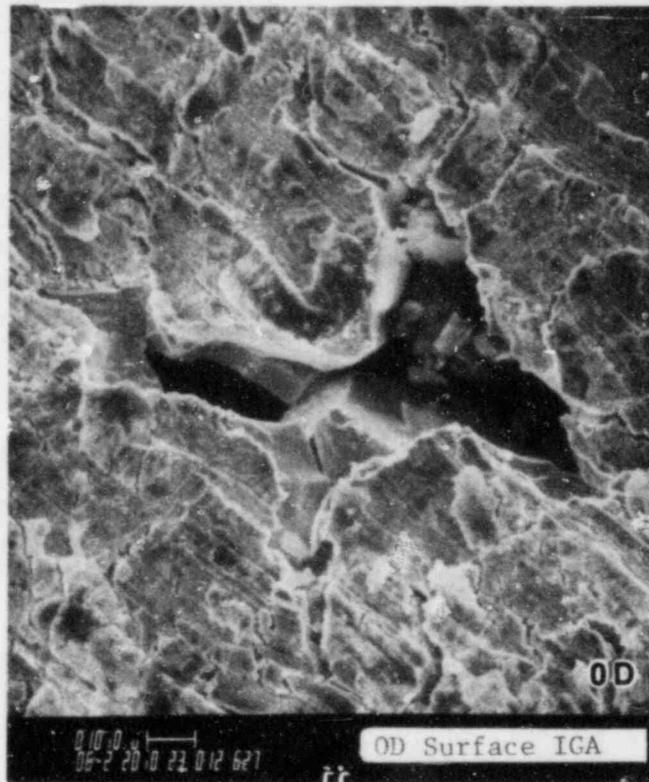
Figure 2-38. SEM Micrographs of Tube B112-19 Area 6 (After Bending)

SIGA was also detected at approximately 4 inches above the 14th TSP. The SIGA did not appear as uniform over the surface as in the previously examined areas, but there were localized openings which appeared deeper than the typical SIGA. Figure 2-38 shows two of these openings, in which the

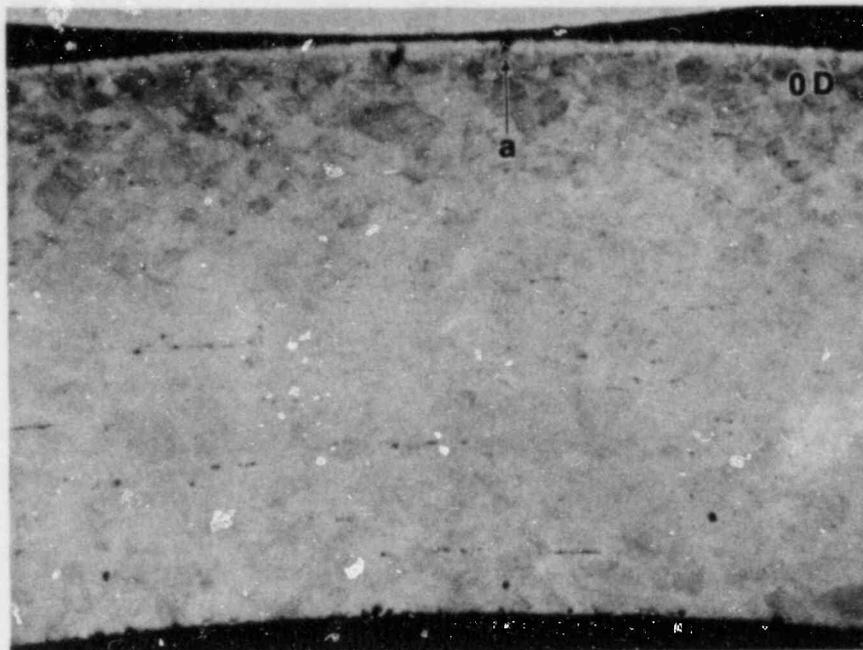
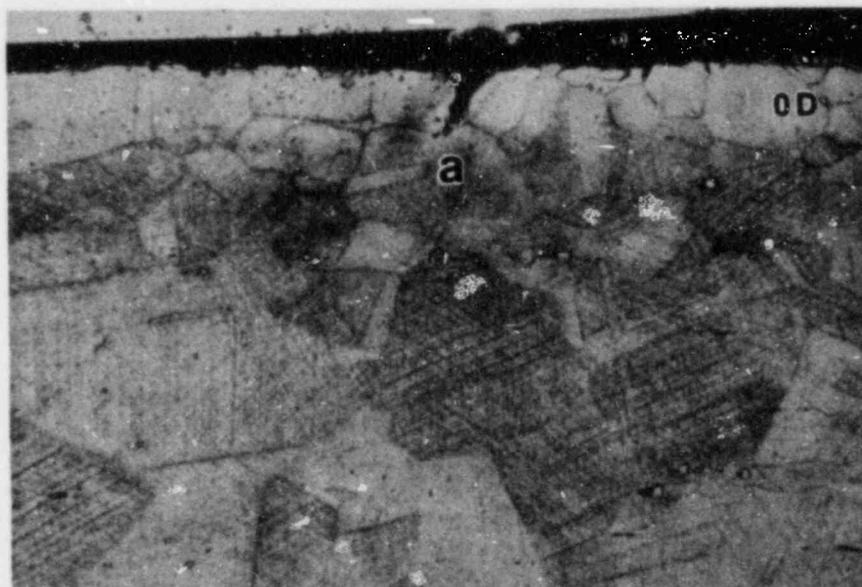
Figure 2-46. Micrographs of Tube B73-8 Area 9

The same procedure was used to determine the depth of the SIGA found at midspan 16. As Figure 2-46 shows, the penetration depth was smaller, being approximately 0.001 to 0.002 inch.

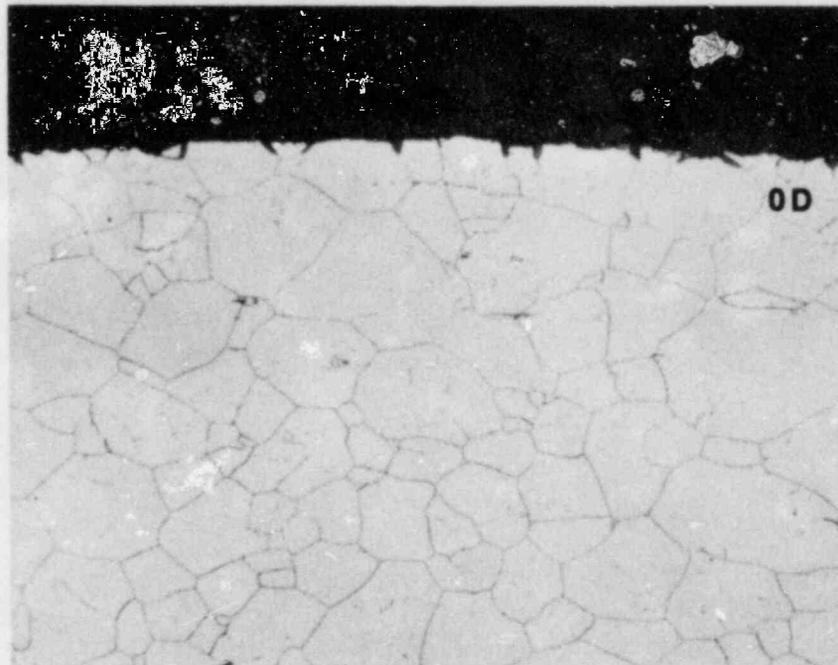
Figure 2-48. Micrographs of Tube B112-19 Areas 2 and 3

Metallography was performed on the bend samples from below and above Area 1 to determine the depth of the penetrations seen using SEM. Figure 2-48 shows typical micrographs of the penetrations found in these areas.

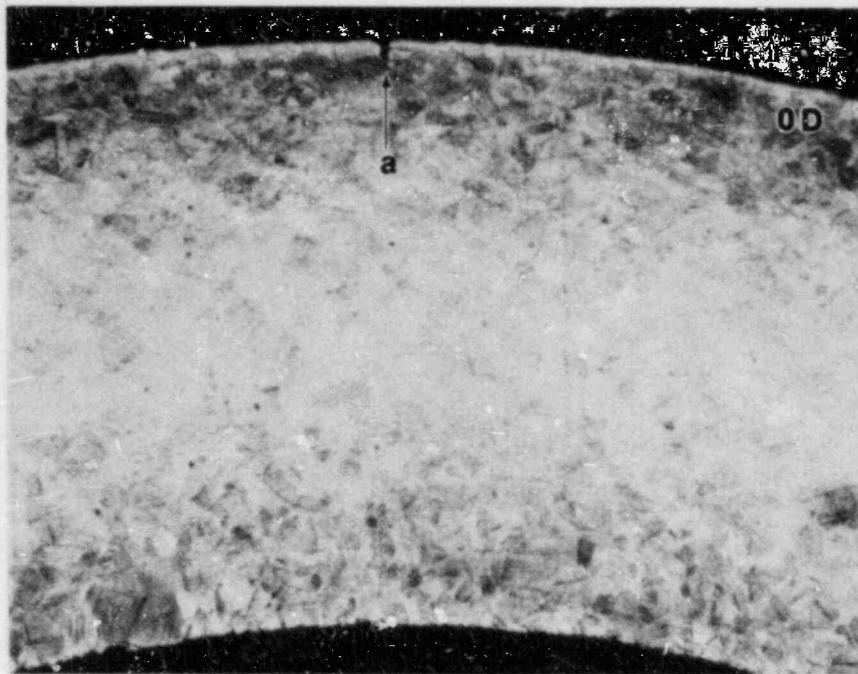
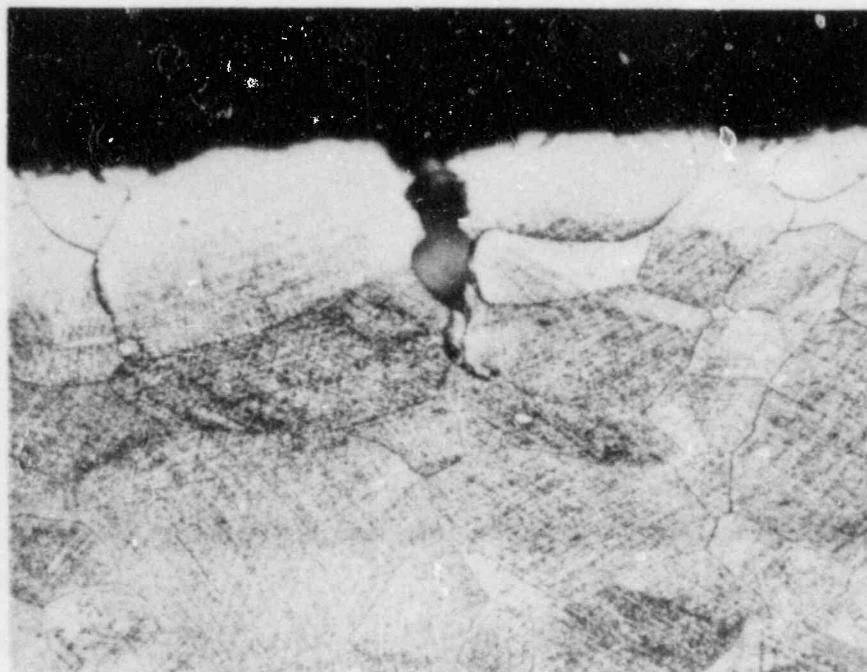
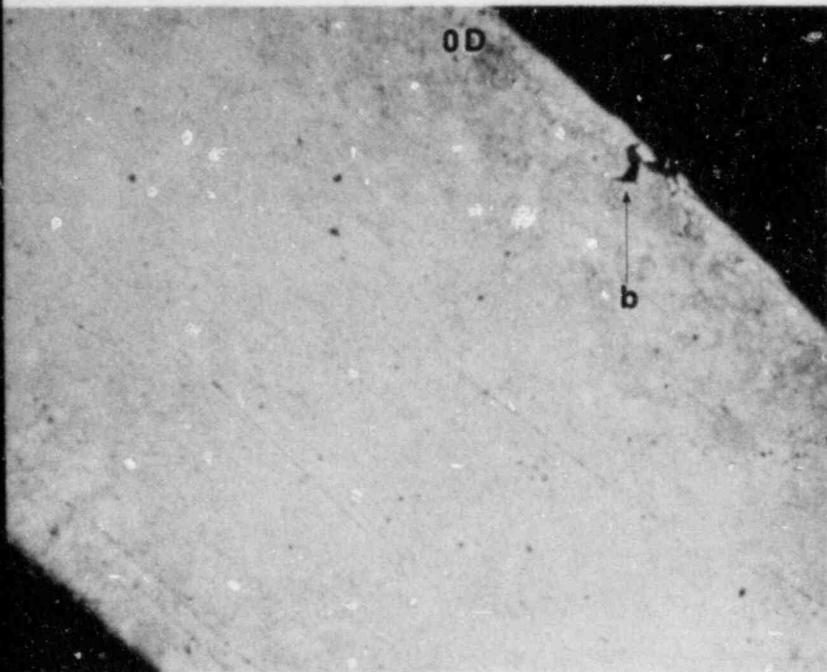
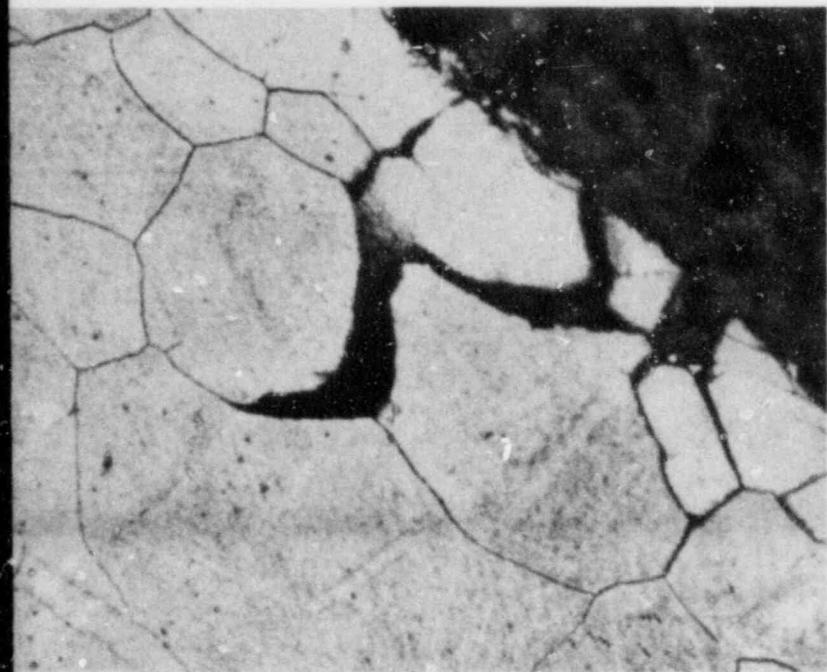
Figure 2-49. Micrographs of Tube
B112-i9 Area 4

The bend samples from these areas were also examined to determine the depth of the SIGA. As Figure 2-49 shows, the maximum depth of the penetrations was approximately 0.003-inch.
