EXAMINATION OF OTSG TUBES
B73-8 AND B112-19 FROM ANO-1
— FINAL REPORT —

RESEARCH AND DEVELOPMENT DIVISION
LYNCHBURG RESEARCH CENTER

SPONSORED BY
ARKANSAS POWER AND LIGHT

June 10, 1983

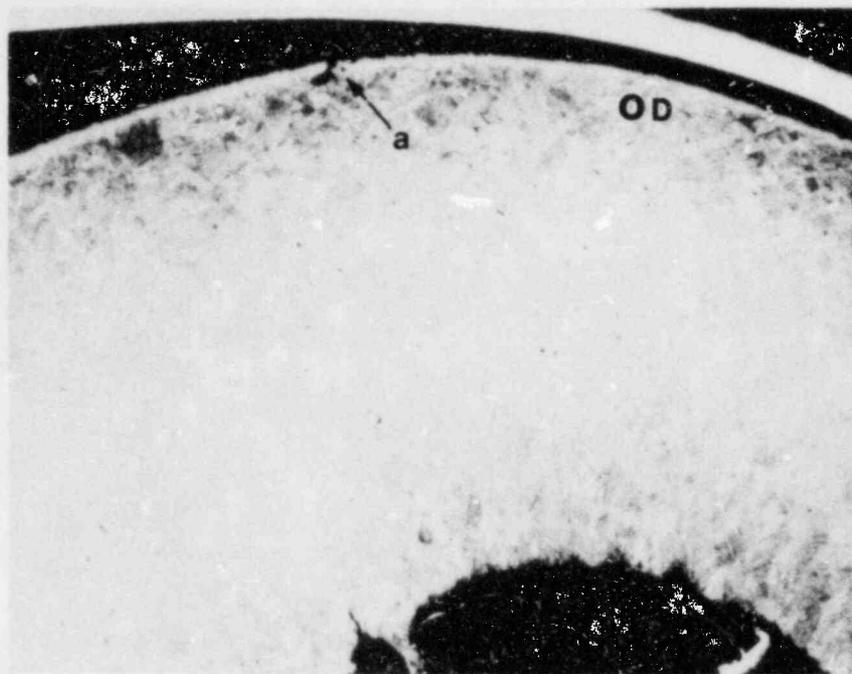
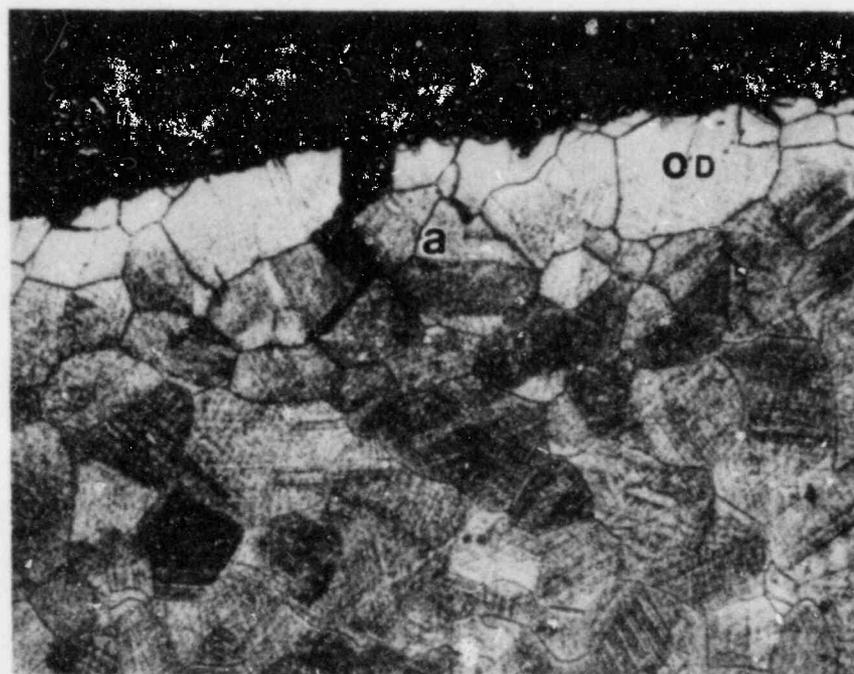
Figure 2-50. Micrographs of Tube B112-19 Area 6

The SIGA seen previously using SEM was metallographically examined. The maximum depth of the penetrations was approximately 0.002-inch and is shown in Figure 2-50.

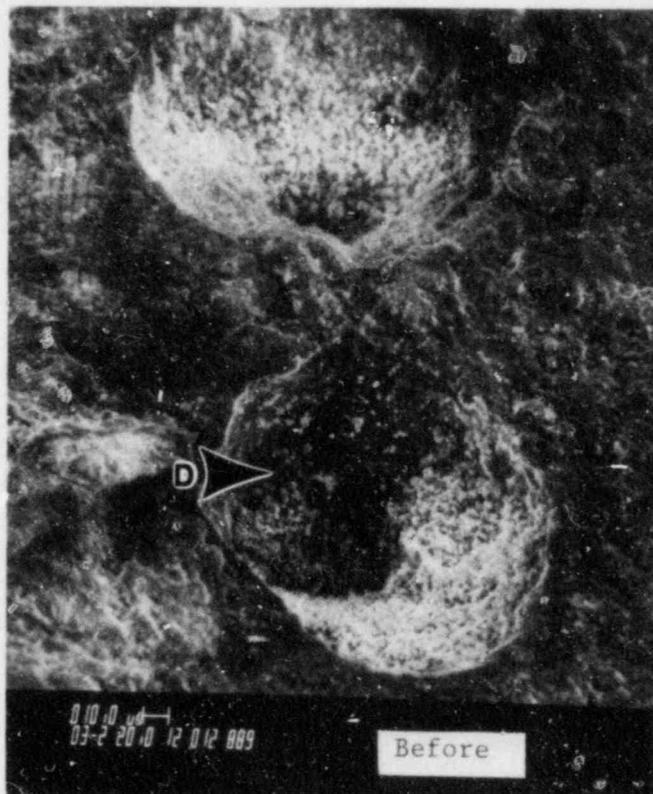
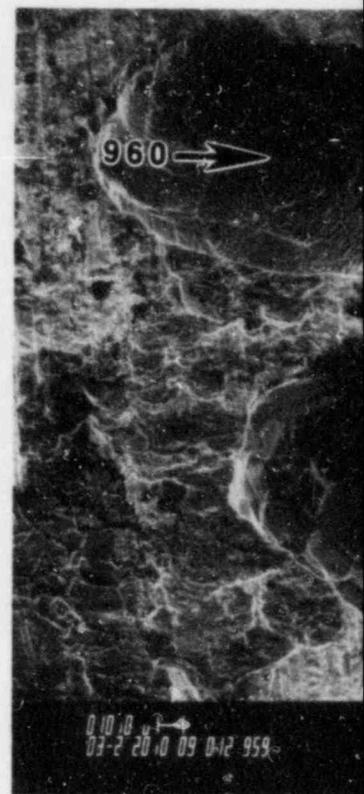
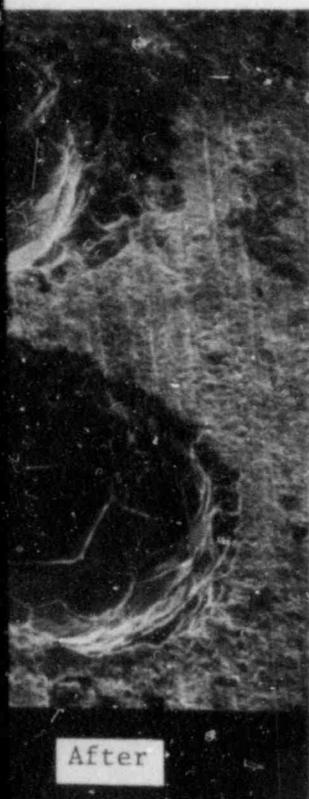
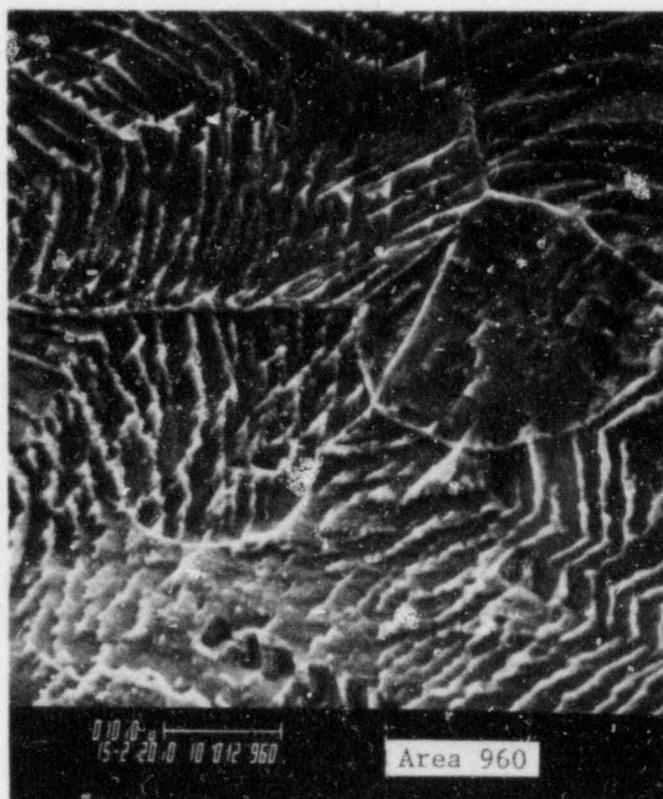
Figure 2-51. SEM Micrographs of Tube B73-8 Near Area 6 (Before and After Cleaning)

The sample from just above the UTS secondary face containing the 100% through-wall hole was reexamined using SEM and revealed pitting attack which was covered with OD surface deposits. To remove those deposits, the sample was cleaned for two minutes in a UT bath of inhibited HCl at ambient temperature and reexamined. After cleaning, much more pitting was observed, along with minor etching or wastage attack. Figure 2-51 shows two individual pits just above the through-wall hole before and after cleaning. The cleaning was partially effective in removing the deposits on the tube surface and 100% effective within the pits. The lighter granular deposits appear to have attacked the base metal grain matrix more severely than the darker deposits and were associated with regions of grain boundary relief and preferential attack of slip lines. EDX data revealed the lighter deposits to be rich in Si and S before cleaning.

Pitting with Light Granular Deposits

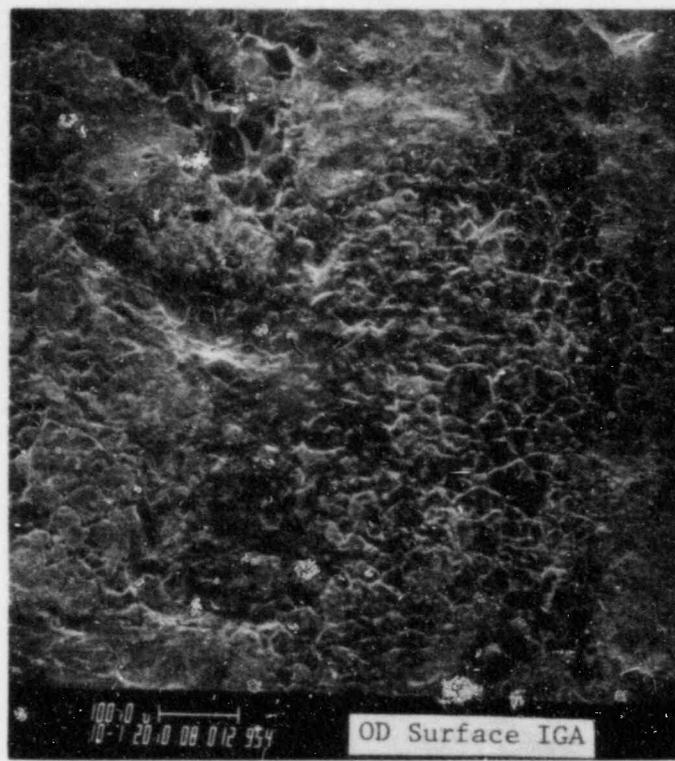
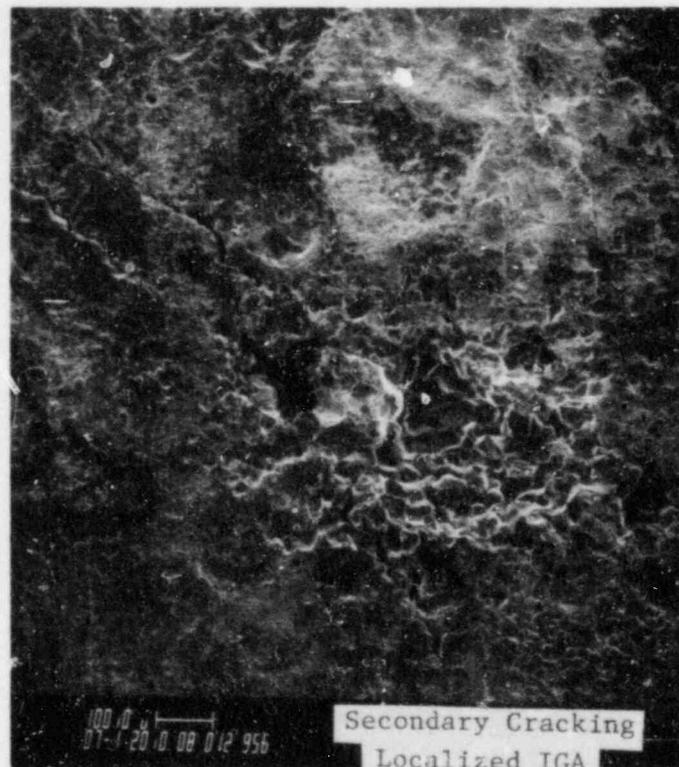
Figure 2-52. SEM Micrographs of Tube B73-8 Near Area 6 (After Cleaning)

There were several regions of localized IGA surrounding the through-wall hole which were linked by secondary IGA cracking. Figure 2-52 shows two of those regions after the sample was cleaned to remove the surface deposits.

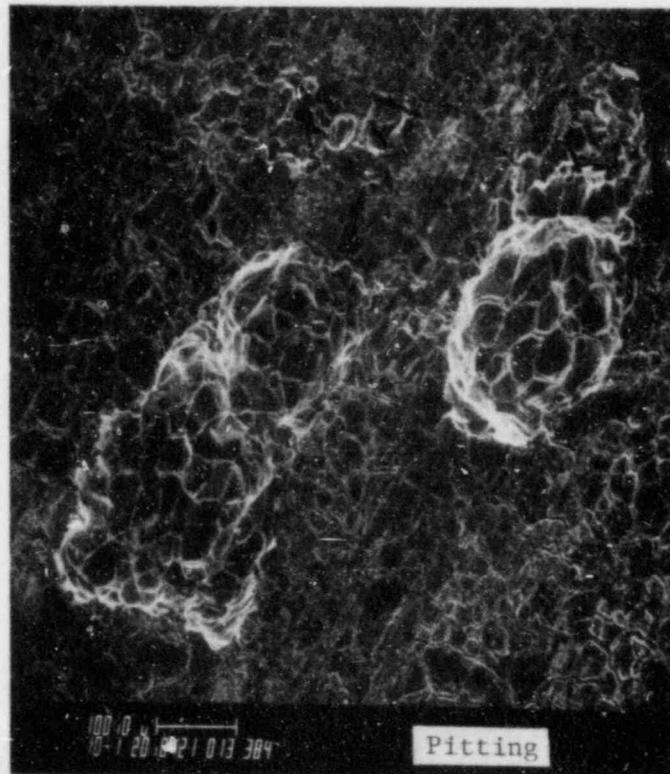
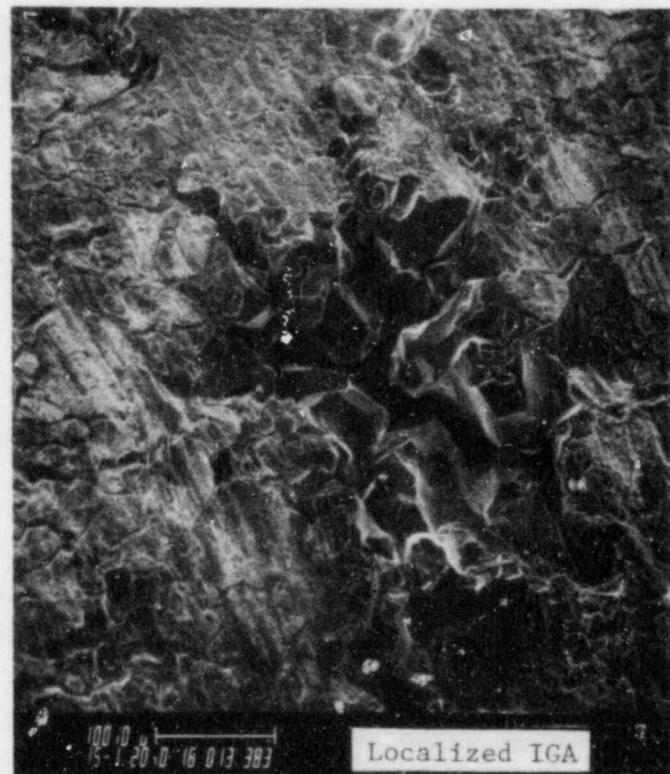
Figure 2-53. SEM Micrographs of Tube B73-8 Area 7 (After Cleaning)

The sample adjacent to Area 6 which was metallographically examined during Phase III was removed from the mounting material and longitudinally bend tested. After cleaning in a UT bath of inhibited HCl solution for two minutes, the OD surface of the sample was examined using SEM. The deposits were not removed from the surface so the sample was cleaned an additional five minutes (seven minutes total) and reexamined. Figure 2-53 shows micrographs which reveal pitting and SIGA, along with areas of more severe localized attack where grains had "fallen out." This pitting is similar to that seen previously in Area 6 after cleaning, and appears to be more severe in the region within two inches above the UTS secondary face.

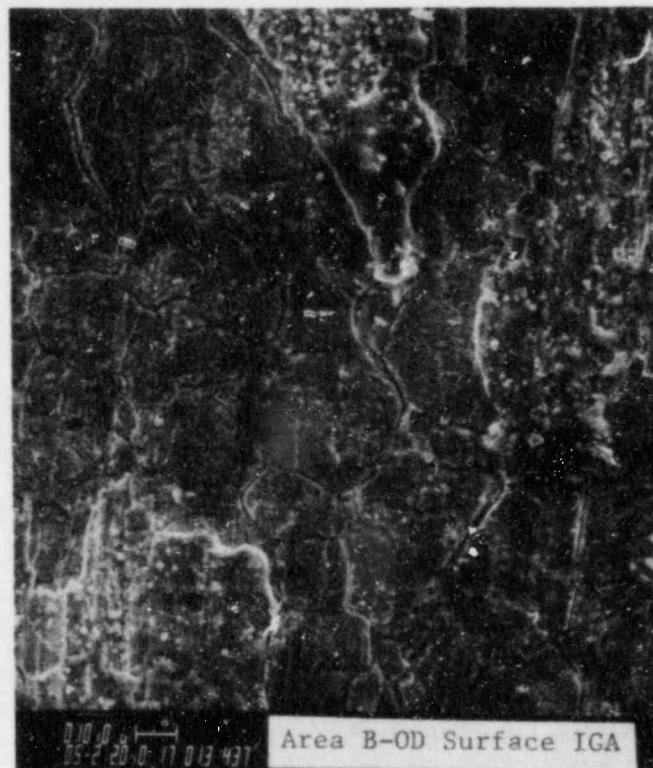
A sample was also removed from the midspan 16 location. After longitudinally sectioning the sample in half, a qualitative SEM examination was performed. In general, the OD surface appearance was typical to that previously noted. As Figure 2-54 shows, there were some areas where the surface deposits had spalled and base metal grains were clearly visible. This sample was then cleaned in a UT bath of inhibited HCl for five minutes and bent using the longitudinal technique. Reexamination of the cleaned and bent sample revealed the typical SIGA seen previously, while some deposits were still present. Therefore, the sample was cleaned an additional five minutes and reexamined, revealing an axial scrape mark approximately half the length of the sample in which localized IGA was present. The localized IGA appeared deeper than the typical SIGA and is shown in Figure 2-55.

Figure 2-54. SEM Micrographs of Tube B73-8 Area 10

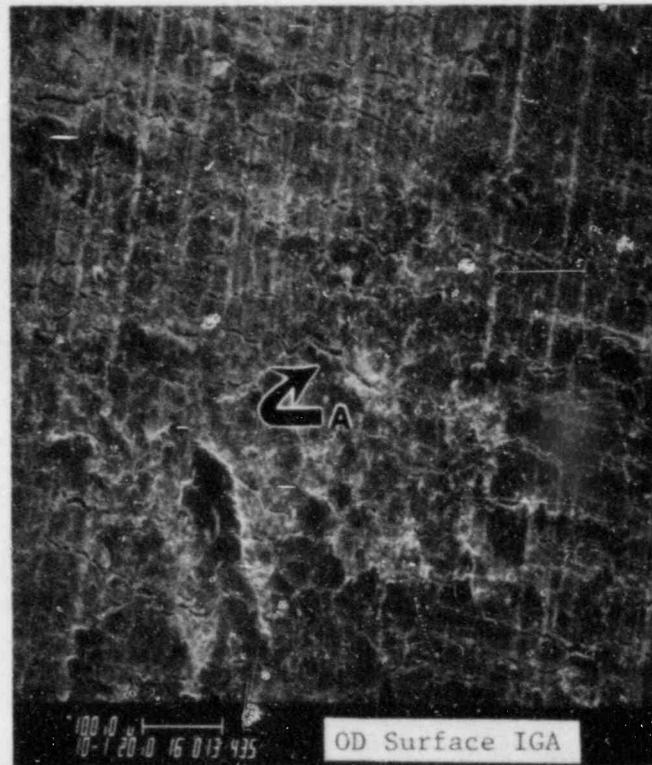
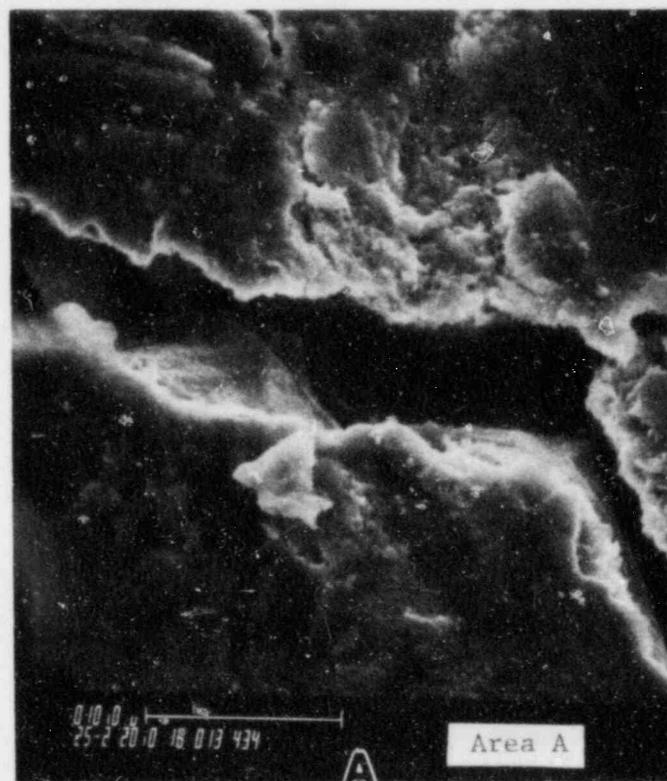
The upper seal weld heat affected zone and hard rolled regions near the top of OTSG tubes have proven to be particularly susceptible to OD initiated IGA and cracking. Since these regions were "drilled out" during the ANO-1 tube removal operations (to permit tube removal), they were not available for examination. To determine if the corrosive specie(s) were present near this elevation, a sample was removed from the top of Piece 1 and examined. The preliminary SEM examination showed surface deposits typical of those seen previously. This sample was bent using the circumferential technique and reexamined using SEM. As Figure 2-56 shows, bending caused the deposits to open along the grain boundaries, prevalently in the circumferential direction. After cleaning the bend sample for five minutes in a UT bath of inhibited HCl, it was reexamined. The surface deposits were again only partially removed, but there were localized regions where individual grains had parted from the tube surface.

Figure 2-56. SEM Micrographs of Tube B73-3 Area 11

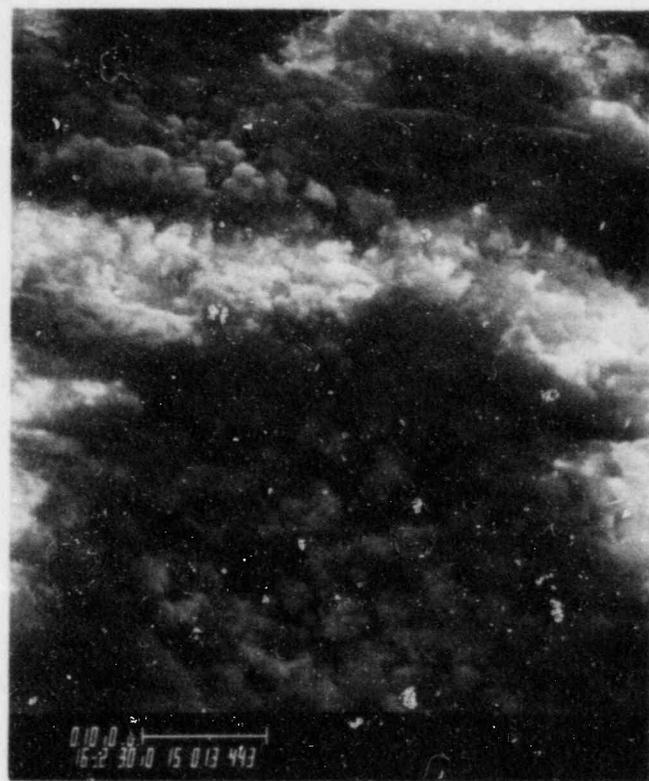
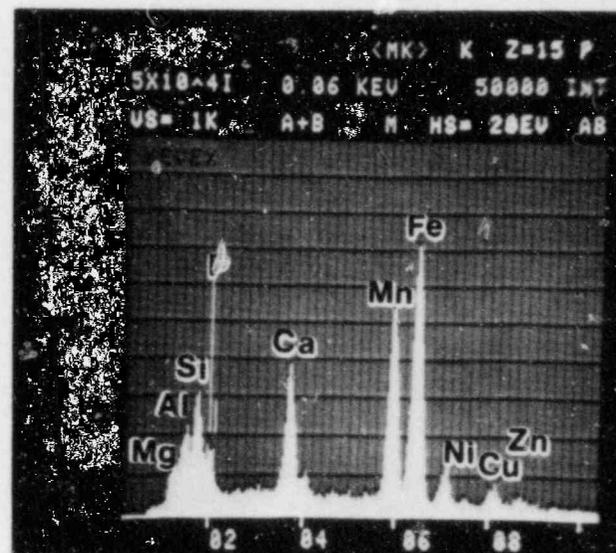
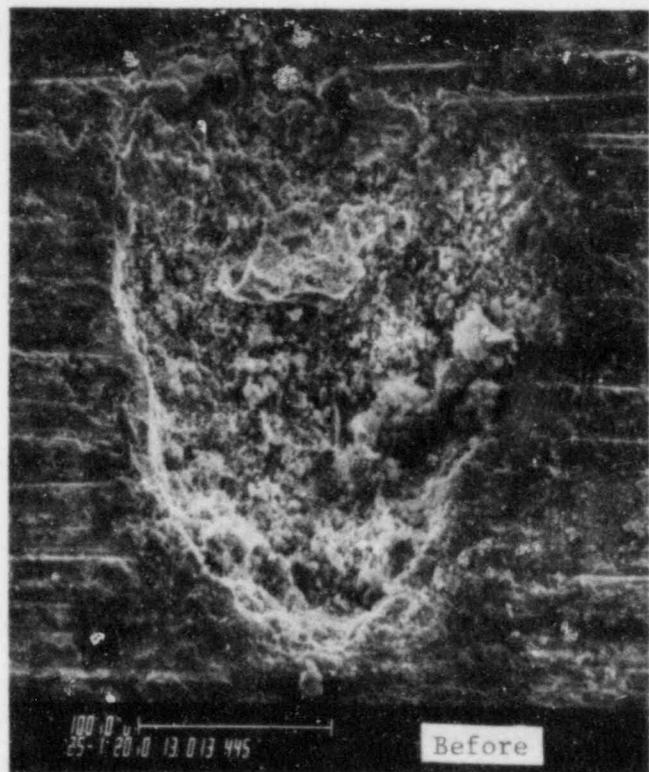
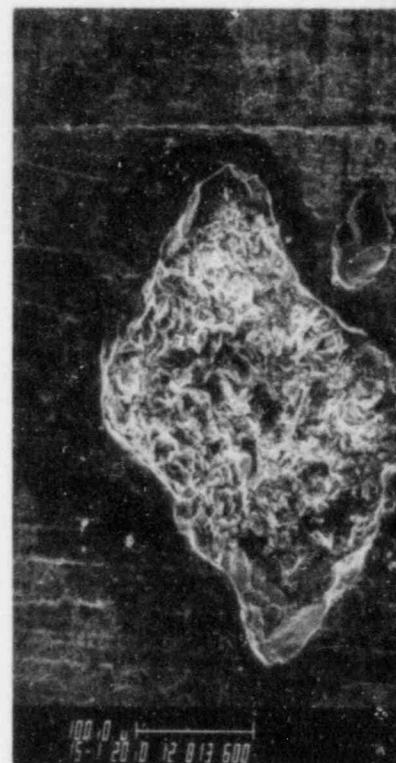
A sample was taken from four inches below the UTS secondary face in the region of heavy black deposits. First the sample was viewed using SEM which showed that the OD surface deposits were, in general, extremely heavy. Other observations include pitting and spalling of surface deposits and are shown in Figure 2-57. The EDX spectrum showed the deposits to contain Mg, Al, Si, P, Ca, Mn, Fe, Ni, Cu, and possibly Zn. The sample was cleaned in a UT bath of inhibited HCl and then a UT bath of acetone. Reexamination of the sample showed that these solutions were not effective in removing the deposits. Therefore, the sample was cleaned in a UT bath of Endox 214 (commercial degreaser) for 20 minutes. This solution was only partially effective in removing the deposits and was limited to the pitted areas as shown in Figure 2-57. The sample was then bent in the circumferential direction and reexamined using SEM, revealing the typical SIGA seen on the previously examined samples. In attempts to remove more of the deposits, the sample was cleaned in a UT bath of inhibited HCl at 125°F for two

← Surface Deposit Before Cleaning

Pitting

Figure 2-57. SEM Micrographs of Tube B73-8 Area 12 (Before and After Cleaning)

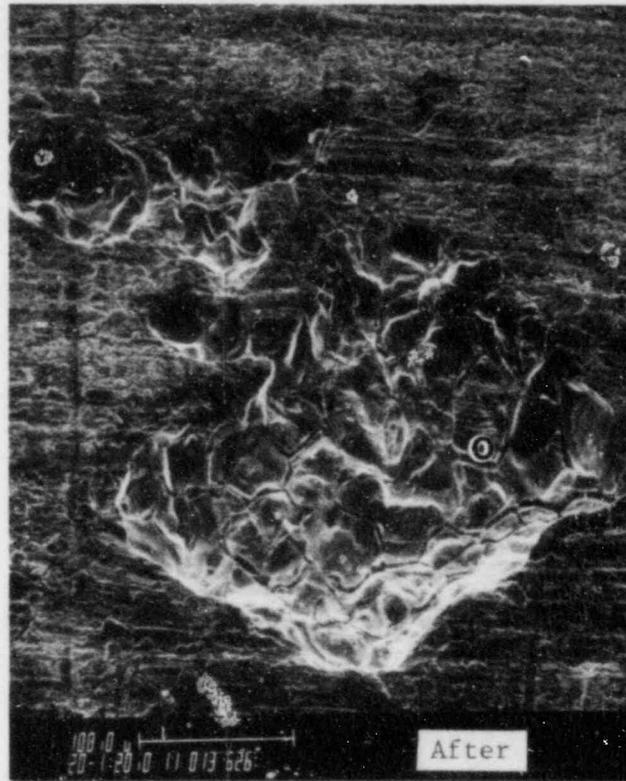
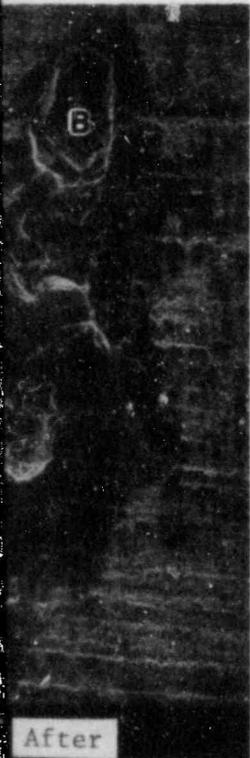
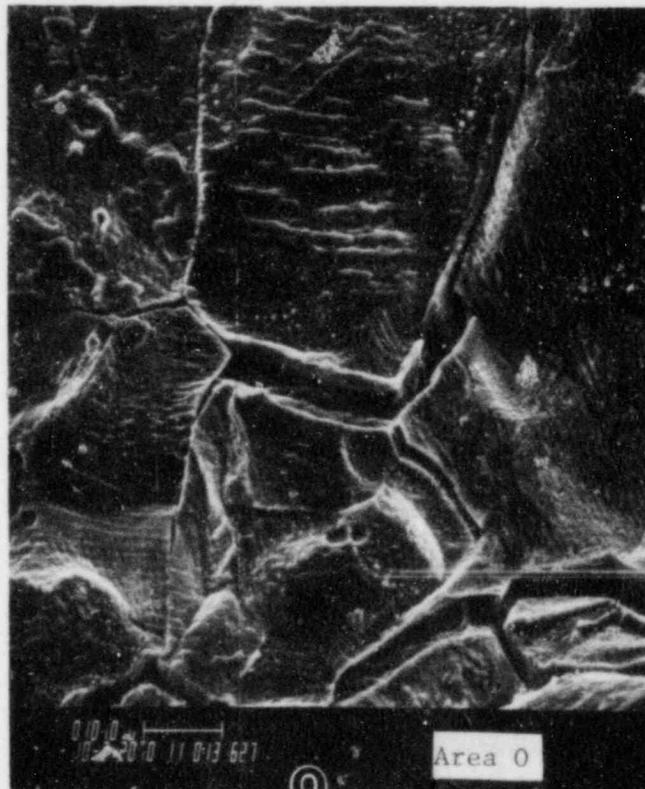
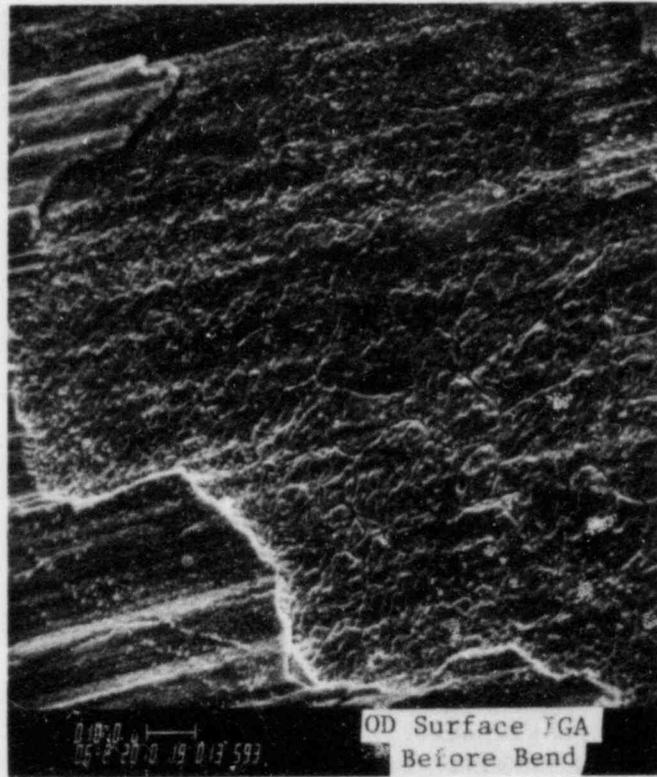
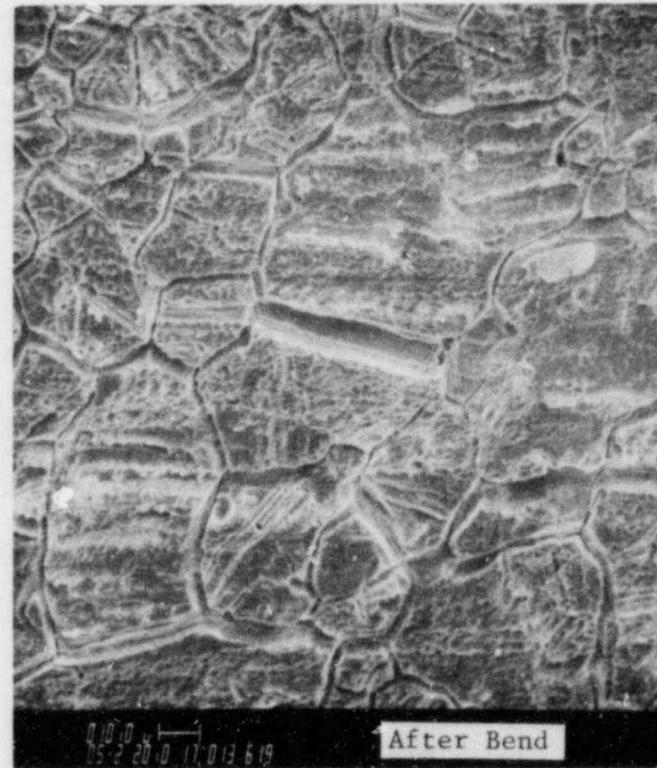
minutes. Many more areas of pitting were revealed when examined using SEM, but the surface deposits were not completely removed. A 125°F solution of 20% nitric acid and 2% hydrofluoric acid was then used to further clean the sample. As Figure 2-58 shows, this solution was 100% effective in removing the deposits. The grains were etched by the acid bath, making the attack appear more severe than the typical SIGA seen on previously examined samples.

OD Surface
Deposits

Figure 2-58. SEM Micrographs of Tube B112-19 Area 7
(After Cleaning)
