GRAND GULF NUCLEAR STATION

UNIT 1

REPORT ON THE
DIVISION I, II and III
DIESEL GENERATORS

NUCLEAR PLANT ENGINEERING
OPERATIONAL ANALYSIS SECTION
DIVISION I, II, AND III DIESEL GENERATOR
OPERABILITY REPORT

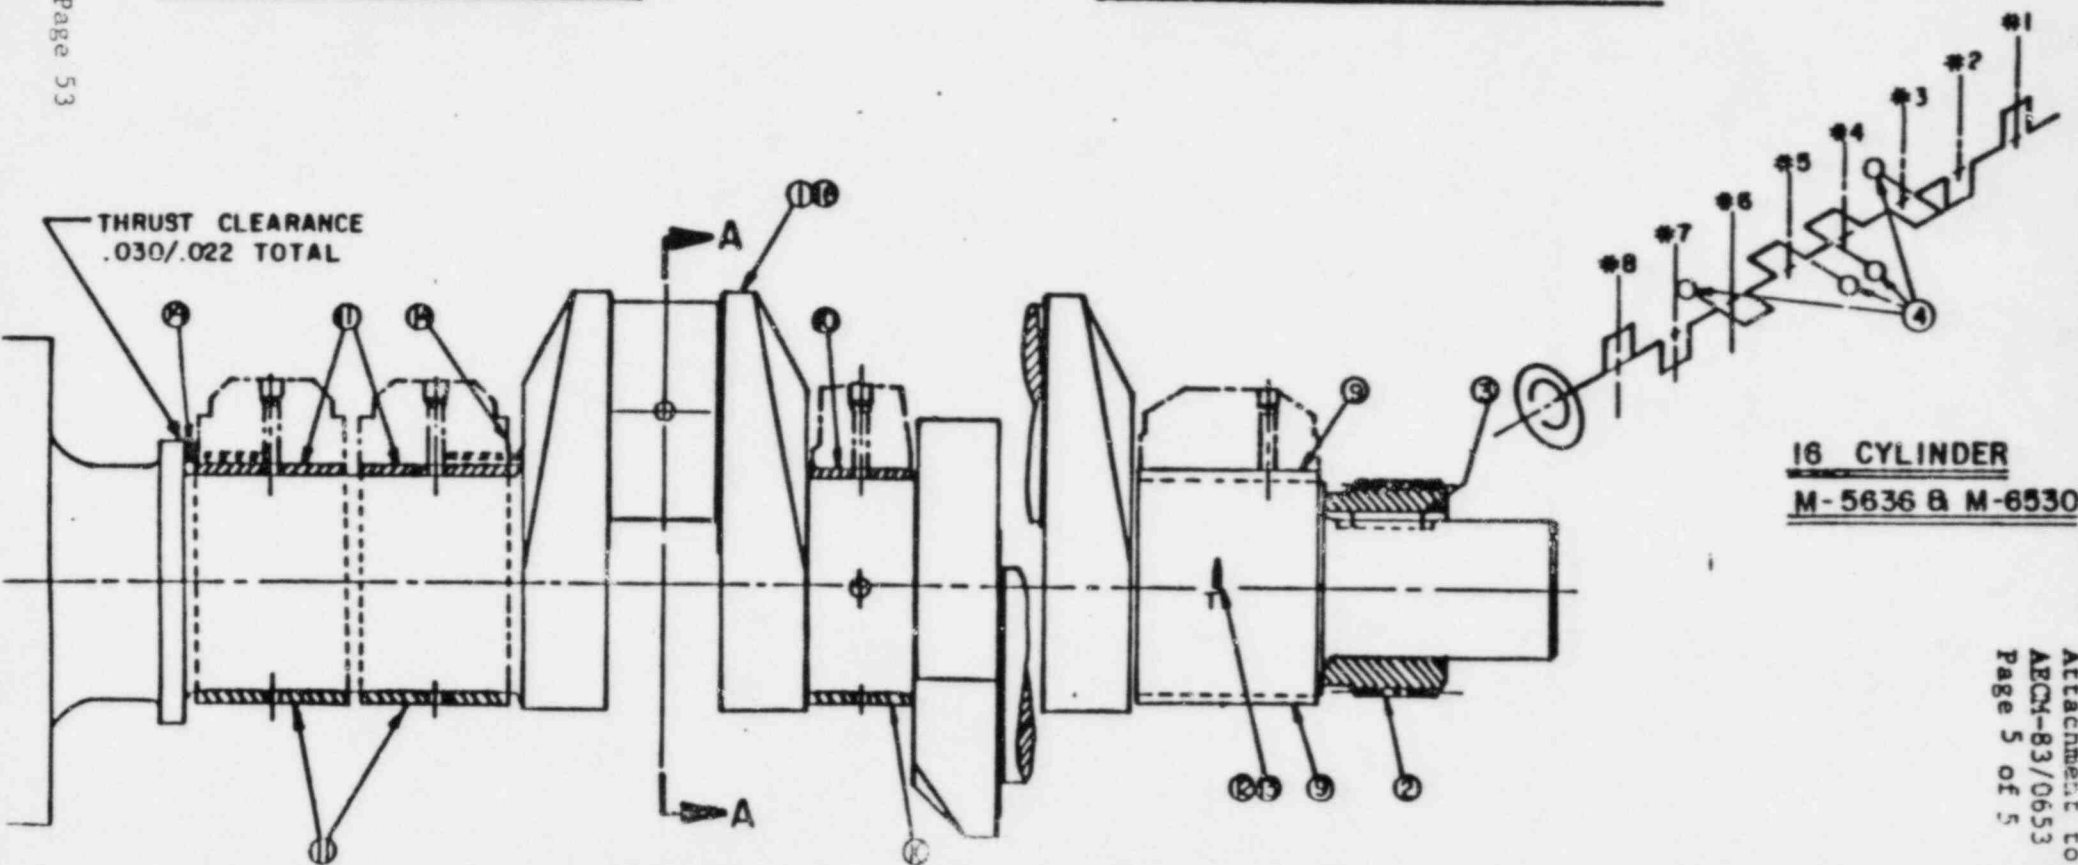
SHOREHAM CONFIGURATION

The shape of the GGNS crankarm is also circular, rather than elliptical, giving added crankarm cross-sectional area at the most probable fracture plane (see attached figure.)
