FaAA83-10-16 PA07395

EMERGENCY DIESEL GENERATOR CONNECTING ROD BEARING FAILURE INVESTIGATION SHOREHAM NUCLEAR POWER STATION

Failure Analysis Associates 2225 East Bayshore Road Palo Alto, California 94303

October 31, 1983

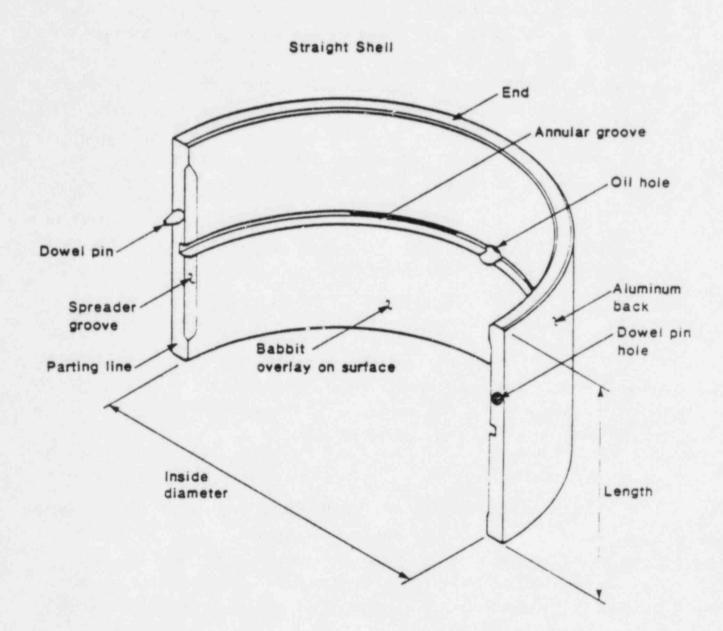
Figure 2. Broken connecting rod bearing, DG103, No. 5.

The most severe damage was suffered by the No. 5 upper bearing (associated with the No. 5 cylinder) of diesel generator set DG103. This bearing is shown in Figure 2. This half-shell was fractured into two separate pieces (the smaller of which is not shown in Figure 2) near one end of the bearing. Three other upper bearings contained cracks through their thicknesses. These cracks were in the same relative location as the fracture surface on the broken bearing, but had not intercepted the bearing end to cause complete fracture. These cracked bearings were in No. 3 and No. 4 in DG103 and No. 4 in DG102.
