Subject: James A. FitzPatrick Nuclear Power Plant
Docket No. 50-333
Core Spray "A" Metallurgical Analysis

A METALLOGRAPHIC INVESTIGATION OF A
TYPE 304 STAINLESS STEEL SCHEDULE 80 PIPE

AN INVESTIGATION OF FLAWS ON THE
INSIDE SURFACE OF A TYPE 304 STAINLESS
STEEL SCHEDULE 80 PIPE

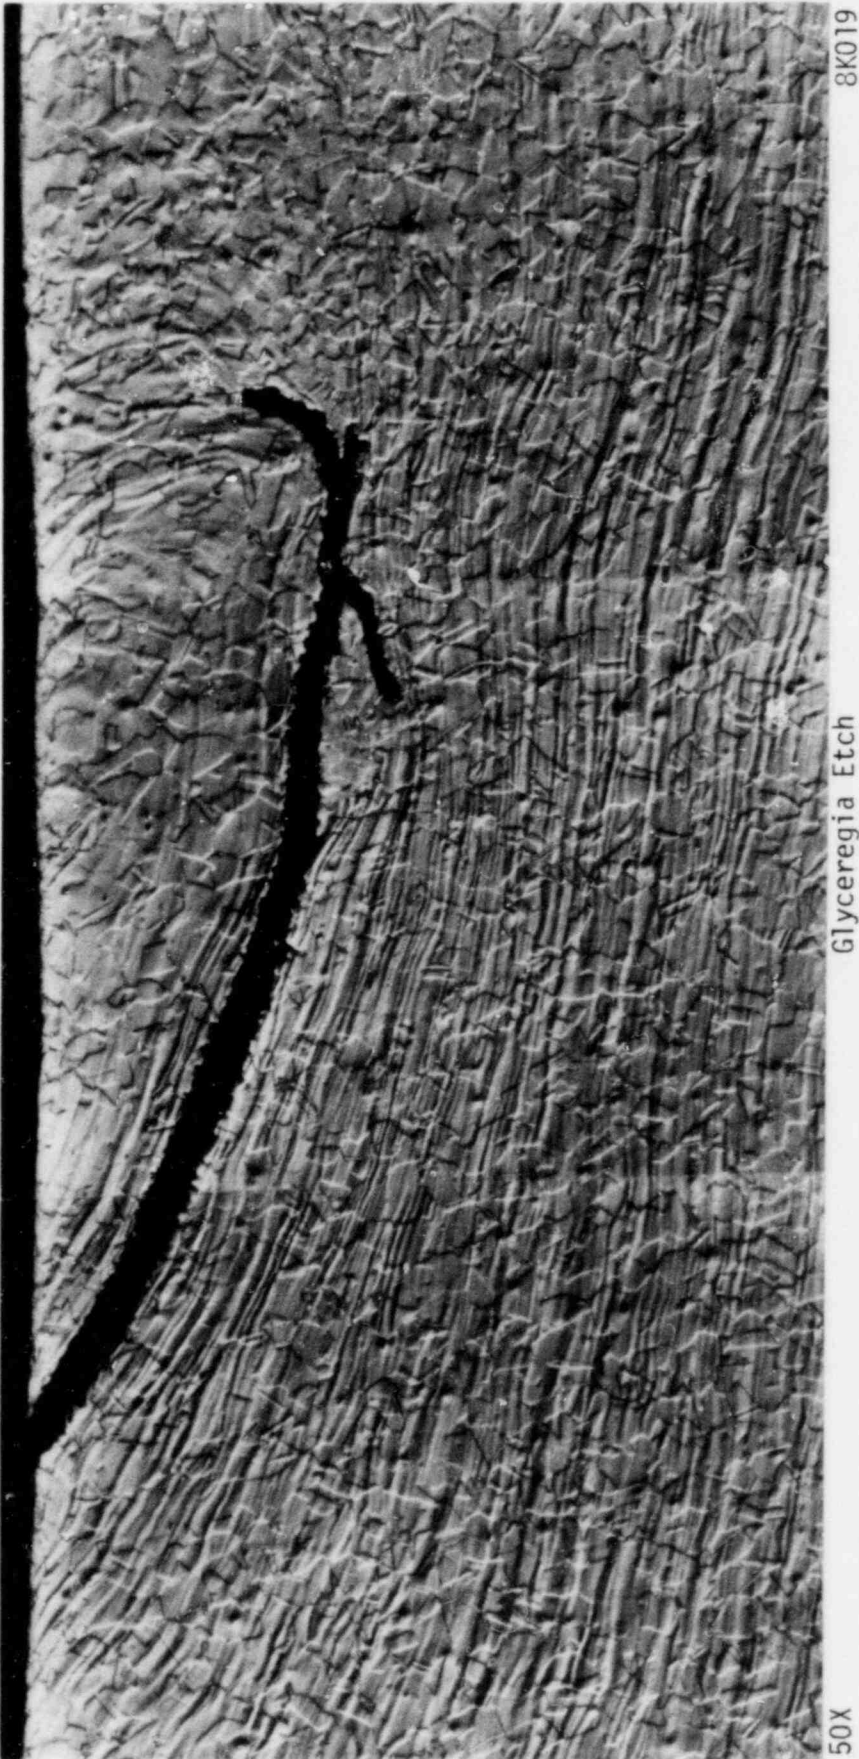
FIGURE 8. THE FLOW PATTERN OF METAL AROUND SURFACE FLAW NO. 2 OBSERVED IN SPECIMEN 2-P-F

The photomicrograph was taken using Nomarski interference-contrast microscopy to enhance the metal-flow pattern.

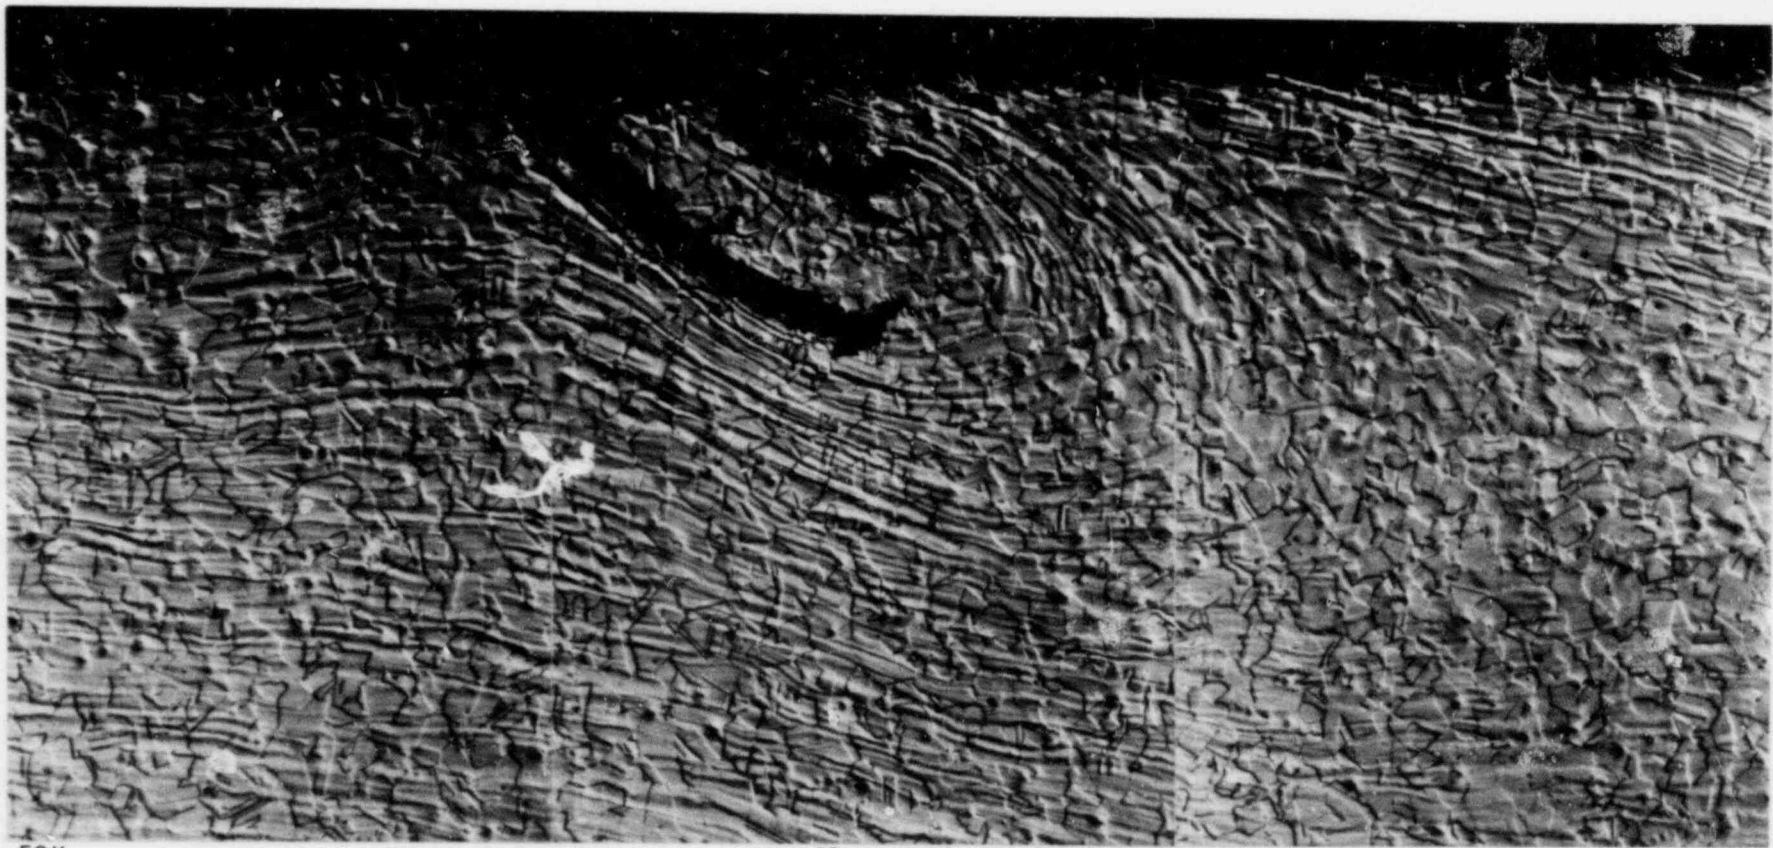
FIGURE 10. THE FLOW PATTERN OF METAL AROUND SURFACE FLAW NO. 2 IN SPECIMEN 2-R-R

at some earlier time. Specimen 2-N-N was taken at approximately the mid-length of Flaw No. 2. In that section, shown in Figure 9, the flaw appears very much like a surface fold, or lap. The depth of the flaw was about 0.035 inch. Specimen 2-R-R was taken across a thin sliver of surface metal that had been lifted, but not removed, from the surface; the appearance of the sliver can be seen in Figure 10. Part of the sliver was detached from the surface of the pipe at the location of Specimen 2-R-R.

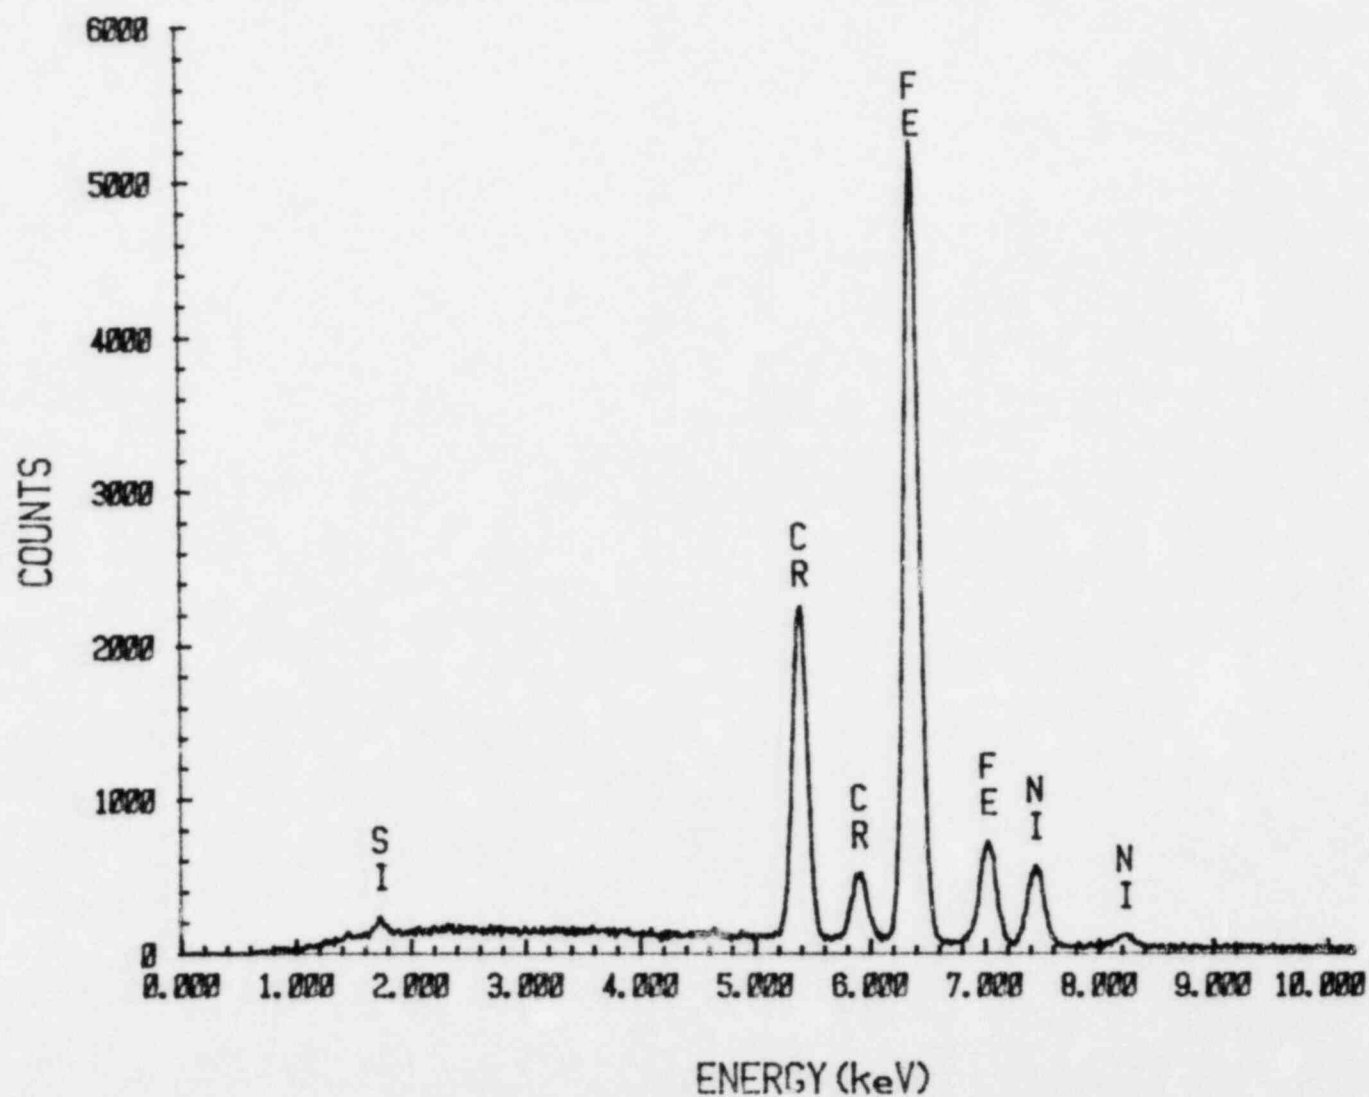
The relative concentrations of chromium and nickel in the pipe (Area 1 in Table 4) and in the weld metal (Area 2 in Table 4) agree quite well with the contents of those two elements that were obtained by emission-spectrographic analytical techniques. (Refer to Table 1 for the comparison.) The X-ray-energy spectrum for the pipe, which was nearly the same as the spectrum for the weld metal, is shown in Figure 12.

FIGURE 12. ENERGY-DISPERSIVE X-RAY SPECTRUM OBTAINED FROM AN ANALYSIS OF THE TYPE 304 STAINLESS STEEL MATRIX IN SPECIMEN 1-S-S OF FLAW NO. 1 (AREA 1 in TABLE 4)

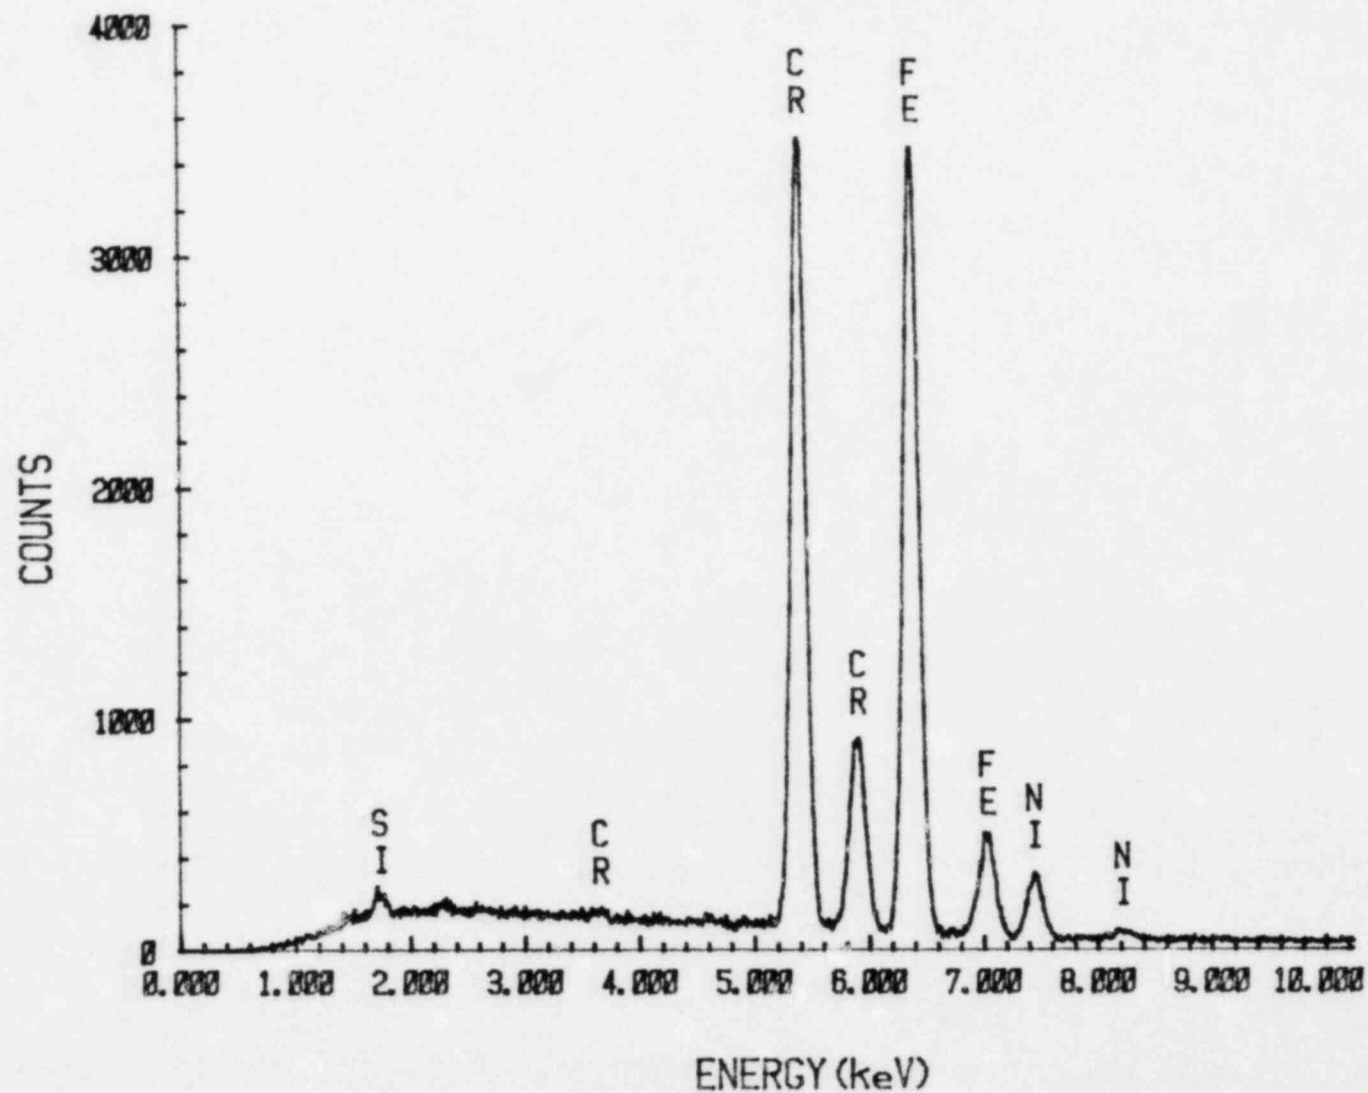
The corrosion products that were analyzed in Flaw No. 1 (Area 3 in Table 4) are identified by the arrow in Figure 13, a cross section of Flaw No. 1 observed in Specimen 1-S-S. The X-ray-energy spectrum for Area 3 is presented in Figure 14. The analysis of the chromium present in the corrosion products indicated that the chromium content was nearly twice the chromium content of the pipe. The increase in the chromium content was accompanied by decreases in the iron and nickel contents.

FIGURE 14. ENERGY-DISPERSIVE X-RAY SPECTRUM OBTAINED FROM AN ANALYSIS OF CORROSION PRODUCTS IN FLAW NO. 1 OBSERVED IN SPECIMEN 1-S-S (AREA 3 in TABLE 4)

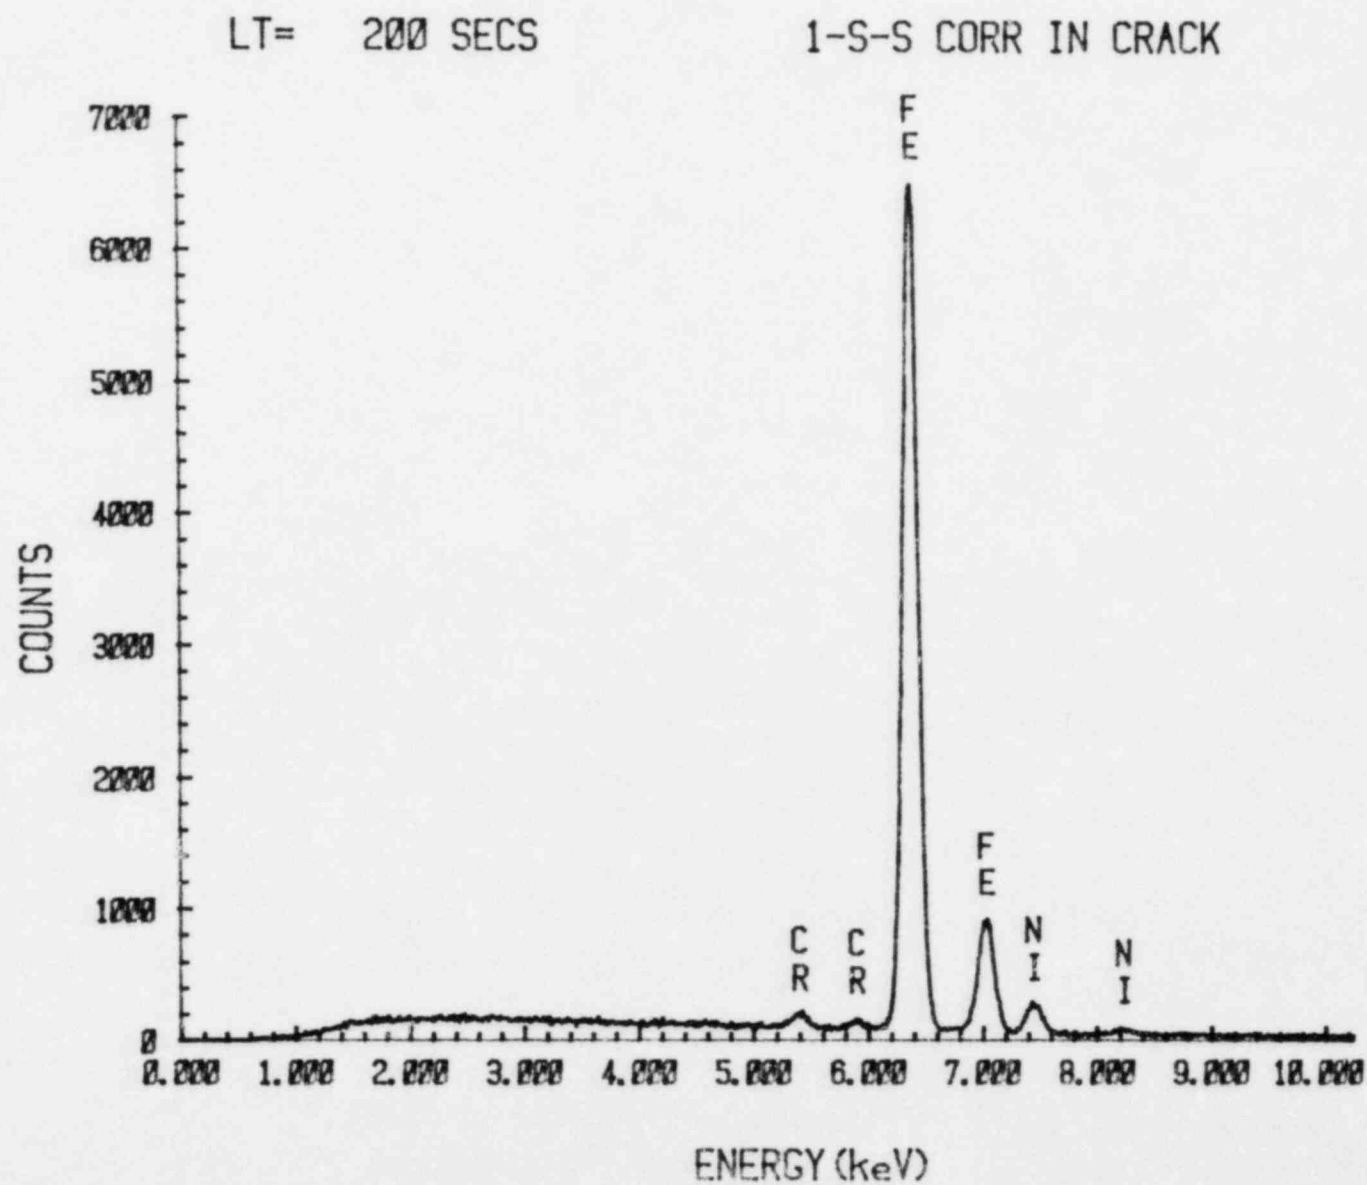
The region represented by Area 4 in Table 4, a region of corrosion products in the IGSCC below Flaw No. 1 near the inside surface of the pipe, is shown in Figure 15a. Those corrosion products contained a relatively low concentration of chromium, as was indicated also by the X-ray-energy spectrum of Area 4 presented in Figure 16. The X-ray distribution map of chromium presented in Figure 15b indicates the low concentration of chromium in the major portion of the corrosion products in the grain boundaries. (A region that exhibits a relatively sparse population of white dots in an X-ray-distribution map of an element indicates that the region contains a lower concentration of the element than do the regions that exhibit more dense populations of white dots.) The major decrease in the chromium content was balanced by a major increase in the iron content.

FIGURE 16. ENERGY-DISPERSIVE X-RAY SPECTRUM OBTAINED FROM AN ANALYSIS OF CORROSION PRODUCTS IN THE CRACK (AREA 4 IN TABLE 4)

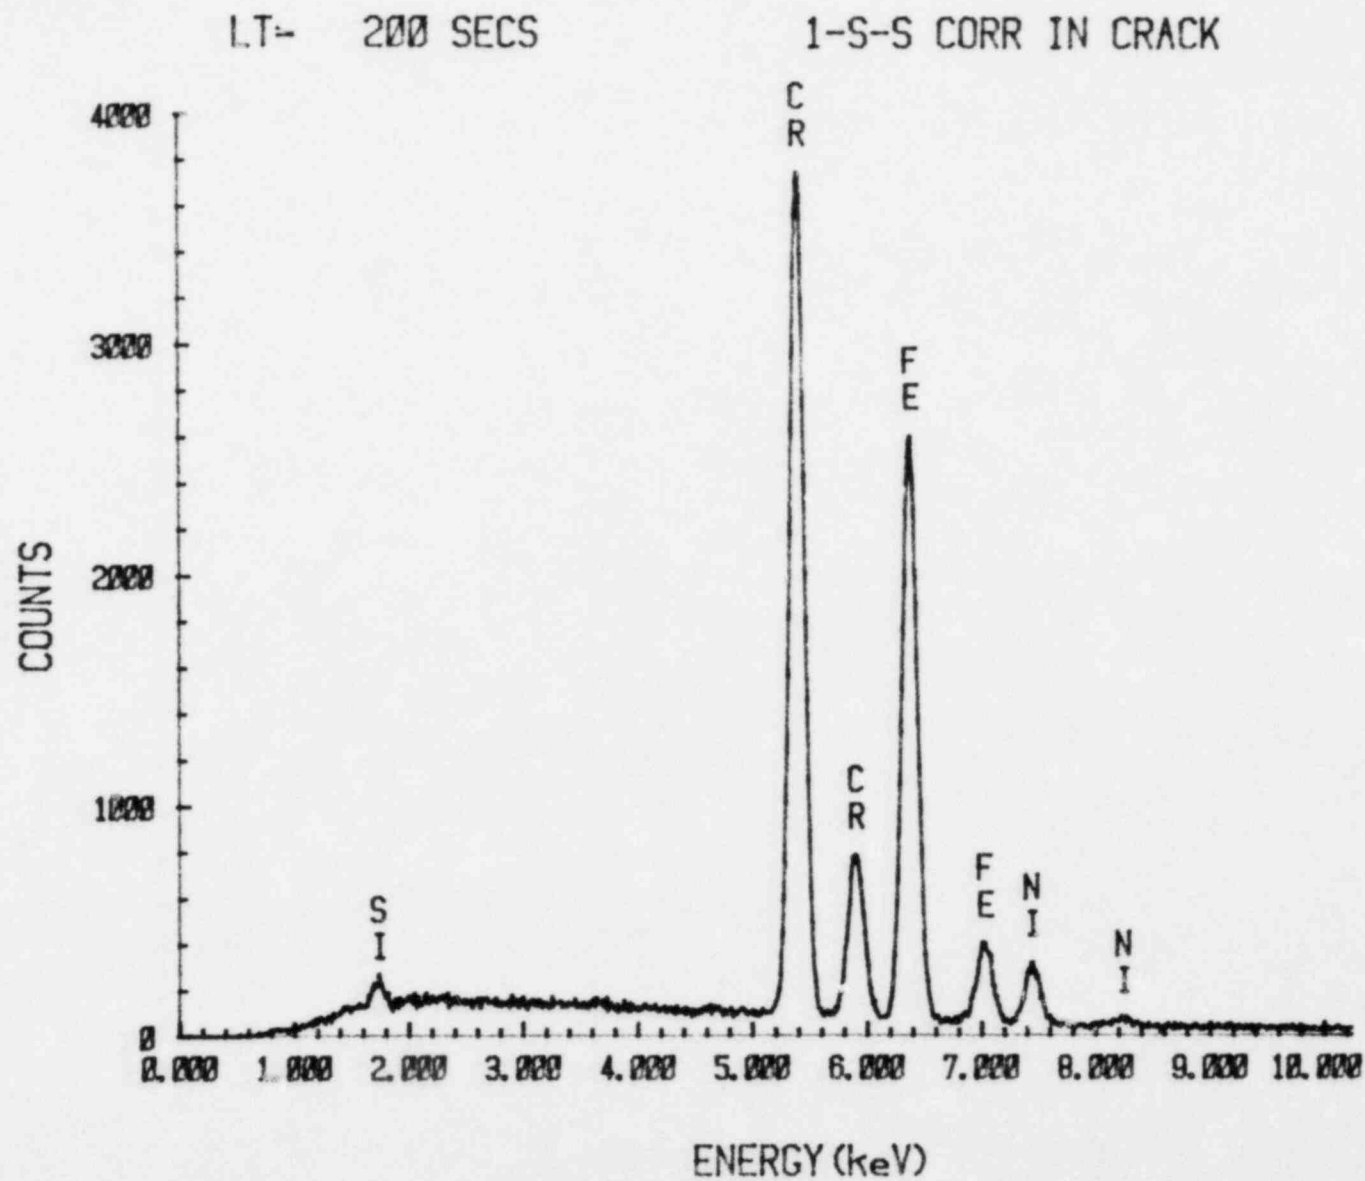
FIGURE 17. ENERGY-DISPERSIVE X-RAY SPECTRUM OBTAINED FROM AN ANALYSIS OF CORROSION PRODUCTS IN A BRANCH CRACK (AREA 6 IN TABLE 4)

chromium; the low chromium concentrations were similar to that found in the corrosion products in the main crack near the inside surface (Area 4 in Table 4).

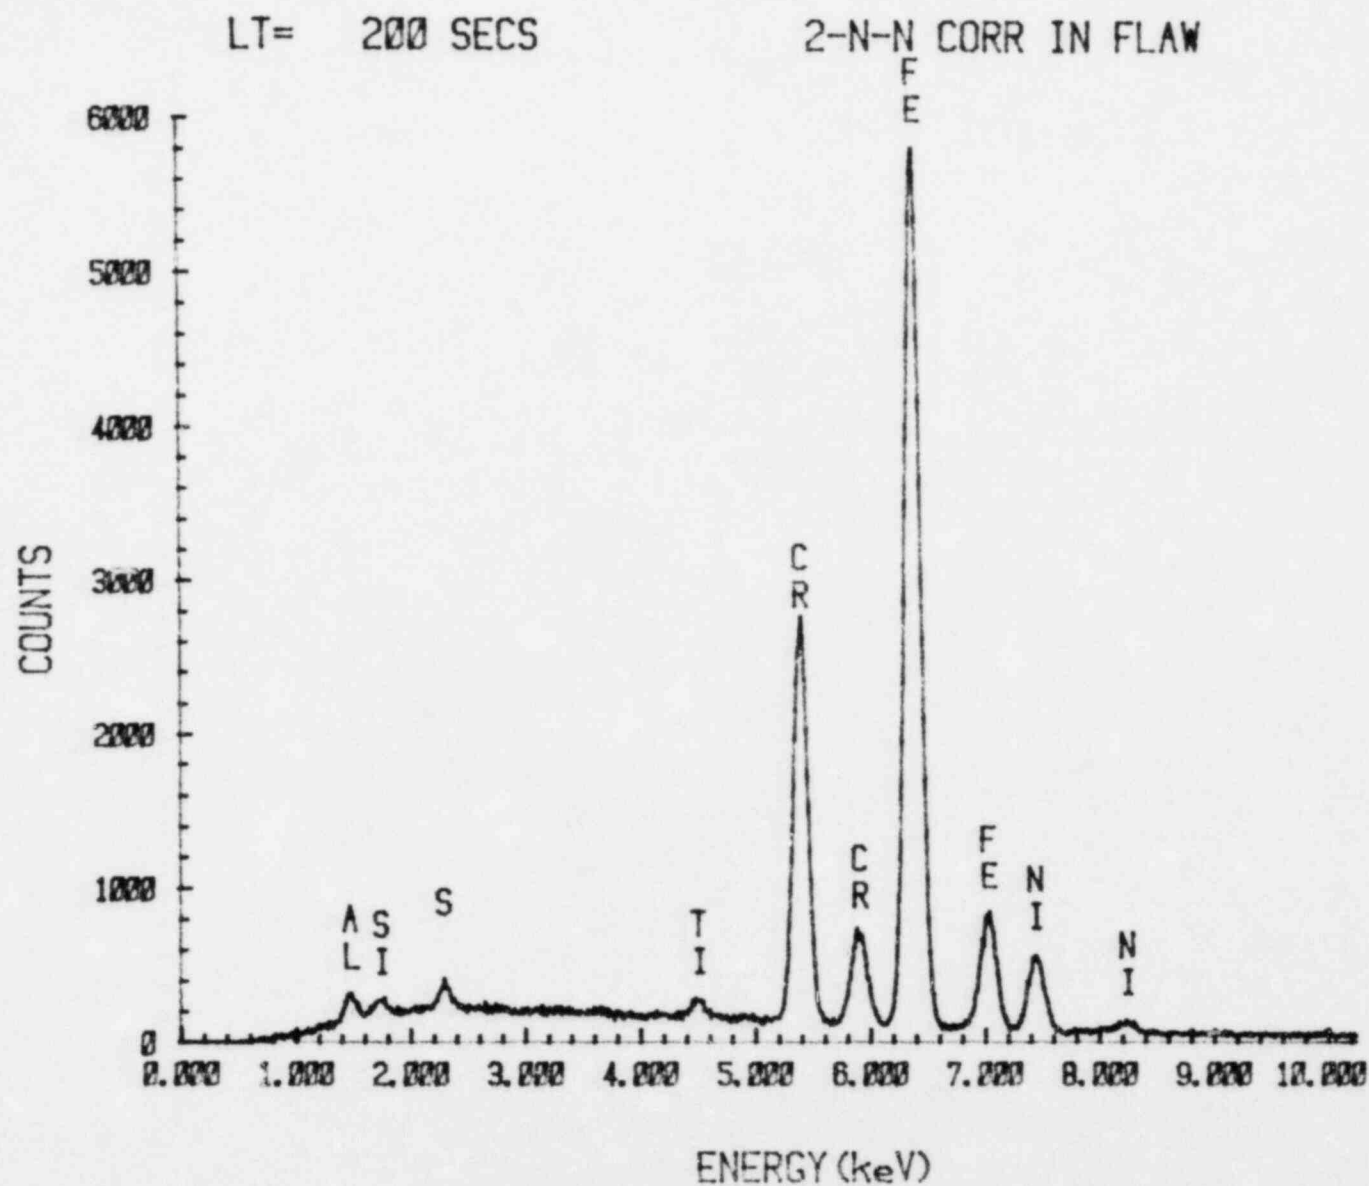
FIGURE 18. ENERGY-DISPERSIVE X-RAY SPECTRUM OBTAINED FROM AN AREA SCAN OF CORROSION PRODUCTS IN FLAW NO. 2, SPECIMEN 2-N-N (AREA 1 IN TABLE 5)
