Metallurgical Examination
Cracked Field Weld No. 212
Feed Water Pipe to Nozzle; Steam Generator 1-2.

Pacific Gas & Electric Co.
Diablo Canyon Nuclear Project

Pullman Power Products Co.
Williamsport, Pennsylvania

Date: 6/23/77

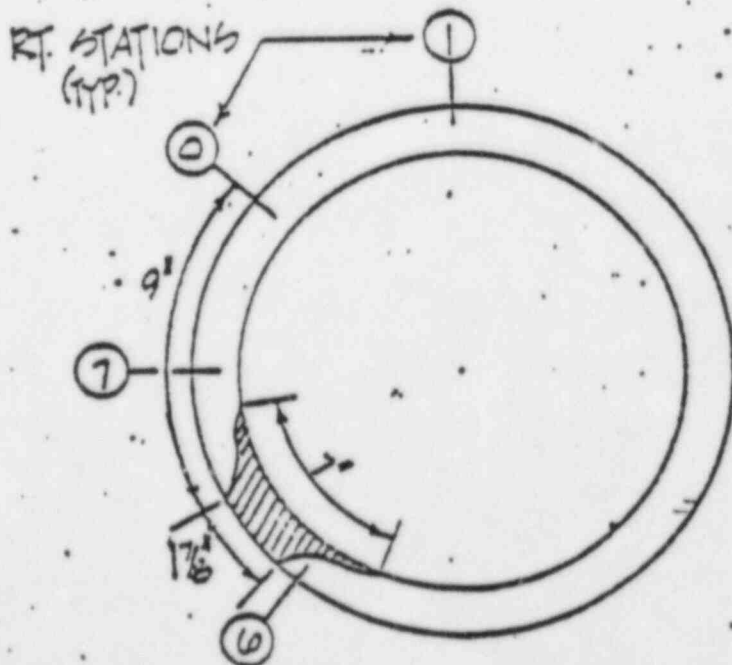
It is my belief that the crack was peculiar to F.W. 212 only and not of a generic nature. Therefore, at this time we are assuming that no further repair will be required and that when the disposition of D.R. 3370 is completed the subject will be closed.

1. WALL THICKNESS MEASR. ARE APPROXIMATE
2. REF. TO DR. 3366 REV A
3. STEAM GENERATOR 1-2
FW. #212
NO. 500146
LINE # KU-555-10 II
