April 16, 1984

SUBJECT: Waterford 3 Steam Electric Station Docket No. 50-382 Construction Adequacy of WSES-3 Basemat

ATTACHMENT "A"

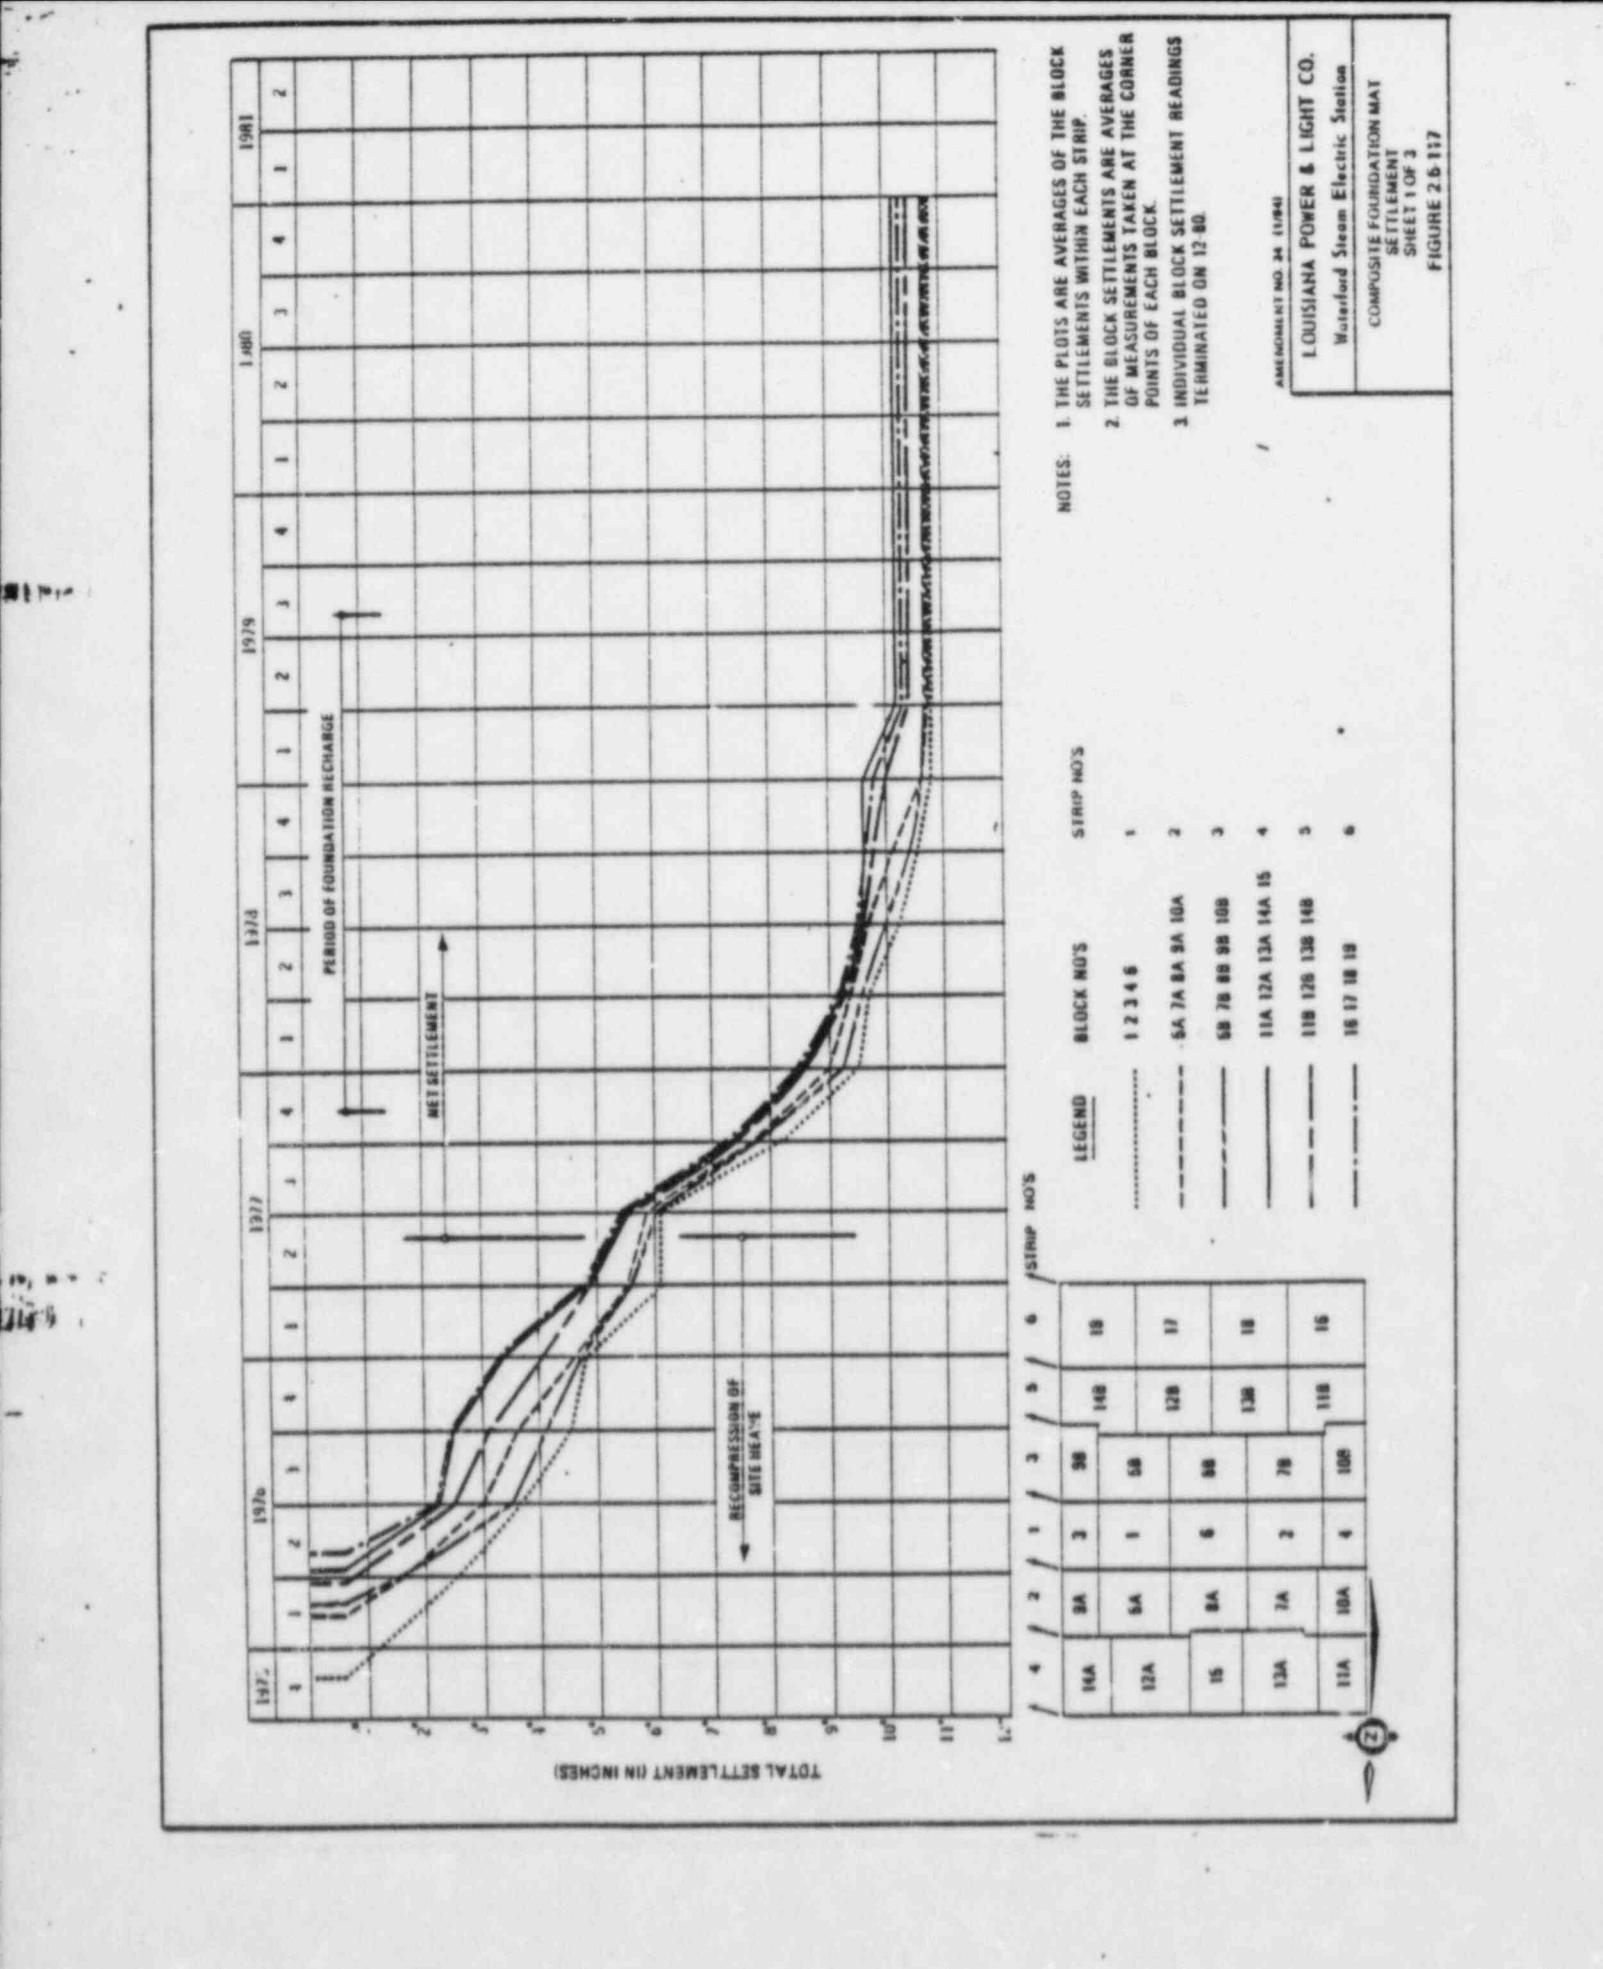
Distribution of pressure under each block was not maintained since the mat was considered as a single mat.

Backfilling and concrete construction was established through drawing no. LOU-1564-G-490, "General Nuclear Plant Island Structure Construction Sequence". This drawing provided the evaluation criteria for top of concrete as related to top of fill. Generally, construction was sequenced to place concrete (walls/floors, etc.) uniformally by constructing the buildings with minimal differentiation in loading. Consequently, backfilling operations followed suit and maintained a uniformity of placement as well.
