FLORIDA POWER AND LIGHT COMPANY

TURKEY POINT UNIT 3

PRELIMINARY DRAFT OF

CONTAINMENT DOME REPORT

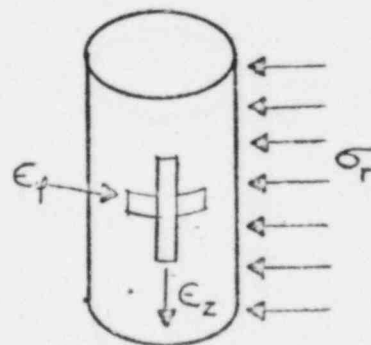
CORE REMOVED
FROM DOME
DELAMINATED
SURFACE ON
BOTTOM OF
SPECIMEN

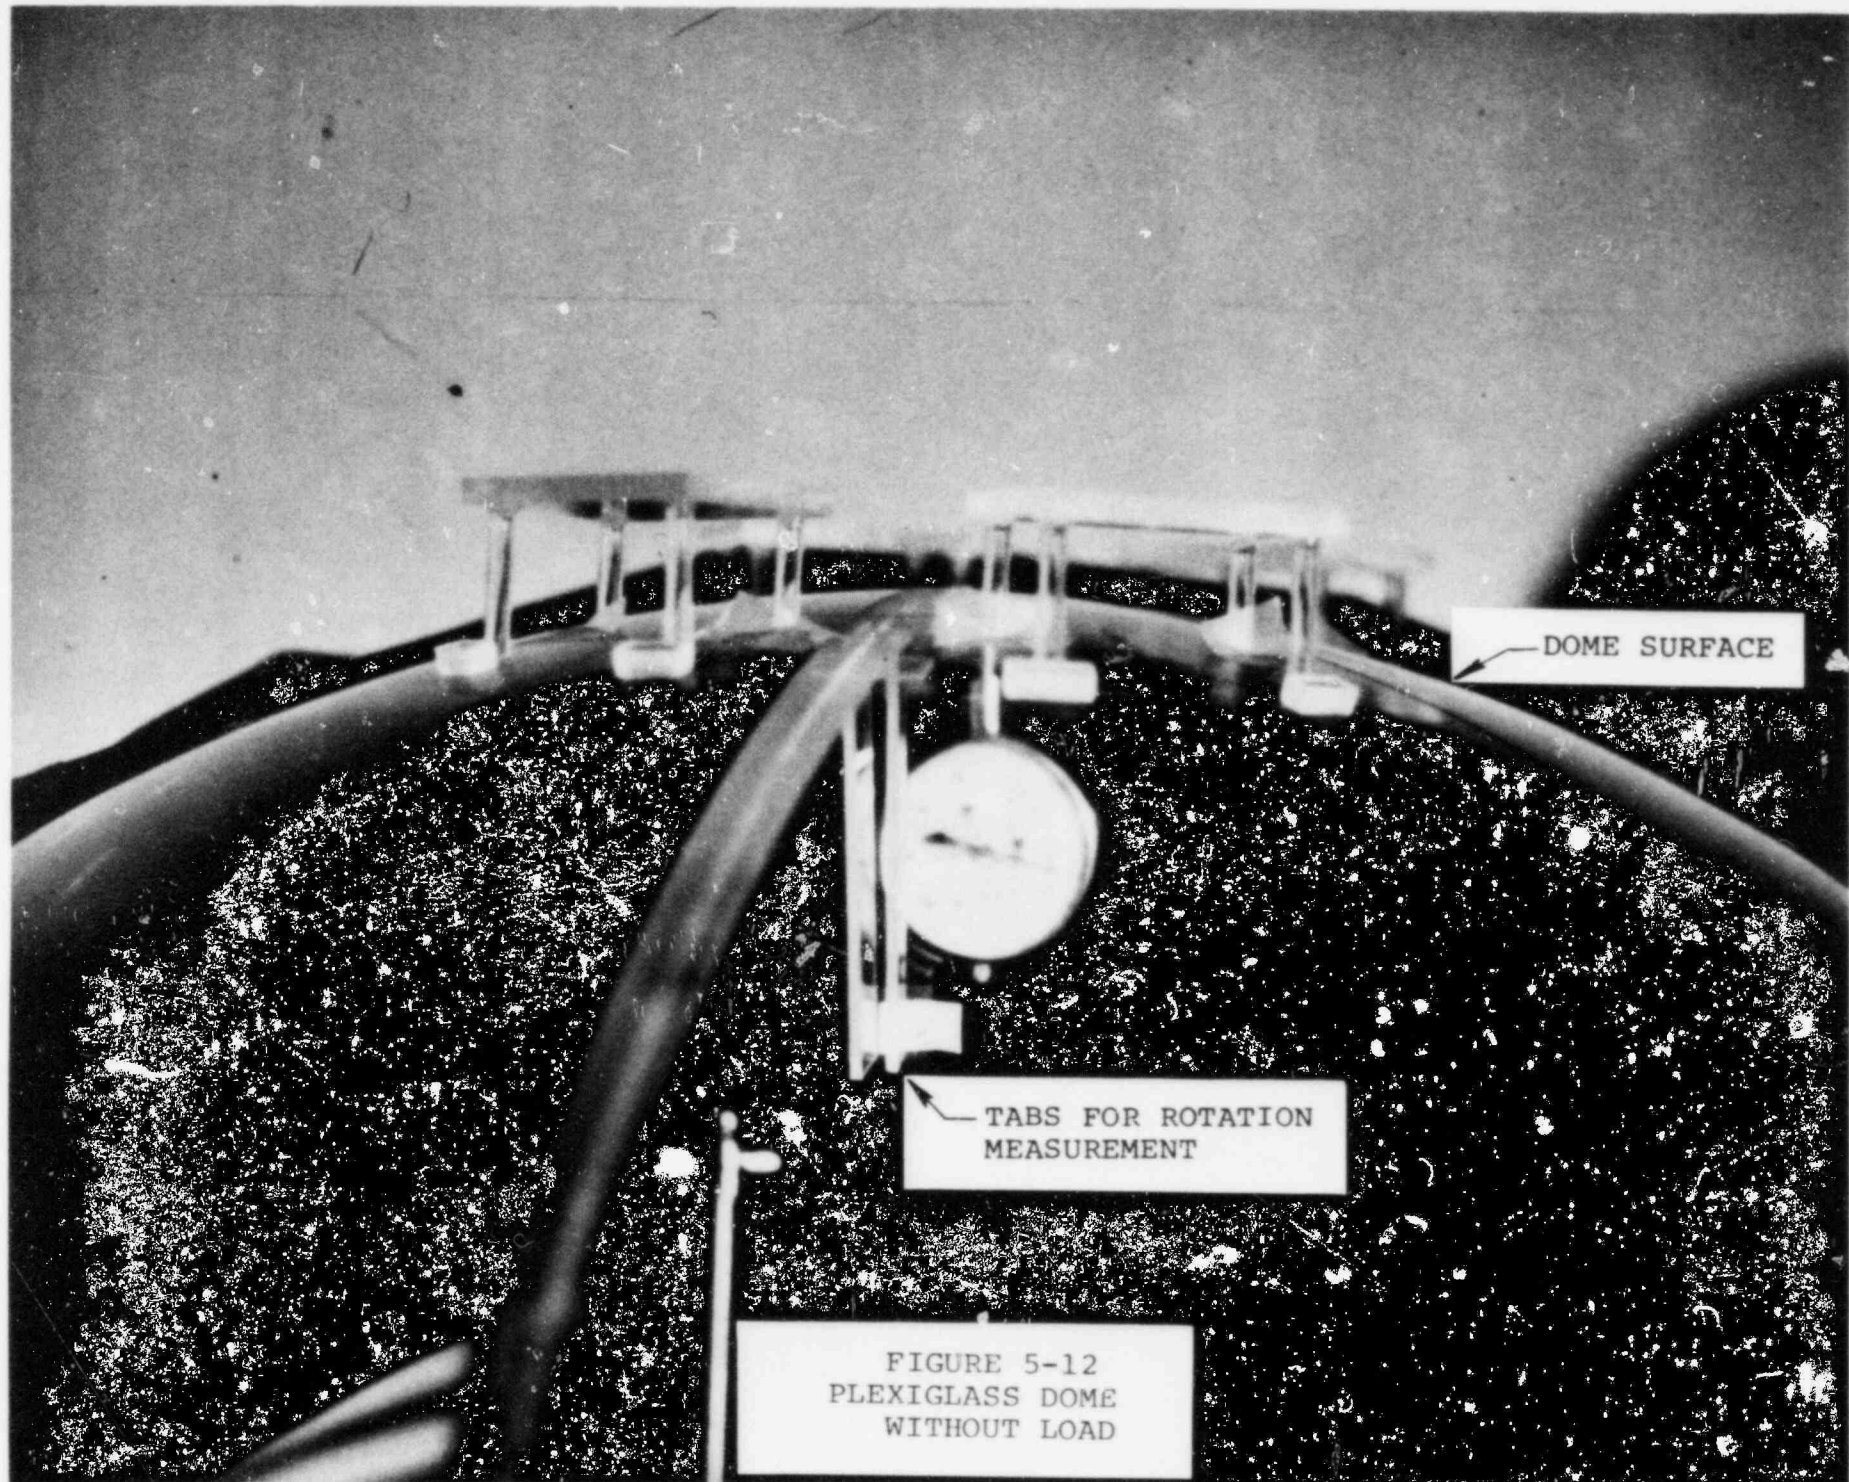
FIGURE 5-12
PLEXIGLASS DOME
WITHOUT LOAD

Two plexiglass domes were obtained to help visualize the phenomenon of the joint rotation. One of the domes was a hemisphere and the other was a hemisphere cut in half and then taped together so that only shear could be transmitted through the joint. Figures 5-12 and 5-13 show the split plexiglass dome before and after applying a load across the joint. Two plexiglass tabs were mounted normal to the surface, pointing inward, on each side of the simulated joint. The photographs indicate that as the load is applied the joint rotates, opening at the bottom.
