FLORIDA POWER & LIGHT COMPANY

TURKEY POINT UNIT 3

INTERIM REPORT

CONTAINMENT DOME CONCRETE

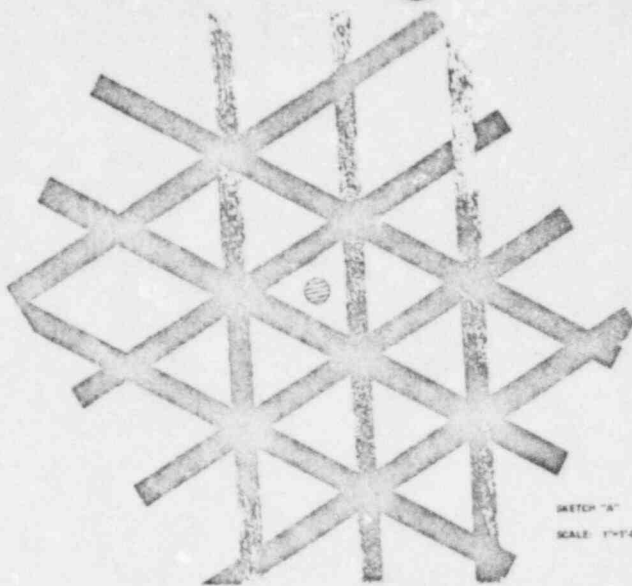
SKETCH "A"  
SCALE: 1"=4'

depth of coring. In general, an attempt has been made to drill the holes to a 16 inch depth, this being supplemented by a few 29 inch deep core holes. The coring log and a sketch showing the location of core holes is included as Appendix B. The deepest lamination found is in core hole #23 at a depth of 15 inches.
