NUCLEAR REACTOR PRESSURE VESSEL TRANSPORTATION INCIDENT

POINT BEACH UNIT 1

VOLUME I

PREPARED FOR
WISCONSIN MICHIGAN POWER COMPANY
231 WEST MICHIGAN STREET
MILWAUKEE, WISCONSIN 53201

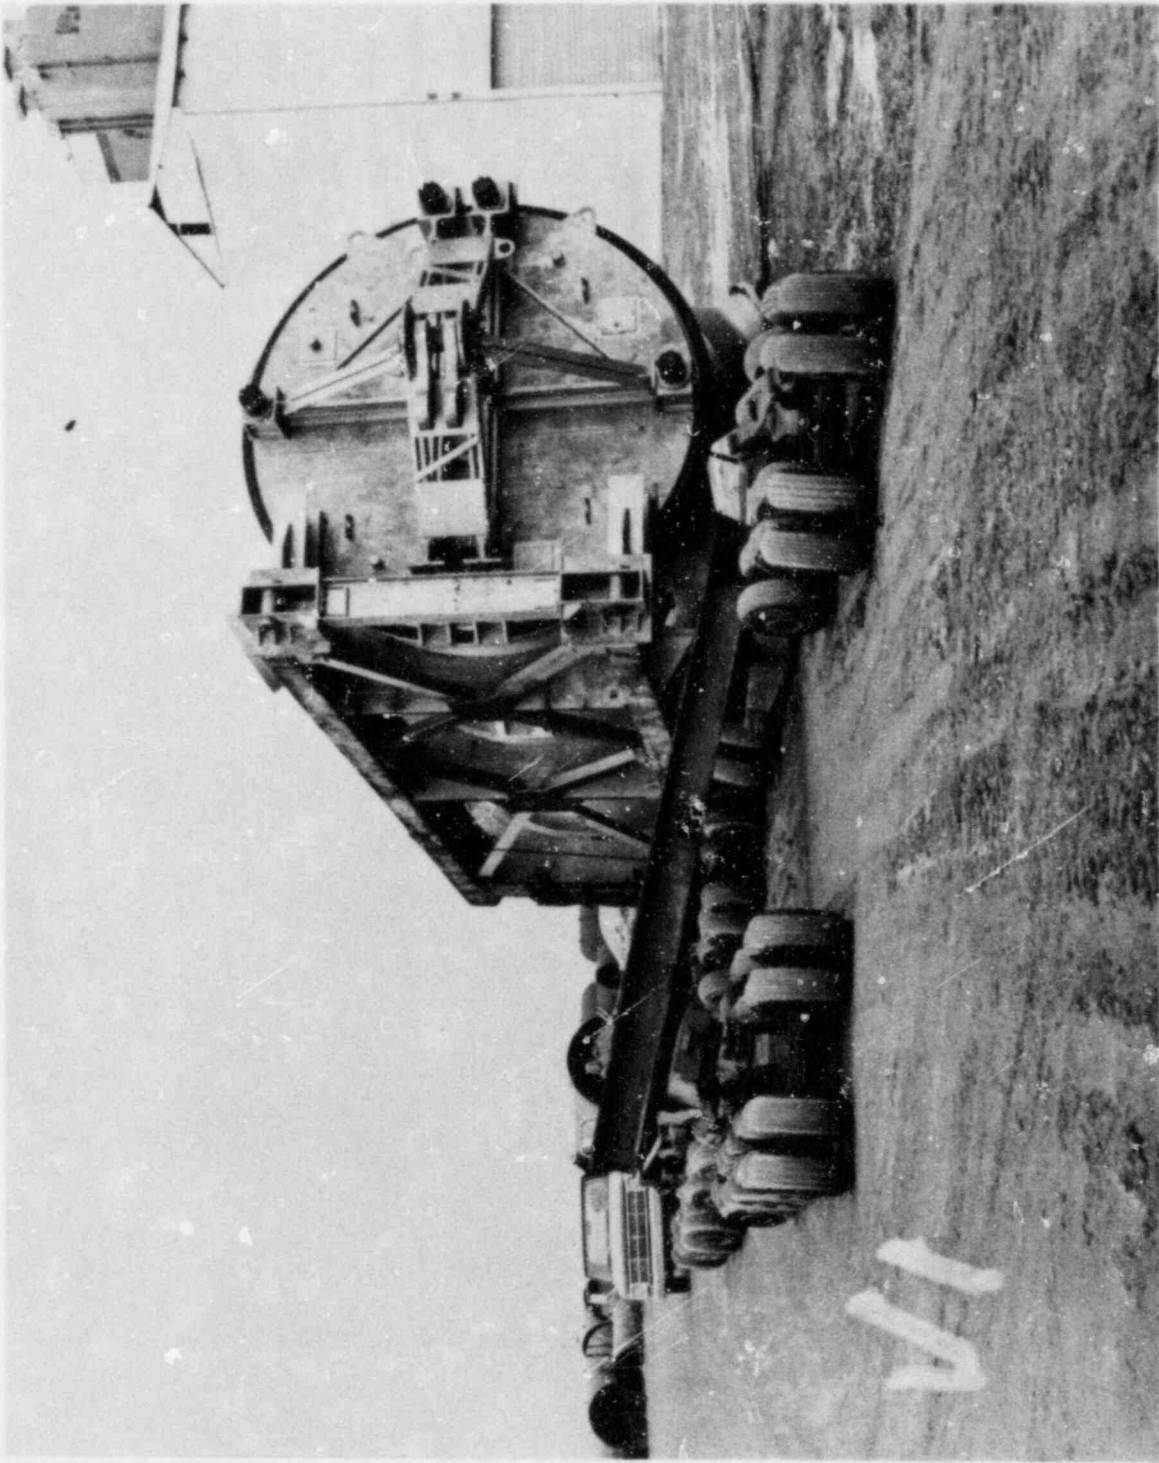
FIGURE 1. POSITION OF REACTOR VESSEL AFTER
TRANSPORTATION INCIDENT - VIEW 1.

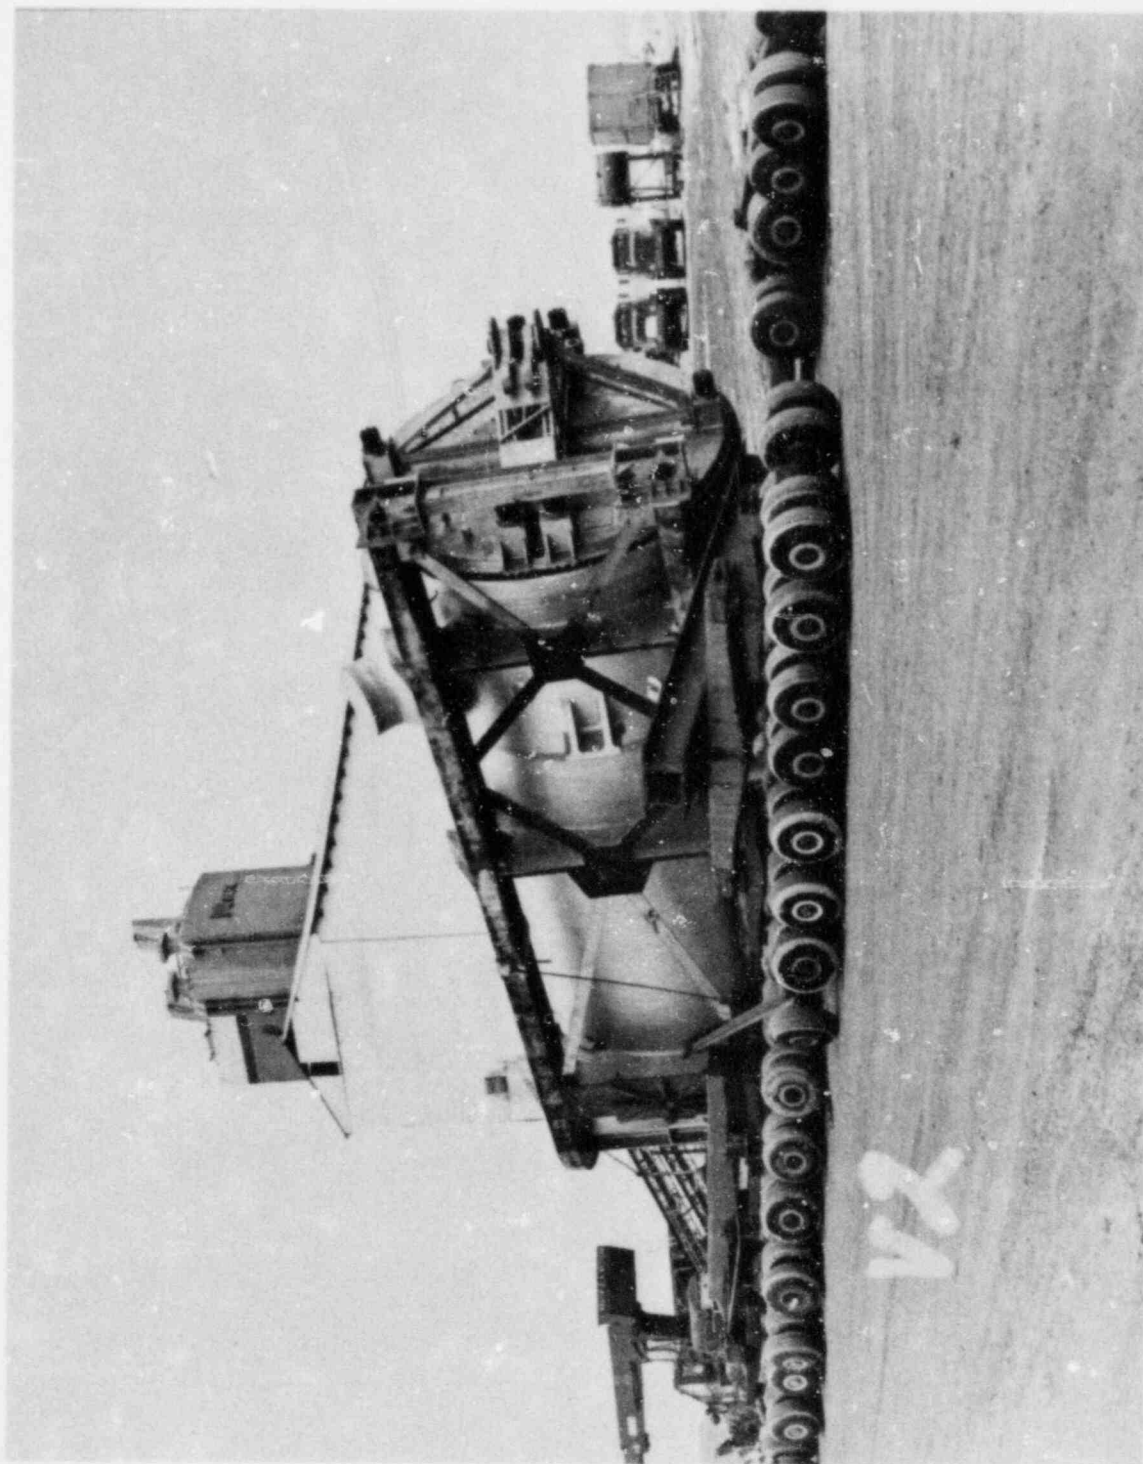
FIGURE 2. POSITION OF REACTOR VESSEL AFTER TRANSPORTATION INCIDENT - VIEW 2.

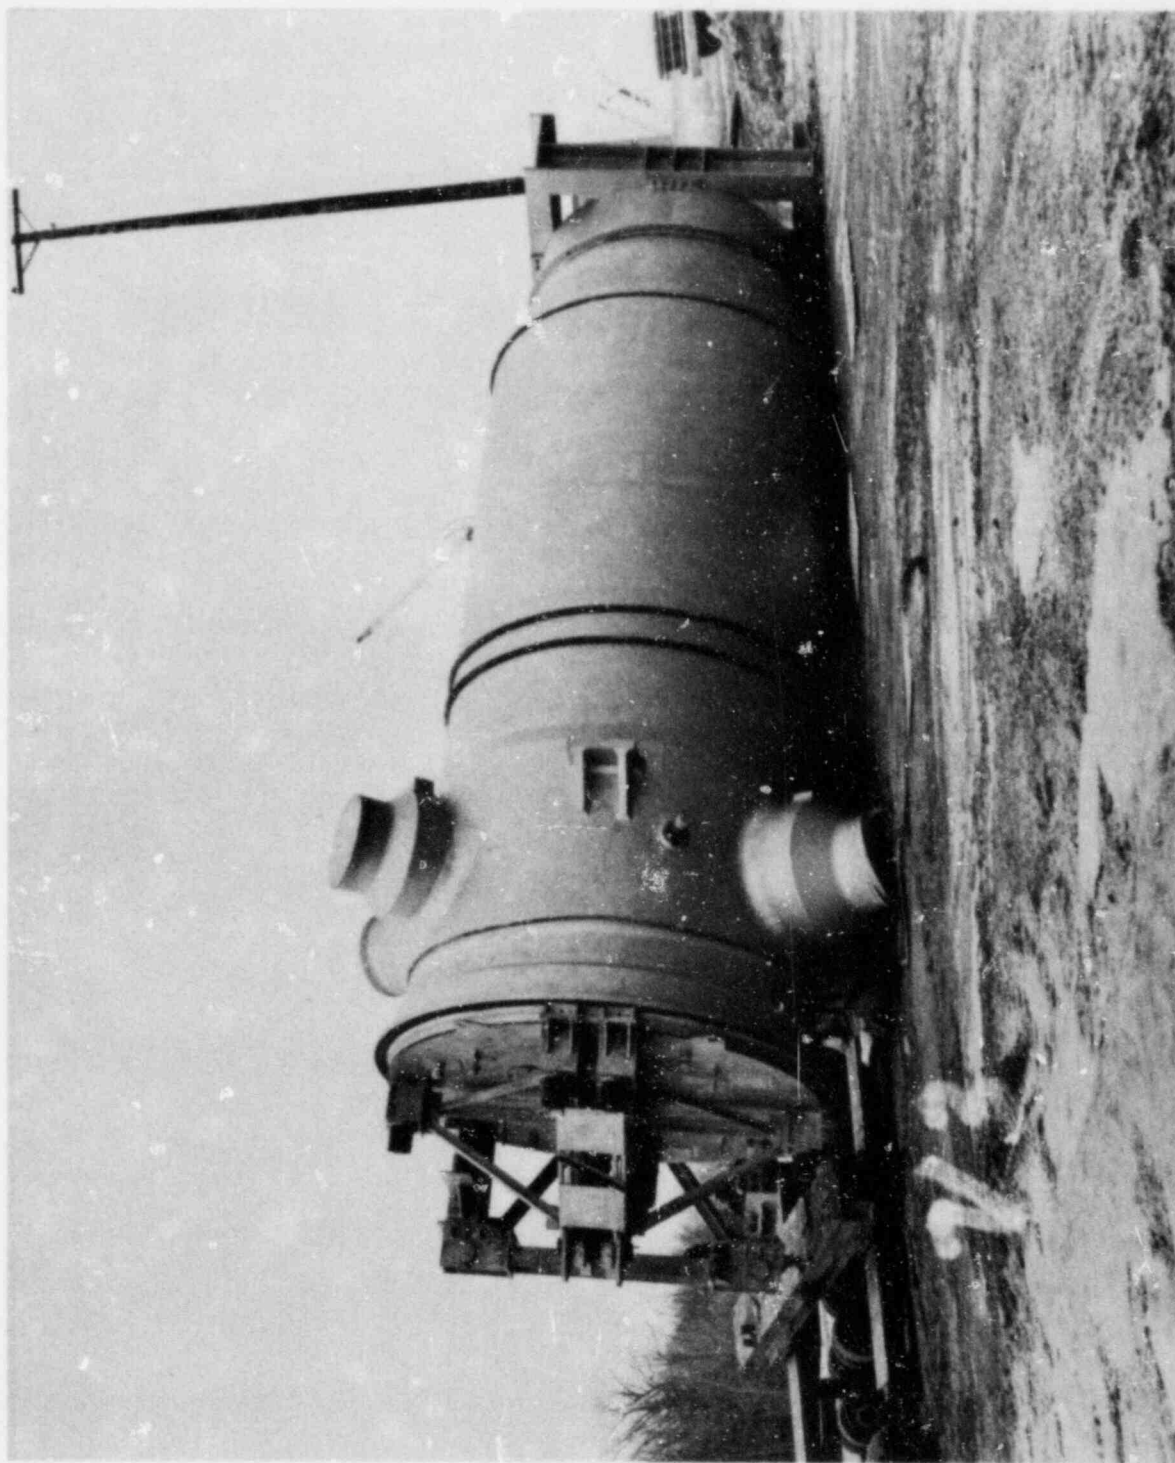
FIGURE 3. POSITION OF REACTOR VESSEL AFTER TRANSPORTATION INCIDENT - VIEW 3.

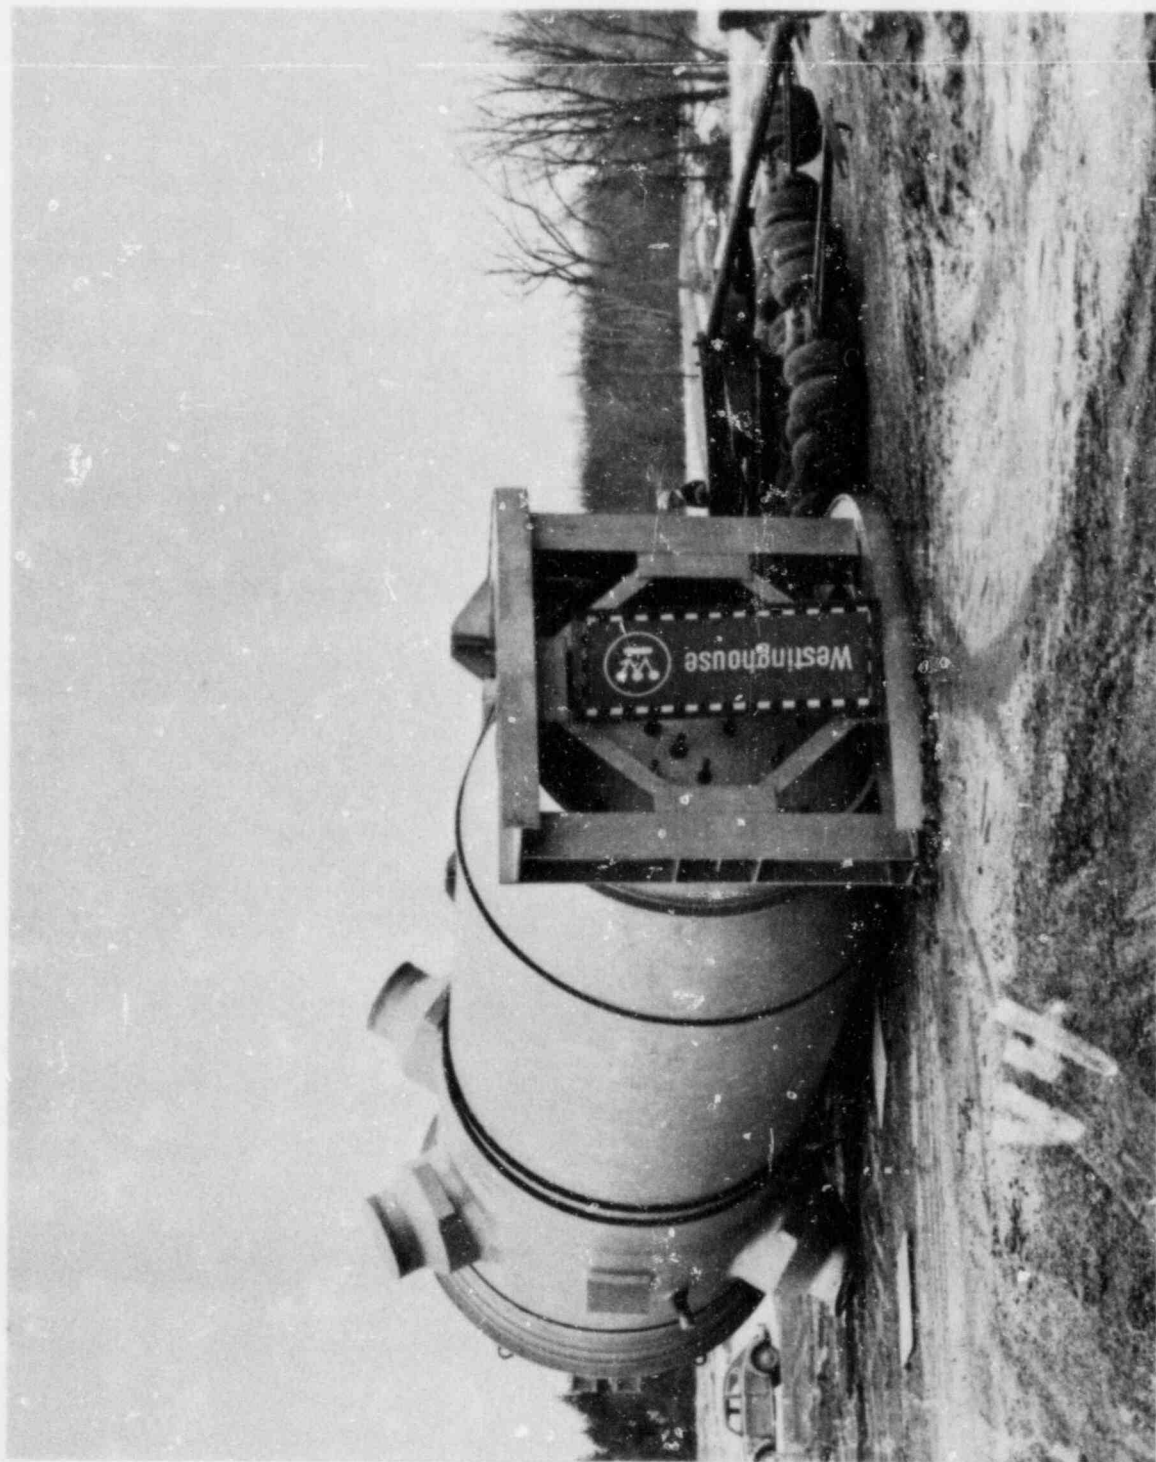
FIGURE 4. POSITION OF REACTOR VESSEL AFTER TRANSPORTATION INCIDENT - VIEW 4.

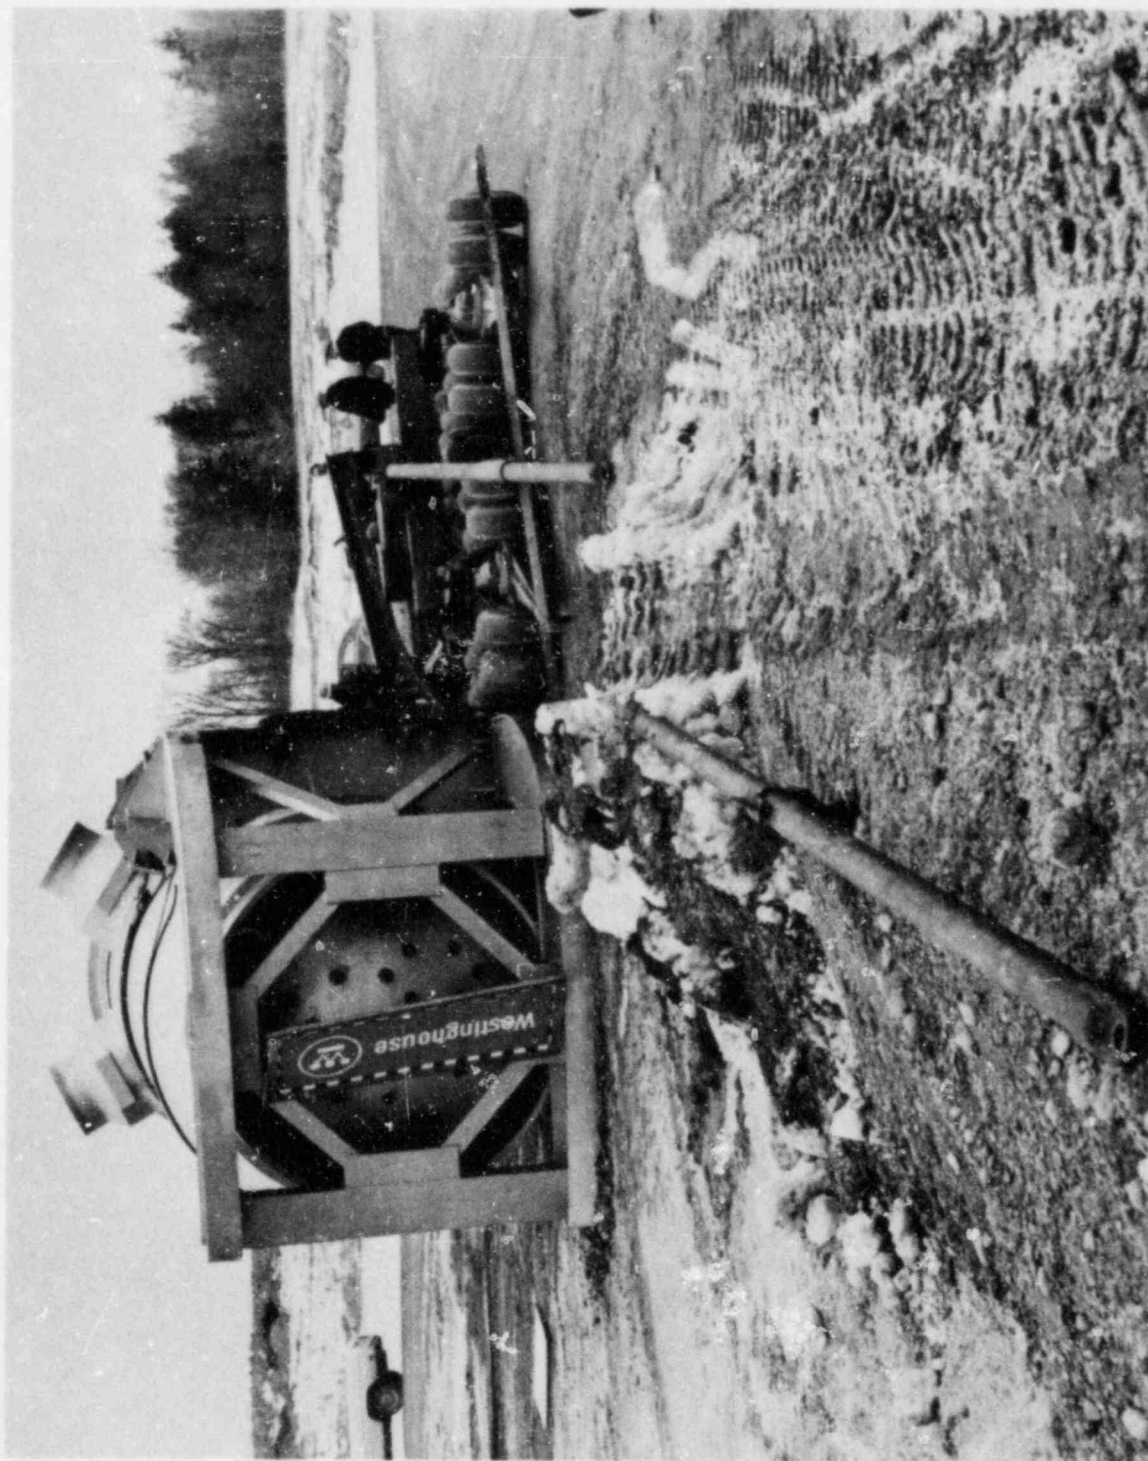
FIGURE 5. POSITION OF REACTOR VESSEL AFTER
TRANSPORTATION INCIDENT - VIEW 5.

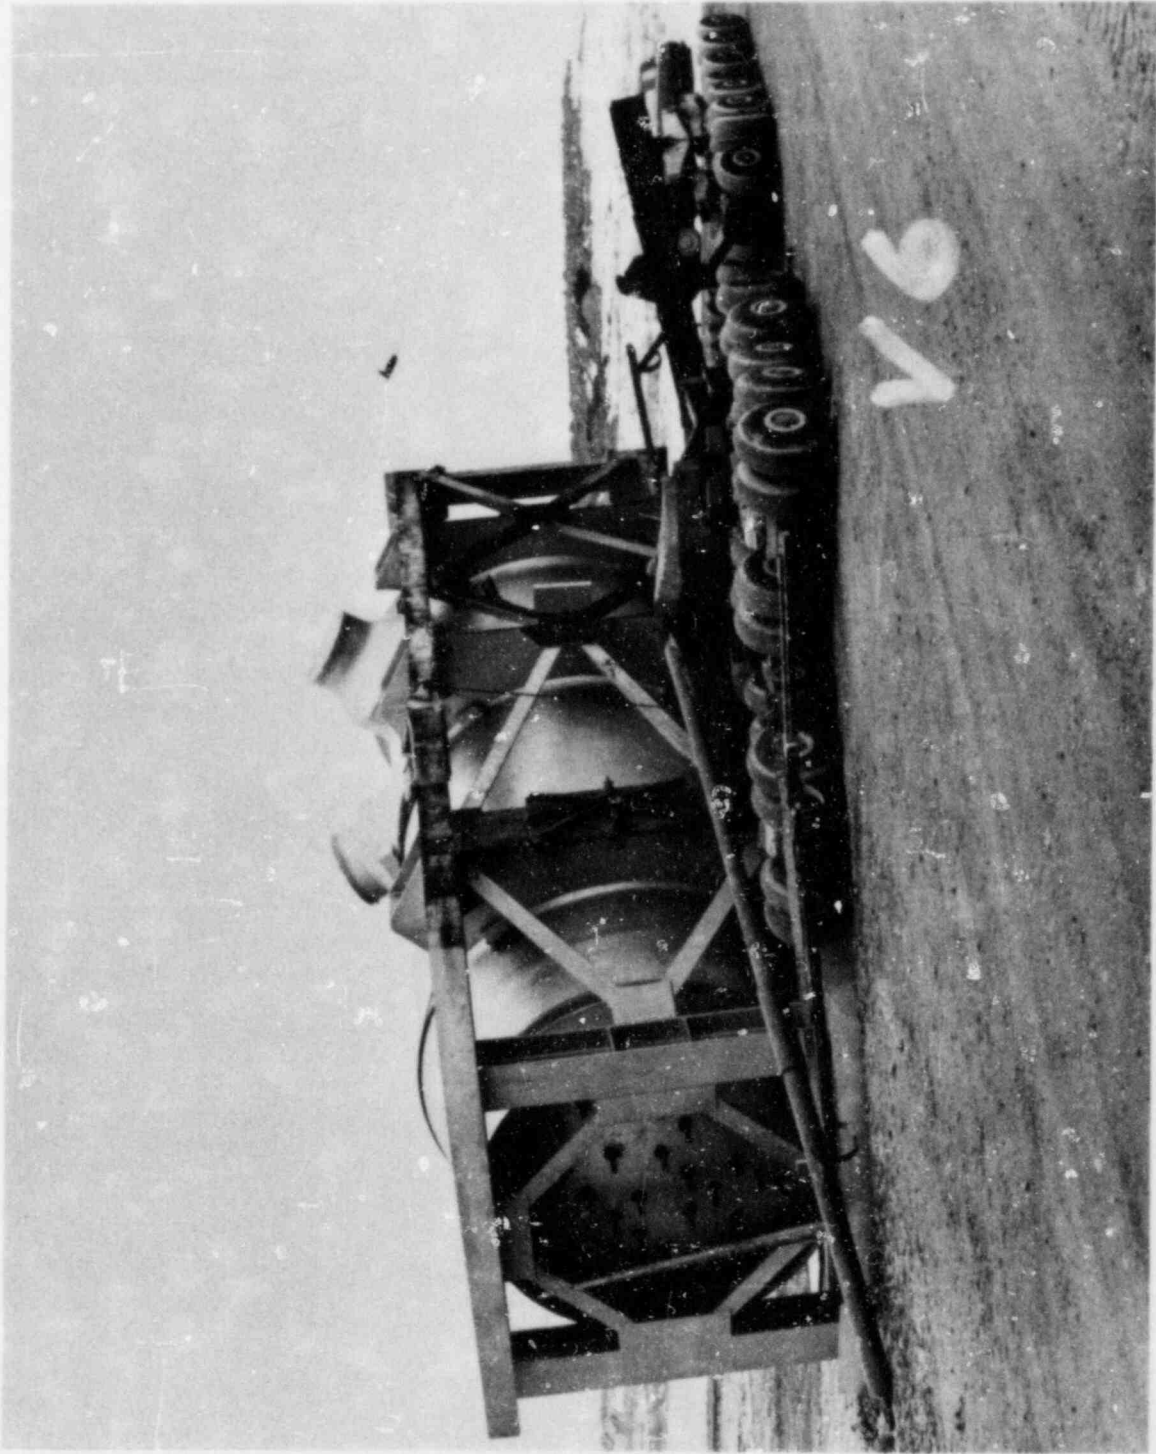
FIGURE 6. POSITION OF REACTOR VESSEL AFTER
TRANSPORTATION INCIDENT - VIEW 6.

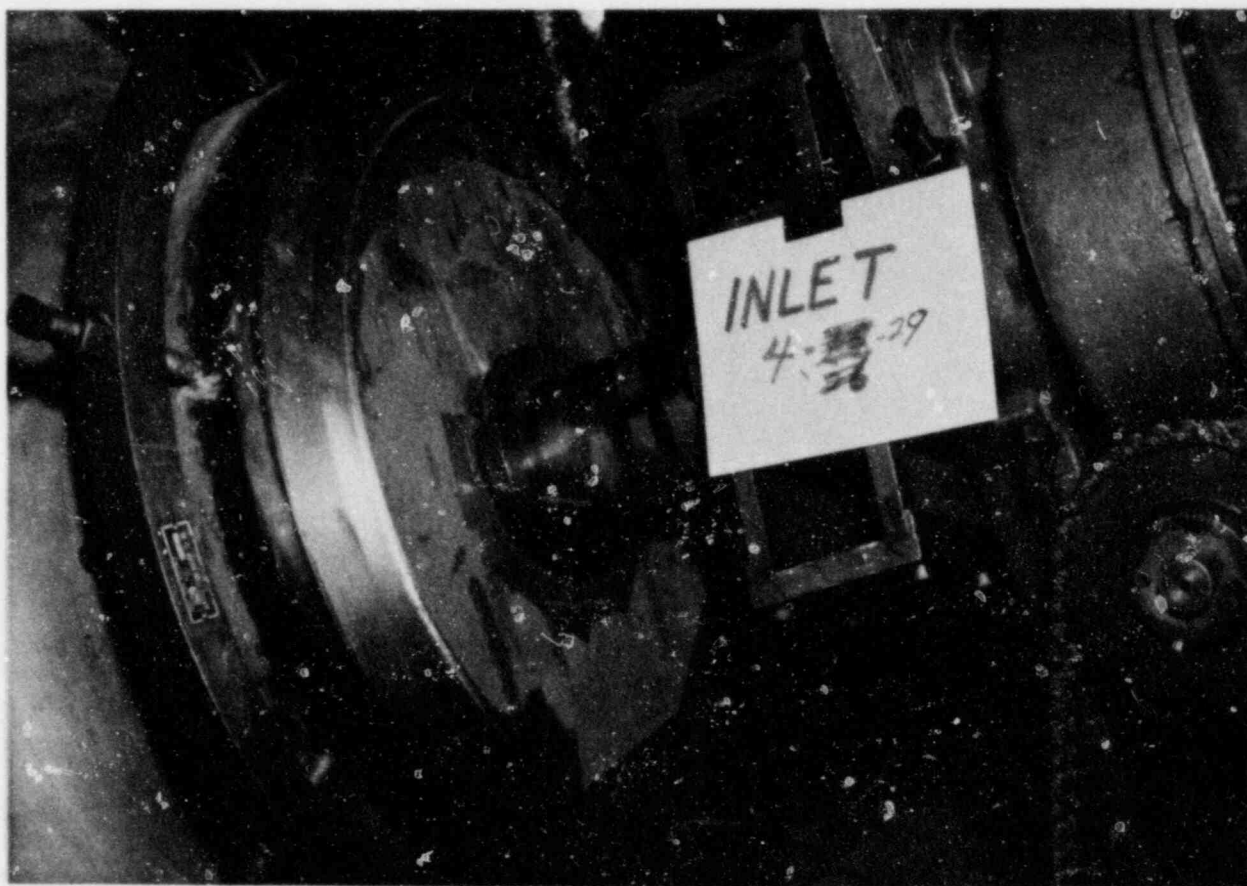
FIGURE 25. INLET NOZZLE - MACHINING OPERATION.

Welded repairs to the damaged inlet and outlet nozzle weld end preparations and to the scored nozzle overlay were carried out in accordance with the approved procedures and are considered acceptable.

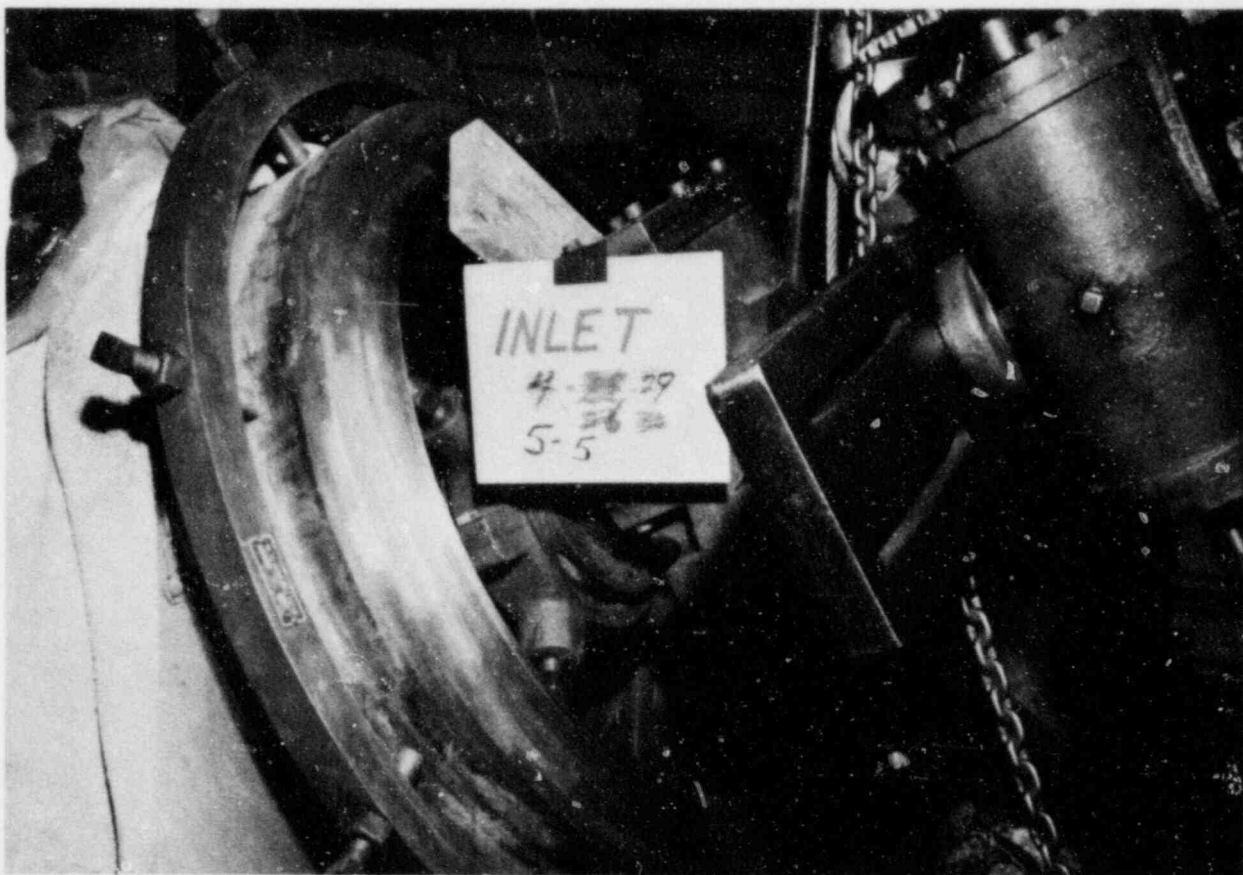
FIGURE 26. INLET NOZZLE - MACHINING OPERATION.

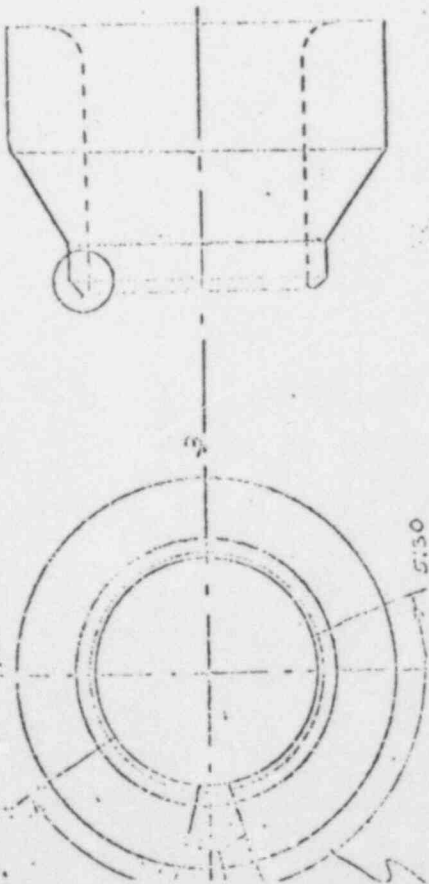
"I.E. AREA THE .055" WELDING LIP IS COMPLETELY SHOWN OFF.

NOTE: THE .055" WELDING LIP IS ROLLED INTO THE CURVED SURFACE OF THE VESSEL.

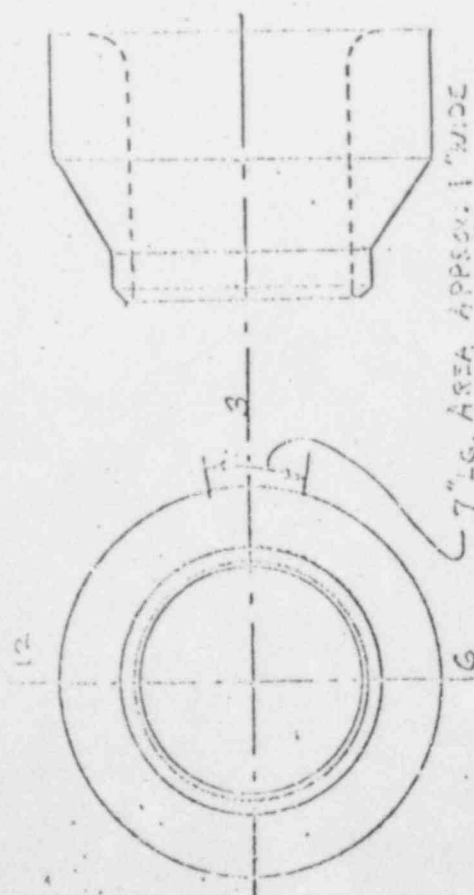
7 1/2" LG. AREA APPROX. 1" WIDE

WHERE FLANGE OF SKID
 WAS DEFORMED ABOUT 1/2" OUT OF
 STRAIGHT WHEN ACCIDENT OCCURRED.
 THERE IS NO VISIBLE SURFACE DEFORMATION IN THE AREA

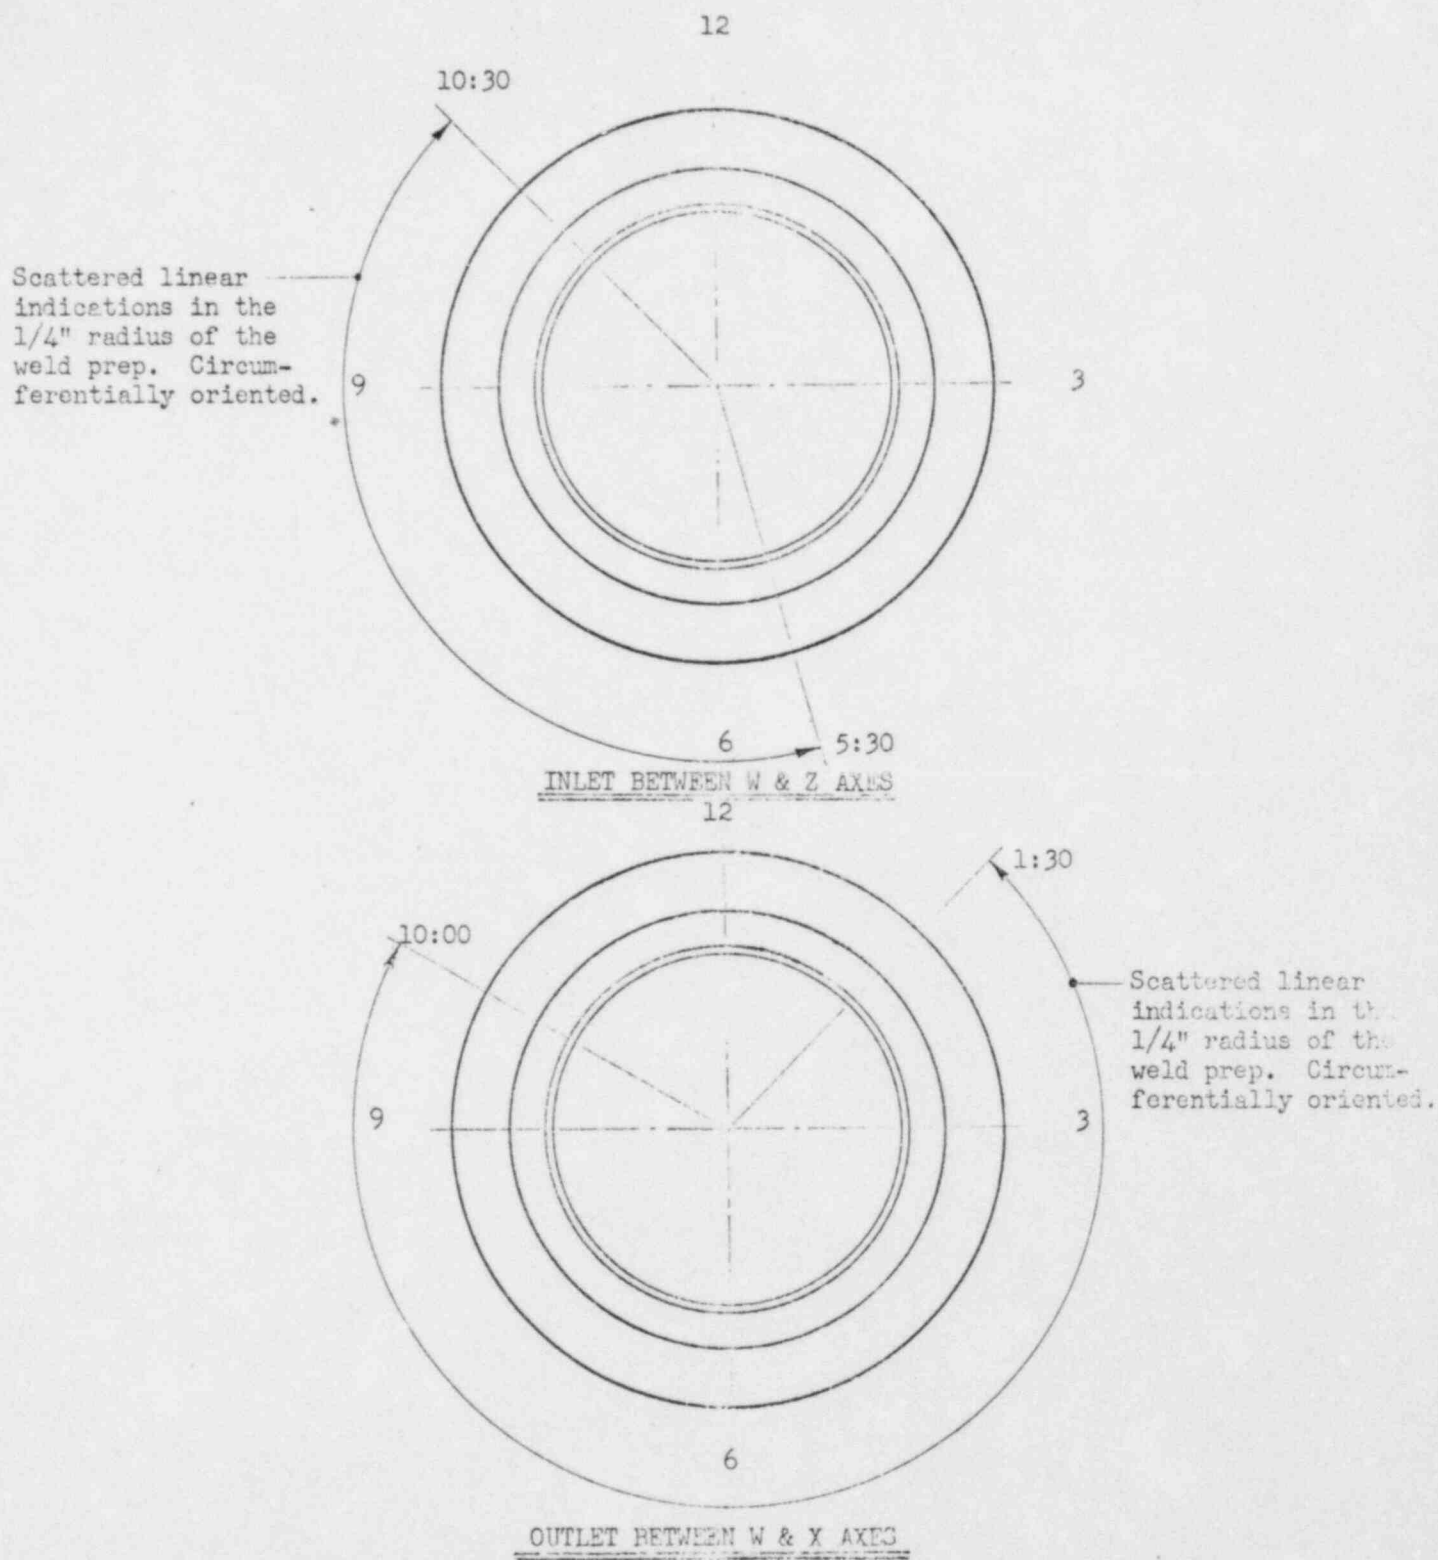
Figure 2

NOTE: Due to damage of .055" lip on weld prep, the liquid penetrant inspection was rejected. (See Figure 2)

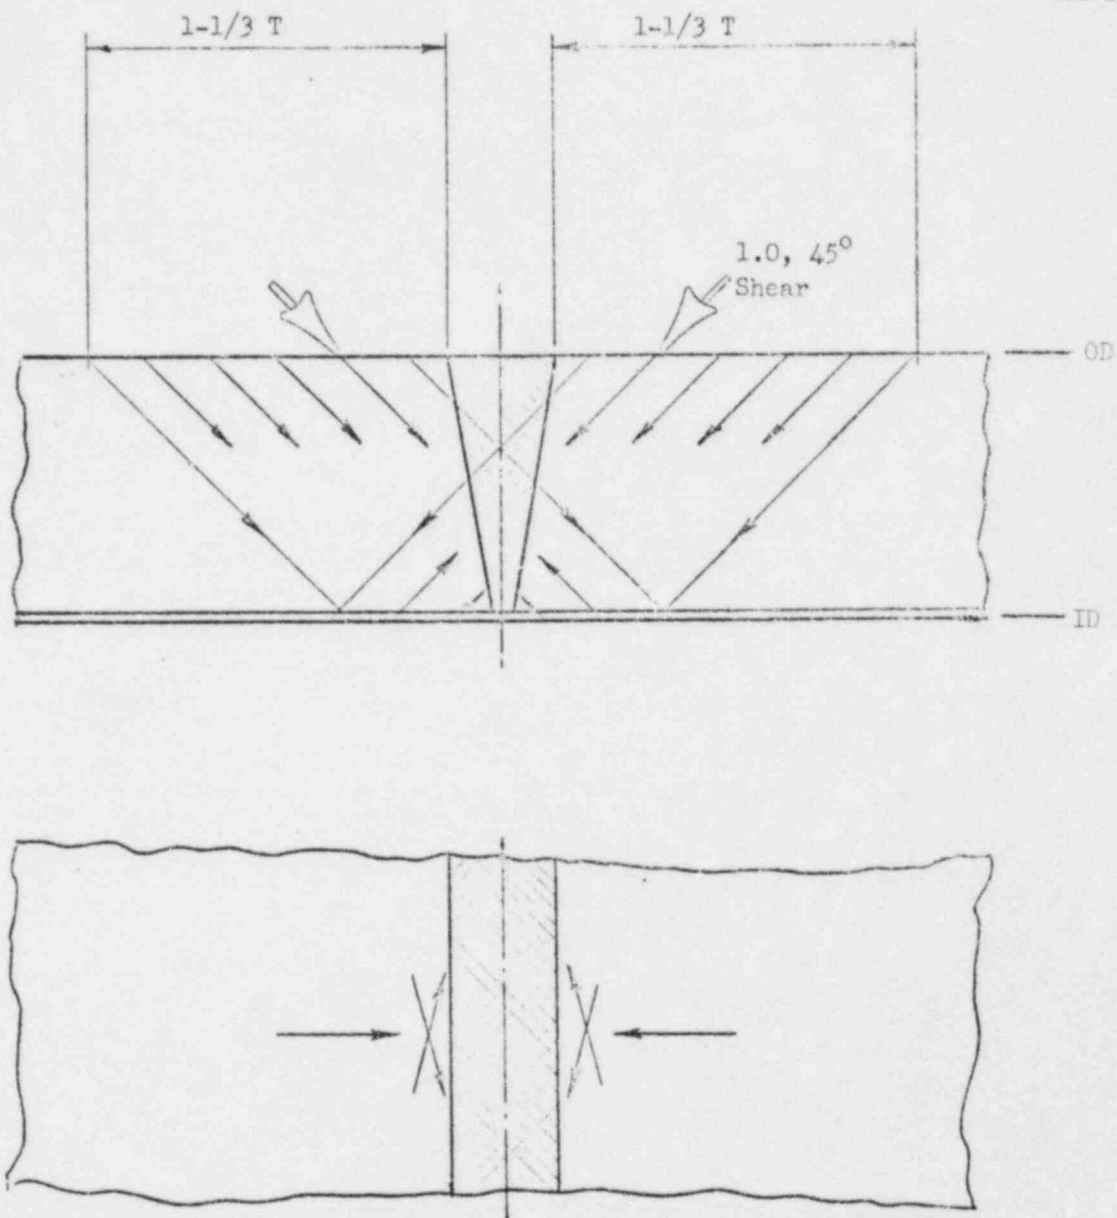
Figure 3

1) Ultrasonic Inspection - Circumferential weld seam was tested 90° in both directions from the "W" Axis in accordance with B&W Specification S-204C, Rev. 1 and found acceptable. Testing was done from the outside of the vessel using a longitudinal wave and shear wave search as shown in Figure 3. The following ultrasonic equipment was used:

1) Ultrasonic Inspection - The two longitudinal weld seams were tested in accordance with B&W Specification S-204, Rev. 1 and found acceptable. Testing was done from the outside of the vessel using a longitudinal wave and shear wave search as shown in Figure 3. The following ultrasonic equipment was used:

Weld cross sections showing, schematically, the mode, test frequency, test directions, extent of testing and the test surfaces used in the contact ultrasonic testing of the circumferential and axial seam welds in the WEP reactor vessel.

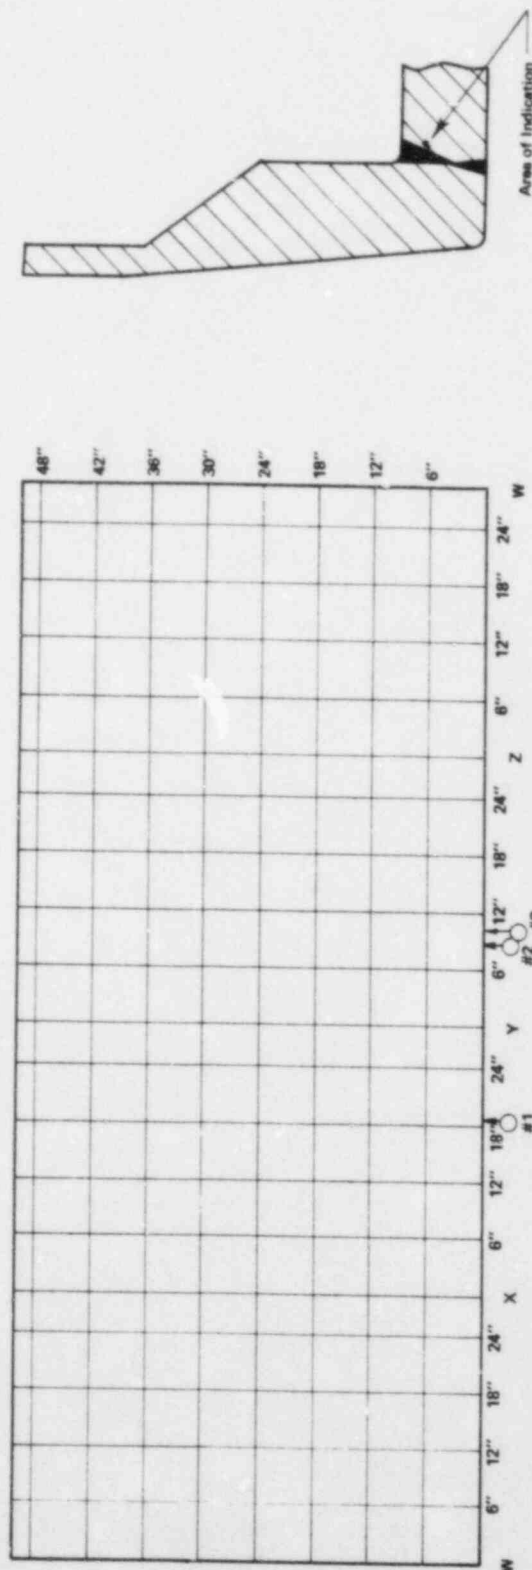
FIGURE 3

4.2.7 Area (6) The nozzle to nozzle shell course welds - Three (3) recordable indications were detected when testing in accordance with Paragraph 3.2.1.2 and charted as shown in Figure 3.

REPORTABLE INDICATIONS ON THE INLET NOZZLE

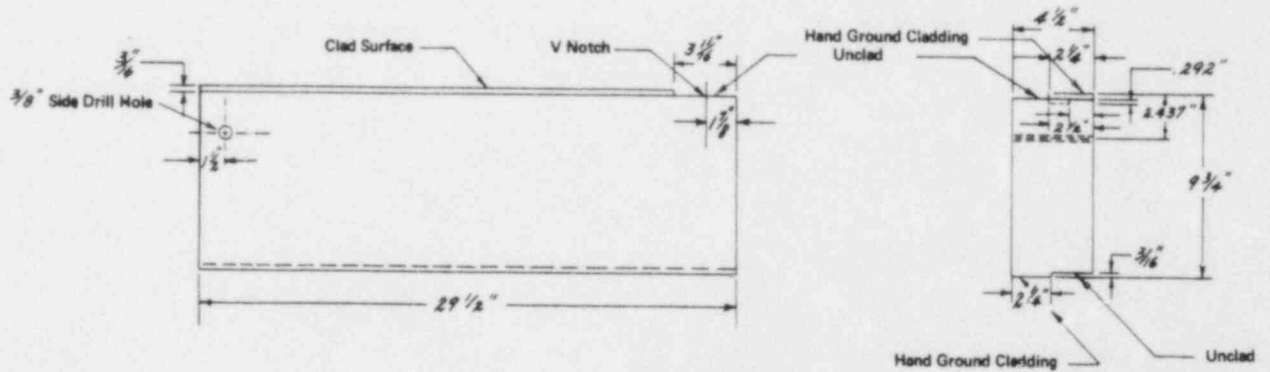
FIGURE 4

ULTRASONIC CALIBRATION BLOCK

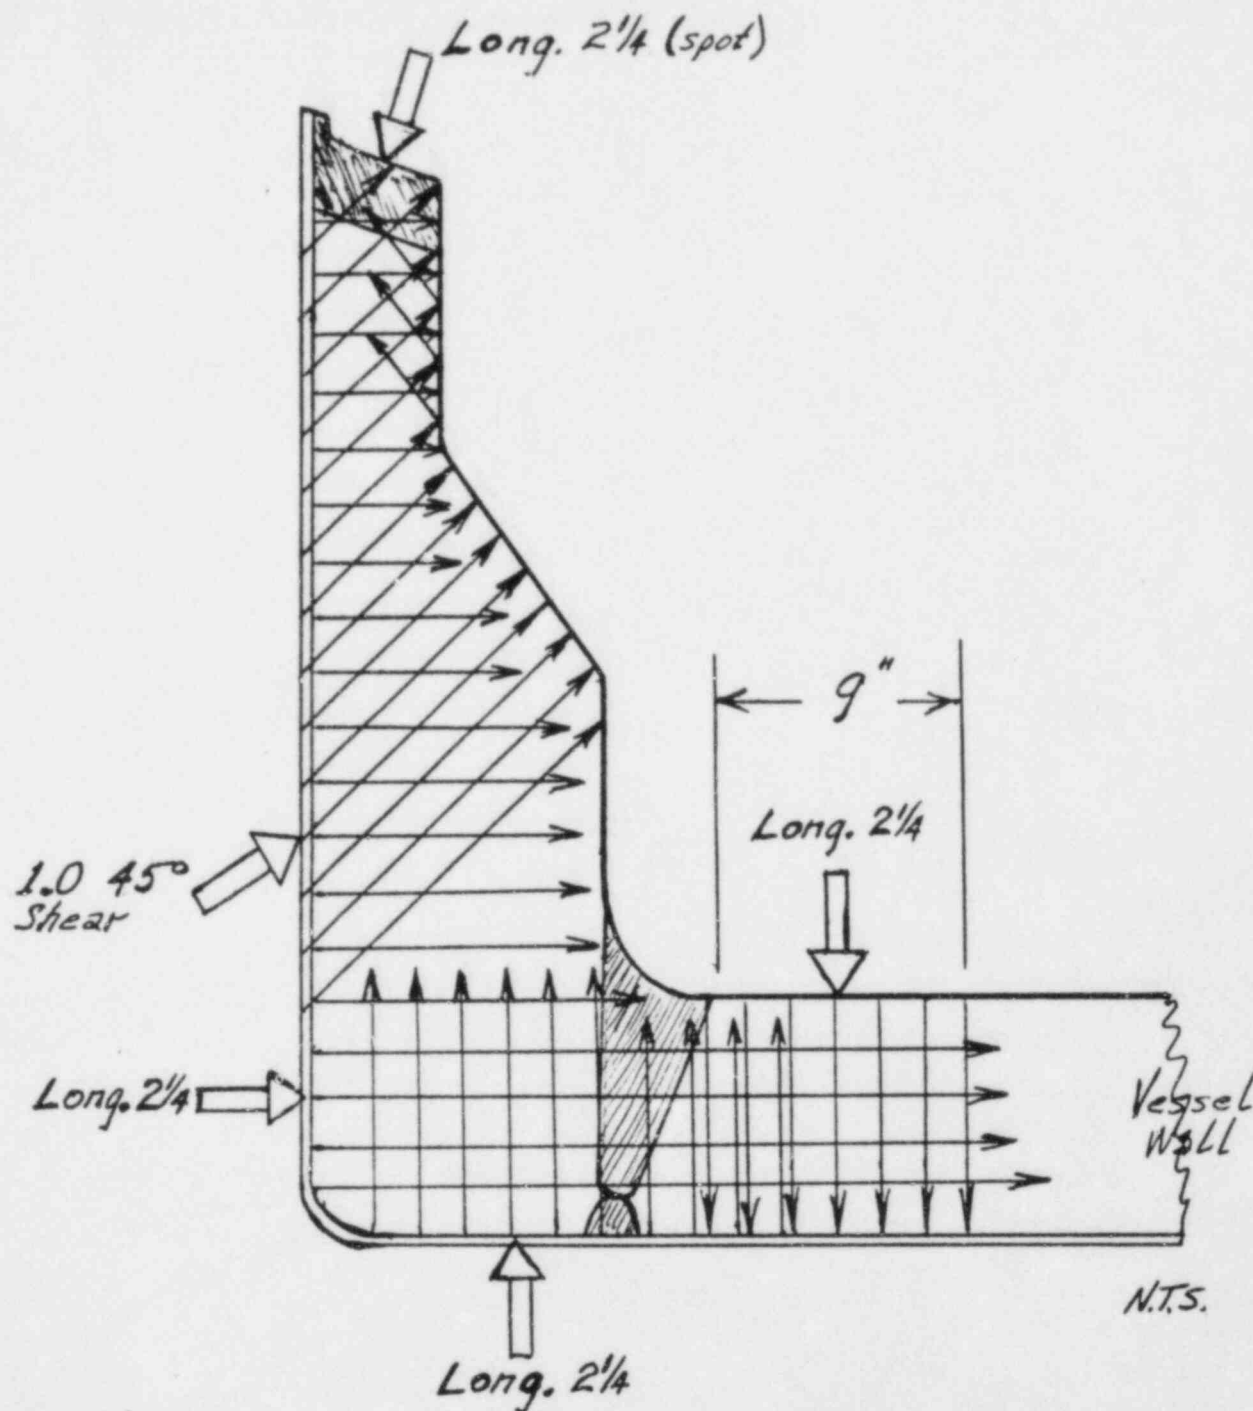
Figure 1

Nozzle cross section showing (schematically) the mode, test frequency, test direction, extent of testing and the test surfaces used in the contact ultrasonic testing performed on the W-2 and W-X nozzles of the WEP vessel.

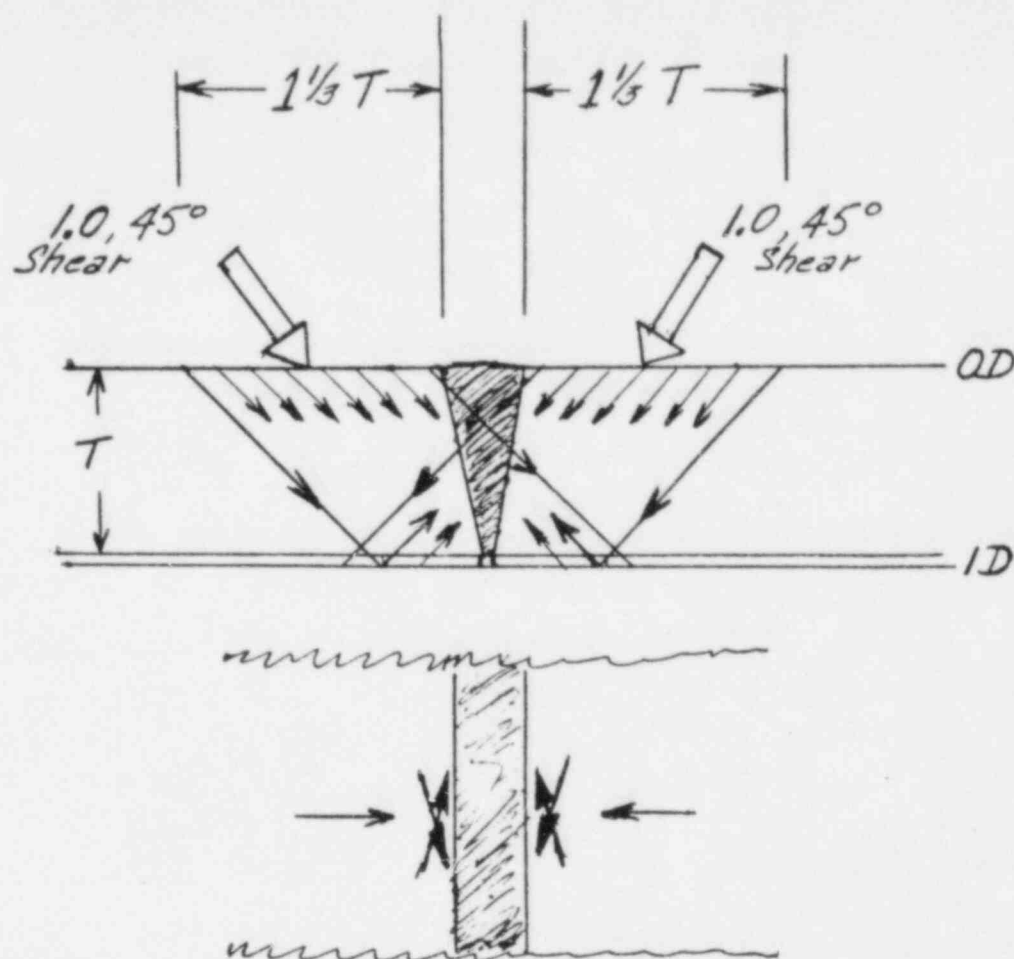
Figure 2

Weld cross sections showing, schematically, the mode, test frequency, test directions, extent of testing and the test surfaces used in the contact ultrasonic testing of the circumferential and axial seam welds in the WEP reactor vessel.

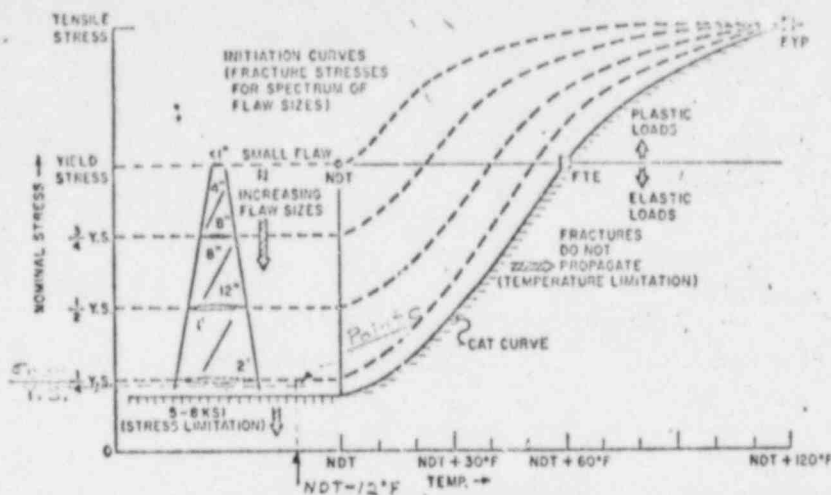
- from Figure 9 of Reference 2 there is no crack large enough to cause fracture due to the local stress at the nozzle end.

- from Figure 9 the minimum crack size at Point CU is 2feet

Fig. 9—Generalized fracture analysis diagram, as referenced by the NDT temperature

The maximum NDT for any point on the vessel is +50°F. The temperature at the time of the fall was 38°F. This is NDT -12°F for the loaded sections.

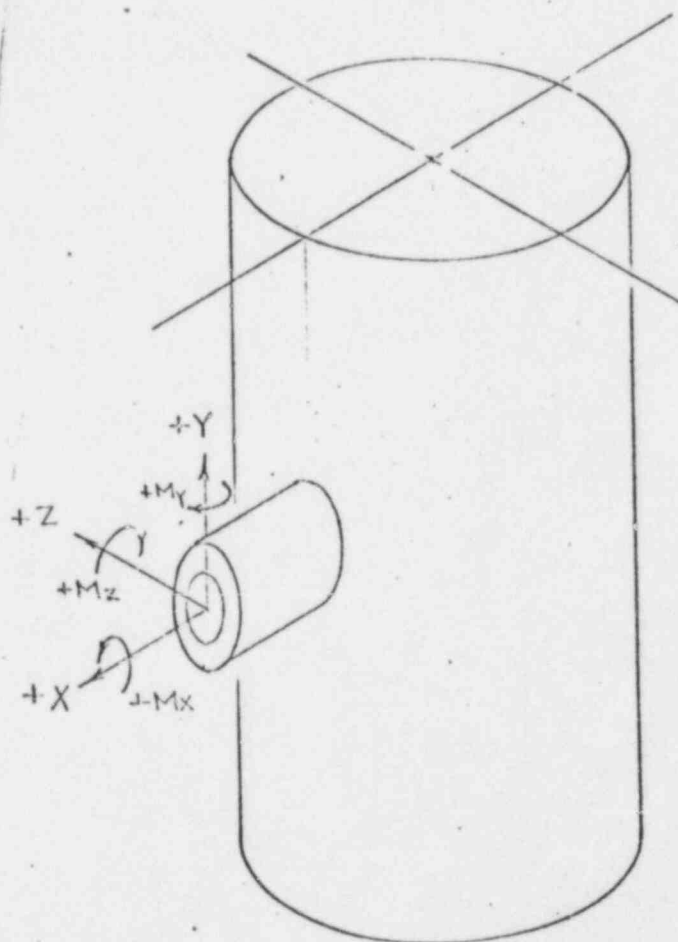
FIGURE 1

STRESSES IN A NOZZLE DUE TO EXTERNAL MECHANICAL LOADS
