NUCLEAR REACTOR PRESSURE VESSEL TRANSPORTATION INCIDENT

POINT BEACH UNIT 1

VOLUME I

PREPARED FOR
WISCONSIN MICHIGAN POWER COMPANY
231 WEST MICHIGAN STREET
MILWAUKEE, WISCONSIN 53201

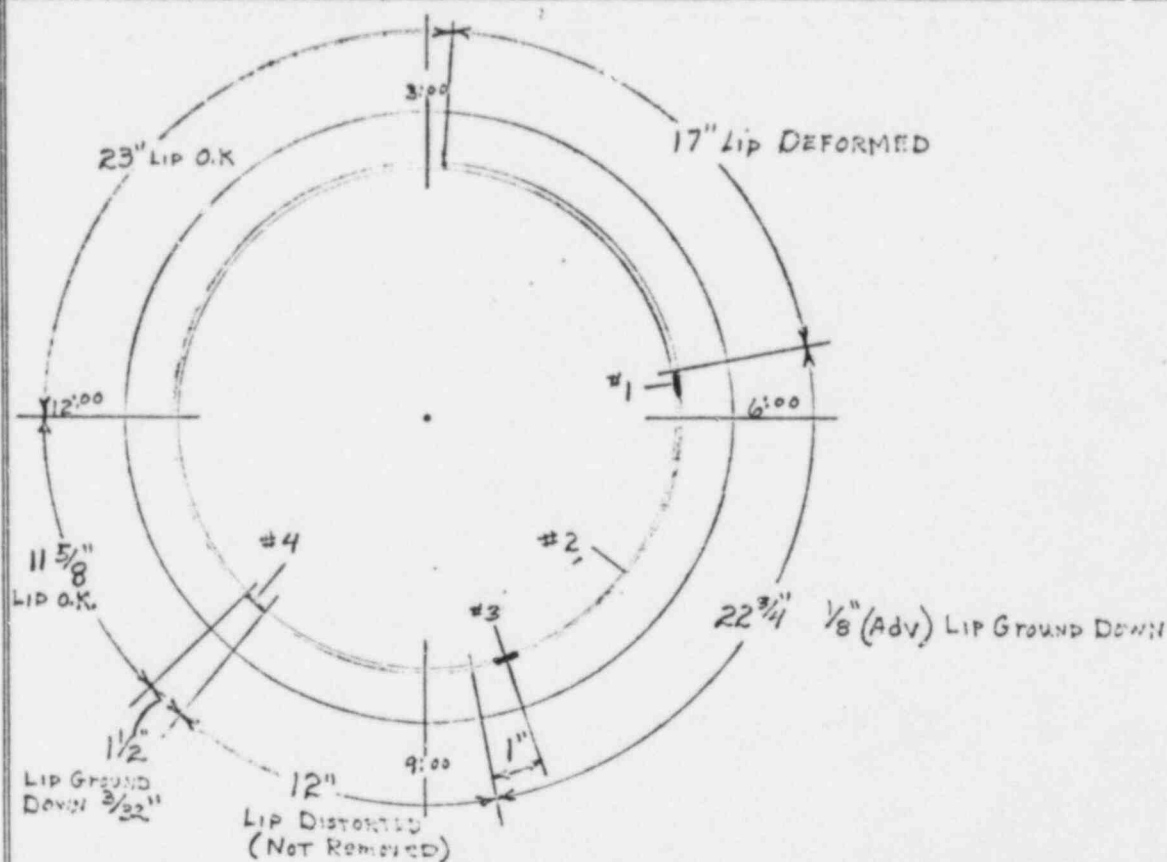
| INDICATION No. | TYPE | SIZE |
|---|---|---|
| # 1 | GROUND LIP | $\frac{3}{16}$ Removed From FACE x $1\frac{1}{4}$ " Lg. |

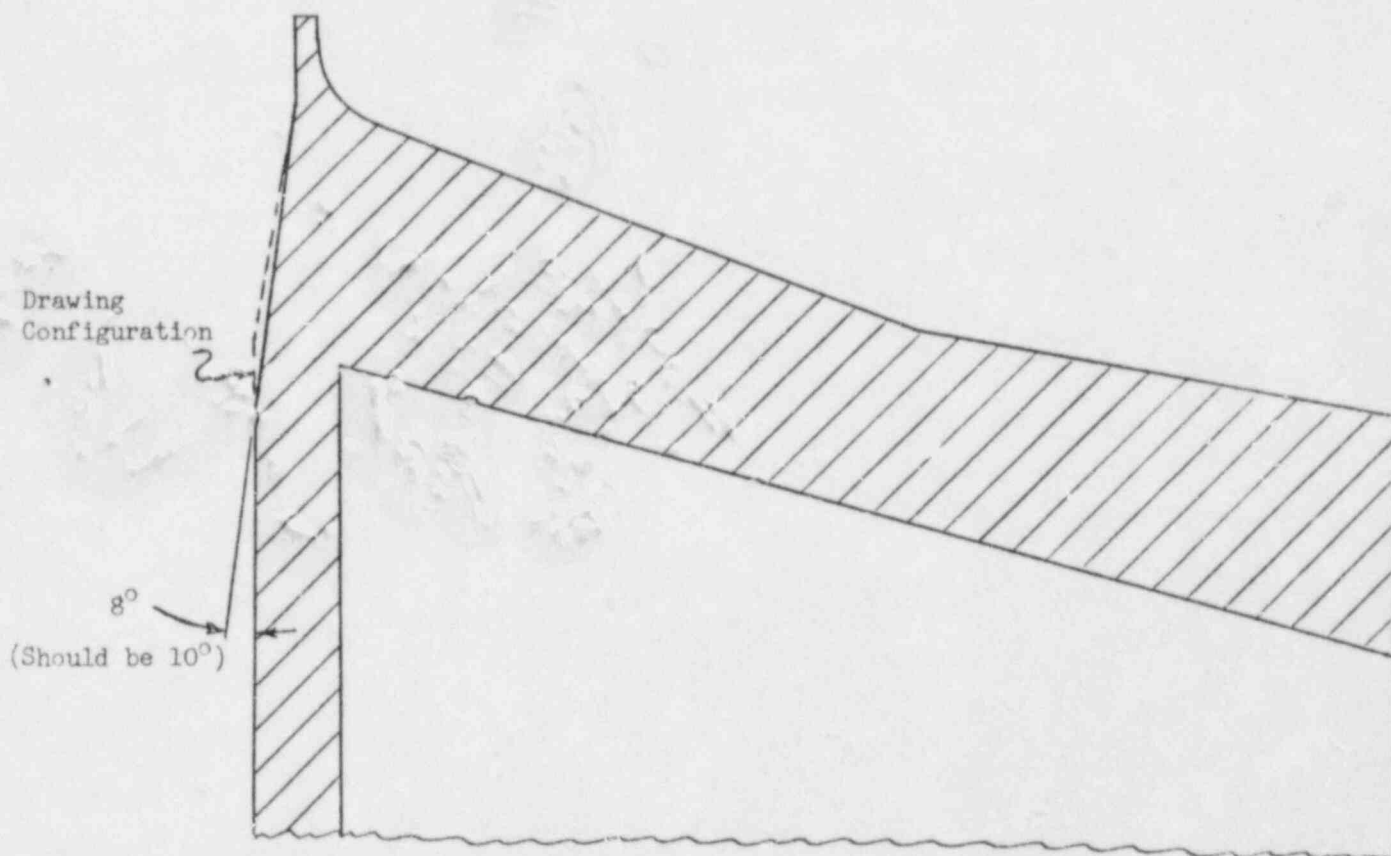
Final Machining - Inlet Nozzle

As a result of the repair to the nozzle weld preparations, the nozzles which were damaged during the transportation incident are returned to the as shipped condition.
