Trojan Nuclear Plant
Docket 50-344
License NPF-1

STEAM GENERATOR TUBE INTEGRITY SAFETY ANALYSIS REPORT
FOR
TUBE SUPPORT PLATE INTERSECTIONS

PORTLAND GENERAL ELECTRIC COMPANY

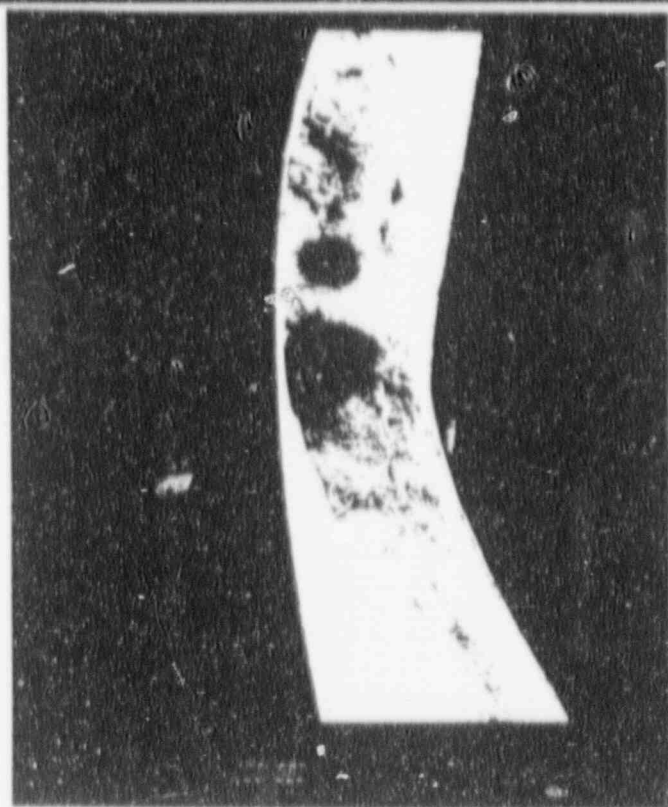
Figure 4-3: Burst Crack of CR30064 TSP #1.

Figure 4-3 shows a similar examination of the 'C'R30C64 TSP #1 axial burst crack. In this case the predominantly axial (with some circumferential) cracks on the OD surface opened up from the bulging of the tube section during the burst test. Again, the crack surface is jagged, is intergranular and shows evidence of branching.

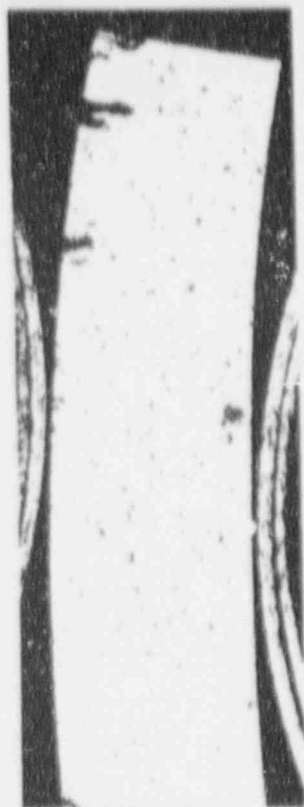
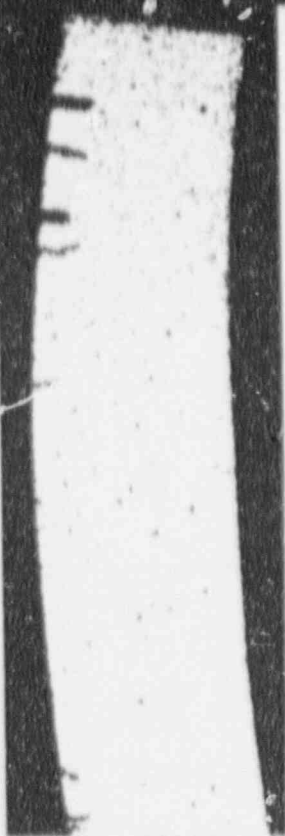
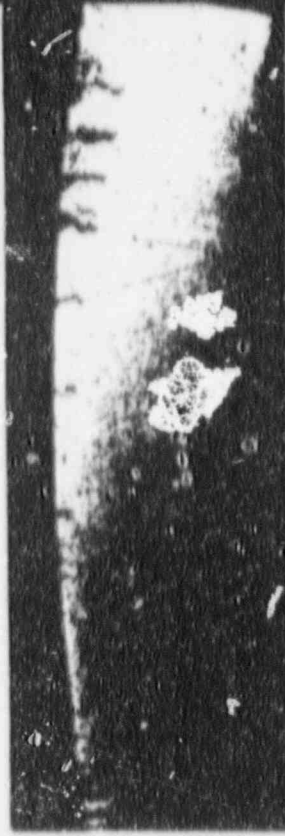
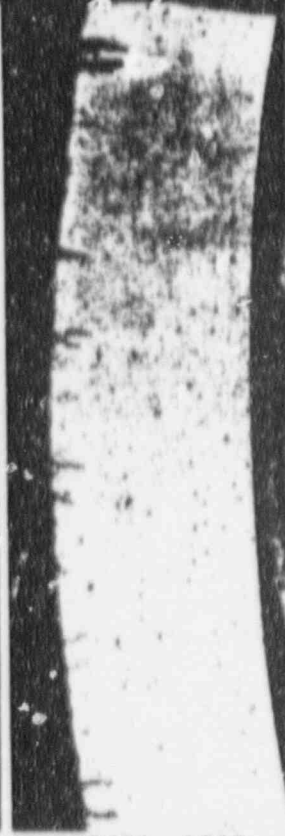
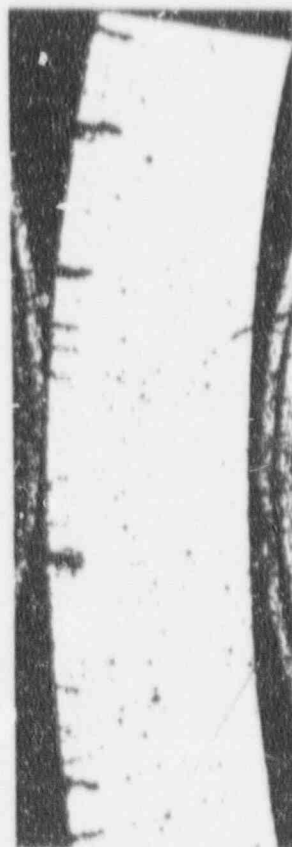
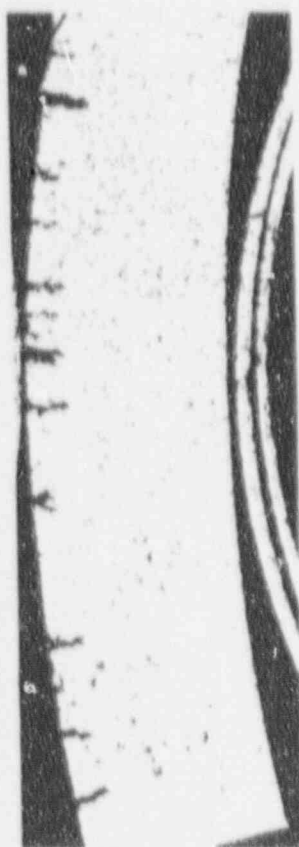
[Figure 5-18. Transverse View of 'D'R12C8 TSP #3 Seq. Grinds (20X)]

[Sets of longitudinal and transverse sections were examined at sequential levels approximately .025" apart. Table 5-2 summarizes the levels that were investigated. Figure 5-18 presents an example of how degradation changes from level to level. Both long and short axial penetrations are evident. Figures 5-19 through 5-21 present examples of IGA and IGSCC at the three support plates of 'D'R12C8.]

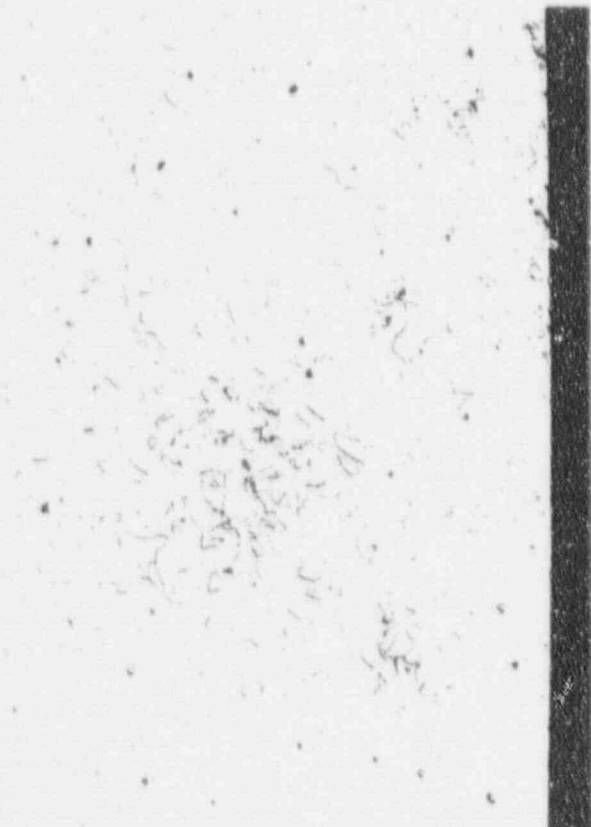
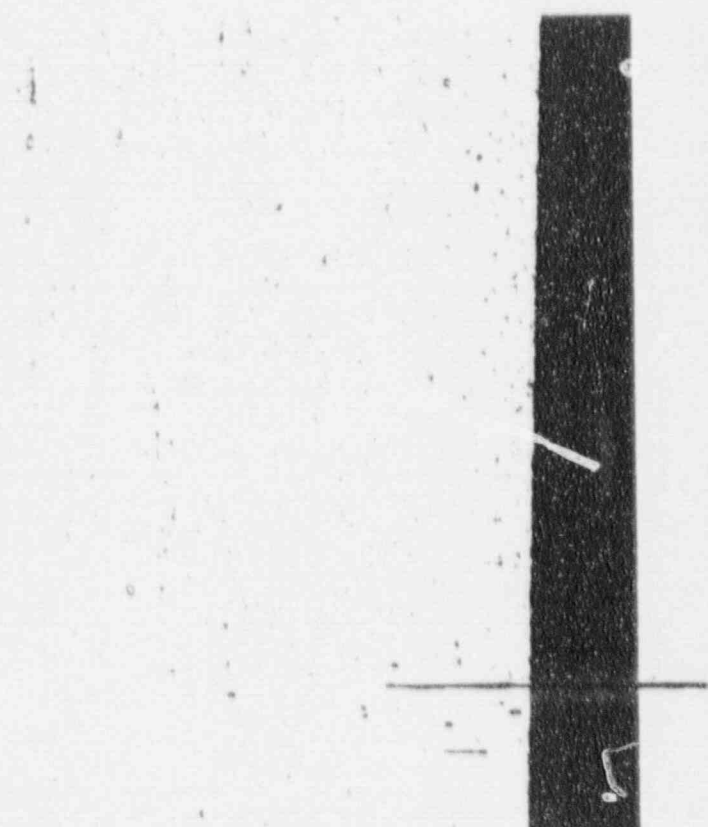
[Figure 5-22. View of 'C'R25C58 TSP #1 (200X).]

[Longitudinal and transverse mounts of the first TSP of 'C'R25C58 were also inspected. The transverse mount was inspected at four elevations, spaced .050 inches apart, without etching the second and third levels. In no case were any penetrations observed. Figure 5-22 presents views of 'C'R25C58 TSP #1.]
