Westinghouse Energy Systems

**Kewaunee Steam Generator  
Tube Plugging Criteria for  
ODSCC at Tube Support Plates**

November, 1991

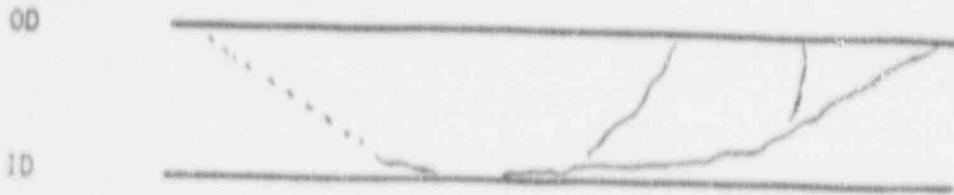
OD origin, axially oriented, intergranular stress corrosion cracks were observed confined entirely within the first support crevice region on hot leg tube R31-C46, removed in 1986 from Steam Generator C of Plant A-2. Destructive examination was confined to half of the tube circumference (the half with a single axial NDE indication). The main crack, composed of at least four microcracks which grew together, was 0.52 inch long and was through wall for approximately 0.02 inch. The morphology of the individual microcracks was branched SCC with moderate IGA components to the SCC. Figure 4-1 shows a sketch of SEM (scanning electron microscope) fractographic results of the main crack (only the mid to upper portion of the crack was examined) and a sketch of the overall crack distribution observed within the support plate crevice region. Figure 4-2 shows a sketch of the crack distribution (a composite of two transverse metallographic sections) and depth as viewed by metallography as well as a micrograph of a crack showing the crack morphology. In addition to the main macrocrack, (which included a 46% deep axial crack next to the main crack), two smaller axial cracks were observed at other circumferential positions on the half-circumference section examined.

Sketch of Burst Crack

Macrocrack Length = 0.52 inch

Figure 4-1. Summary of crack distribution and morphology observed on the first support plate crevice region of tube R31-C46.

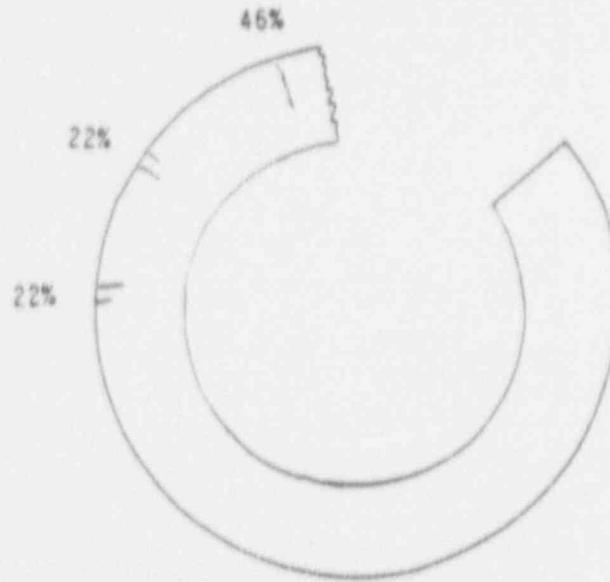
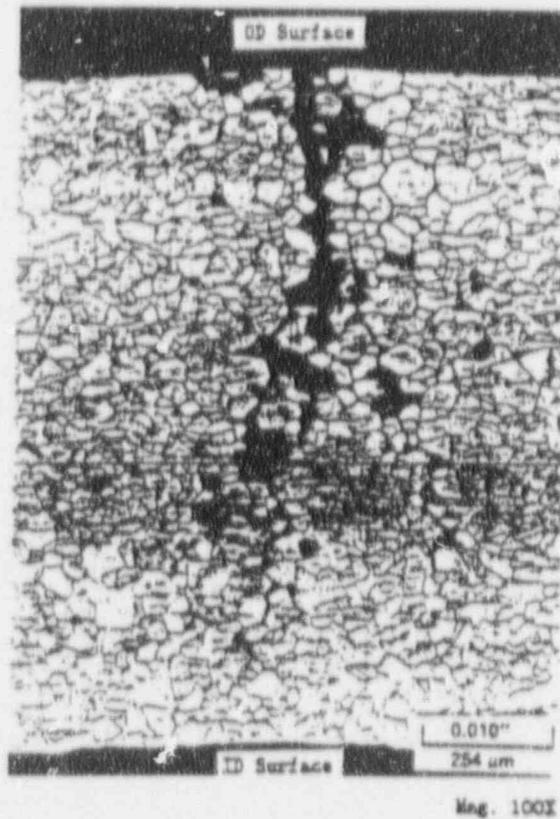
Figure 4-2. Secondary crack distribution and a photomicrograph of one of the cracks in a transverse metallographic section of the first support plate crevice region of tube R31-C46. The crack morphology is that of IGSCC with moderate IGA components.

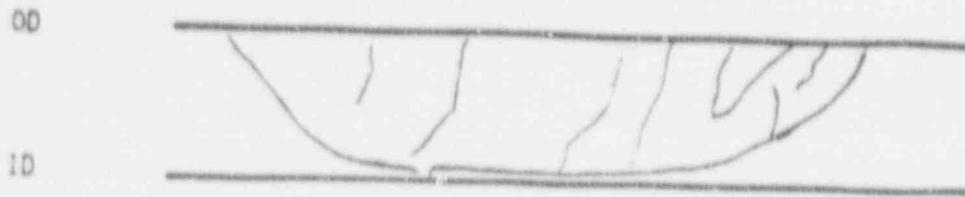
metallography. The macrocrack was 0.4 inch long and through wall for 0.01 inch. However, the crack was nearly (effectively) through wall for 0.1 inch. The macrocrack was composed of seven individual microcracks that had mostly grown together by intergranular corrosion (the separating ledges had intergranular features that ranged from 40 to 90% of the length of the ledges). Since no metallography was performed on the axial cracks, it is not possible to definitively describe the axial crack morphology at this location. At the eighth support plate region of the same tube, metallography showed that the morphology was that of SCC with a crack depth to IGA width ratio (D/W) of 15. Figure 4-3 summarizes the crack distribution and morphology data for the fifth support plate crevice region.

In addition to the OD origin axial macrocracks observed at the fifth support plate region, five local areas had circumferential intergranular corrosion. The maximum penetration observed for the circumferential cracking was 46% through wall. The morphology of the circumferential cracking was more that of IGA patches than of SCC. Figure 4-4 provides micrographs of relevant cracks showing the morphology of axial and circumferential cracks. As stated above, the axial cracks had a morphology of IGSCC with a moderate D/W ratio of 15 while the circumferential cracking had a morphology more like that of IGA, with a D/W ratio of 1.

Sketch of Burst Crack

Macrocrack Length = 0.4 inch

Figure 4-3. Description of OD origin corrosion at the fifth support plate crevice region of tube R4-C61.

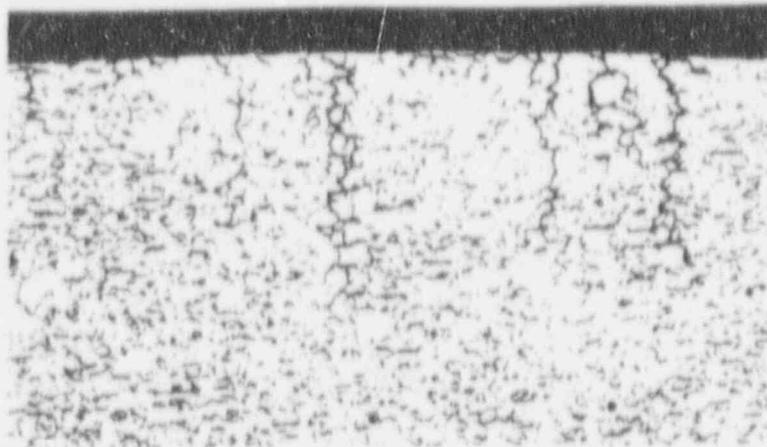
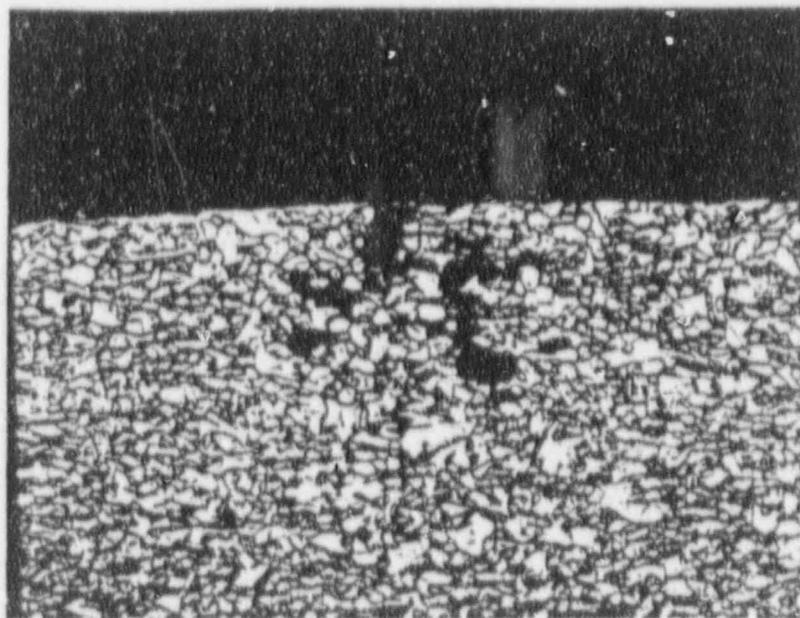
Figure 4-4. Photomicrographs of tube R4-C61 corrosion degradation. Top photo shows axial crack morphology (transverse section) at the eighth support plate location (no transverse metallography was performed at the fifth support plate region). Bottom photo shows circumferential crack morphology (axial section) at fifth support plate region.

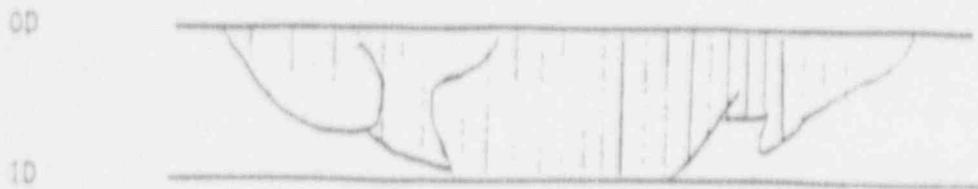
Sketch of Burst Crack

Macrocrack length = 0.42 inches

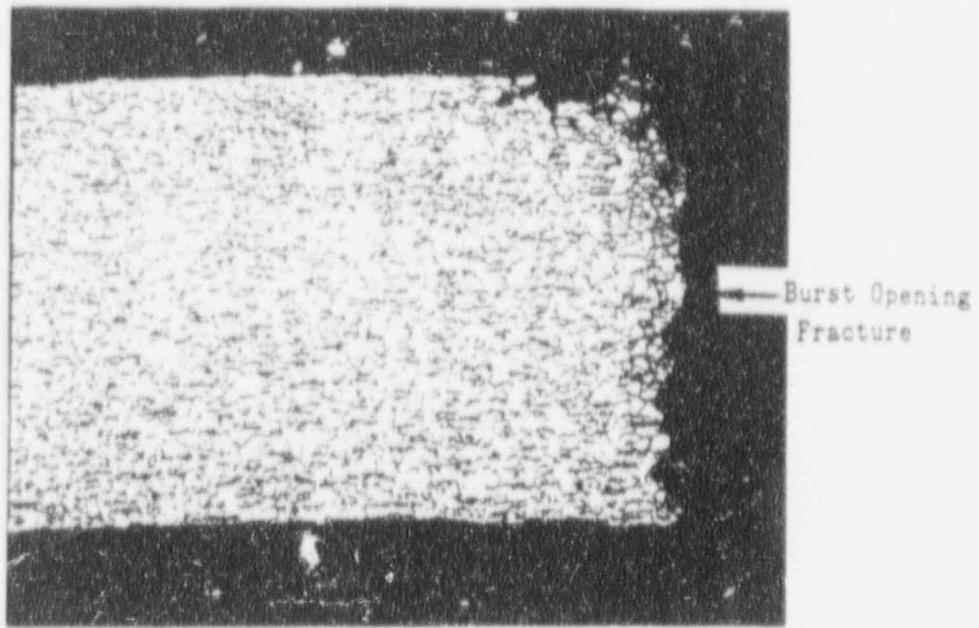
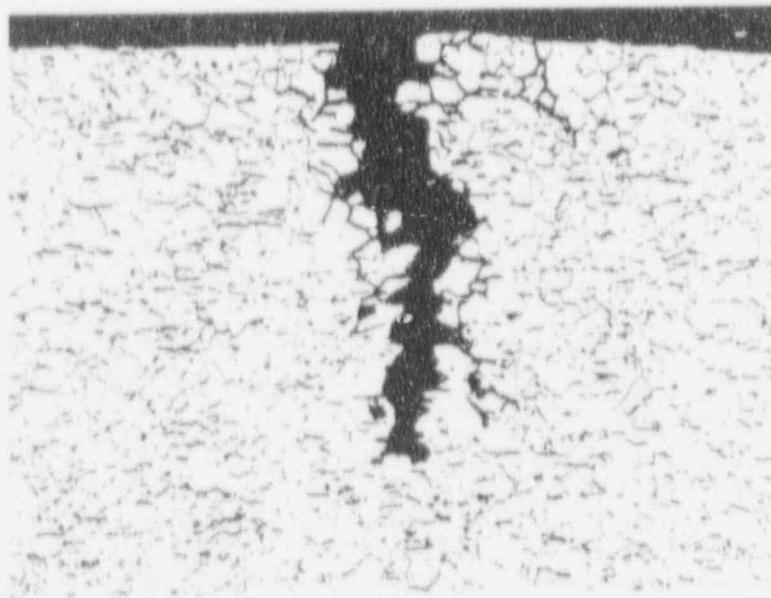
Figure 4-7. Top photomicrograph is from a transverse section through one half of the main burst crack. The crack morphology is that of IGSCC with some IGA characteristics (width of IGA is 0.006 inch on one side of the crack). Bottom micrograph is from a transverse section through a typical crack located near the burst crack. The morphology is that of IGSCC with only minor IGA characteristics. (Note: crack is opened wide by tube deformation).

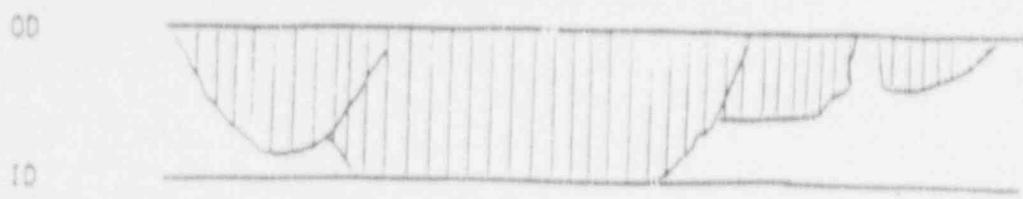
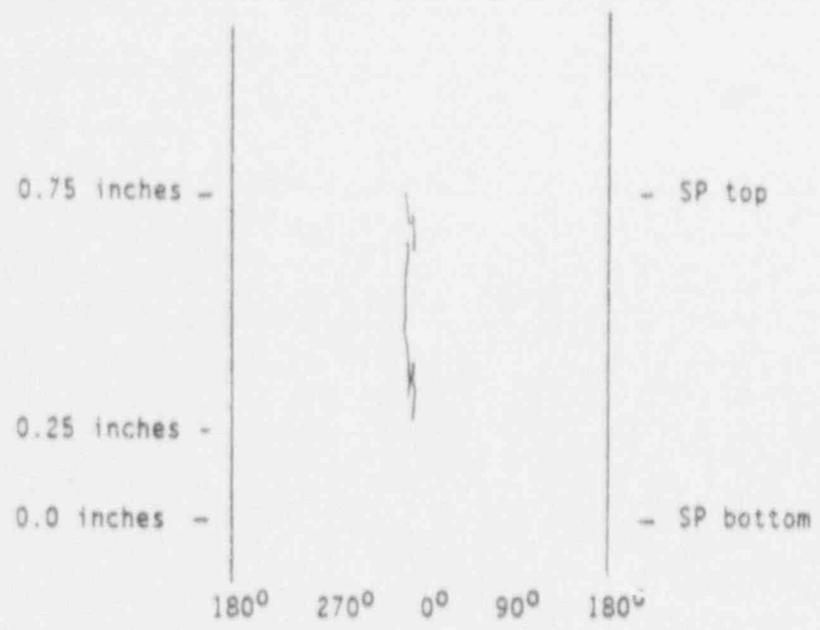
Figure 4-8 shows a sketch of the SEM fractographic observations on the burst fracture face of the first support plate region of tube R21-C22. Within the center of the burst opening, a 0.50 inch long OD origin macrocrack was observed. The macrocrack was located at an orientation of 330° and was entirely confined to within the support plate crevice region. The corrosion crack had only intergranular features. The macrocrack was composed of four microcracks. Three of the microcracks were joined by intergranular corrosion, while the top most microcrack was still separated from the others by metal. The macrocrack was through wall for approximately 0.15 inch. Figure 4-8 also provides a description of the crack morphology. The crack morphology was that of SCC with significant IGA components. The width of IGA surrounding the SCC is estimated to be approximately 0.030 inch ( $D/W = 1.7$ ). One additional crack was later observed on the specimen by metallographic examination. Figure 4-9 provides a sketch of the crack distribution and depth observed by metallography. Figure 4-10 provides micrographs of the cracks. As can be observed, the secondary crack morphology had lesser IGA components ( $D/W = 19$  to 37).

Macrocrack Length = 0.50 inches  
 Throughwall Length = 0.15 inches  
 Number of Microcracks = 4 (two ligaments with intergranular features, one with ductile overload features)  
 Morphology = Intergranular SCC with significant IGA characteristics (width of IGA 0.030 inches)

Figure 4-8. Description of OD origin corrosion at the first support plate crevice region of tube R21-C22.

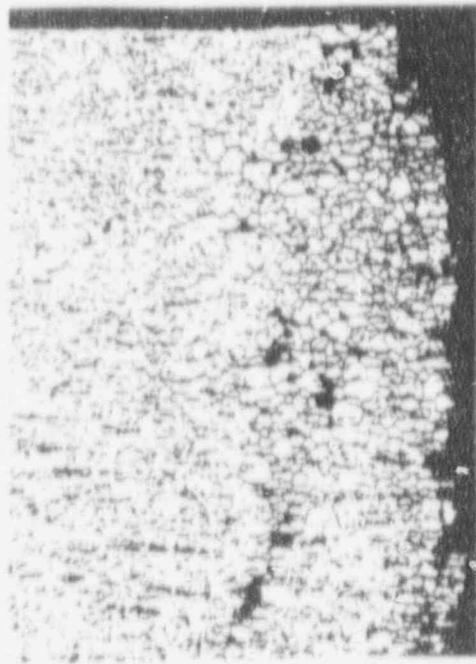
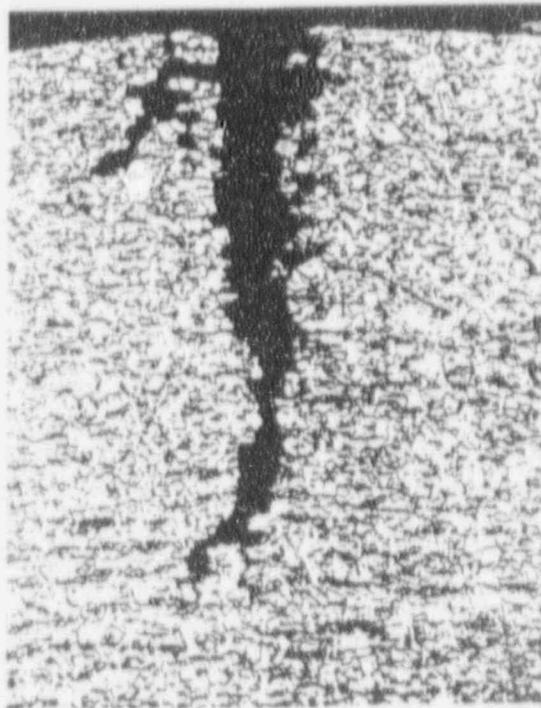
Figure 4-10. Top micrographs are from a transverse section through one half of the main burst crack. The morphology is that of IGSCC with significant IGA characteristics (width of IGA is 0.015 inch on one side of the crack). Bottom micrograph is from a transverse section through the only other crack found in the crevice region. Its morphology is more that of IGSCC. (Note: crack has been opened wide by tube deformation).

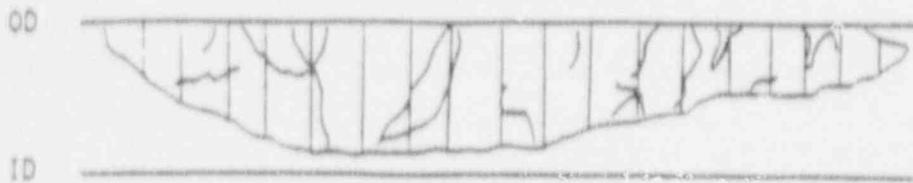
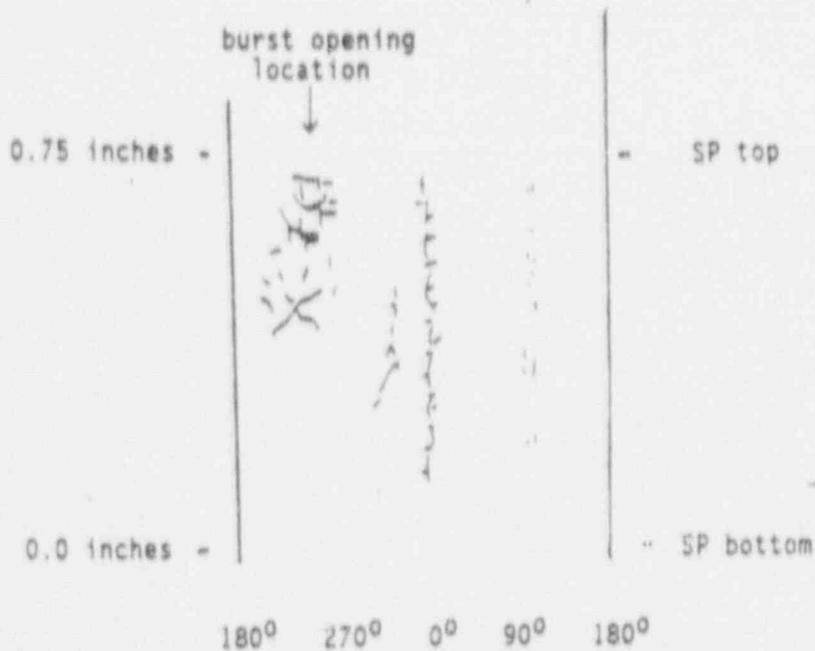
Figure 4-11 shows a sketch of the SEM fractographic observations on the burst fracture face of the first support plate region of tube R38-C46. A 0.37 inch long, OD origin, axial macrocrack was observed. The intergranular crack was up to 78% through wall and was contained within the support plate crevice region. The macrocrack was composed of numerous microcracks which had an unusual spatial distribution. They had orientations which ranged from axial to circumferential generating a spider-like crack distribution. Three other crevice locations had less deep but significant intergranular crack distributions. Their locations are also shown in Figure 4-11. Figure 4-12 shows the crack distribution and depth as determined by transverse metallographic examinations. Figure 4-13 shows photomicrographs of cracks in transverse sections obtained from within the crevice region. The cracks are opened wide by tube deformation. The morphology of the cracks is that of IGSCC with minor to moderate IGA components ( $D/W = 14$  to 28).

Macrocrack Length = 0.37 inches

Number of Microcracks = numerous (ligaments have intergranular features)

Morphology = Intergranular SCC with minor IGA features  
(Unusual spider-shaped crack distribution)

Figure 4-11. Description of OD origin corrosion at the first support plate crevice region of tube R38-C46.

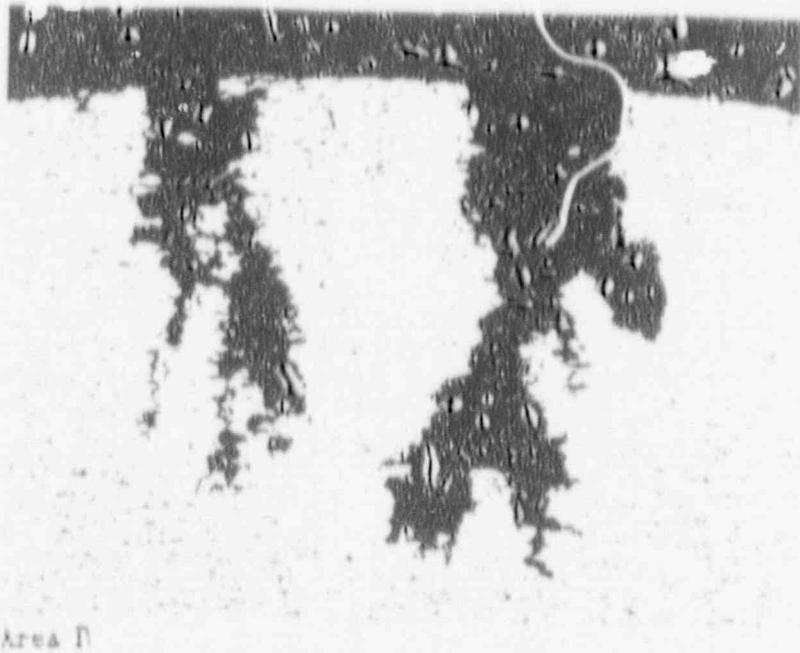
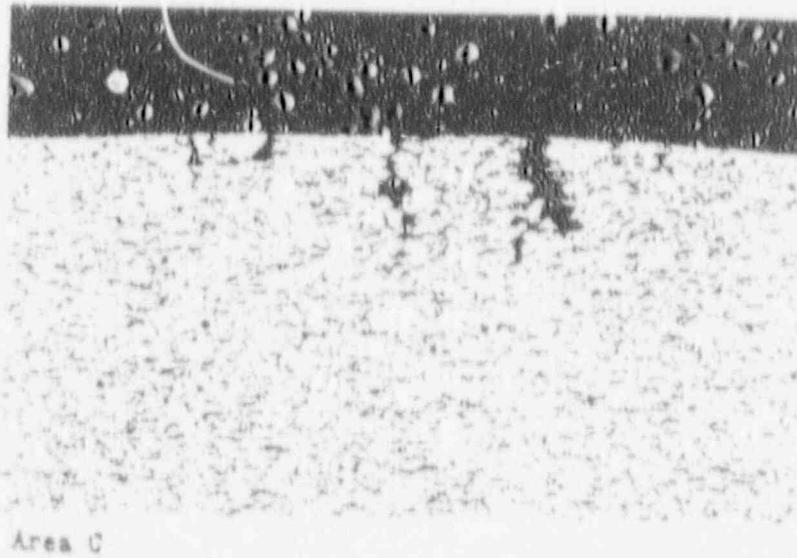
Figure 4-13. Photomicrographs of a transverse metallographic section through the first support plate crevice region of tube R38-C46. The crack morphology is that of IGSCC with minor IGA characteristics. Mag. 100X.

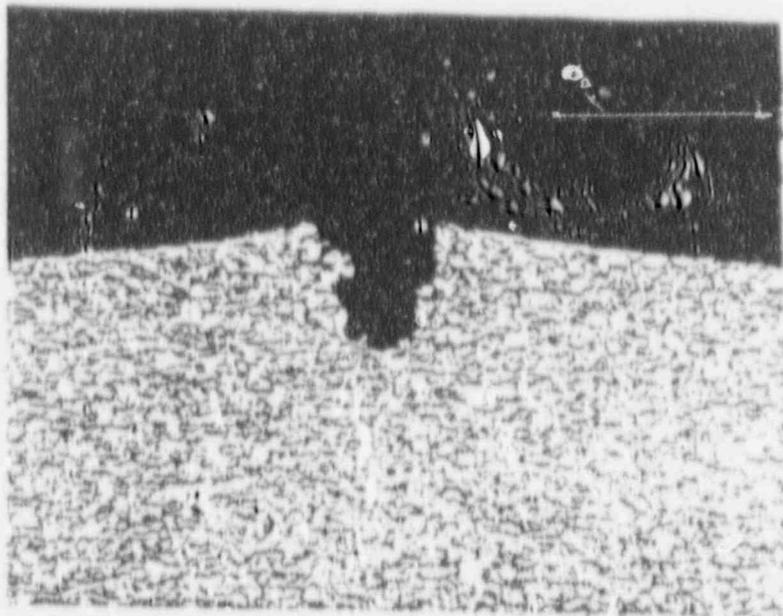
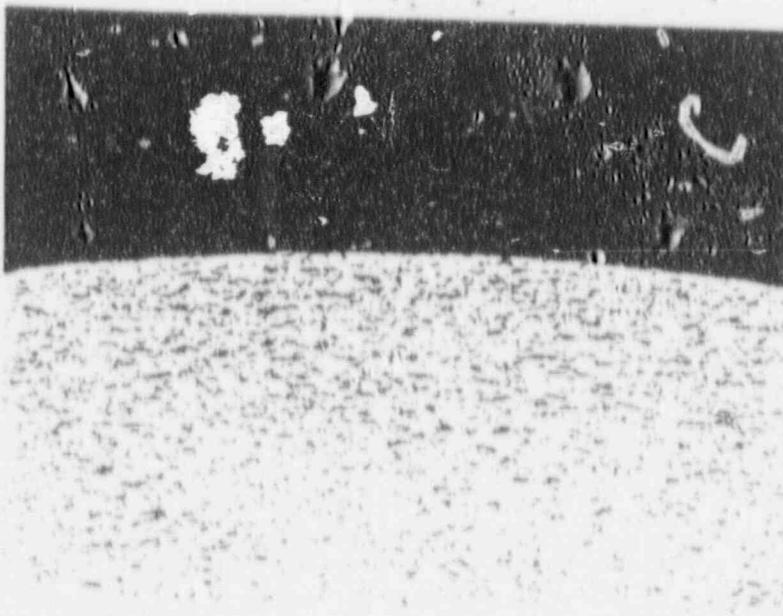
0.2 inch below the support plate top edge, the penetrations formed two short parallel axial cracks, 0.06 inch long and up to 0.0015 inch deep. Consequently, all three support plate regions of tube R16-C50 had no, or only very minor, IGSCC degradation. Figure 4-14 shows a micrograph of the largest crack found, that within the first support plate crevice region. The morphology is that of IGSCC with only minor to moderate IGA components.

Figure 4-14. Cracks at the OD surface of Plant A tube R16-C50 at the first tube support plate crevice, Mag. 100X.

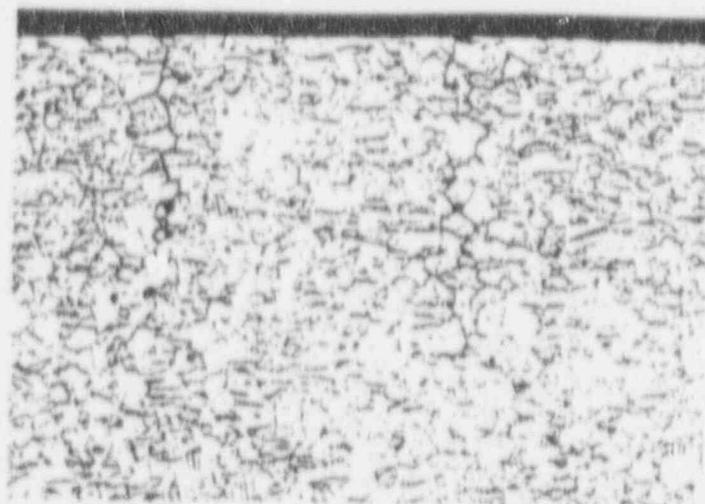
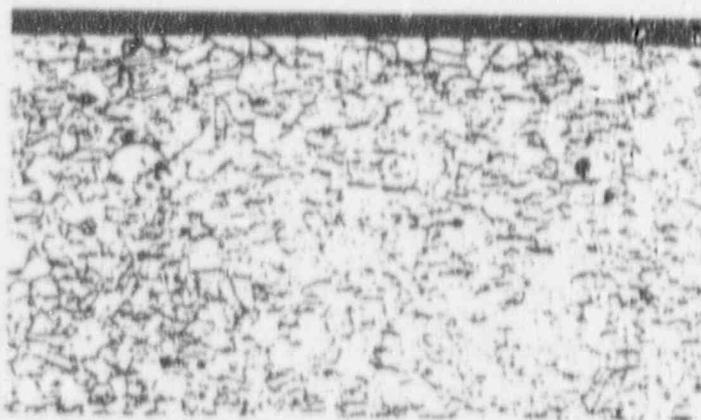
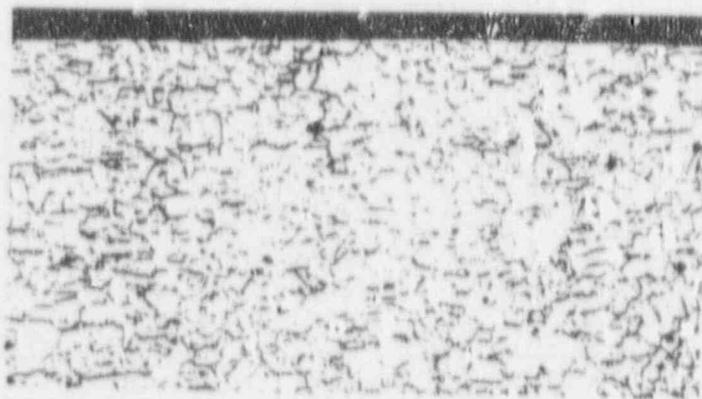
Destructive examination of tube R16-C53 found OD origin intergranular corrosion within all three support plate regions. The first support plate region of tube R16-C53 had numerous OD origin, intergranular, axial stress corrosion cracks, but the depth of cracking was shallow (0.0055 inch maximum depth). At the second support plate of tube R16-C53, axial intergranular stress corrosion cracking was found on the tube OD concentrated near the support plate top edge and to a lesser extent near the support plate bottom edge. There were dozens of very tight stress corrosion cracks located discontinuously around the circumference, but located within all four quadrants of the tube. The maximum depth of penetration was 0.011 inch (22%). The third support plate region also had numerous but relatively shallow OD origin, intergranular, axial SCC. The maximum depth of degradation was 0.0065 inch. Consequently, the only support plate region of tube R16-C53 with corrosion degradation of any potentially noticeable (by eddy current) depth was the second support plate region where the maximum depth was 0.011 inch (22% through wall). The morphology of these cracks ranged from that of IGSCC (Figure 4-15) to that of IGSCC with significant IGA components (Figure 4-16).

Figure 4-15. Photomicrographs of a transverse section from the first support plate  
brvice region of tube R16-C53. Mag. 100X.

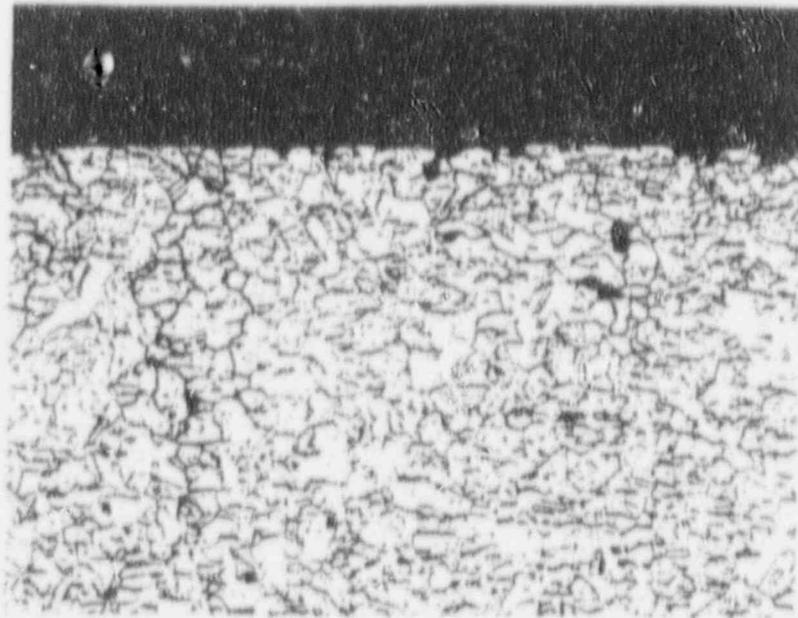
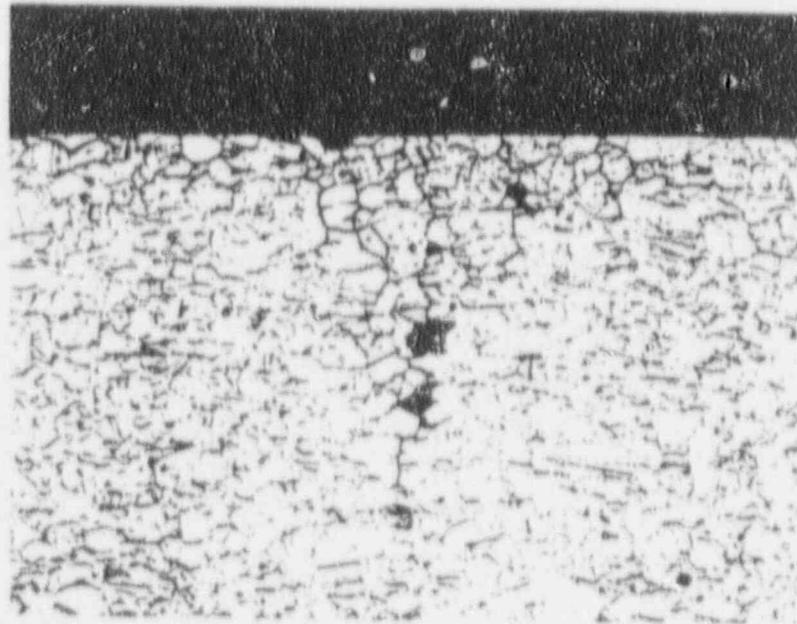
Figure 4-16. Additional micrographs from the same transverse section shown in Figure 4-15, tube R16-C53. Mag. 100X.

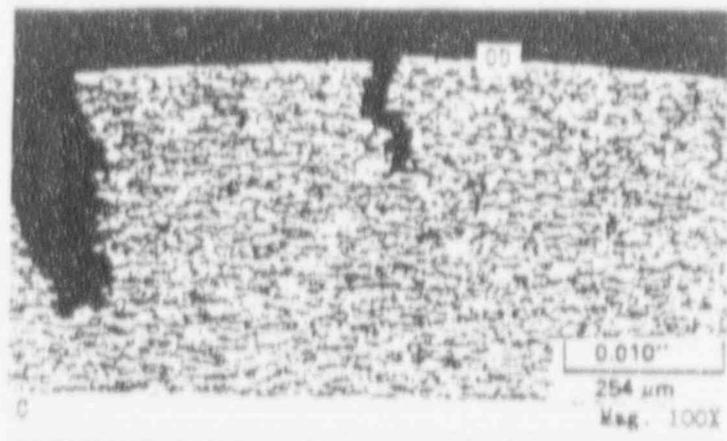
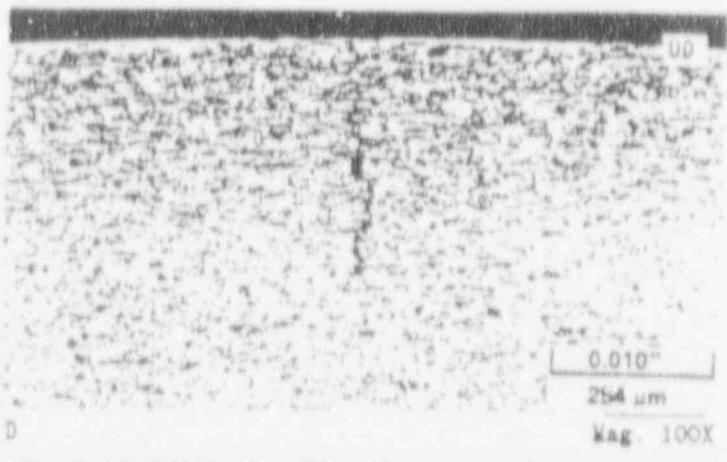
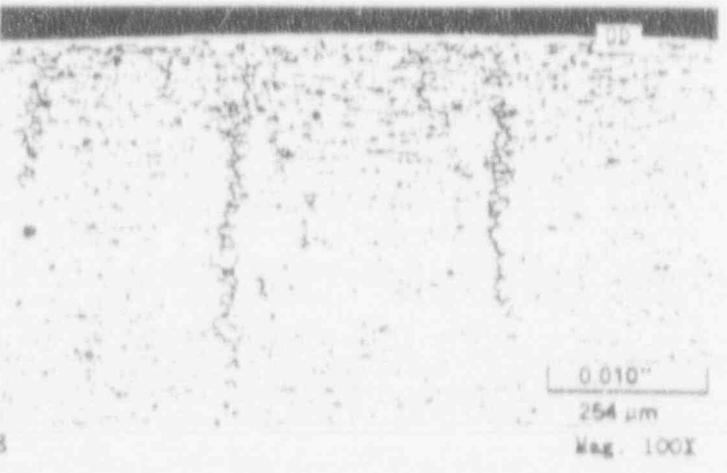
Figure 4-20. Crack details in Areas C, D, and E of metallographic cross section shown in previous figure, tube R20-C26 HL.

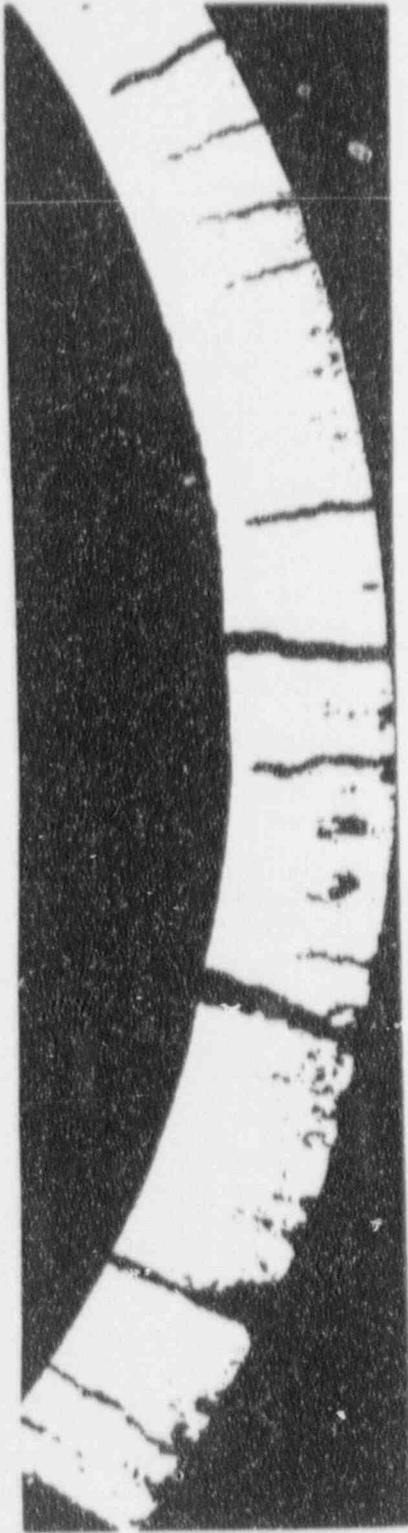
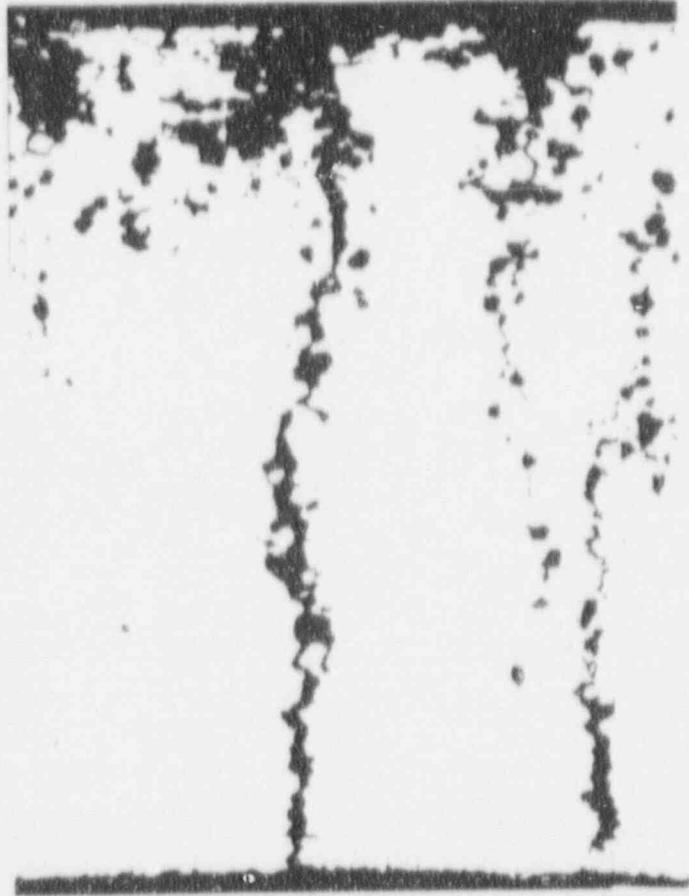
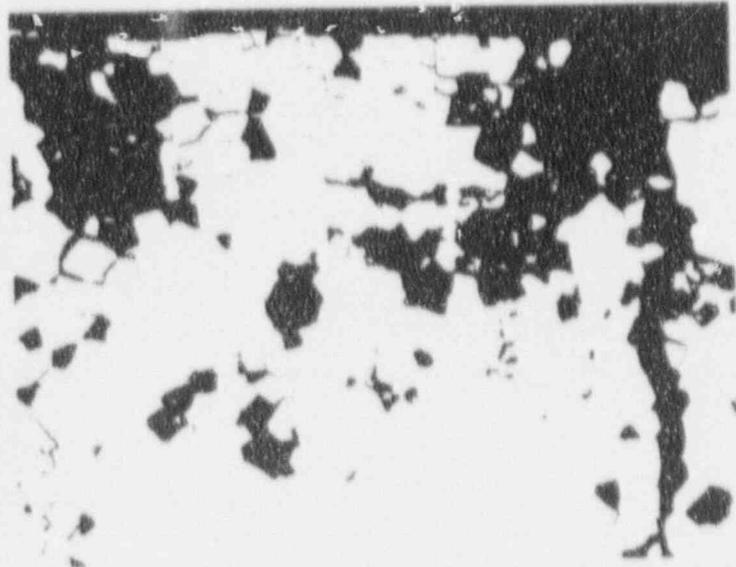
While not examined by Westinghouse, the following presents data regarding Plant J-1 and Plant N-1. Figure 4-23 and 4-24 show photomicrographs from the first and second support plate regions of tube R8-C74 of steam generator 2 of European Plant J-1. The intergranular corrosion appears to be very similar to that at Plant L. Table 4.4 presents qualitative morphological data. While there is a slightly lower crack density, the extent of IGA associated with individual cracks is similar (moderate D/W ratios), the extent and depth of IGA is similar and the origin of the IGA also appears to be that of closely spaced axial IGSCC interacting near the surface to form local IGA patches. It is also interesting that the maximum depth of IGA compared to the depth of IGSCC is similar, typically one-third to one-half of the IGSCC depth. The data from the support plate regions at Plant N-1 was not in a form where firm conclusions regarding corrosion morphology could be made. Table 4.4 also presents an attempt to force conclusions from the data available to Westinghouse. Averaging the data from the three support plate regions, it is concluded that a corrosion morphology similar to Plant L (tube R12-C8) and Plant J-1 exists at Plant N-1.

Figure 4-23 Transverse photomicrographs of intergranular corrosion at the first support plate region of tube L8-C74 from Plant J-1

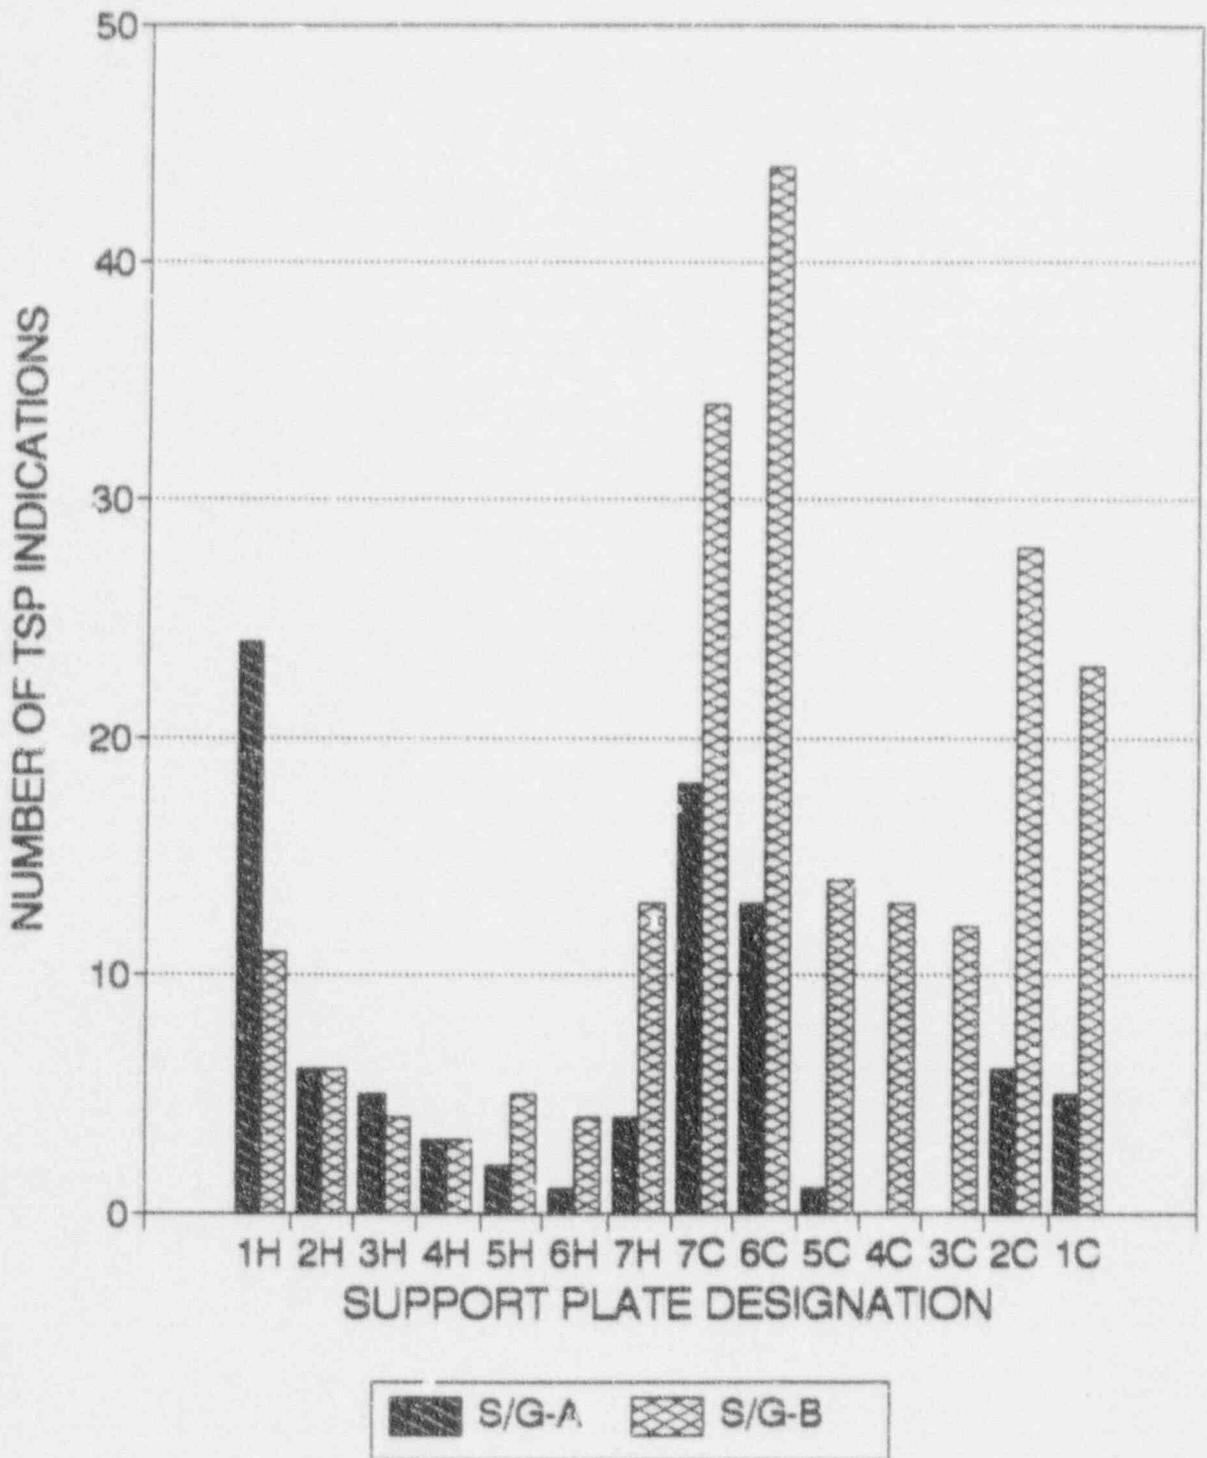
Nearly 70% of the tube support plate indications were in S/G-B and the remaining in S/G-A. In S/G-B, more indications were found on the cold leg side than on the hot leg side. Figure 5-1 displays the frequency distribution of TSP indications by support plate locations. Of all plate locations, support plate 6C (sixth plate from the bottom, in the cold leg) in S/G-B had the greatest number of indications. The lowest and highest plates had more indications than the intermediate level TSPs. The number of indications at each TSP location as a percentage of the total in each S/G is shown in Figure 5-2. In S/G-A, the largest percentage of indications were in the lowest hot leg support plate (Plate 1H), followed by the highest cold leg TSP (Plate 7C). In S/G-B, the largest percent TSP indications were in Plate 6C, followed by Plate 7C.

Figure 5-1. Frequency Distribution of TSP Indications by Location (March 1991 Inspection)

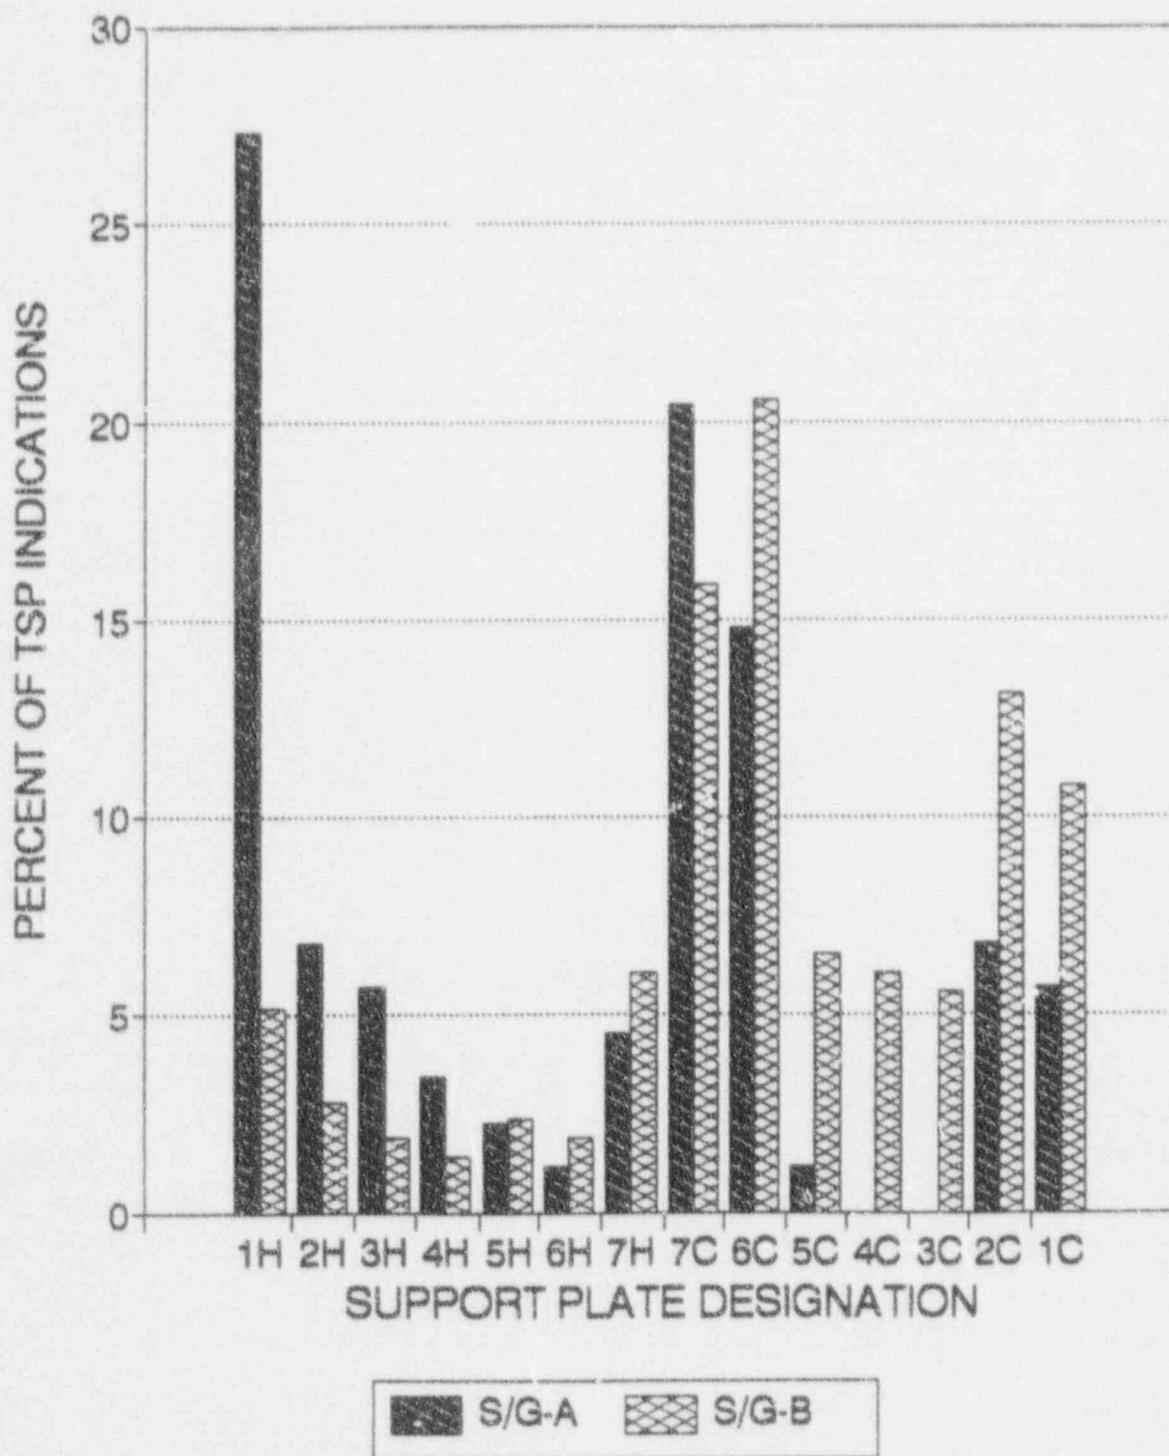
Figure 5-2. Percentage Distribution of TSP Indications by Location (March 1991 Inspection)

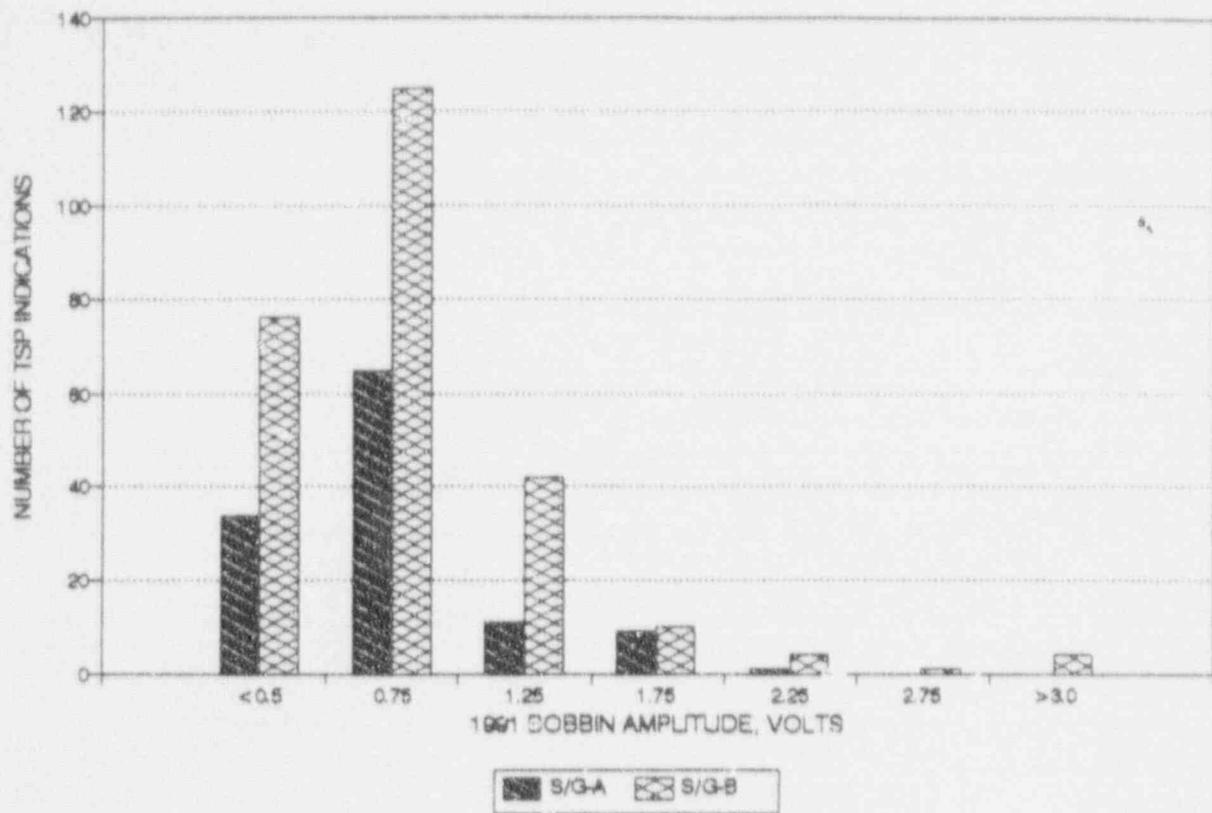
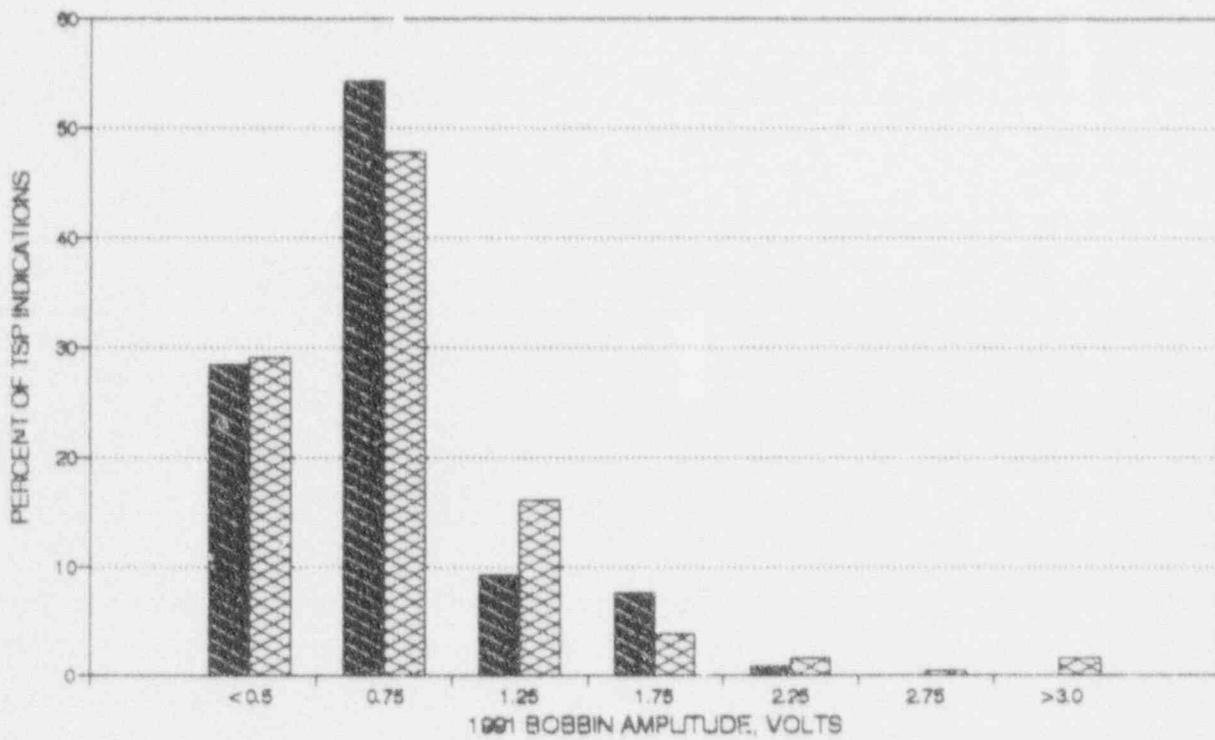
Figure 5-3. Frequency and Percentage Distribution of TSP Indication Voltage Amplitudes (March 1991 inspection)

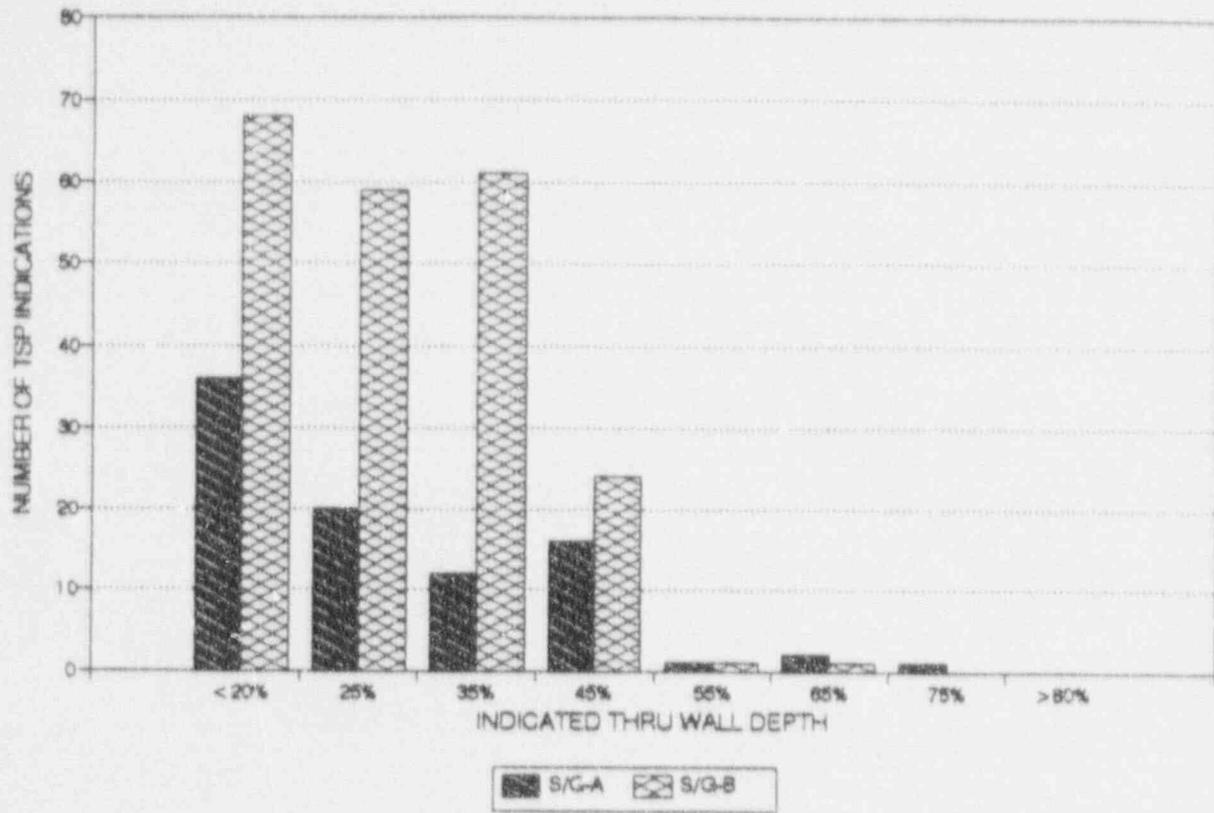
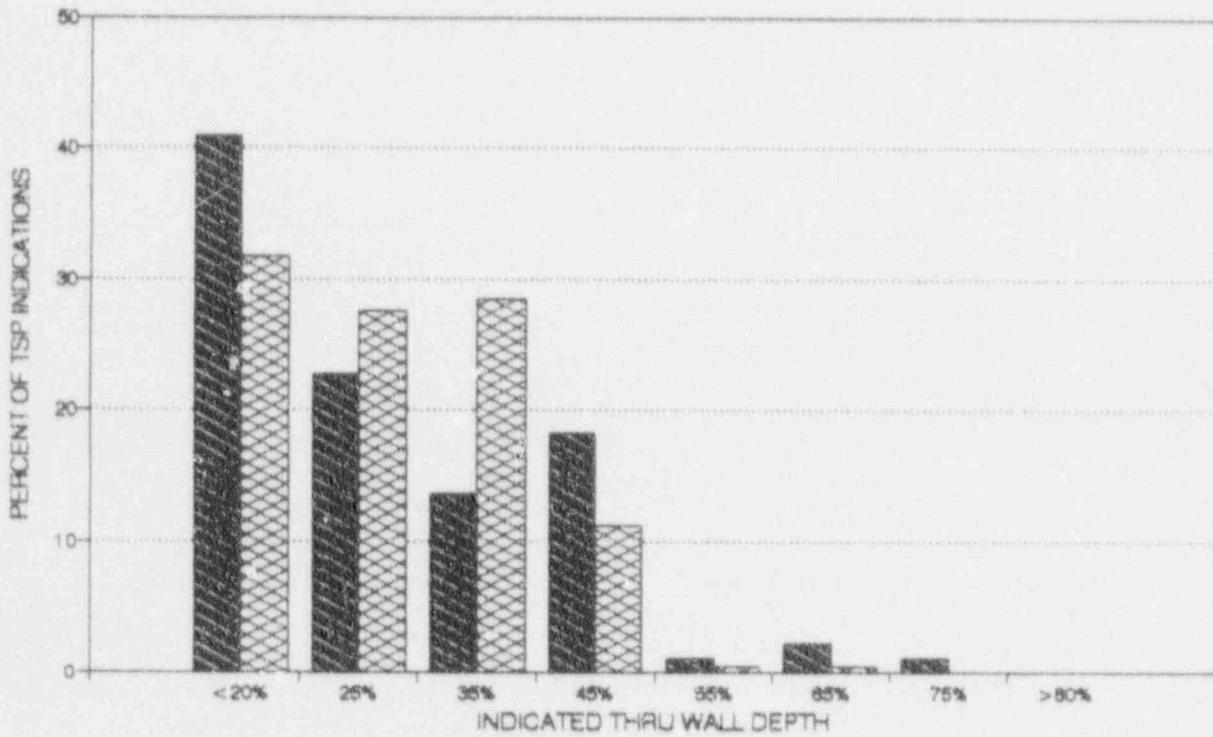
Figure 5-4. Frequency and Percentage Distribution of Indicated Depths (March 1991 Inspection)
