Westinghouse Energy Systems

**Kewaunee Steam Generator  
Tube Plugging Criteria for  
ODSCC at Tube Support Plates**

November, 1991

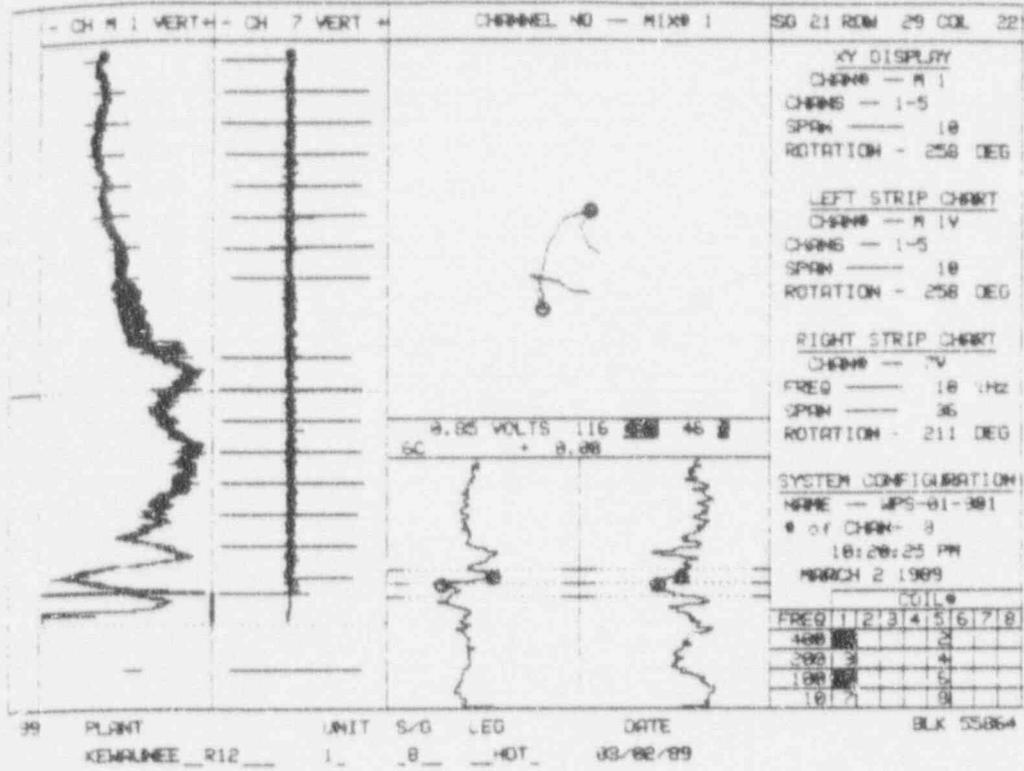
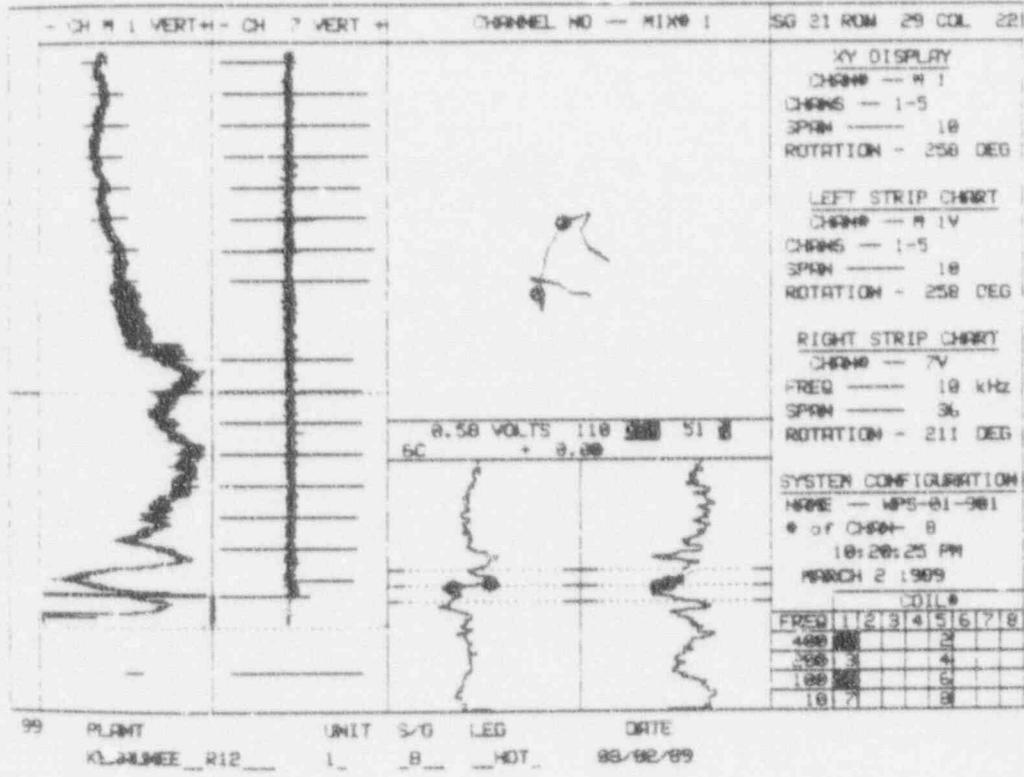
Figure 5-6. Distorted Bobbin Coil Signal (March 1990 Inspection)

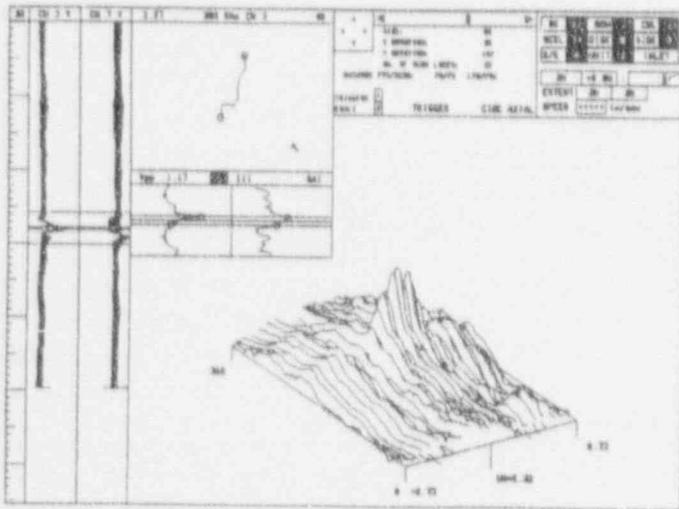
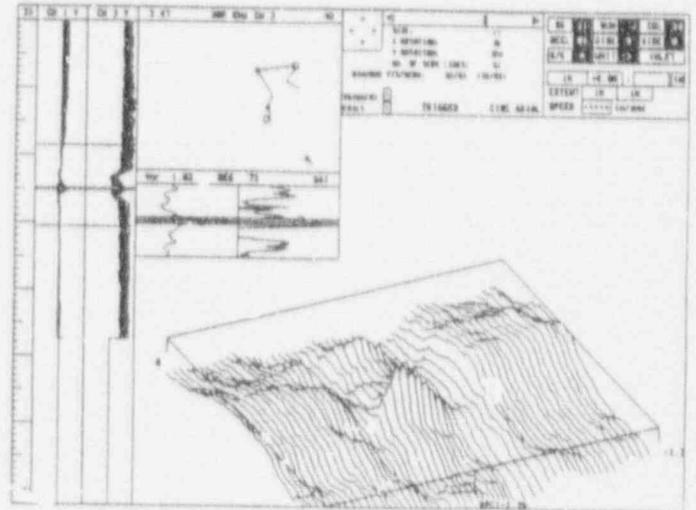
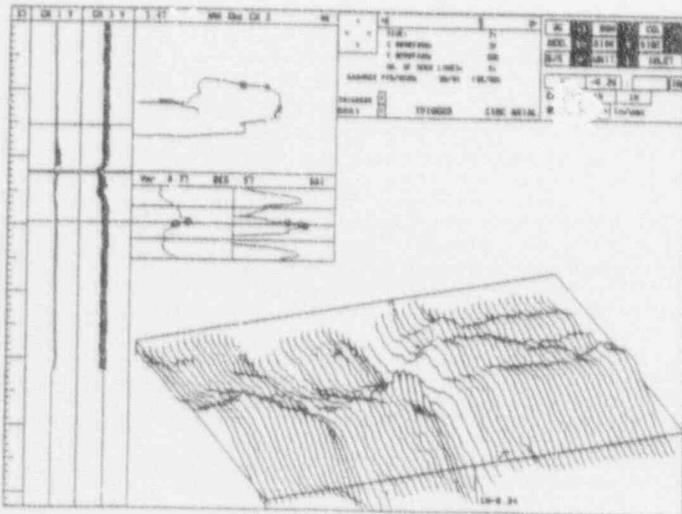
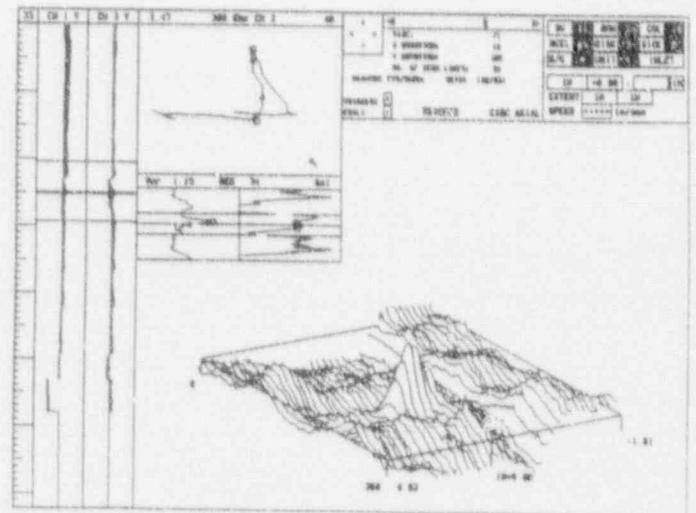
Figure 5-24. Example RPC Traces from Hot Leg Support Plate Locations in S/G-A (March 1991 Inspection)

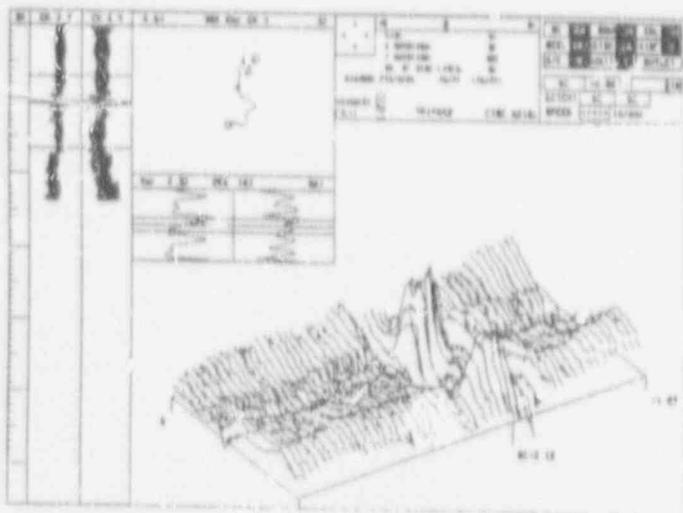
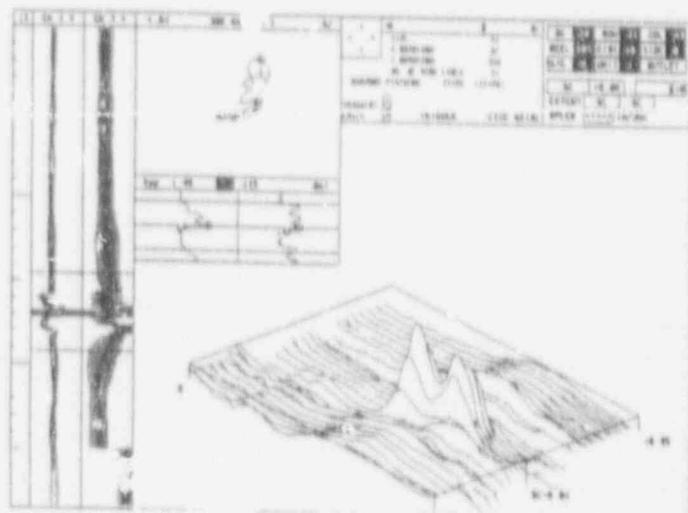
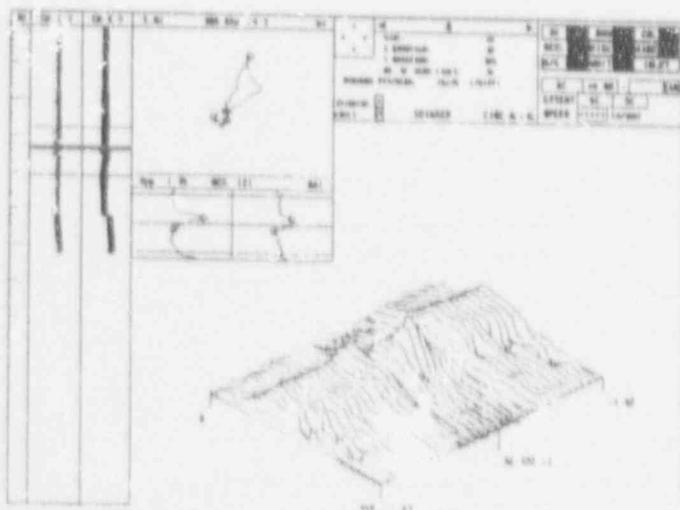
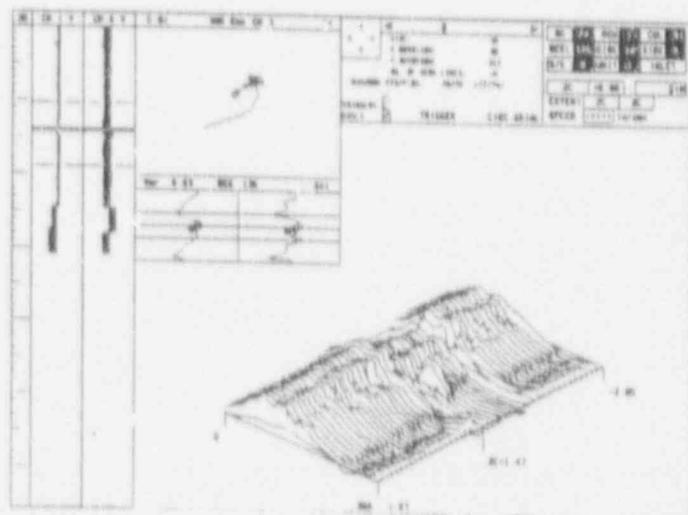
Figure 5-25. Example RPC Traces from Cold Leg Support Plate Locations in S/G-B (March 1991 Inspection)

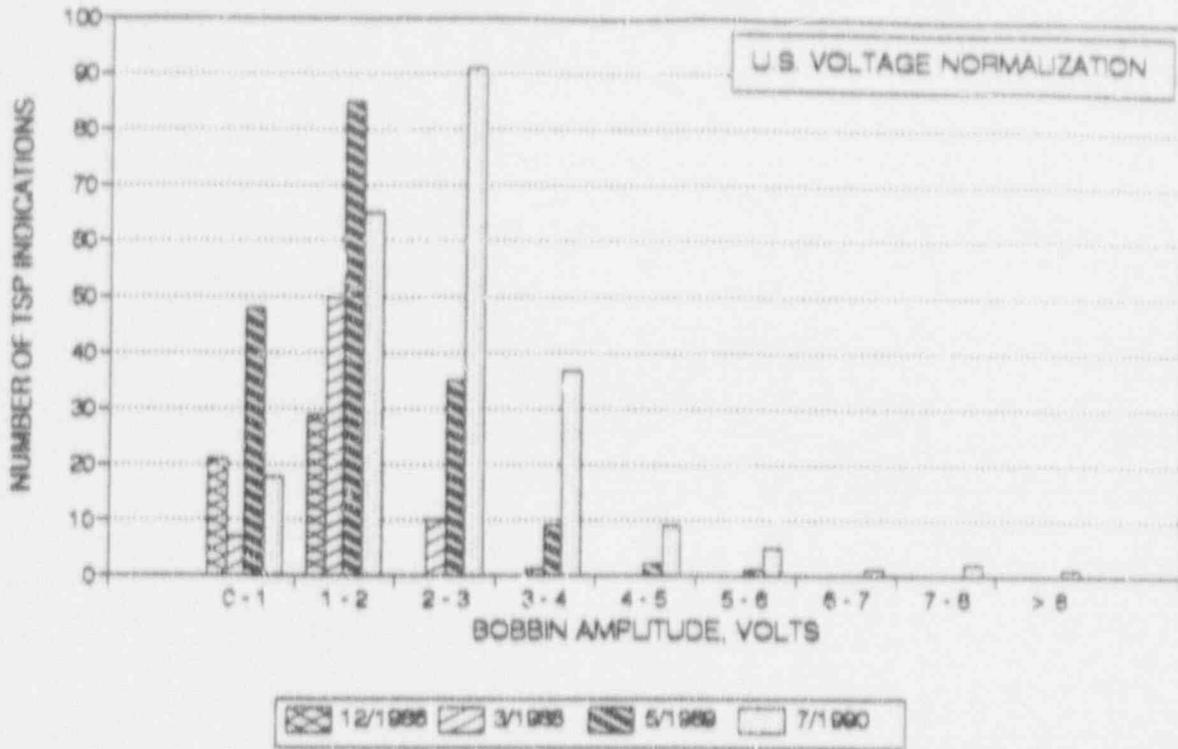
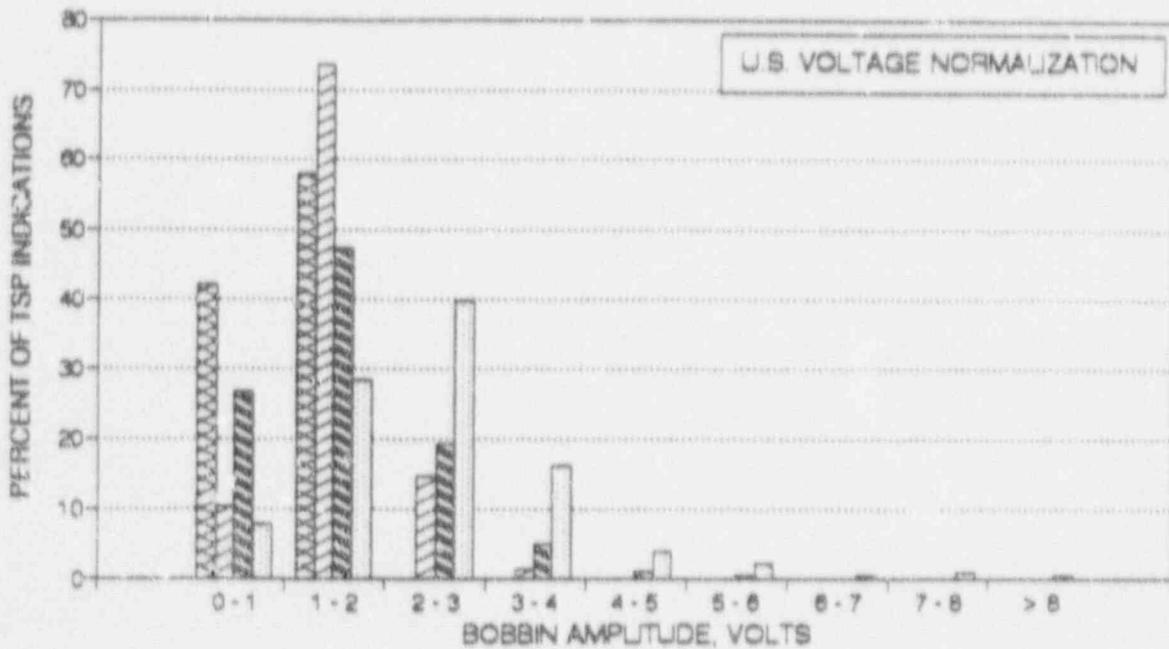
Data for ODSCC at TSPs for French Unit H-1, S/G-1 are available for four successive inspections with no tube plugging, as shown in Figure 6-6. The upper figure shows the number of indications versus voltage amplitude while the lower figure shows the percentage distribution of indications within each outage. Without tube plugging to eliminate the larger indications, the distribution becomes more heavily weighted at the larger indications with increasing operating time.

Figure 6-6. Distribution of TSP Indications for Plant H-1 (1986 to 1990)

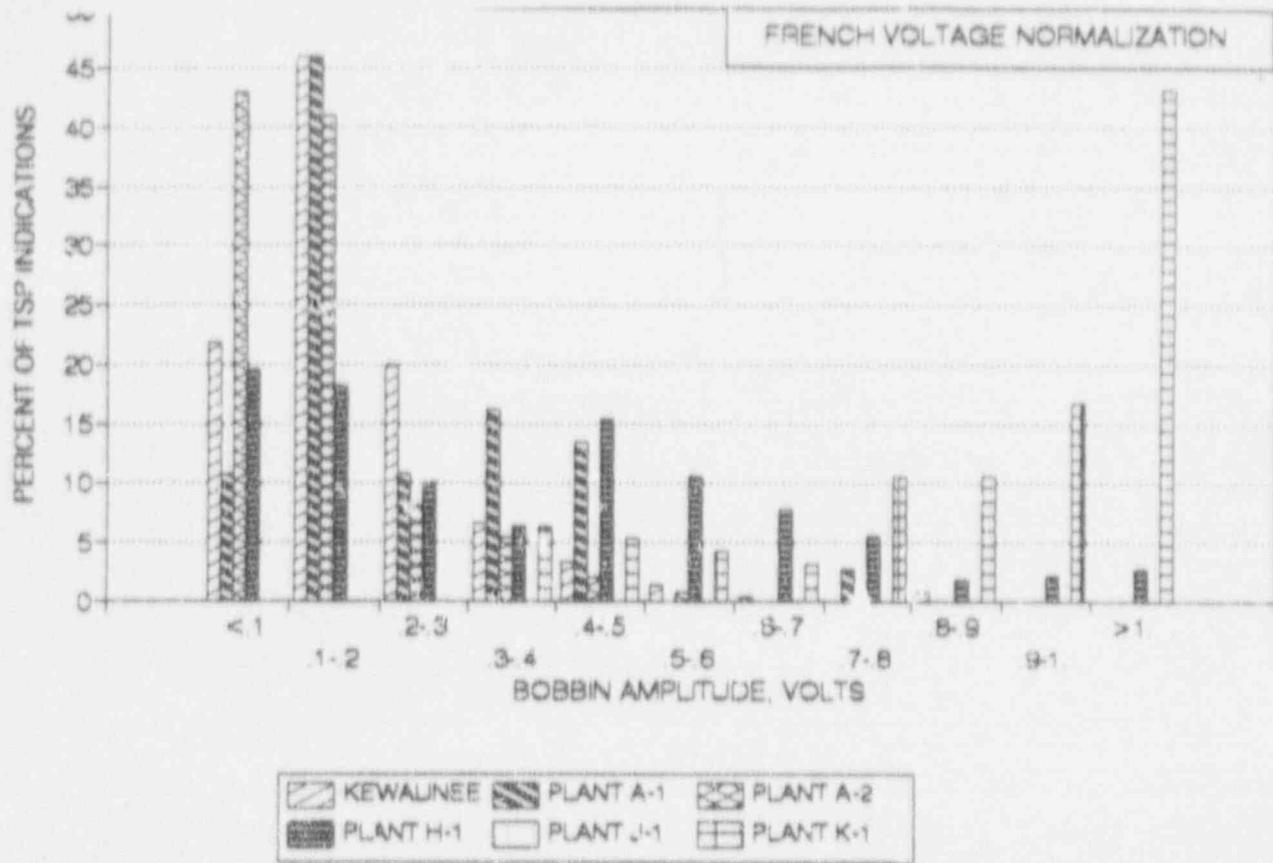
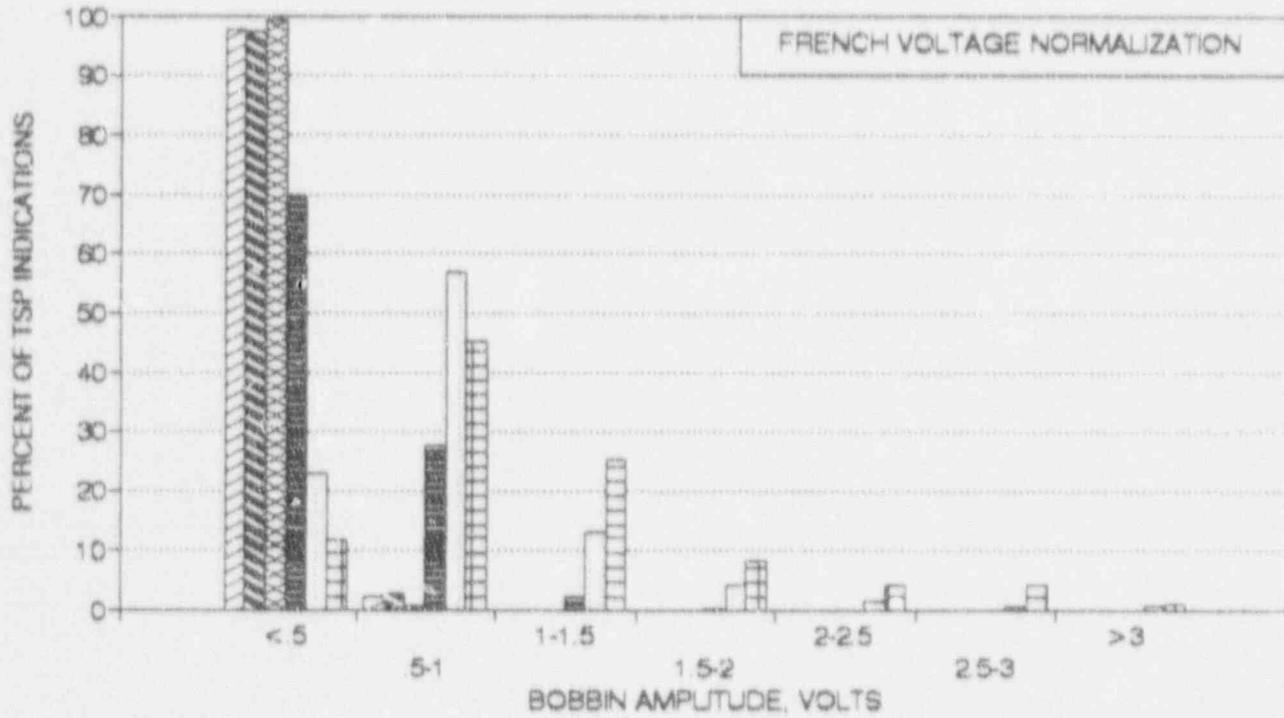
European data is currently available for French Units H-1 and J-1 and Belgian Unit K-1. It is useful to compare the percentage voltage distributions for these units with the Kewaunee data and data from two other domestic units, Plant A-1 and A-2. This is shown in Figure 6-7. The lower figure is scaled to include all available data while the reduced scale of the upper figure is included to emphasize the small voltage range of the U.S. data compared to the European data.

The European units of Figure 6-7 with higher equivalent bobbin voltage signals have operated with no identifiable leakage. This result indicates that operating leakage due to ODSCC at TSPs is expected to be insignificant. This is supported by the fact that only 3 cases of small operating leakage, as shown in Table 6.3, have been identified to date.

Figure 6-7. Comparison of Voltage Indications at TSPs Between U.S. and European Plants

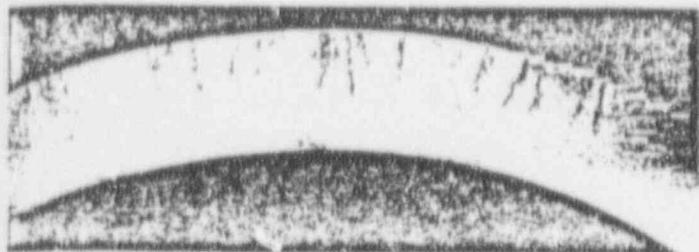
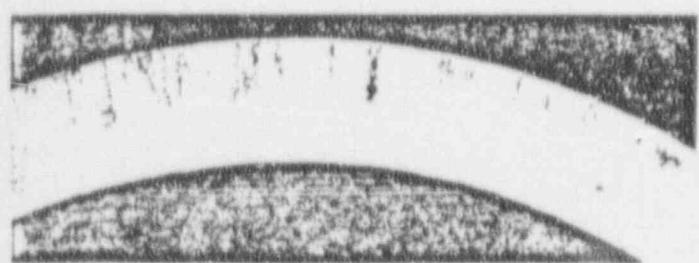
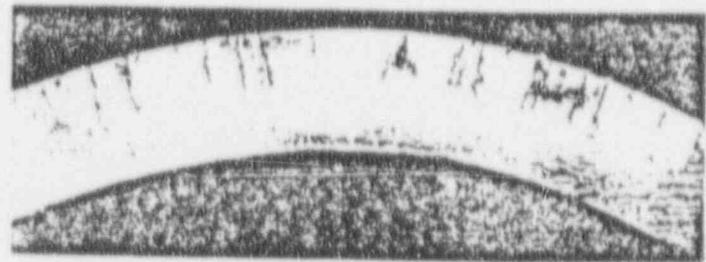
Fourteen tubes have been removed from French units with destructive examination results currently available. Figure 6-8 shows the crack morphology for a tube with a 0.7 volt (~3.7 U.S. volts) indication. The tube exams indicate many axial cracks of comparable depth around the tube circumference. The cracks are dominantly ODSCC with somewhat more IGA participation than seen in most domestic pulled tube data such as the Plant A data. The multiple crack networks would be expected to increase bobbin coil voltage compared to one or only a few deep cracks as typical of the domestic data. Figure 6-9 shows the French data added to Figure 6-2. This figure shows the trend toward higher voltages from the French data for a given maximum depth. Similarly, the data points for Plants L, M and N, which show increased IGA with multiple cracks, also show a tendency toward the higher voltage range of the data. The data for Plant N, as described in Section 4, are from a non-Westinghouse unit with egg crate supports and were reported as IGA. Overall, the data for IGA and IGA/SCC indications show comparable or higher voltage levels than obtained for SCC with minor IGA.

Figure 6-8. Crack Morphology for Pulled Tube from French S/G

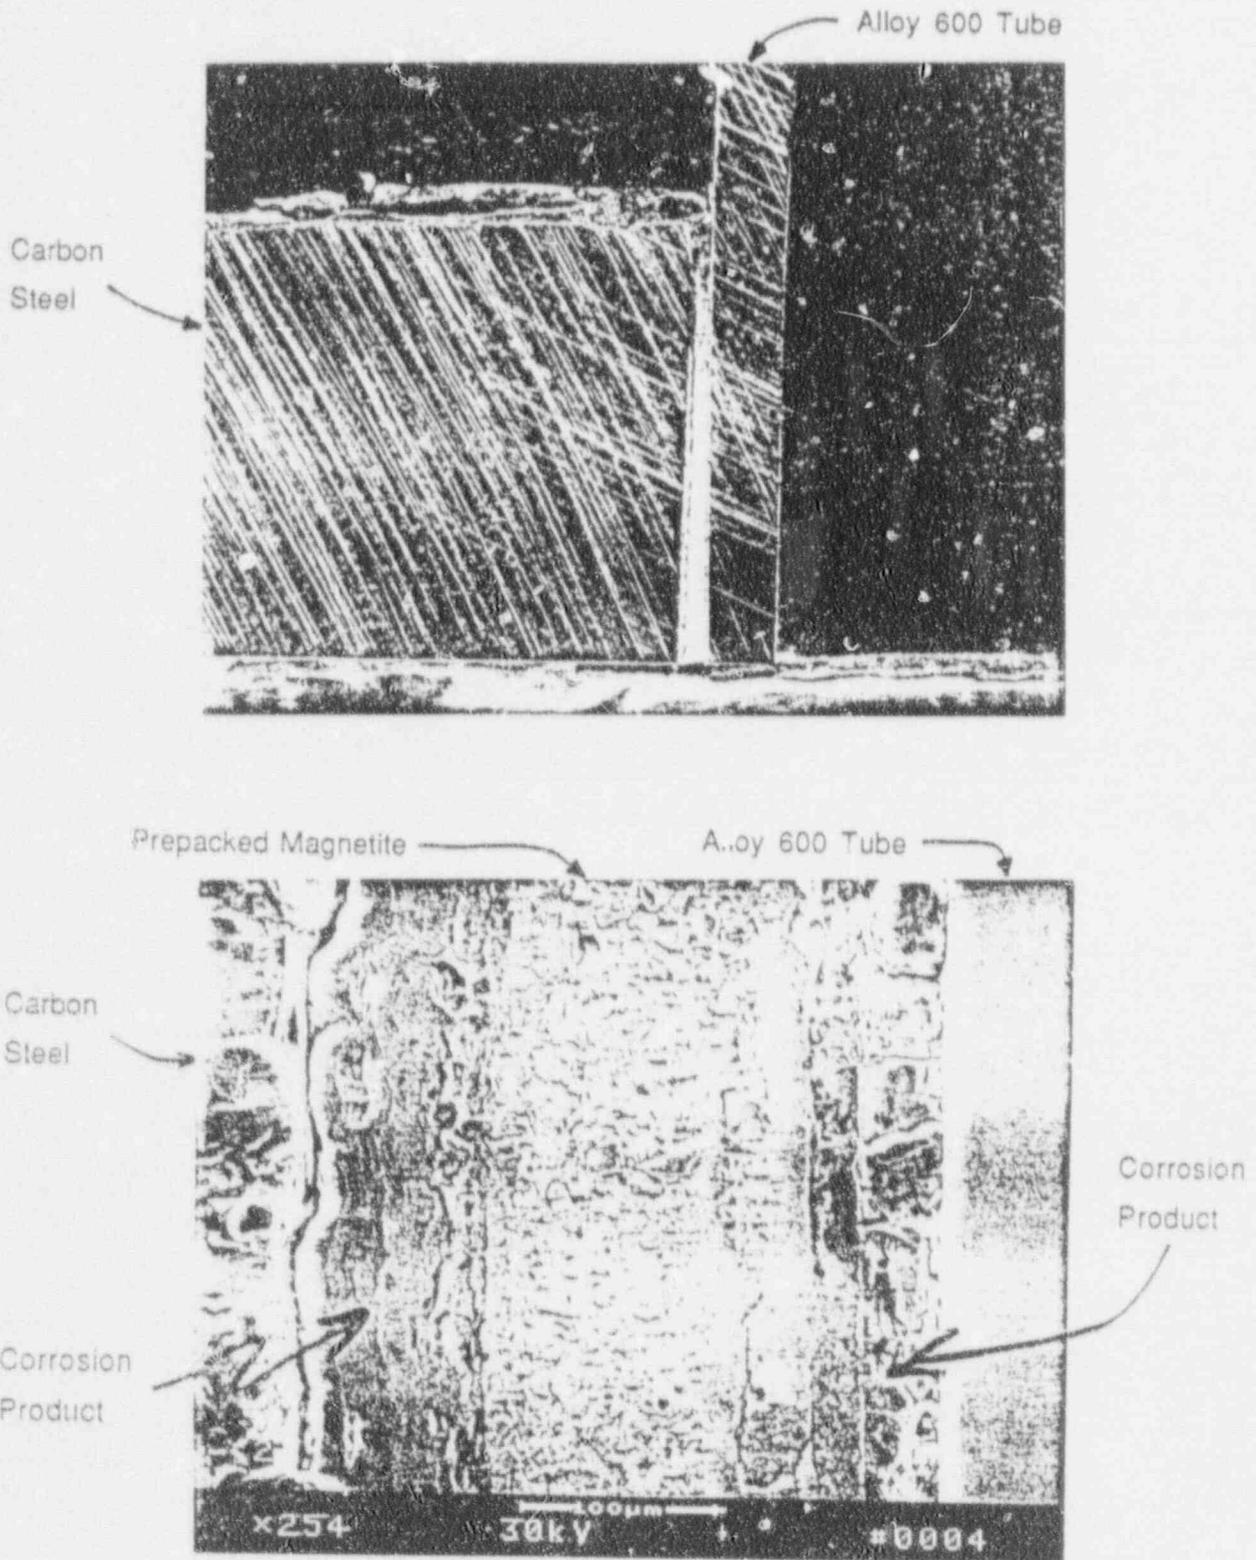
Figure 7-3. Section Through a Dented Tube Support Plate Intersection

A section through the tube and collar of specimen Trial-1 is shown in Figure 7-3. The packed magnetite and the corrosion products in the crevice are clearly evident. A scanning electron photograph of the polished section in Figure 7-3a shows several layers of corrosion products along with the starting layer of packed magnetite. The EDS nickel and iron maps of Figure 7-4 show that the corrosion product adjacent to the Alloy 600 tube is enriched in nickel and somewhat depleted in iron. The corrosion product adjacent to the carbon steel collar appears to have the same iron content as the packed magnetite layer. The corrosion product layers in general appear to be relatively dense and any leakage path would be highly tortuous.

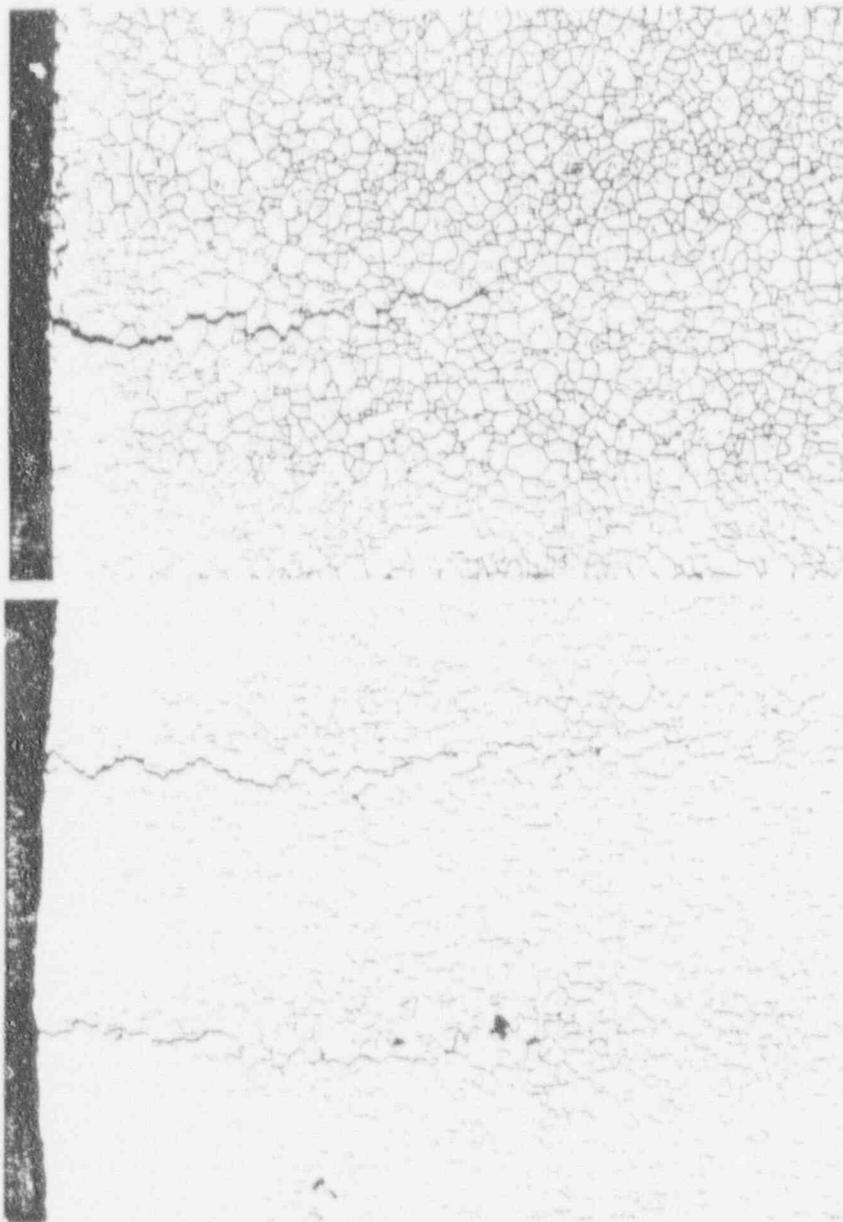
Figure 7-6. Metallograph of Cracked Specimens

Plugging criteria which are partially based upon eddy current characterization, leak rate and burst strength testing of laboratory specimens depend upon a reasonable simulation of actual service produced cracks. The crack morphologies of service tubes, doped steam test specimens and model boiler test specimens are presented in this section. An intergranular mode of cracking is common to cracks produced in these three environments. Figure 7-5 illustrates this fact with scanning electron fractographs. A further illustration of intergranular cracking is provided by the metallographic details shown in Figure 7-6.

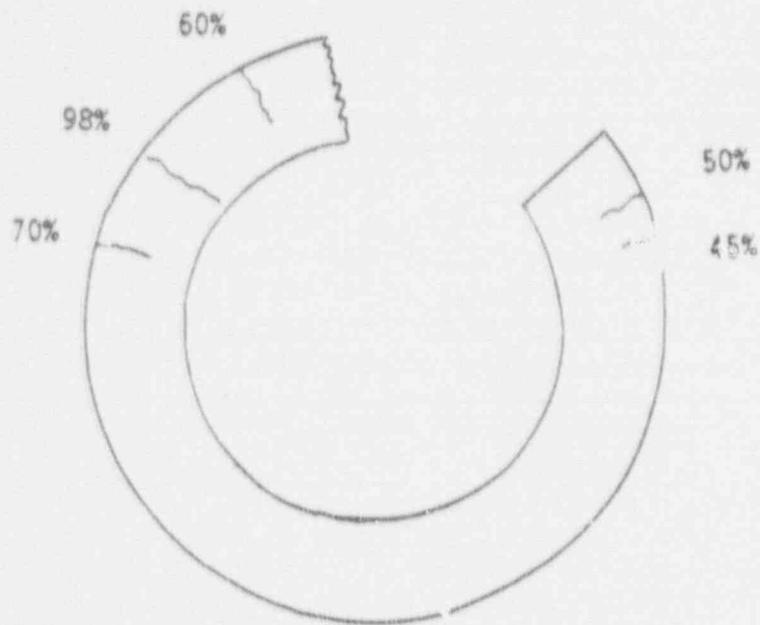
200X

Fractography of the burst crack showed that the environmental cracks were intergranular and typical of stress corrosion cracking (SCC). The macrocrack was 0.52 inch long and did not penetrate the ID wall although it was at many locations up to 98% through wall. The macrocrack was composed of at least six microcracks, all of which had joined together by intergranular SCC. A metallographic cross section through many of the secondary cracks observed on the circumference within the tube support plate intersection revealed five cracks with depths ranging from 45 to 98% through wall. A sketch of the location of these cracks relative to the burst fracture is shown in Figure 10-1. A typical crack morphology of a secondary crack is shown in this figure. A summary of the observed OD origin secondary cracks and morphology of the main crack are shown in Figure 10-2.

Figure 10-1 Sketch of a metallographic cross section through secondary support plate crevice cracks in Tube 543-4. A typical crack micrograph is also shown.

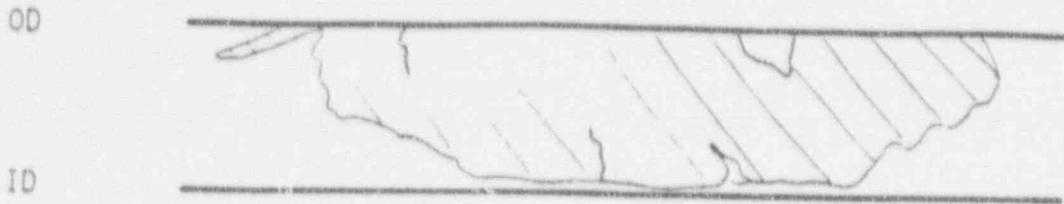
Macrocrack Length = 0.52 inches  
 Throughwall Length = 0 (98% throughwall)  
 Number of Microcracks = 6 (all ligaments with intergranular features)  
 Morphology = IGSCC

Figure 10-2 Summary of crack distribution and morphology observed on Tube 543-4.

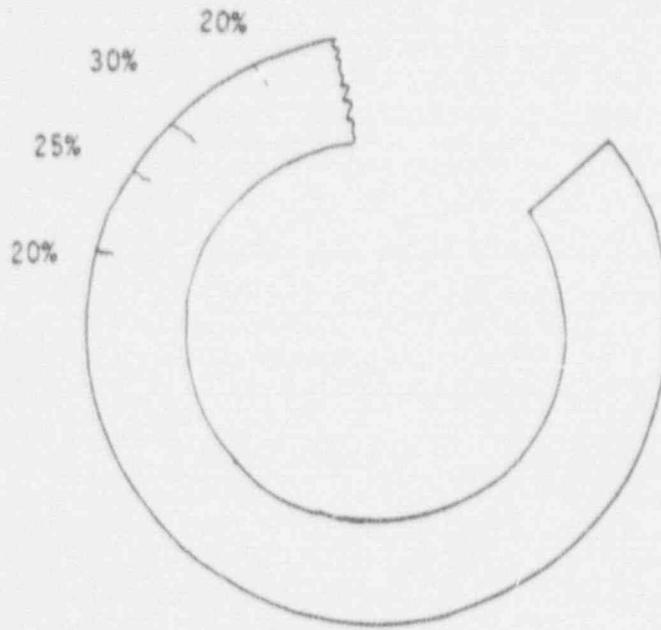
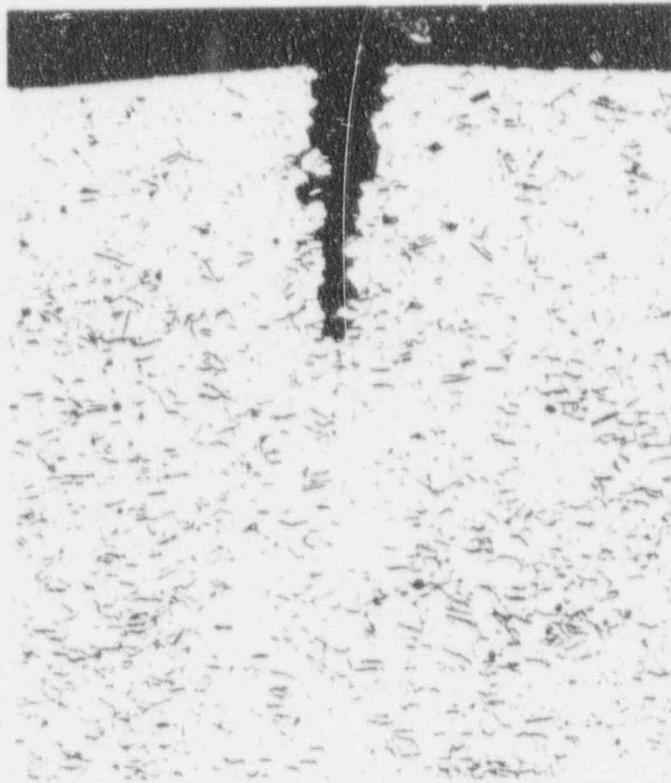
100X

The burst crack was relatively short (0.16 inch long) but deep, 95% through wall. The secondary cracks were all short and axially orientated. A summary of the shape, morphology and distribution of cracks found in Tube 525-1 is presented in Figures 10-3 and 10-4.

Figure 10-3 Secondary crack distribution in a metallographic cross section of Tube 525 in the support plate crevice region. A micrograph of one of the cracks is also shown.

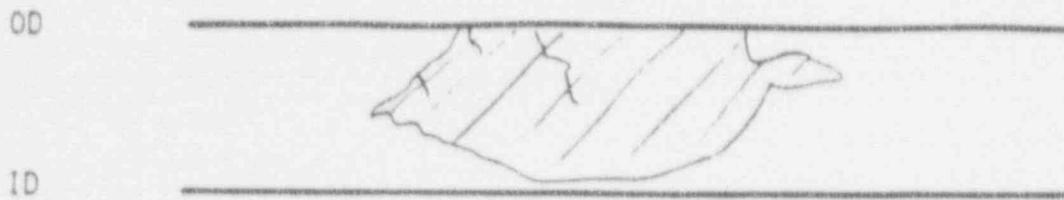
Macrocrack Length = 0.16 inches

Figure 10-4 Summary of crack distribution and morphology observed on Tube 525.

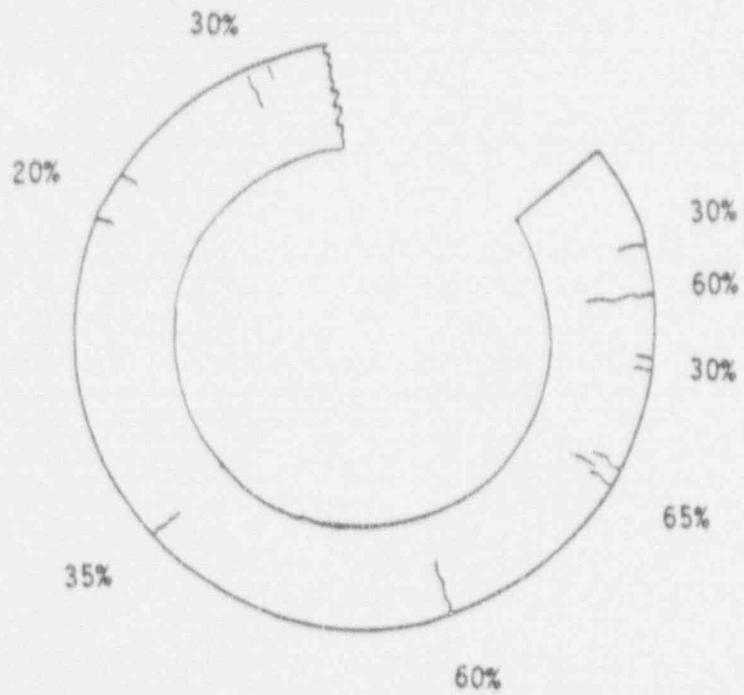
100X

A network of axial and circumferential secondary cracks was observed near the burst crack. The axially orientated burst crack was composed of at least five microcracks which joined to form the macrocrack. Ledges separating these microcracks showed partially ductile features (shear dimples) while the crack face was entirely intergranular. The OD origin major crack was 0.34 inch long and penetrated the ID wall for a length of 0.14 inch. The secondary crack distribution found in the metallographic cross section is shown in Figure 10-5, and a summary of the cracks observed in the support plate region of the tube is presented in Figure 10-6.

Figure 10-5 Secondary crack distribution and a micrograph of one of these cracks in a metallographic cross section of Tube 533-4.

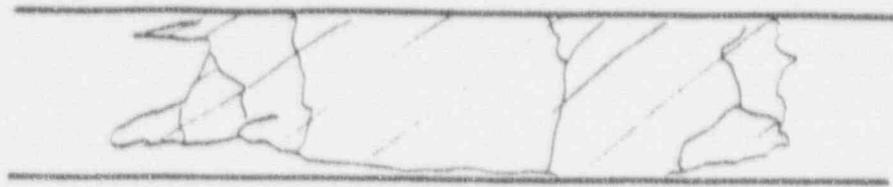
Figure 10-6 Summary of crack distribution and morphology observed on Tube 533-4.

Sketch of Burst Crack

Macrocrack Length = 0.34 inches

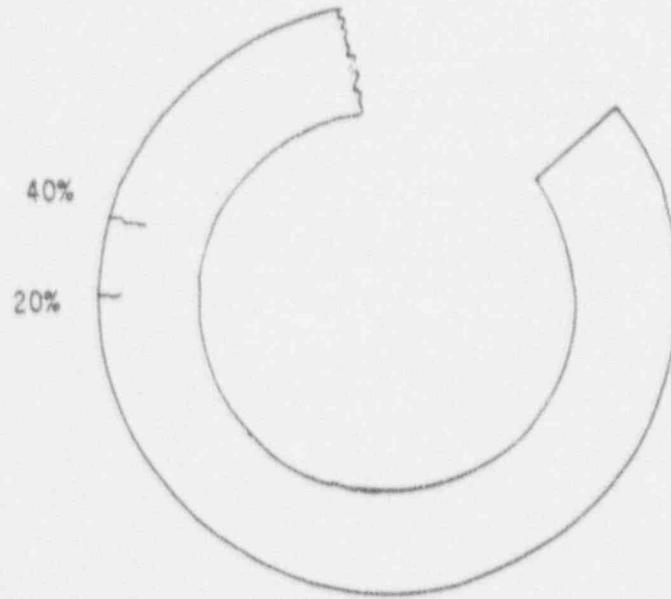
Figure 10-7 Secondary crack distribution and a micrograph of one of these cracks in a metallographic cross section of Tube 536-1.

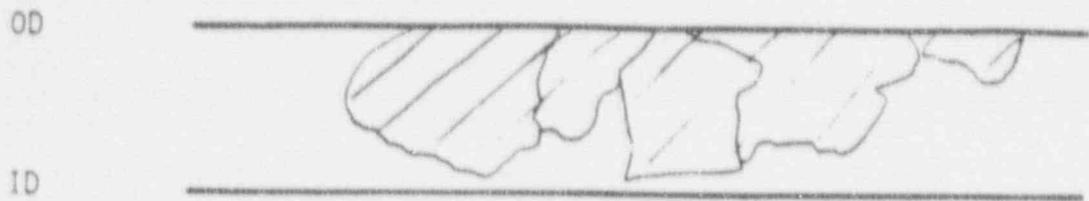
Macrocrack Length = 0.4 inches

Figure 10-8 Summary of crack distribution and morphology observed on Tube 536-1.

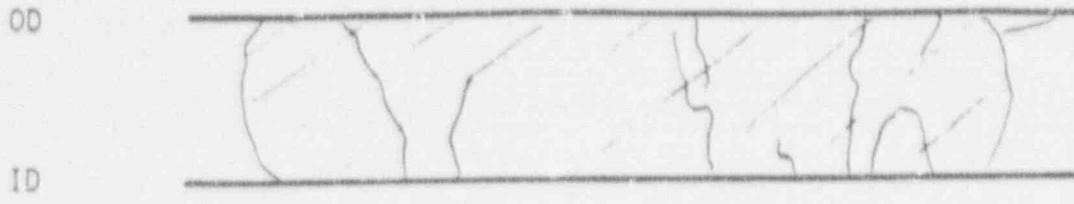
Macrocrack Length = 0.4 inches

Figure 10-9 Summary of crack distribution and morphology observed on Tube 558-1.

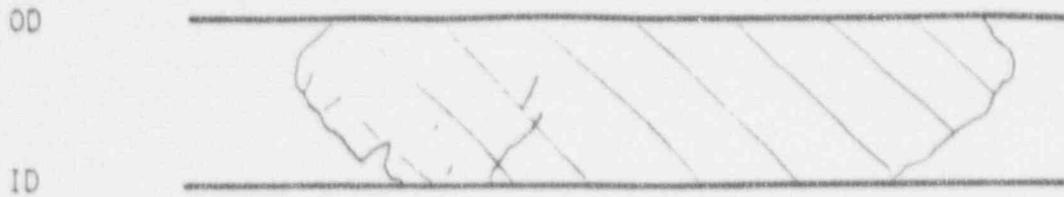
Macrocrack Length = 0.44 inches

Figure 10-10 Summary of crack distribution and morphology observed on Tube 571-1.

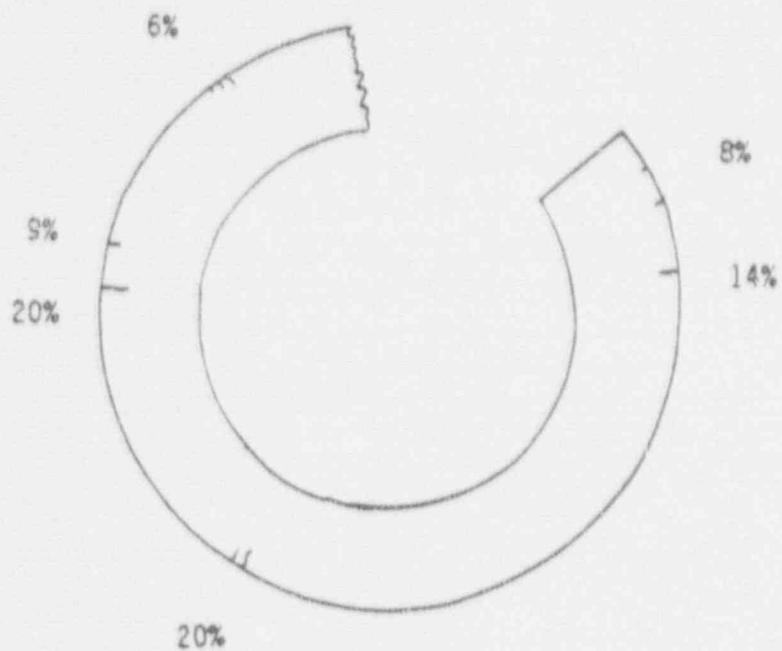
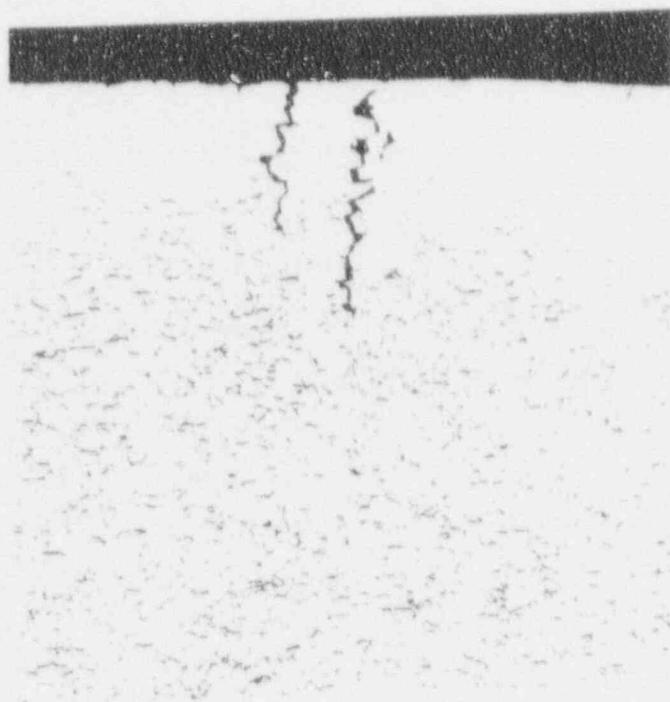
Figure 10-11 Secondary crack distribution and a micrograph of one of these cracks in a metallographic cross section of Tube 533-3 within the Teflon support plate region.

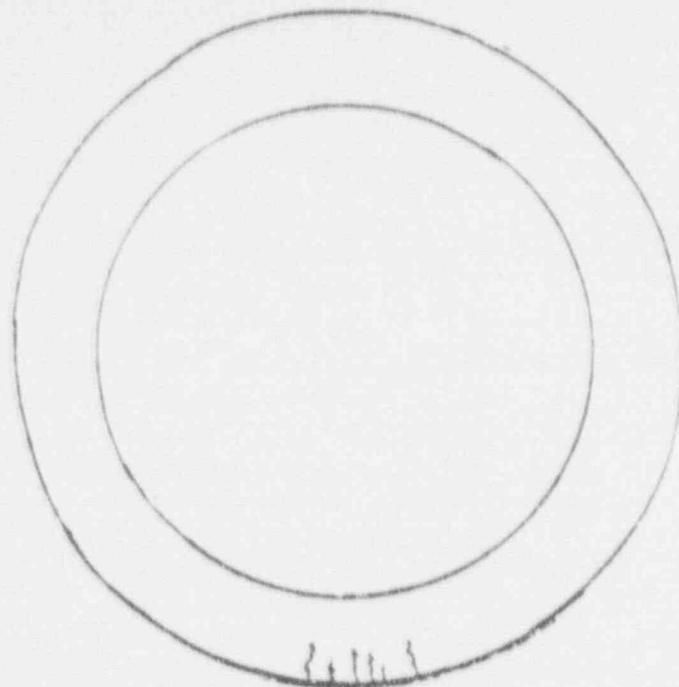
51% 51% 66%

Figure 10-12 Crack distribution and a micrograph of one of these cracks in a metallographic cross section of Tube 533-3 within the steel collar region.

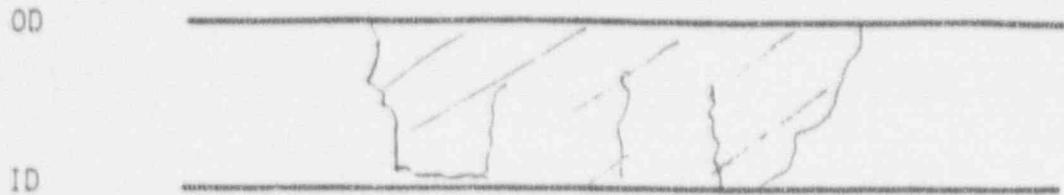
The collars of this model boiler specimen were removed. Several small axial cracks were observed at the support intersections. One was located under the Teflon collar and a few were located under the top steel collar. The crack within the Teflon collar intersection was opened and examined by SEM. The macrocrack face exhibited intergranular features with some ductile tearing on a ligament separating two microcracks. The macrocrack was 0.27 inch long and was composed of four microcracks. The OD origin crack penetrated the ID wall for a length of 0.17 inch. A metallographic cross section through the center of the Teflon collar intersection revealed numerous small intergranular stress corrosion cracks. The location (on the tube) and depth of these cracks is shown in Figure 10-11, together with one micrograph. A metallographic cross section through some of the cracks within the steel collar intersection revealed the crack distribution shown in Figure 10-12. The characterization of the through wall crack found under the Teflon collar and the crack distribution around the tube within the Teflon support is shown in Figure 10-13.

Macrocrack Length = 0.27 inches

Figure 10-13 Summary of crack distribution and morphology observed on Tube 533-3 at the Teflon intersection.

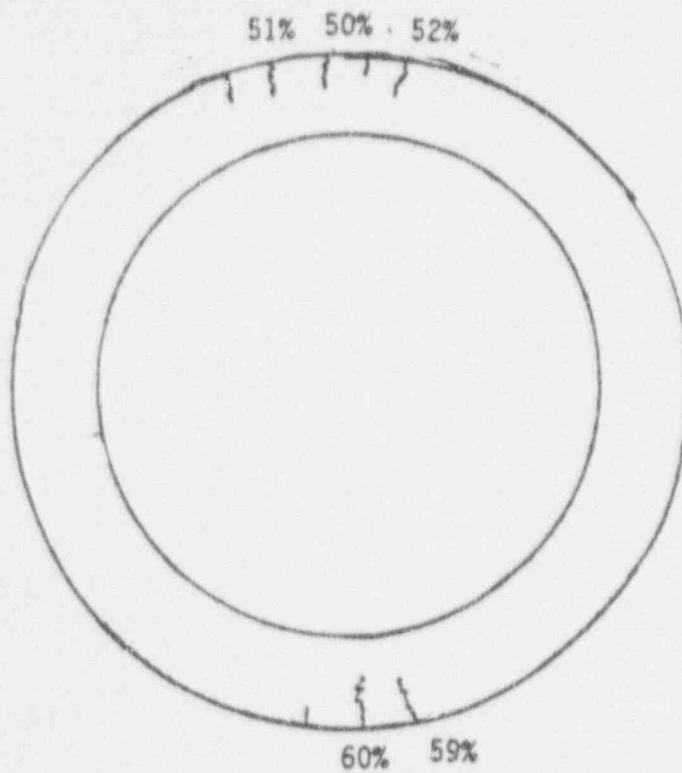
Figure 10-15 Crack distribution and a micrograph of one of these cracks in a metallographic cross section of Tube SL-FH-11 in Plane B.

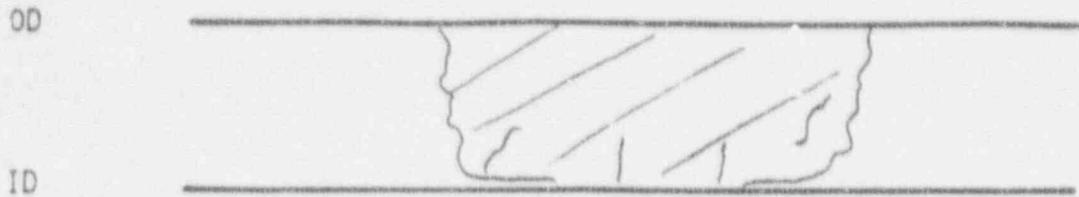
Doped steam specimen SL-FH-11 developed a large number of OD origin cracks. The largest agglomeration of these cracks was opened for fractographic examinations and cross sectional cuts made above (A) and below (B) the opened section of the macrocrack for metallographic examinations. The opened section of the tube showed an intergranular macrocrack, 0.37 inch long. The ligaments separating the 4 microcracks of the macrocrack had only intergranular features. The crack penetrated the ID wall for a length of 0.23 inch. The cross sectional cuts made through planes A and B produced the crack distributions and typical crack morphologies depicted in Figures 10-14 and 10-15. A summary of the crack observations made at this location is shown in Figure 10-16.

Macrocrack Length = 0.37 inches

Figure 10-16 Summary of crack distribution and morphology observed on Tube SL-FH-11.

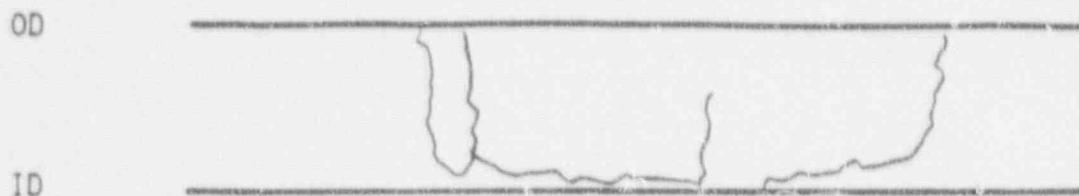
A longer but more shallow crack network was found on the opposite side of the tube from the crack described above. The crack network was opened and examined fractographically. The macrocrack was 0.46 inch long and was composed of at least three microcracks. It penetrated the ID wall locally for a length of only 0.03 inch. The crack morphology was intergranular with some ductile features at ligament locations. A summary sketch of the crack profile and character is shown in Figure 10-17.

Macrocrack Length = 0.46 inches

Figure 10-17 Summary of crack distribution and morphology observed on second crack opened in the laboratory on Tube SL-FH-11.

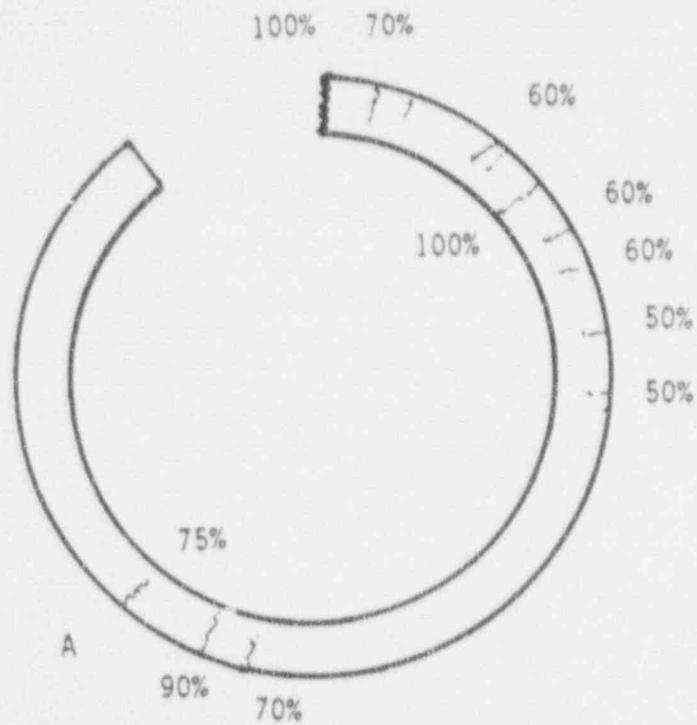
Figure 10-20 Crack distribution found by a metallographic cross section through the center of the crevice (top) and a photomicrograph of one of the secondary cracks (bottom) showing IGSCC with negligible IGA aspects. Mag. 100X

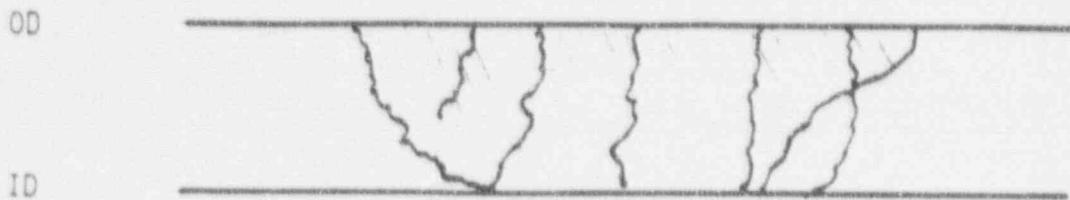
Macrocrack Length = 0.67 inch

Figure 10-21 Summary of overall crack distribution and morphology observed on tube 528-2.

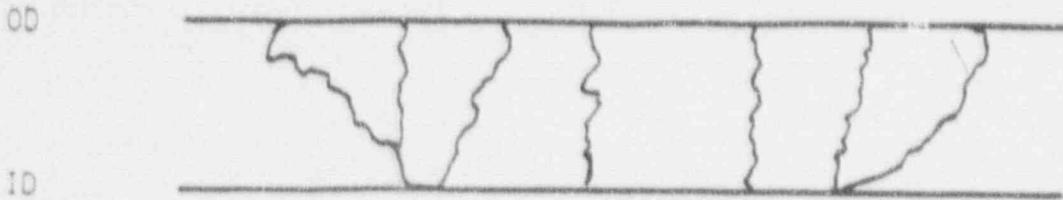
Macrocrack Length = 0.70 inch

Figure 10-25 Summary of overall crack distribution and morphology observed on tube 532-1.

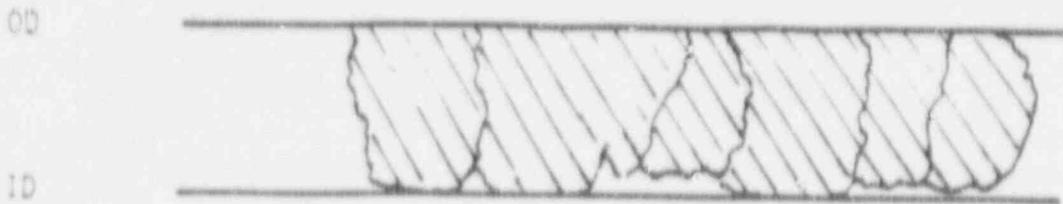
Macrocrack Length = 0.75 inch

Figure 10-29 Summary of the burst crack and overall crack distribution in the crevice region of tube 532-2.

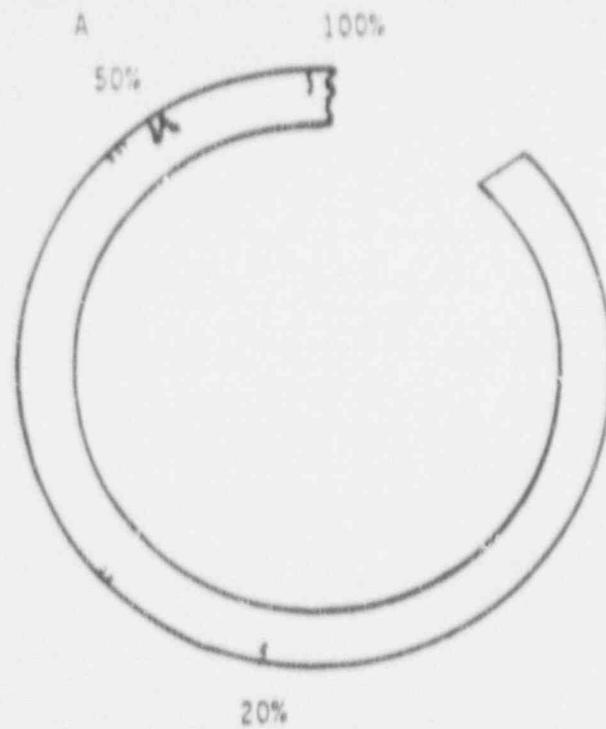
Figure 10-30 Sketch of crack distribution in a metallographic cross section of tube 535 through the center of the crevice and a photomicrograph of crack A. Mag. 100X
