Westinghouse Energy Systems

**Kewaunee Steam Generator  
Tube Plugging Criteria for  
ODSCC at Tube Support Plates**

November, 1991

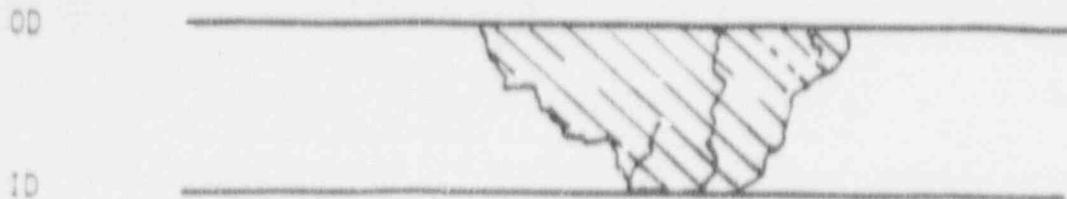
Numerous secondary, but small, microcracks were observed around the circumference within the crevice region. Fractography of the burst crack showed that it was composed of three microcracks which joined together by intergranular corrosion to form the macrocrack. The morphology of the macrocrack was IGSCC with negligible IGA aspects. The macrocrack was relatively short (0.28 inch in length) and penetrated through wall for 0.11 inch. A metallographic cross section through the center of the crevice showed numerous secondary cracks, some of which had negligible to minor IGA aspects. The distribution of cracks from the cross section is shown in Figure 10-30 along with a photomicrograph of a secondary crack. A summary of the burst crack description and of the overall crack distribution is given in Figure 10-31.

Macrocrack Length = 0.28 inch

Figure 10-31 Summary of the burst crack and overall crack distribution in the crevice region of tube 535-1.

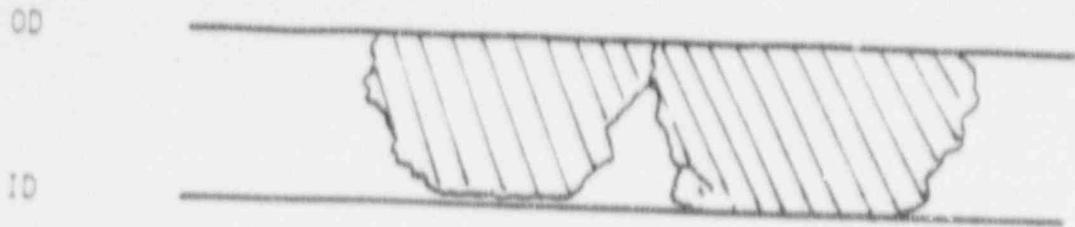
Macrocrack Length = 0.75 inch

Figure 10-34 Summary of burst crack observations and the overall crack distribution observed at the crevice region of tube 555-3.

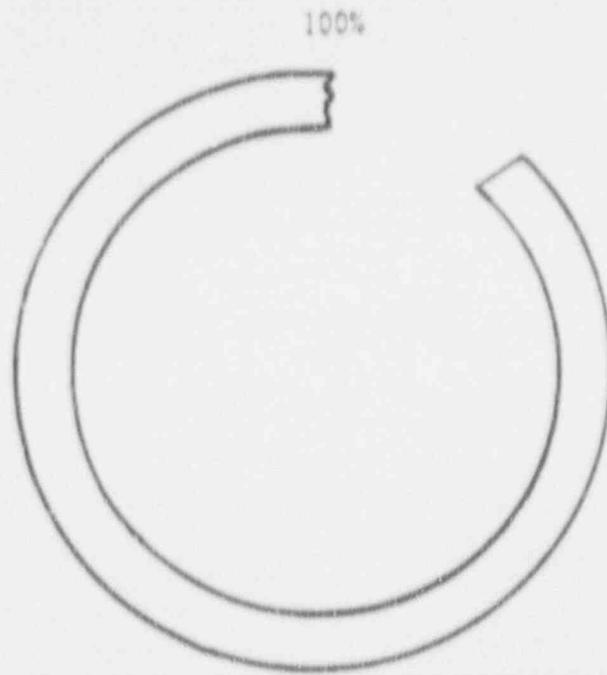
Figure 10-35 Sketch of a metallographic cross section through the center of the crevice region of tube 576-2, showing only the single burst crack, and a photomicrograph of the burst crack.  
Mag. 100X

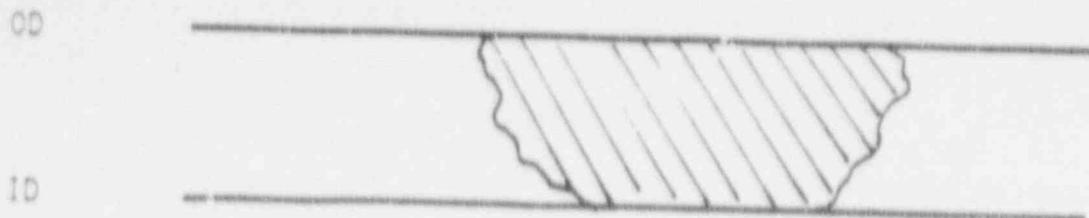
Only one, OD origin, single axial crack was observed after burst testing of tube 576-2. Fractography showed the crack to be 0.30 inch long and it was through wall for 0.22 inch. The macrocrack appeared to be composed of a single microcrack and its morphology was that of IGSCC. A metallographic cross section through the center of the crevice region found no secondary cracks around the circumference. Crack details and crack morphology data are shown in Figures 10-35 and 10-36.

Macrocrack Length = 0.30 inch  
 Throughwall Length = 0.22 inch  
 Number of Microcracks = 1 (no ligaments)  
 Morphology = IGSCC

Figure 10-36 Summary of burst crack observations and the overall crack distribution observed within the crevice region of tube 576-2.

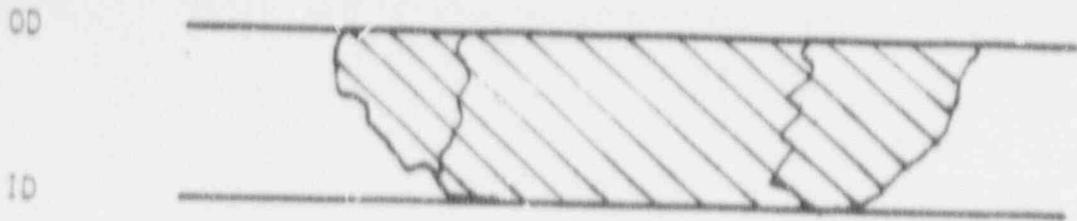
Tube 576-4 also burst with a single crack. Fractography showed the crack to be 0.60 inch long and it was through wall for 0.43 inch. The OD origin intergranular macrocrack was composed of three axial microcracks joined together by ligaments with intergranular features. Visual examination showed a few small axial cracks nearby the burst crack. The morphology of the burst crack was IGSCC with negligible IGA aspects. A metallographic section cut through the center of the crevice found only the burst crack. Crack details and crack morphology data are shown in Figures 10-37 and 10-38.

Macrocrack Length = 0.60 inch

Figure 10-38 Summary of burst crack observations and the overall crack distribution observed at the crevice region of tube 576-4.
