SUBJECT: CLARIFICATION OF A STEP IN OUR PRELIMINARY EVALUATION OF OPERATOR ACTION FOR GINNA SG TUBE RUPTURE EVENT

GINNA STATION
B-STEAM GENERATOR
NRC MEETING
MARCH 23, 1982

GINNA STATION
B-STEAM GENERATOR
CATEGORIZATION OF DEFECTS

RGE S/G-B POST TUBE REPAIR EVALUATION

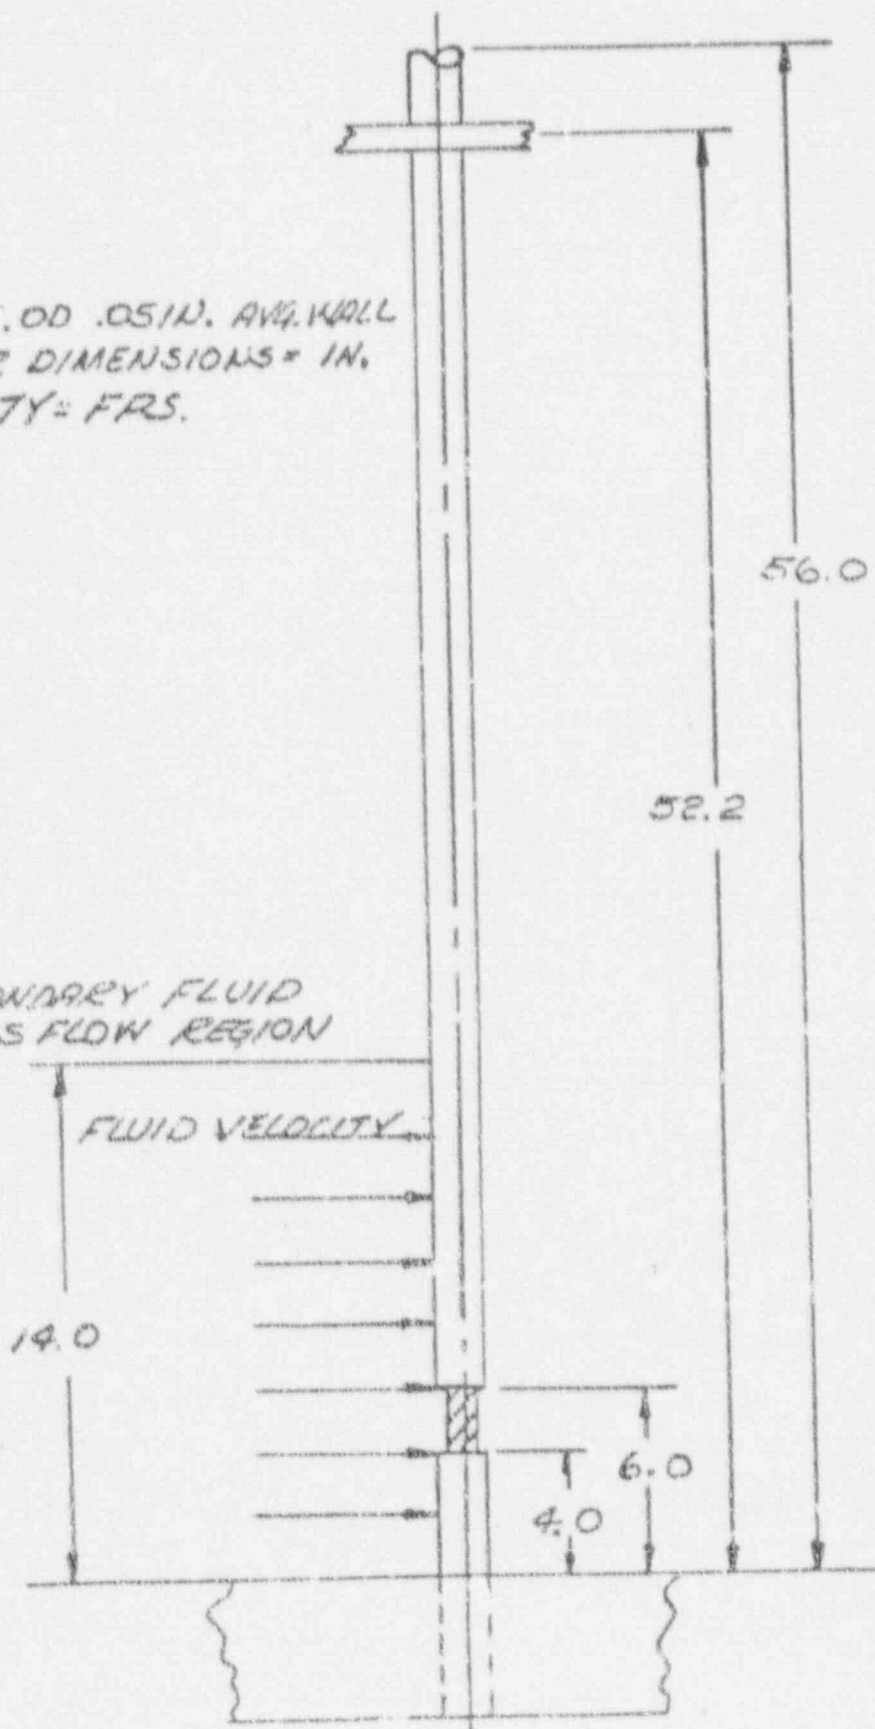
FIXED-FIXED BOUNDARY CONDITIONS
DAMPING RATIO = 0.01

SYMBOL	CROSS SECTION	1ST. MODE FREQ-H.
○	CIRCULAR	58.7
□	FLAT	48.9
◇	10% OVALIZED	58.3
△	KIDNEY	58.2

VIBRATION AMPLITUDE DUE TO VORTEX SHEDDING AND CROSS-FLOW TURBULENCE
ARE RELATIVELY UNAFFECTED BY SMALL DISTORTIONS AND SURFACE IRREGULARITY
