SUBJECT: REVIEW OF INFORMATION PRIOR TO GINNA RESTART

SUBJECT: INPUT FOR GINNA RESTART SER

GINNA STATION
 STEAM GENERATOR EVALUATION
 NRC MEETING
 APRIL 30, 1982

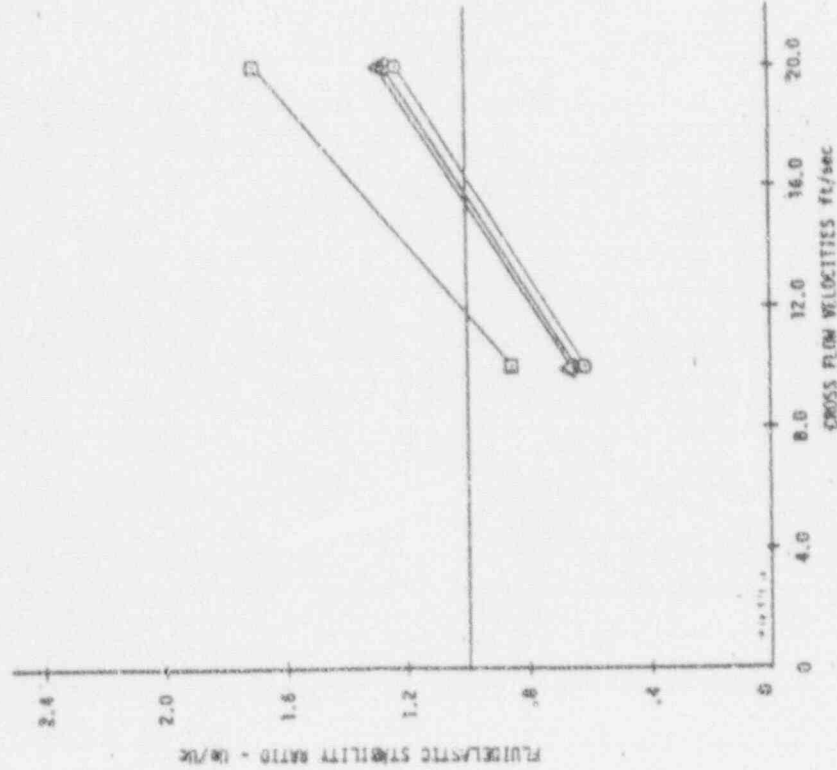
FLUIDELASTIC STABILITY RATIO OF TUBES AS A FUNCTION OF CROSS FLOW VELOCITY, FIXED-FIXED BOUNDARY CONDITIONS

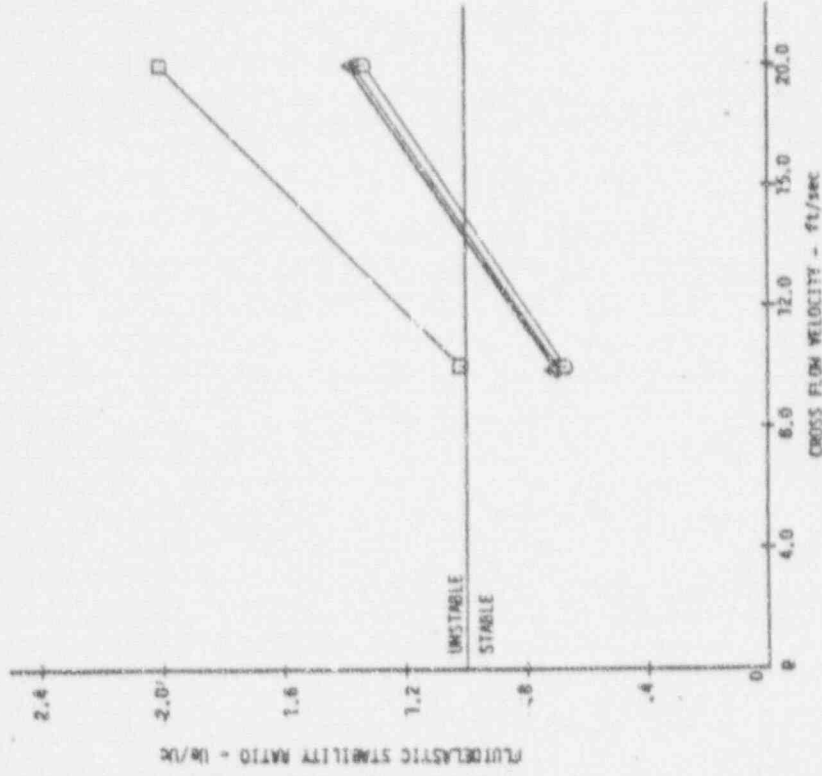
FLUIDELASTIC STABILITY RATIO OF TUBES AS A FUNCTION OF CROSS FLOW VELOCITY, FIXED-PINNED BOUNDARY CONDITIONS

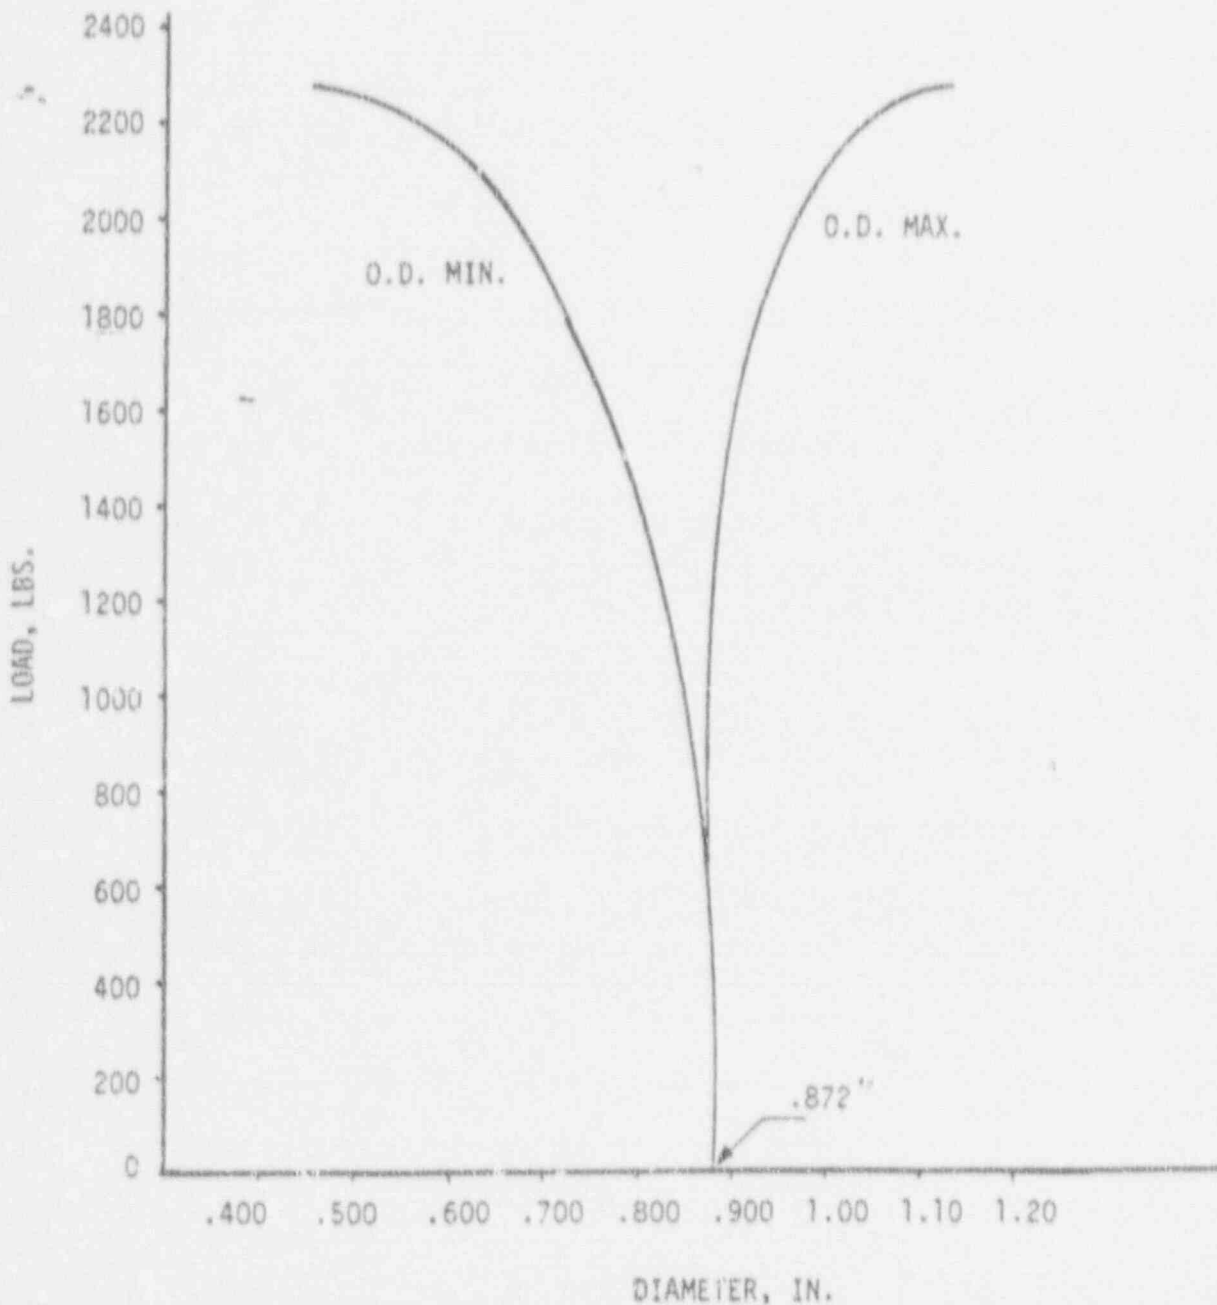
LATERAL LOAD BENCH TEST-STATIC

IMPACT ROD - TIP .125" x 1.00"; 90° TAPER

TUBE, O.D. = .872"

I.D. = .766"

OVALITY = "0" %

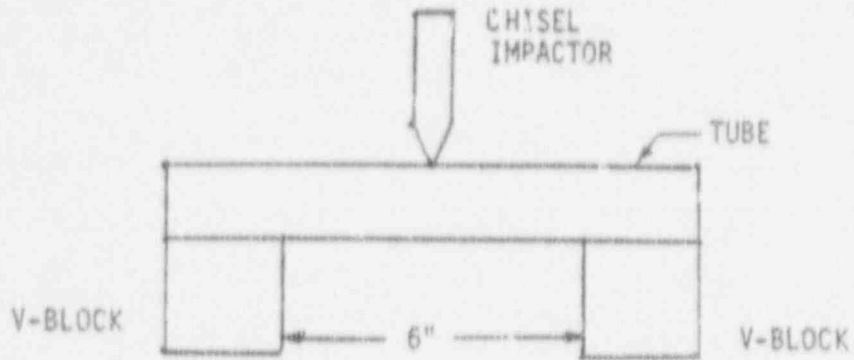
LATERAL LOAD BENCH TEST-STATIC

LOAD (LBS)	OVALITY (%)	
	SHARP CHISEL	BLUNT CHISEL
0	0	0
550	1.1	0.2
700	2.1	0.8
850	3.9	1.9
1000	6.0	3.7

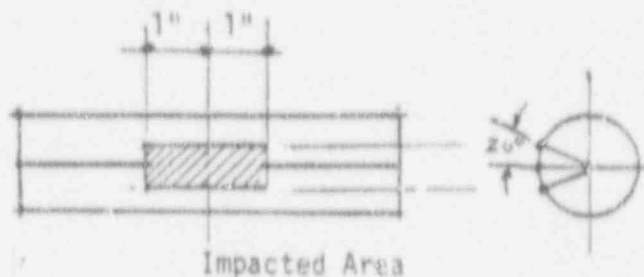
DYNAMIC COLLAPSE TESTING

- 0 EXTERNAL PRESSURE = 1000 PSI
- 0 LATERAL LOAD = 600 LBS
- 0 IMPACTING SEQUENCE:
 - a. IMPACT AT EVERY 1/4" ALONG 0-DEGREE PLANE FROM ONE END OF AREA TO THE OTHER. THEN OFFSET 1/8" AND BACKTRACK.
 - b. REPEAT STEP "a" ON THE + 20° PLANE
 - c. REPEAT STEP "b" ON THE -20° PLANE.

SEQUENCE NO.	SHARP CHISEL (1.00"x0.030")			BLUNT CHISEL (1.00"x0.125")		
	OD MAX/ODMIN (INCH)	ID MIN (INCH)	OVALITY (%)	ODMAX/ODMIN (INCH)	ID MIN (INCH)	OVALITY (%)
INITIAL	0.884/0.861	0.755	2.6%*	0.873/0.873	0.766	0%
1	--	0.724	--	--	0.734	--
2	--	0.699	--	--	0.695	--
3	--	0.680	--	--	0.664	--
4	--	0.660	--	--	0.647	--
FINAL	0.928/0.733	--	23.5%	0.923/0.766	--	18.5%
NO COLLAPSE, DEVELOPED CRACK DURING SUBSEQUENT IMPACTS				TEST IN PROGRESS ΔP INCREASED TO 1500 PSI

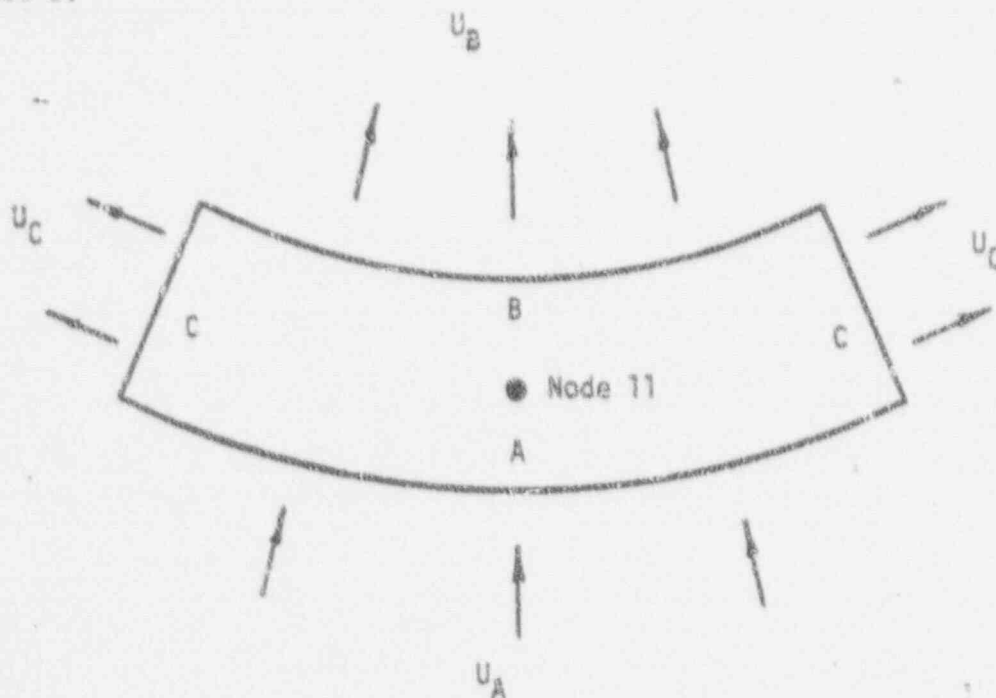
MAXIMUM TUBE GAP VELOCITIES
WITH AND WITHOUT TUBE REMOVAL

BETWEEN-TUBE CROSSFLOW VELOCITIES IN AND NEAR
THE TUBES REMOVED REGION

<u>Location</u>	<u>Crossflow Velocity (nominal)</u>	<u>Crossflow Velocity (1 block of tubes removed)</u>	<u>Crossflow Velocity (2 blocks of tubes removed)</u>
Perimeter Cell (Face A)	8.2 ft/sec	9.13 ft/sec	9.13 ft/sec
Perimeter Cell (Face C)	8.2 ft/sec	9.13 ft/sec	9.13 ft/sec
Perimeter Cell (Face B)	9.01 ft/sec	10.12 ft/sec	10.33 ft/sec
One Cell in from Perimeter (Face B)	8.54 ft/sec	9.48 ft/sec	10.95 ft/sec
Two Cells in from Perimeter (Face B)	8.21 ft/sec	9.16 ft/sec	10.46 ft/sec

<u>Case</u>	<u>Maximum Gap Velocity, ft/sec</u>
Nominal	9.01
One block of tubes removed	10.12
Two block of tubes removed	10.95

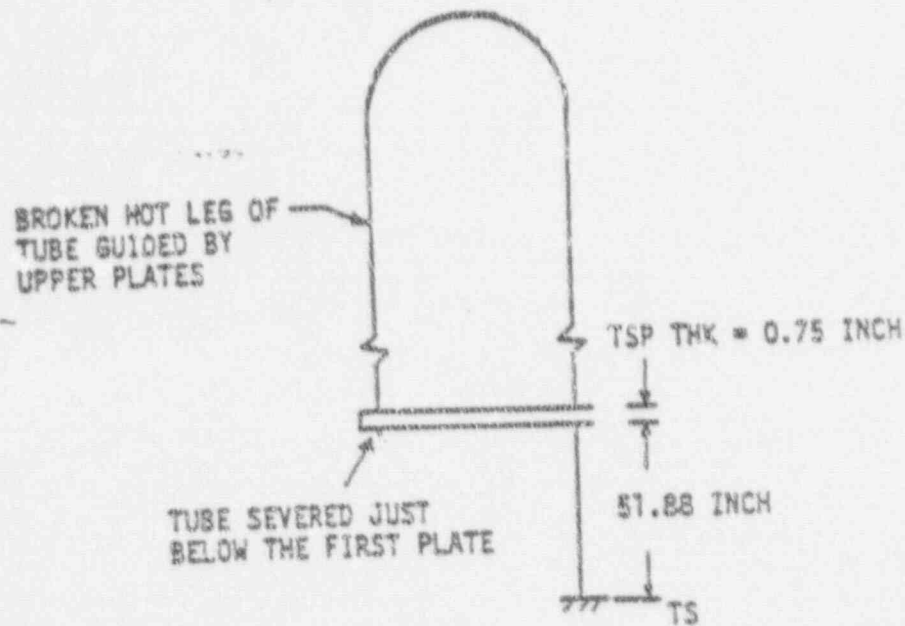
Schematic of a Partial Tube

THERMAL

LATERAL TUBE DEFLECTION
