L77-320

Docket No. 50-346
License No. NPF-3

Supplement to Reportable Occurrence NP-32-77-16
Davis-Besse Nuclear Power Station Unit 1
Date of Occurrence: September 24, 1977

1. SUMMARY

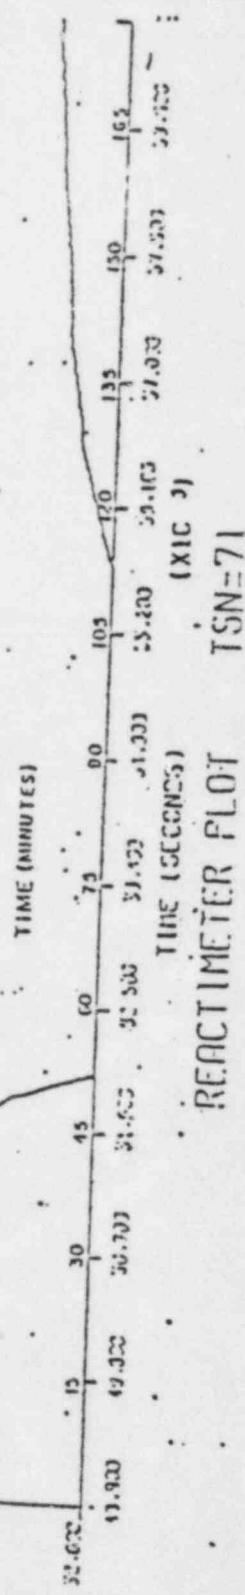
FIGURE 6-1
REACTIMETER PLOT
TSN=71

TIME (MINUTES)	REACTIMETER READING (X10 ⁻³)
0	15.00
15	1.00
30	1.00
45	1.00
60	1.00
75	1.00
90	1.00
105	1.00
120	1.00
135	1.00
150	1.00
165	1.00

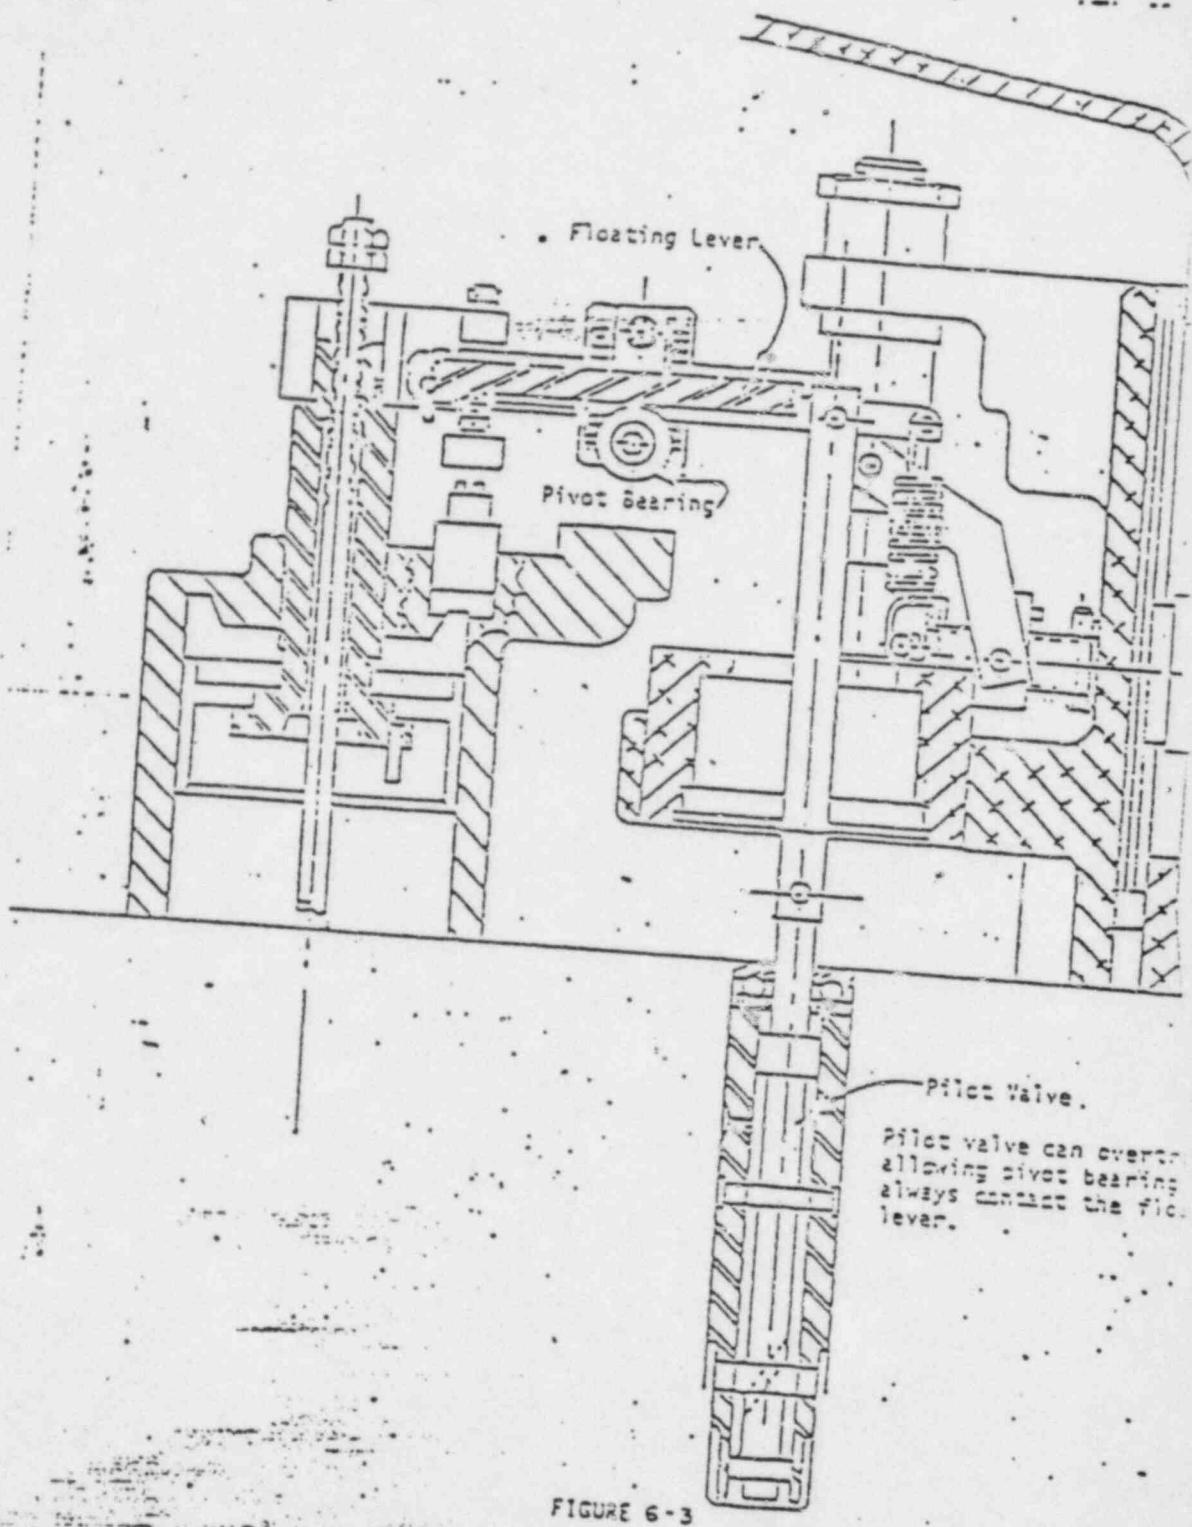
FIGURE 6-3

When the AEP governors arrived at the Woodward Governor Company factory, one of the governors was placed on the test stand. Observing the operation of the speed setting linkage, it became evident that a simple link from the speed setting pilot valve (plunger) to the floating lever would allow removal of the bell coupling spring, low speed pin, "C" link and dashpot plug in the speed setting pilot valve sleeve (see Figure 2). This would allow the speed setting pilot valve to operate when the motor was set in a high speed condition with the speed setting servo at the minimum position (see Figure 6-3).
