Ruptured Cesium-137 Well-Logging Source at Shelwell Services, Inc., Hebron, Ohio

**U.S. Nuclear Regulatory
Commission**

Region III

This U.S. Nuclear Regulatory Commission (NRC) report documents the circumstances surrounding the September 13, 1983, cesium-137 sealed source rupture incident at the Shelwell Services, Inc., facility in Hebron, Ohio. It focuses on the period from approximately 4:00 p.m. (EDT) on September 13, 1983, when the source ruptured, to October 5, 1983, when the radiological emergency response aspects of the event were concluded. Information outside these periods is recounted as necessary. The incident resulted in radiation doses to two licensee employees that exceeded the regulatory limits for whole-body and extremity exposures, and contamination of the licensee's facility, private residences, public buildings, and the personal effects of the licensee's employees, families, and friends. The emergency response required the combined efforts of NRC, U. S. Department of Energy, and state personnel. The report describes the factual information and significant findings associated with the event and, thereby, provides a data base for subsequent detailed analyses and

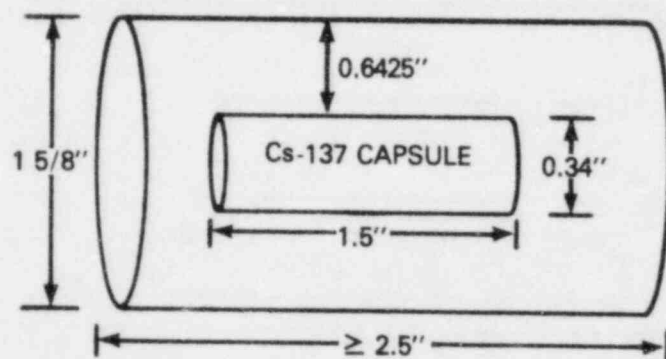
Figure 13. Sketch of source/source holder model used for exposure calculations.

0.6425'' = 1.63 cm stainless steel between outside diameter of source capsule and surface of holder.

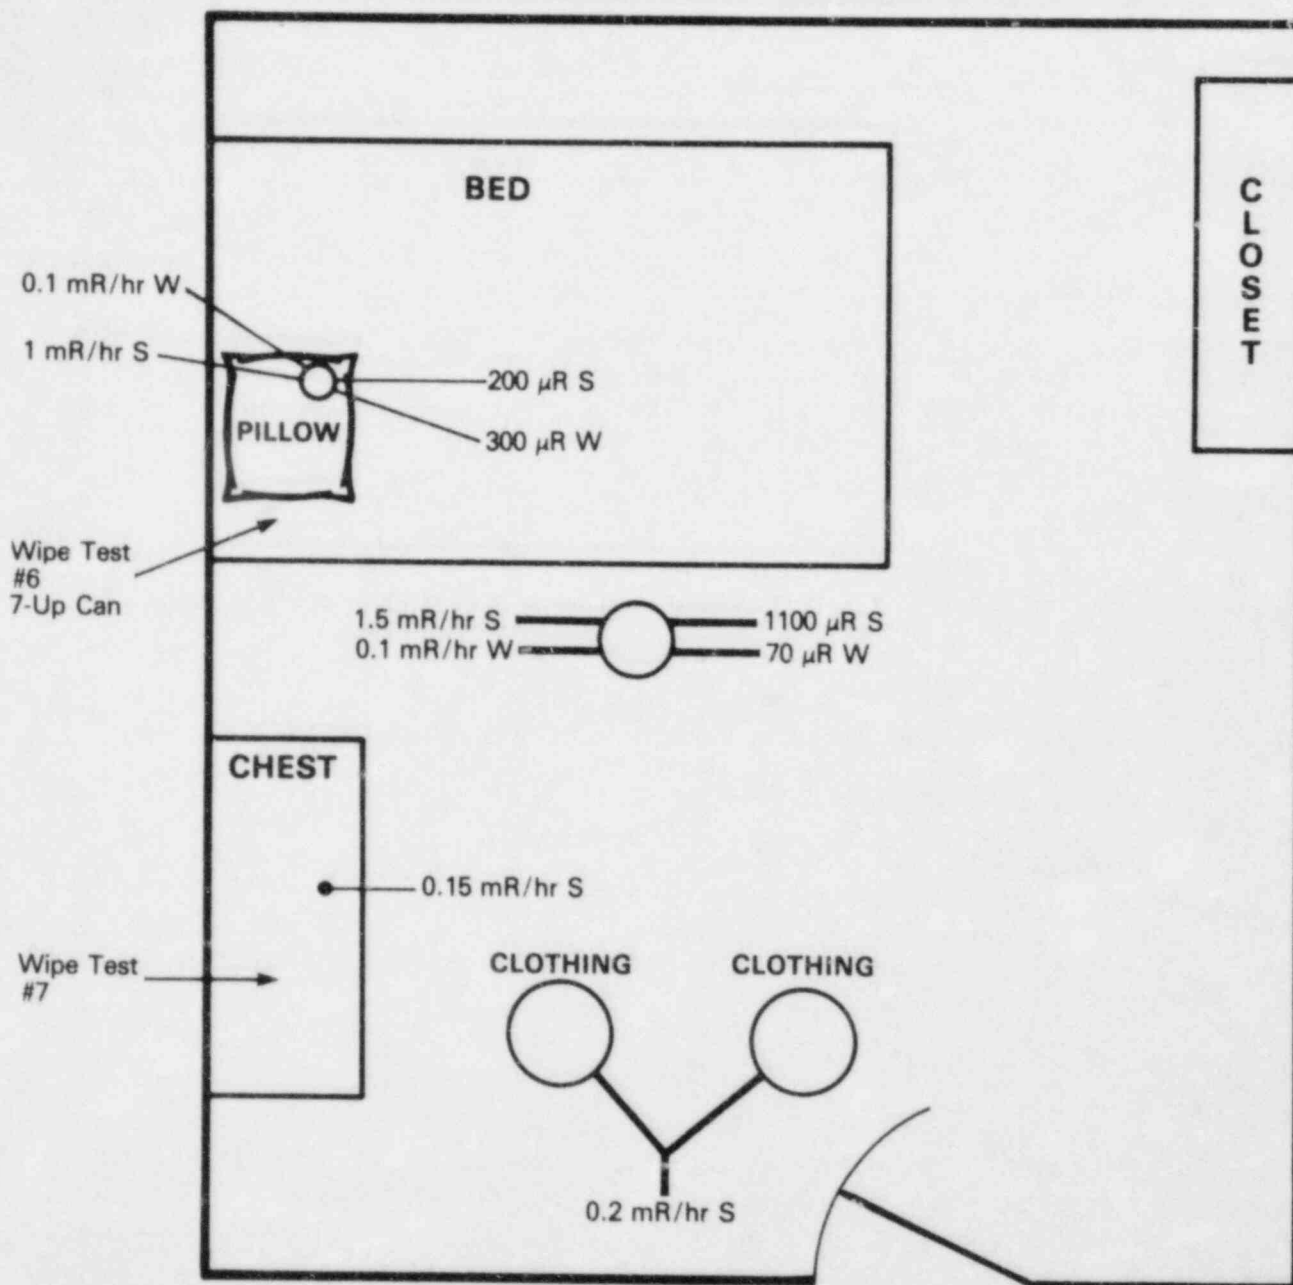
**MAIN BEDROOM SURVEY
RESIDENCE #46
September 17, 1983**

S indicates Surface
W indicates Waist Level

Results in mR/hr were obtained using the Eberline Model E-520.
Results in μ R were obtained using the Eberline Model PRM-7.

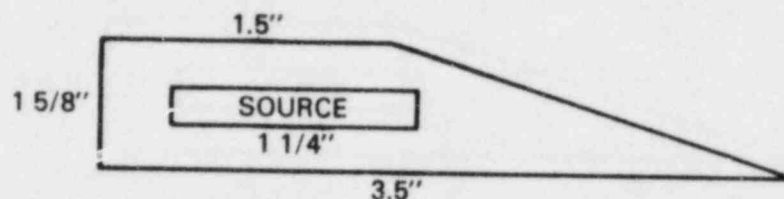
Figure D.1 Sketch of source/source holder as described by licensee.

- (1) Per licensee (sales representative), see Figure D.1.

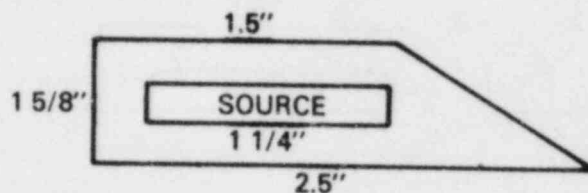
Figure D.2 Sketch of source/source holder as described by licensee.

- (2) Per licensee (machinist), see Figure D.2.

A 3/6" drill bit was used to drill into the holder.

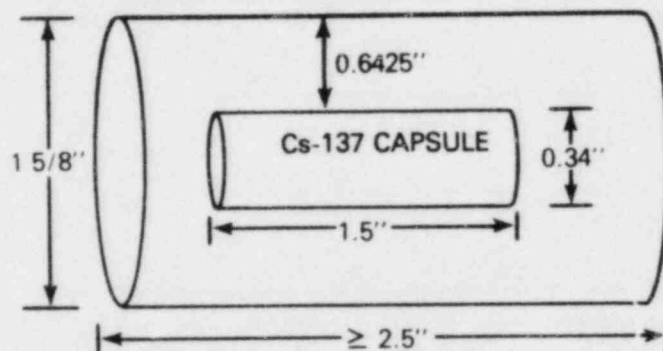
Figure D.3 Sketch of source/source holder model used for exposure calculations

(1) Measurements of Source/Source Holder (see Figure D.3)

$$1\frac{5}{8}'' - 0.34'' = 1.625'' - 0.34'' = 1.285''$$
