MIDLAND NUCLEAR UNITS 1 & 2
CANONIE CONSTRUCTION COMPANY

FILL PLACEMENT QA-QC DAILY REPORT

To G. L. Richardson
 Subject Midland Project, Units 1&2
 Moisture Requirements for
 Backfill prior to Placement
 GLR-02-78-043, QAR SD-40

Subject Midland Project Job 7220
Moisture Requirements for
Backfill Prior to Placement
Spec. C-210, Rev. 5
BCBE-1802

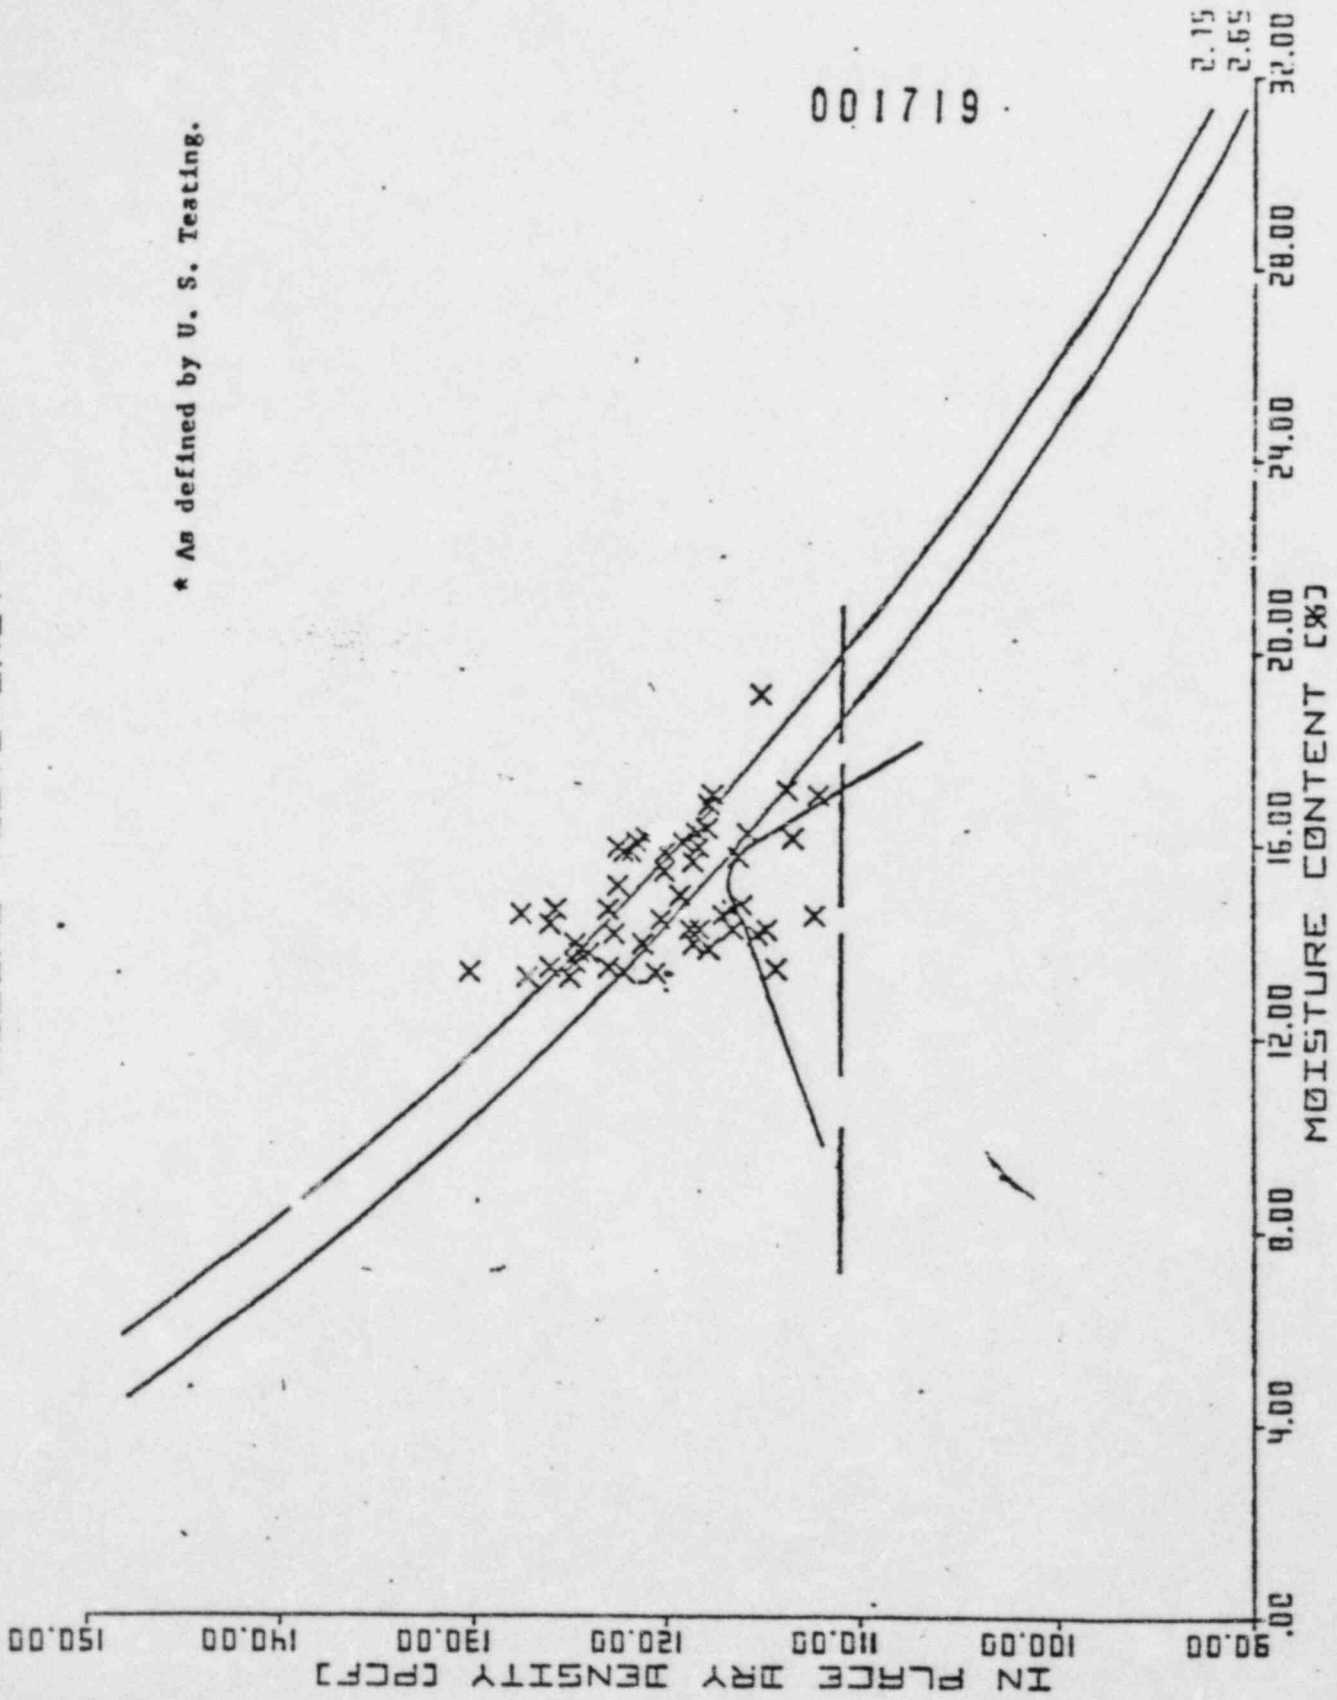
FIGURE 2

Plots of field data for compaction test BMP 278 are shown on Figures 1 through 6. The title of each figure gives the assumptions made in plotting data for the figure. In comparing figures 3 and 4 it is seen that a majority of field tests were made using the nuclear device. The two test results shown on Figure 4 for the sand cone method indicates one test result on each side of the zero air voids curve. The one falling above the zero air voids curve (shown on Figure 4) is designated by U. S. Testing Company as the only passing sand cone test (shown on Figure 6).

MOISTURE-DENSITY FOR BMP 2.8
 SPECIFIC GRAVITY = 2.65
 NUCLEAR DENSOMETER TESTS

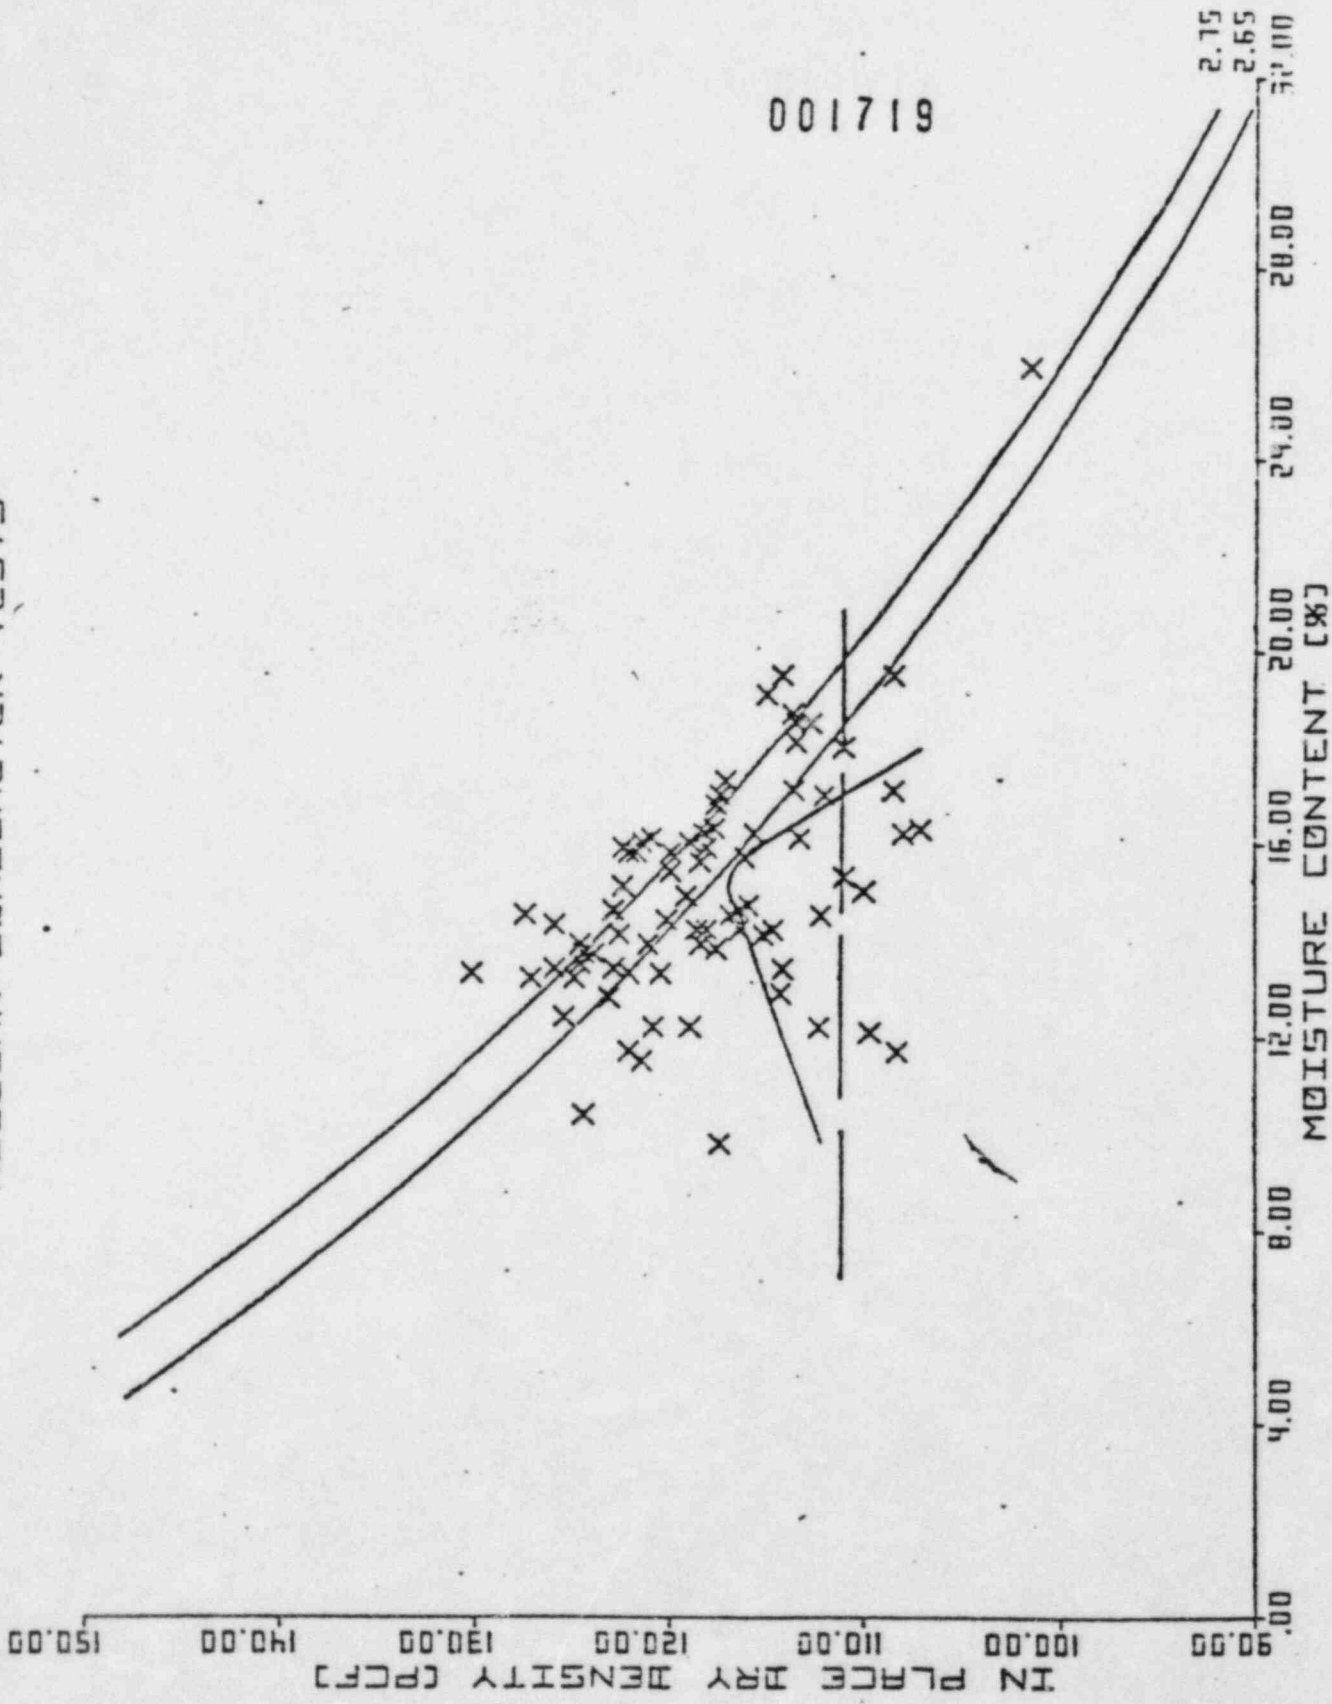
FIGURE 3

MOISTURE-DENSITY CURVE FOR BMP 28
 SPECIFIC GRAVITY = 2.65
 SAND-CONE TESTS

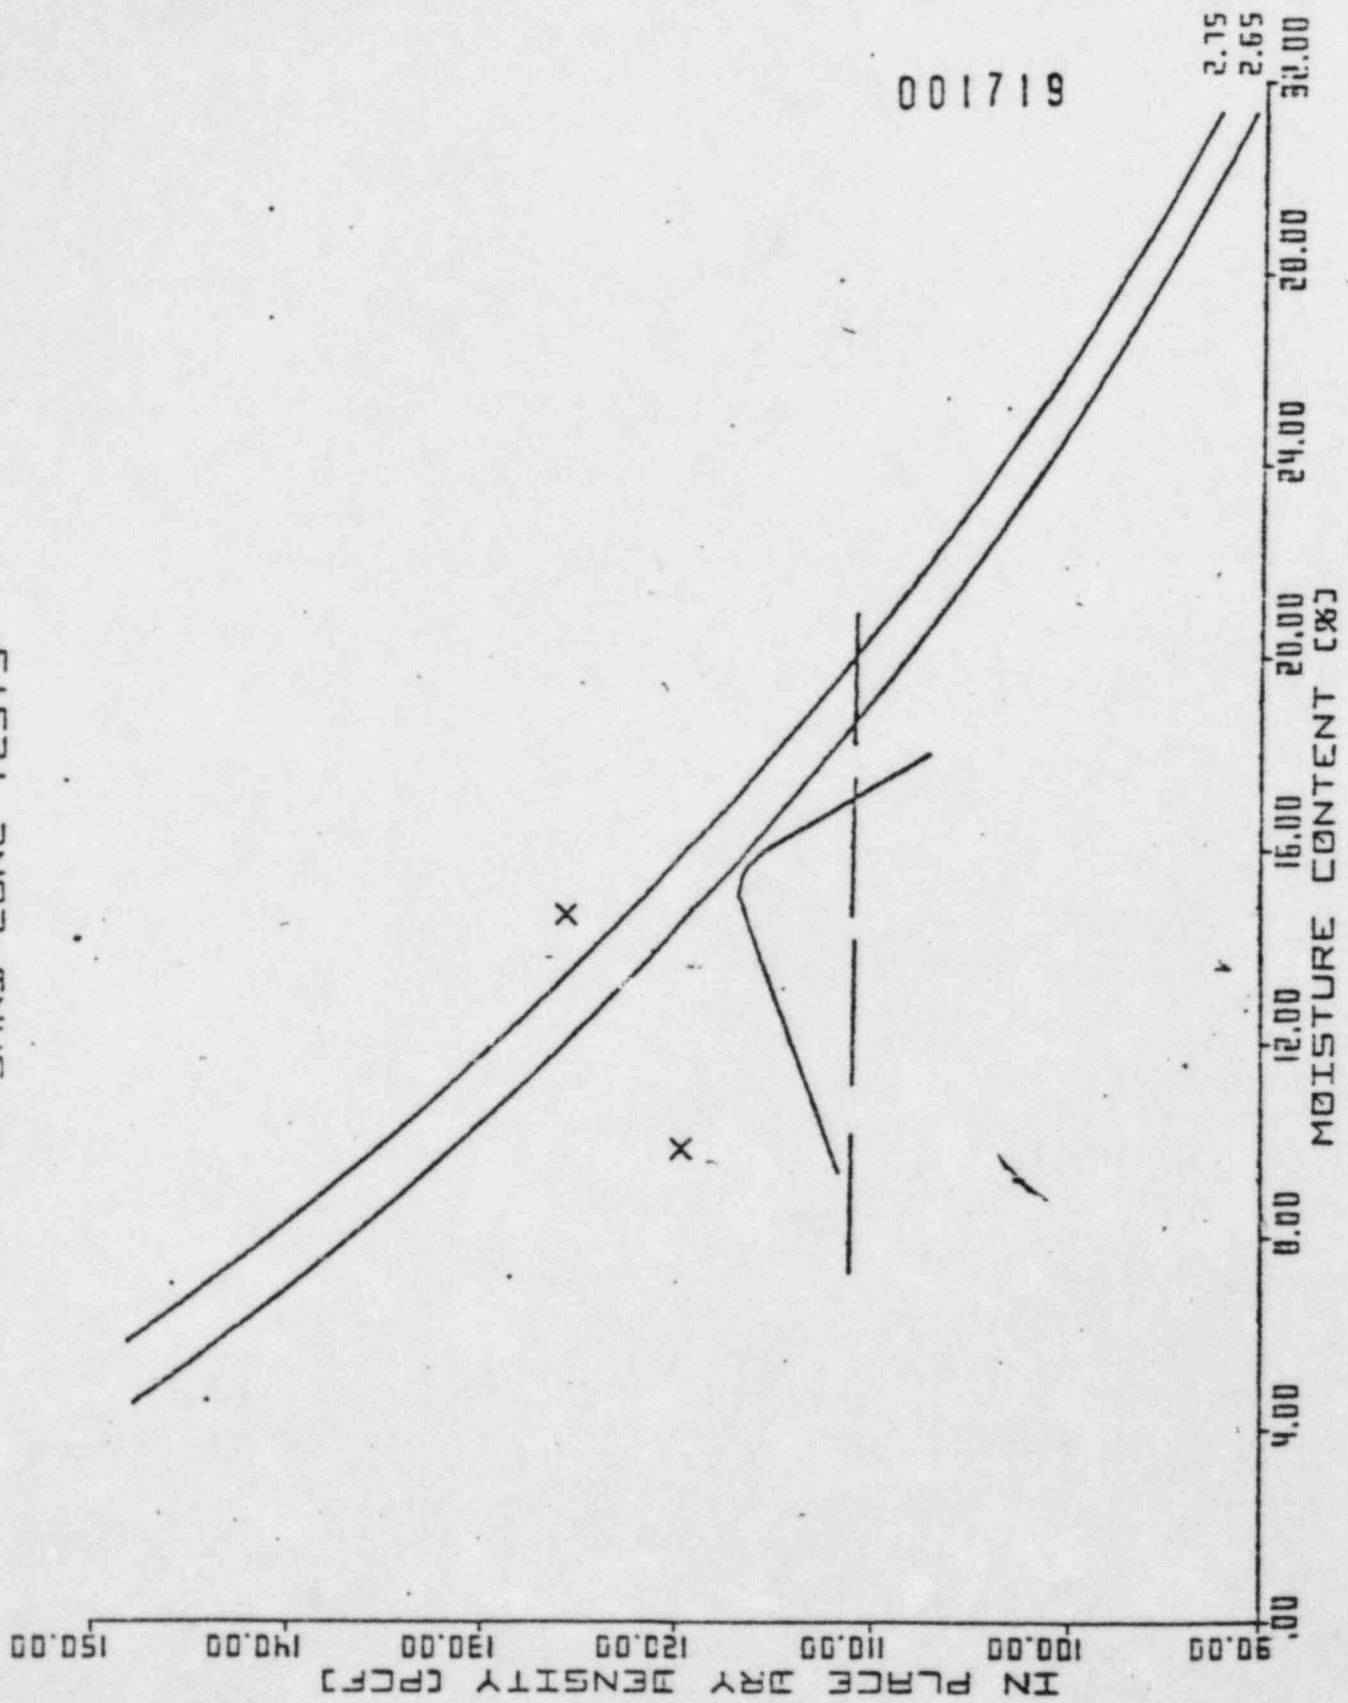
FIGURE 4

MOISTURE DENSITY FOR BMP 2.8
 SPECIFIC GRAVITY = 2.65
 NUC. DENS. PASSING TESTS*

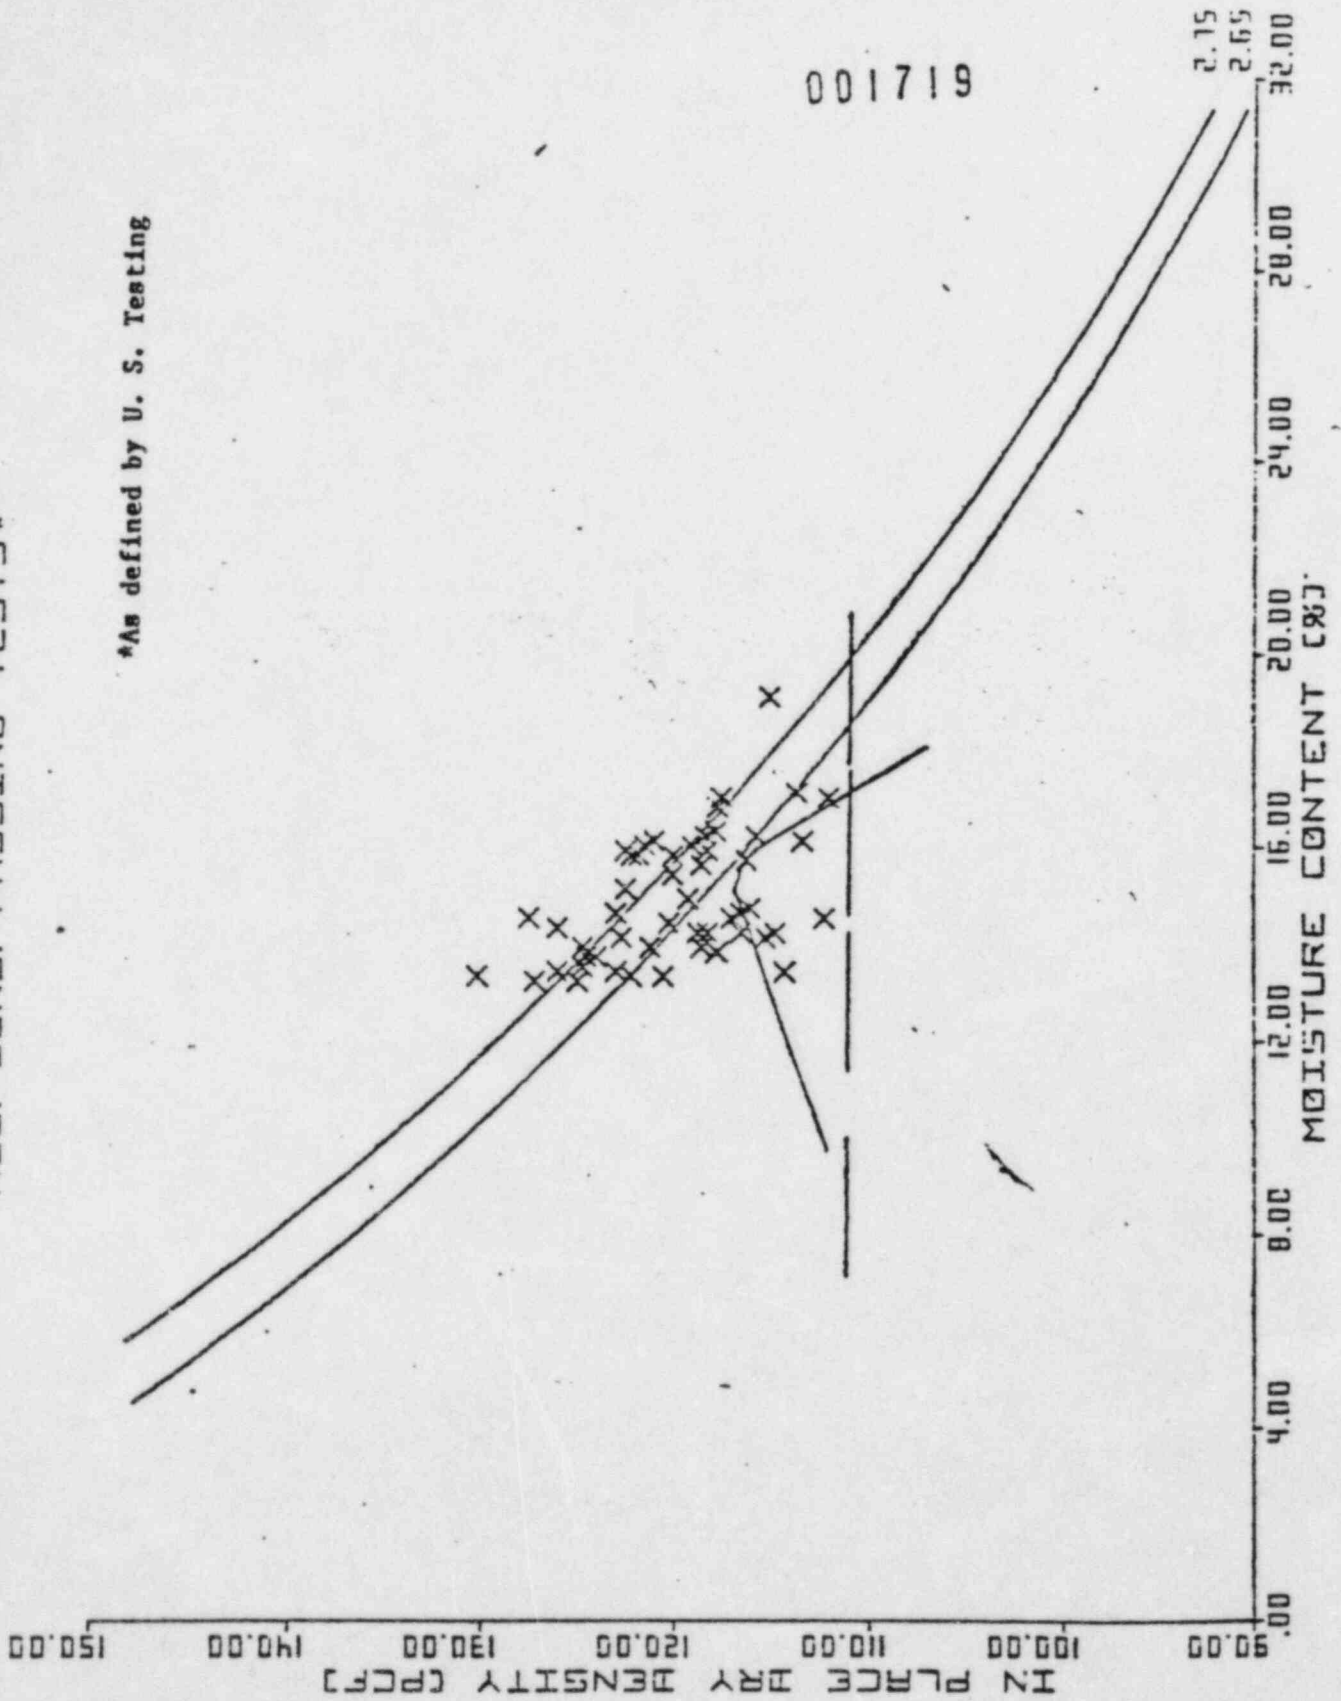
FIGURE 5

MOISTURE-DENSITY TESTS FOR GMP 28
 SPECIFIC GRAVITY = 2.65
 SAND-CONE PASSING TESTS*

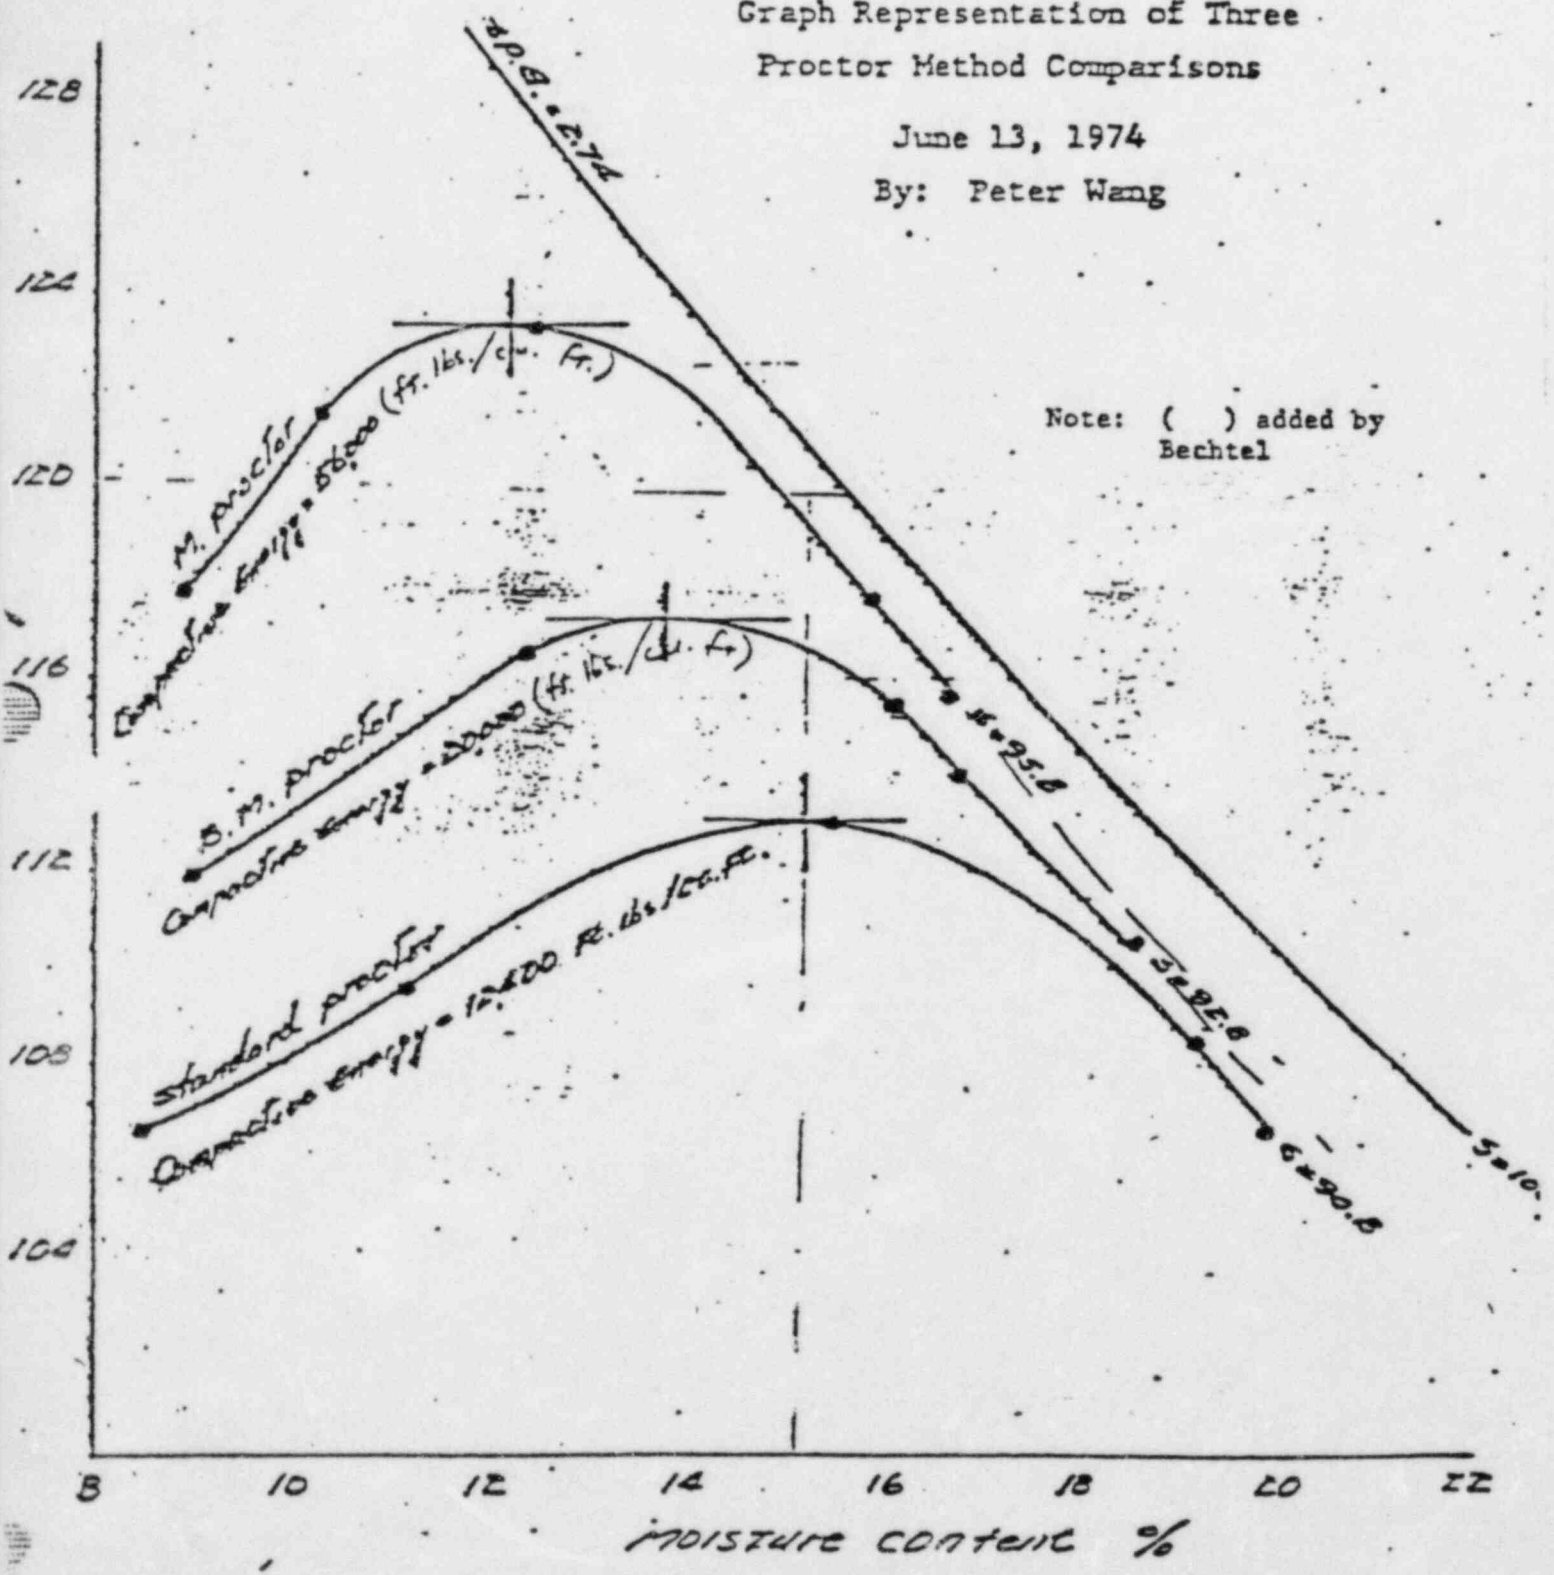
FIGURE - 8

Also, referring to Figure 1 it would appear that soil density varied widely. Specifications called for compactive effort results as defined by ASTM D 1557 which is 56,255 ft-lb/ft³ energy. This was modified to a laboratory test compactive effort of about 20,000 ft-lbs/ft³ energy, often referred to as Bechtel Modified Proctor (BMP). Laboratory compaction test curves should be related to the same effort as that called for in the field for use in comparing with field density tests to determine percent compaction. According to plots of field data shown on Figure 1, density varied from about 108 lb/ft³ to about 130 lb/ft³. It is doubtful that the soil classification or other properties would be similar for such a wide variation in density. It is noted that 100 percent of modified Proctor (ASTM D 1557) which is difficult to obtain, is rated at 56,255 ft-lb/ft³ energy. The curve plotted on Figure 1 is at about 20,000 ft-lb/ft³ energy. For comparative purposes it was determined by U. S. Testing in 1974 that 100 percent of specified effort (20,000 ft-lb/ft³) is approximately equal to 95 percent of the maximum density as determined by ASTM D 1557 (56,255 ft-lb/ft³) Reference Figure 8.

MOISTURE-DENSITY FOR BMP 2-3

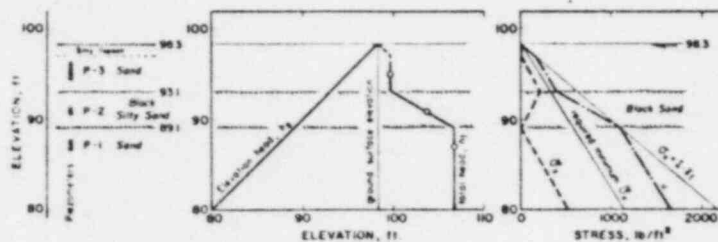
Figs. 2 and 3 show two aspects of a performance evaluation for a recently constructed dam. Figure 2 portrays stress conditions downstream of the dam for a headwater elevation 15 ft (5 m) below the design reservoir level. As this figure indicates, effective stresses fell below the values specified in the performance criteria.

FIG. 2.—Performance Evaluation for Effective Stresses (1 ft = 0.305 m, 1,000 lb/sq ft = 4.88 tons/m² = 47.85 kN/m²)

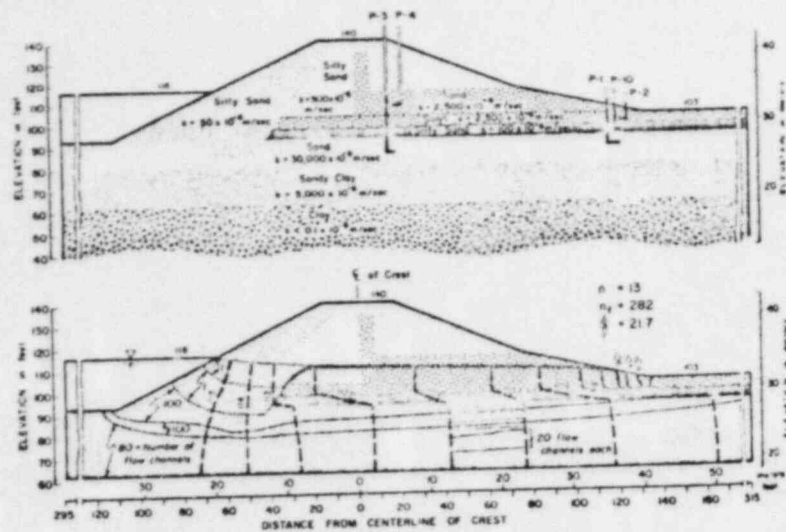
Figure 3 shows the flow net for a partially full reservoir using pore pressures measured prior to the execution of remedial measures. While the net indicates that flow through the dam met the criterion, predicted flow for full reservoir level exceeded the criterion.

FIG. 3.—Performance Evaluation for Flow through Dam

of remedial measures which corrected nearly all of the deficiencies. Continuous periodic evaluations check deficiencies not yet fully corrected.
