SUBJECT: TIA - NORTH ANNA UNIT 1 STEAM GENERATOR TUBE FAILURE EVENT

NORTH ANNA UNIT 1
STEAM GENERATOR TUBE RUPTURE
AND
REMEDIAL ACTIONS TECHNICAL
EVALUATION
SEPTEMBER 1987

The purpose of this report is to document the evaluations of the North Anna Unit 1 Steam Generator "C" Row 9 Column 51 tube rupture event and the steam generator modifications which will be made to minimize the requisite conditions for future occurrence of a similar event.

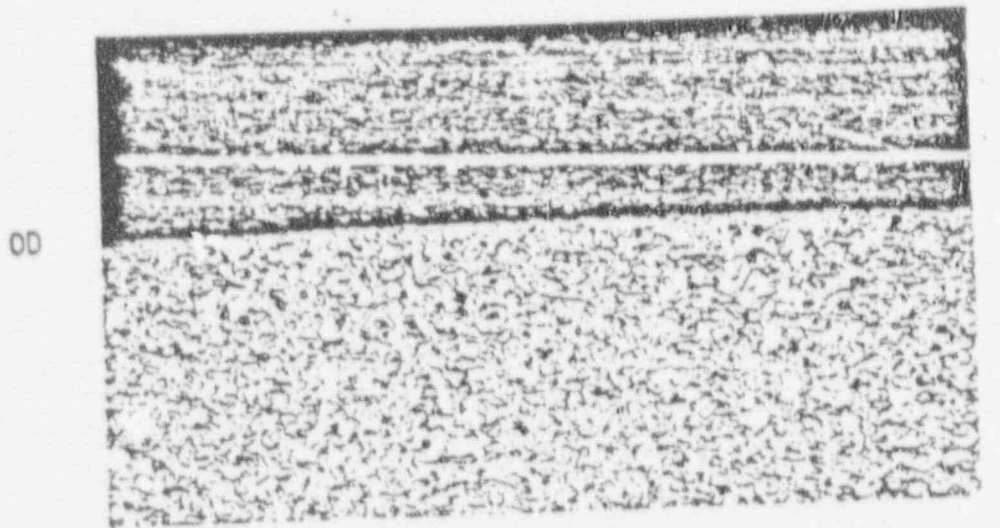
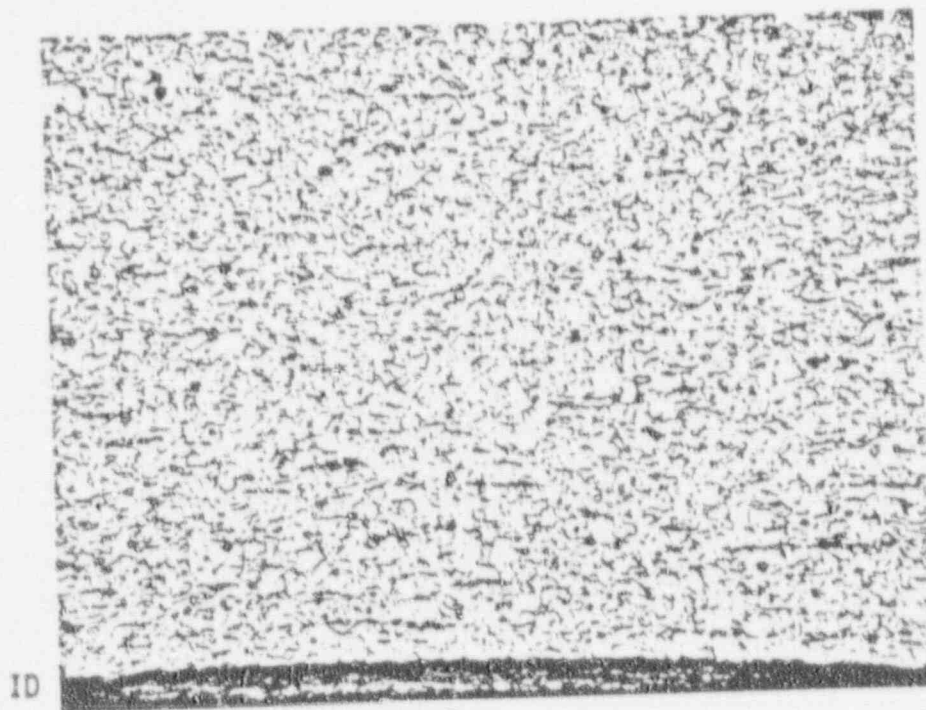
Figure 2.2-1

TRANSVERSE METALLOGRAPHY -5 INCHES BELOW FRACTURE FOR TUBE R9-C54 CL

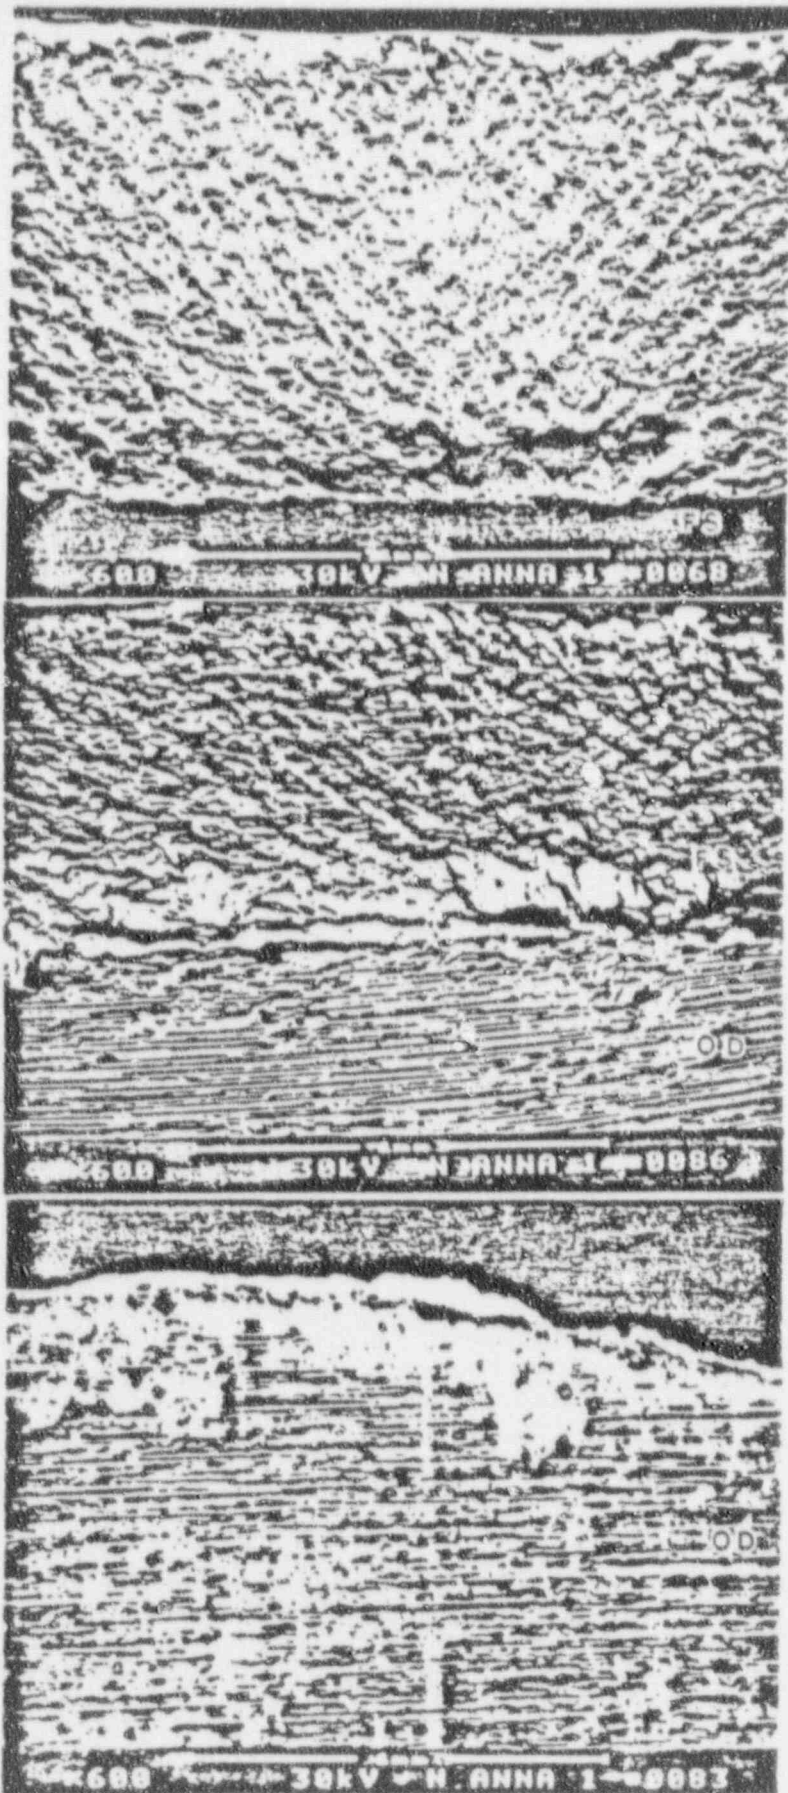
FIGURE 2.2-7

SEM micrographs at various locations near the 135° crack origin on the FS of Piece 9B2.

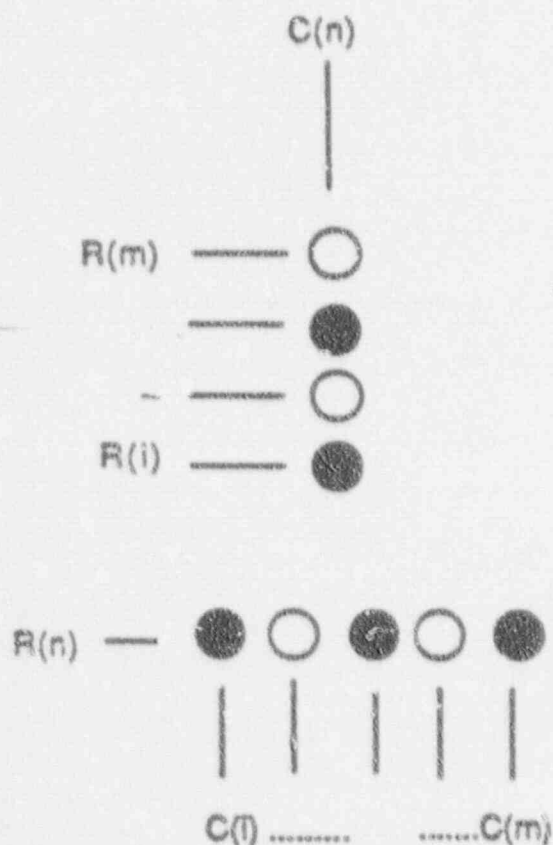
Figure 4.2.4 - 2

Interpretation of Tube Support Conditions

$k < m$: Indicated Unsupported Tubes must be Supported Because AVB is Seen at a Lower Row Number.

Example: S/G - A, Column 8, S/G - C, Column 40, etc.

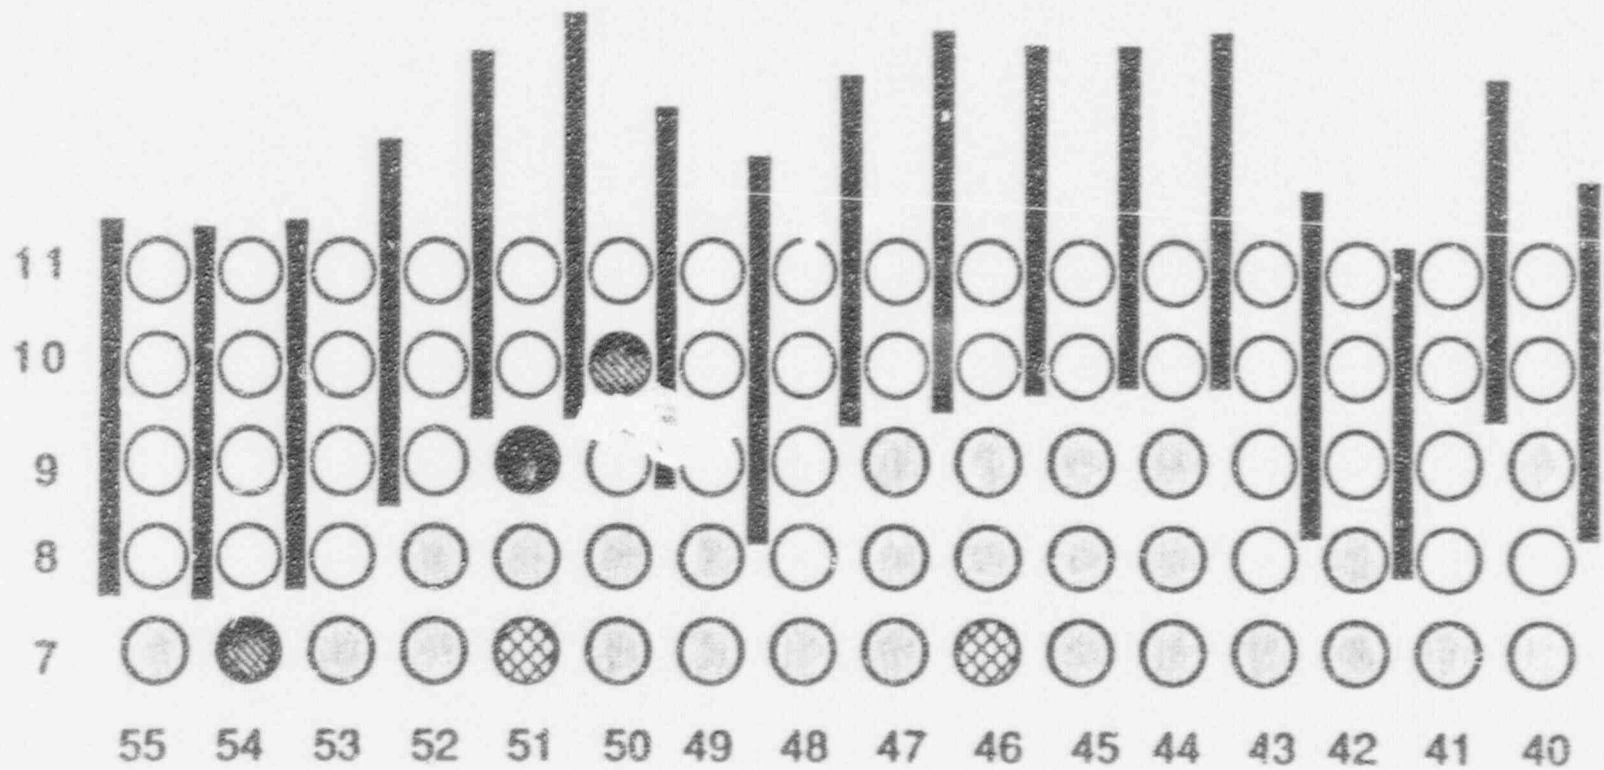
Figure 4.2.4 - 3

N. Anna : S/G - C
Tube Support Conditions

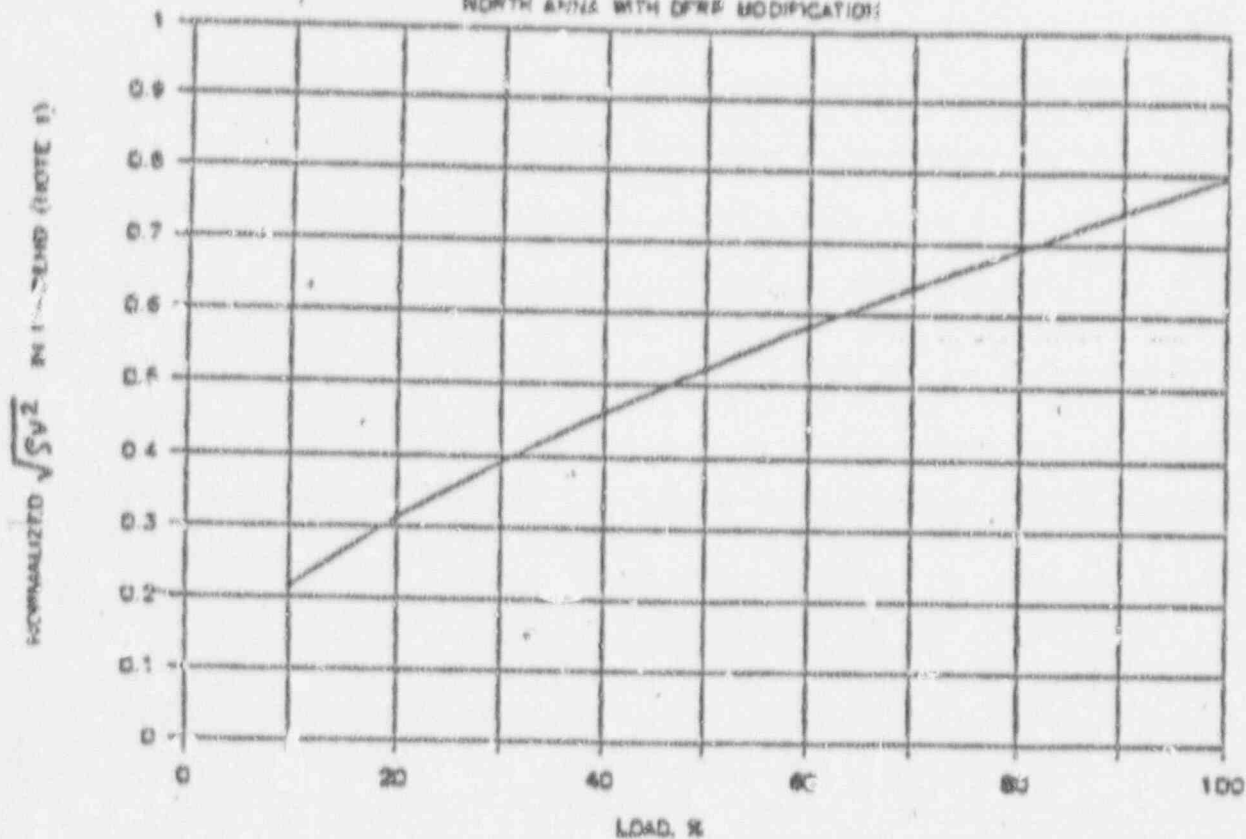
Figure 4.2.6-1

Influence of Load on Stability Ratio

NORTH AXIS WITH DFRP MODIFICATION

Note 1. Normalized Relative to 100% Load Conditions Prior to the Downcomer Flow Resistance Plate (DFRP) Modification.

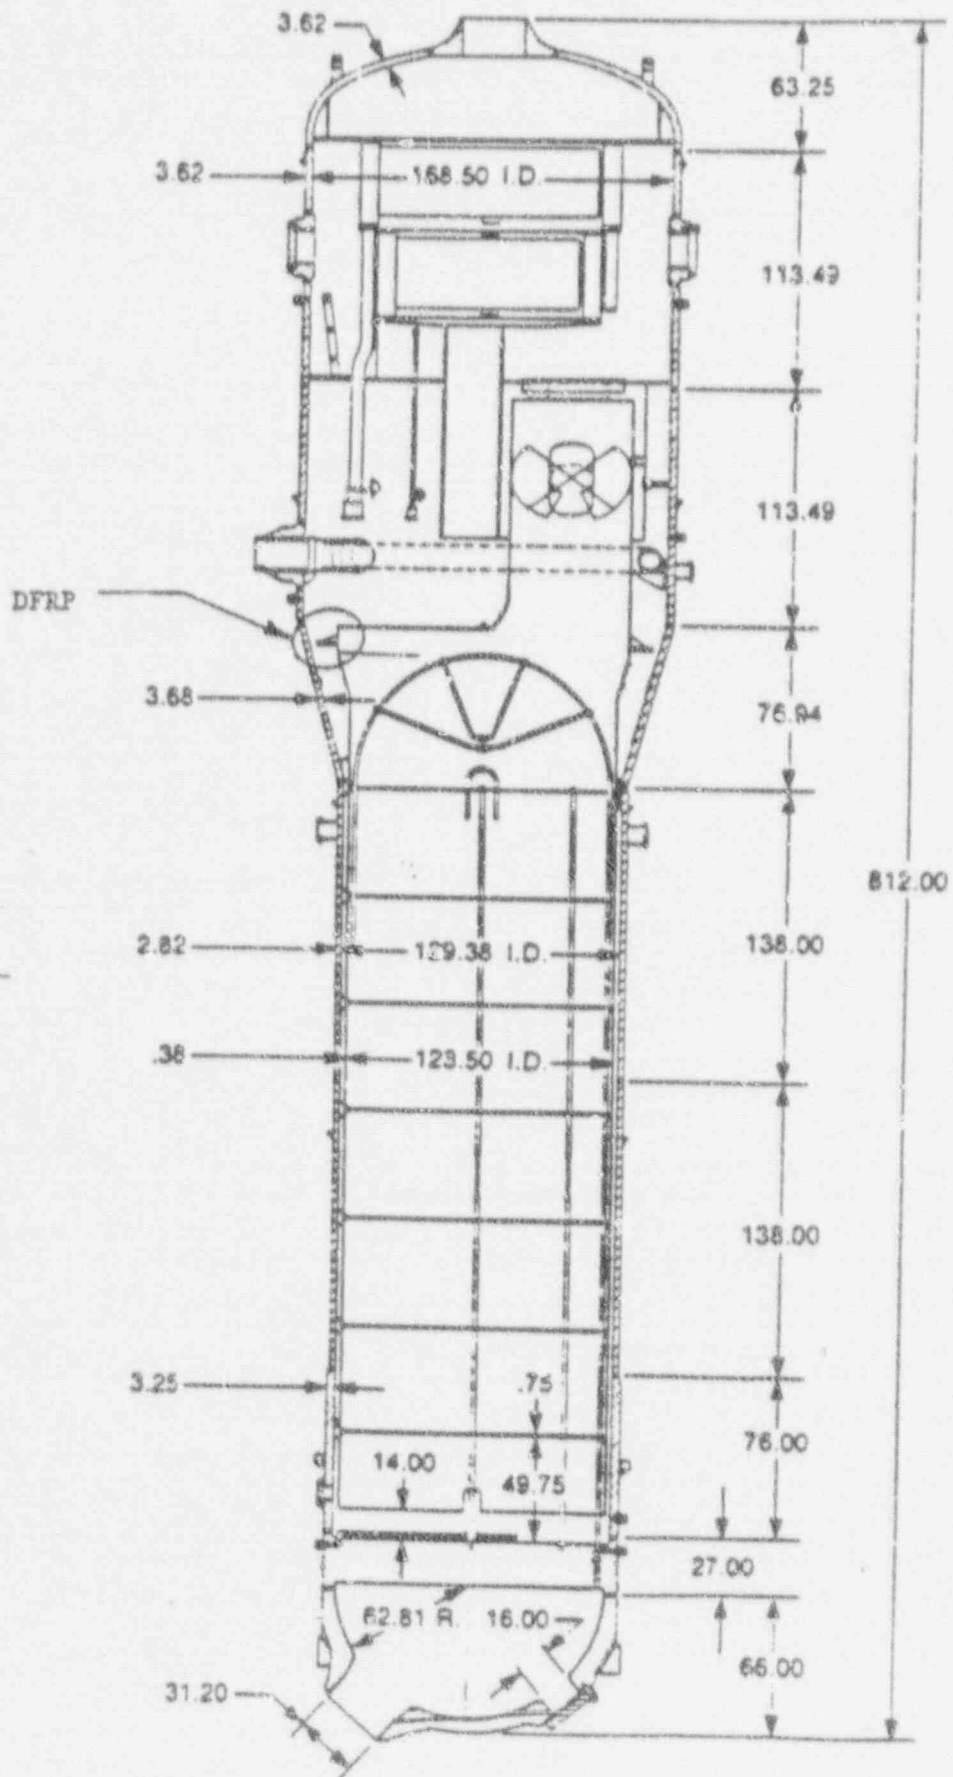
FIGURE 4.5-1

The DFRP assemblies comprise an annular, perforated plate located near the top of the downcomer annulus, between the wrapper and shell of the steam generator, as shown on Figure 4.5-1. Its function is to provide a hydraulic impedance to the recirculating coolant flow in the steam generator, thereby providing one of the hydraulic parameters used to establish the circulation ratio (CR). The purpose of this section of this report is to describe the design and analysis of the DFRP; the evaluation of the influence of the CR, and hence fluid velocities, on tube vibration is described elsewhere in this report.
