BECHTEL INVESTIGATION  
INTO CAUSES  
OF DIESEL GENERATOR  
BUILDING SETTLEMENT

Consumers Power Company  
Midland Plant Units 1 and 2

SUBJECT: MCAR 24 (issued 9/7/78)  
 Settlement of the Diesel Generator Foundations and Building  
 INTERIM REPORT 4  
 DATE: February 16, 1979  
 PROJECT: Consumers Power Company  
 Midland Plant Units 1 & 2  
 Bechtel Job 7220

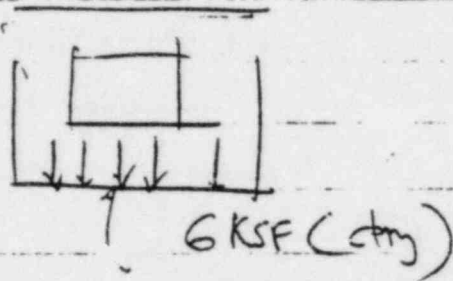
Draw down of water - does it cause additional  
settlement.  
changing the effective stress.

Effective stress would increase -

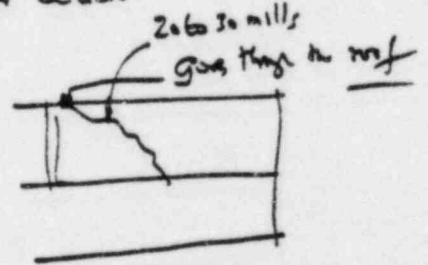
2 to 30 mill - worse as it more:

Need more investigation of the cracking pattern.  
Review construction records.
