UNITED STATES TESTING COMPANY'S
Response to the Bechtel Report

"Review of U. S. Testing Field
and Laboratory Construction
Test Data on Soils Uses as Fill"

Midland Units 1 & 2
Job No. 7220

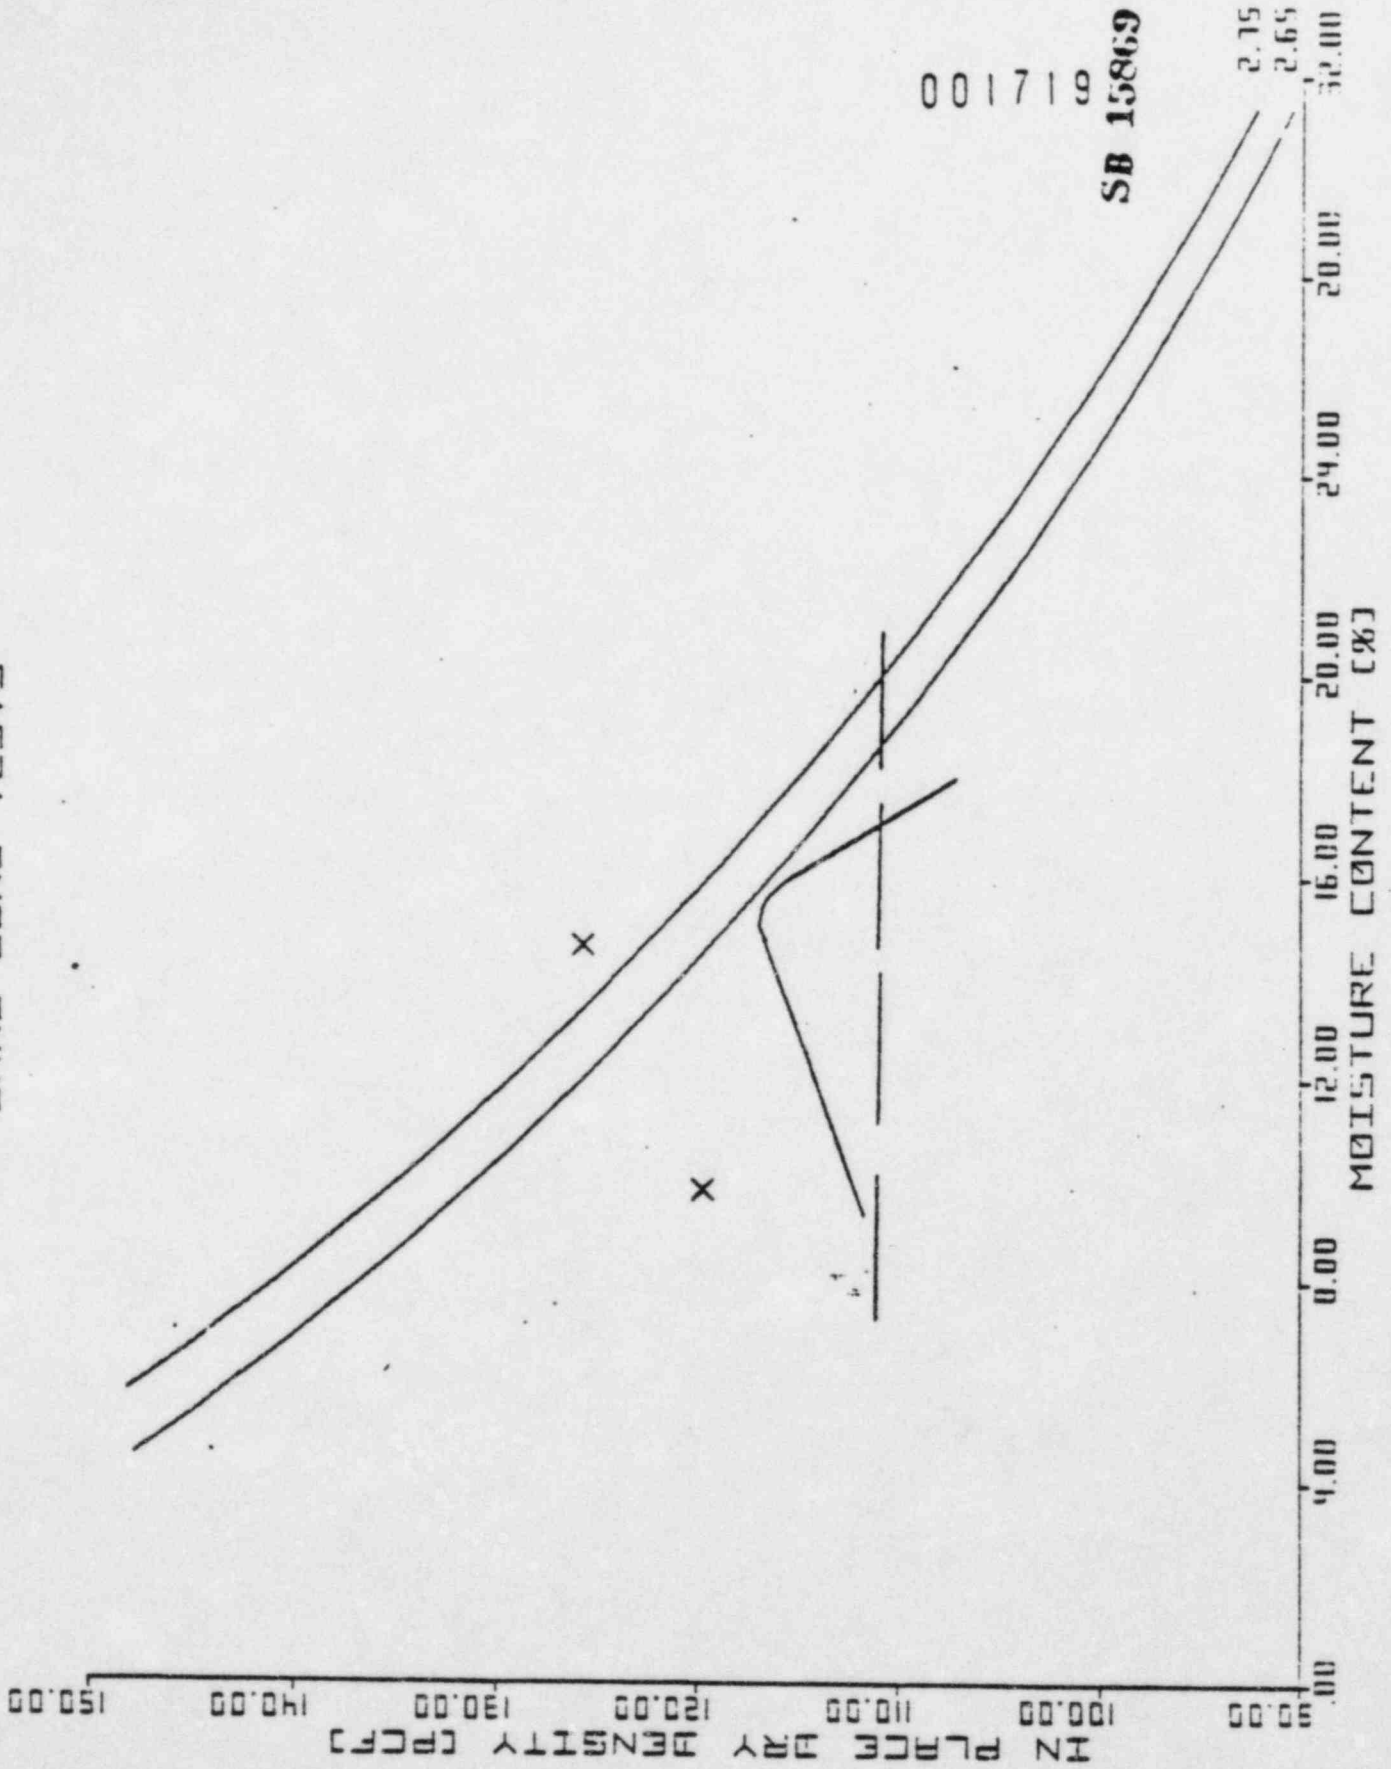
FIGURE 4

Plots of field data for compaction test BMP 278 are shown on Figures 1 through 6. The title of each figure gives the assumptions made in plotting data for the figure. In comparing figures 3 and 4 it is seen that a majority of field tests were made using the nuclear device. The two test results shown on Figure 4 for the sand cone method indicates one test result on each side of the zero air voids curve. The one falling above the zero air voids curve (shown on Figure 4) is designated by U. S. Testing Company as the only passing sand cone test (shown on Figure 6).

MOISTURE-DENSITY FOR BMP 278
 SPECIFIC GRAVITY = 2.65
 SAND-CONE TESTS

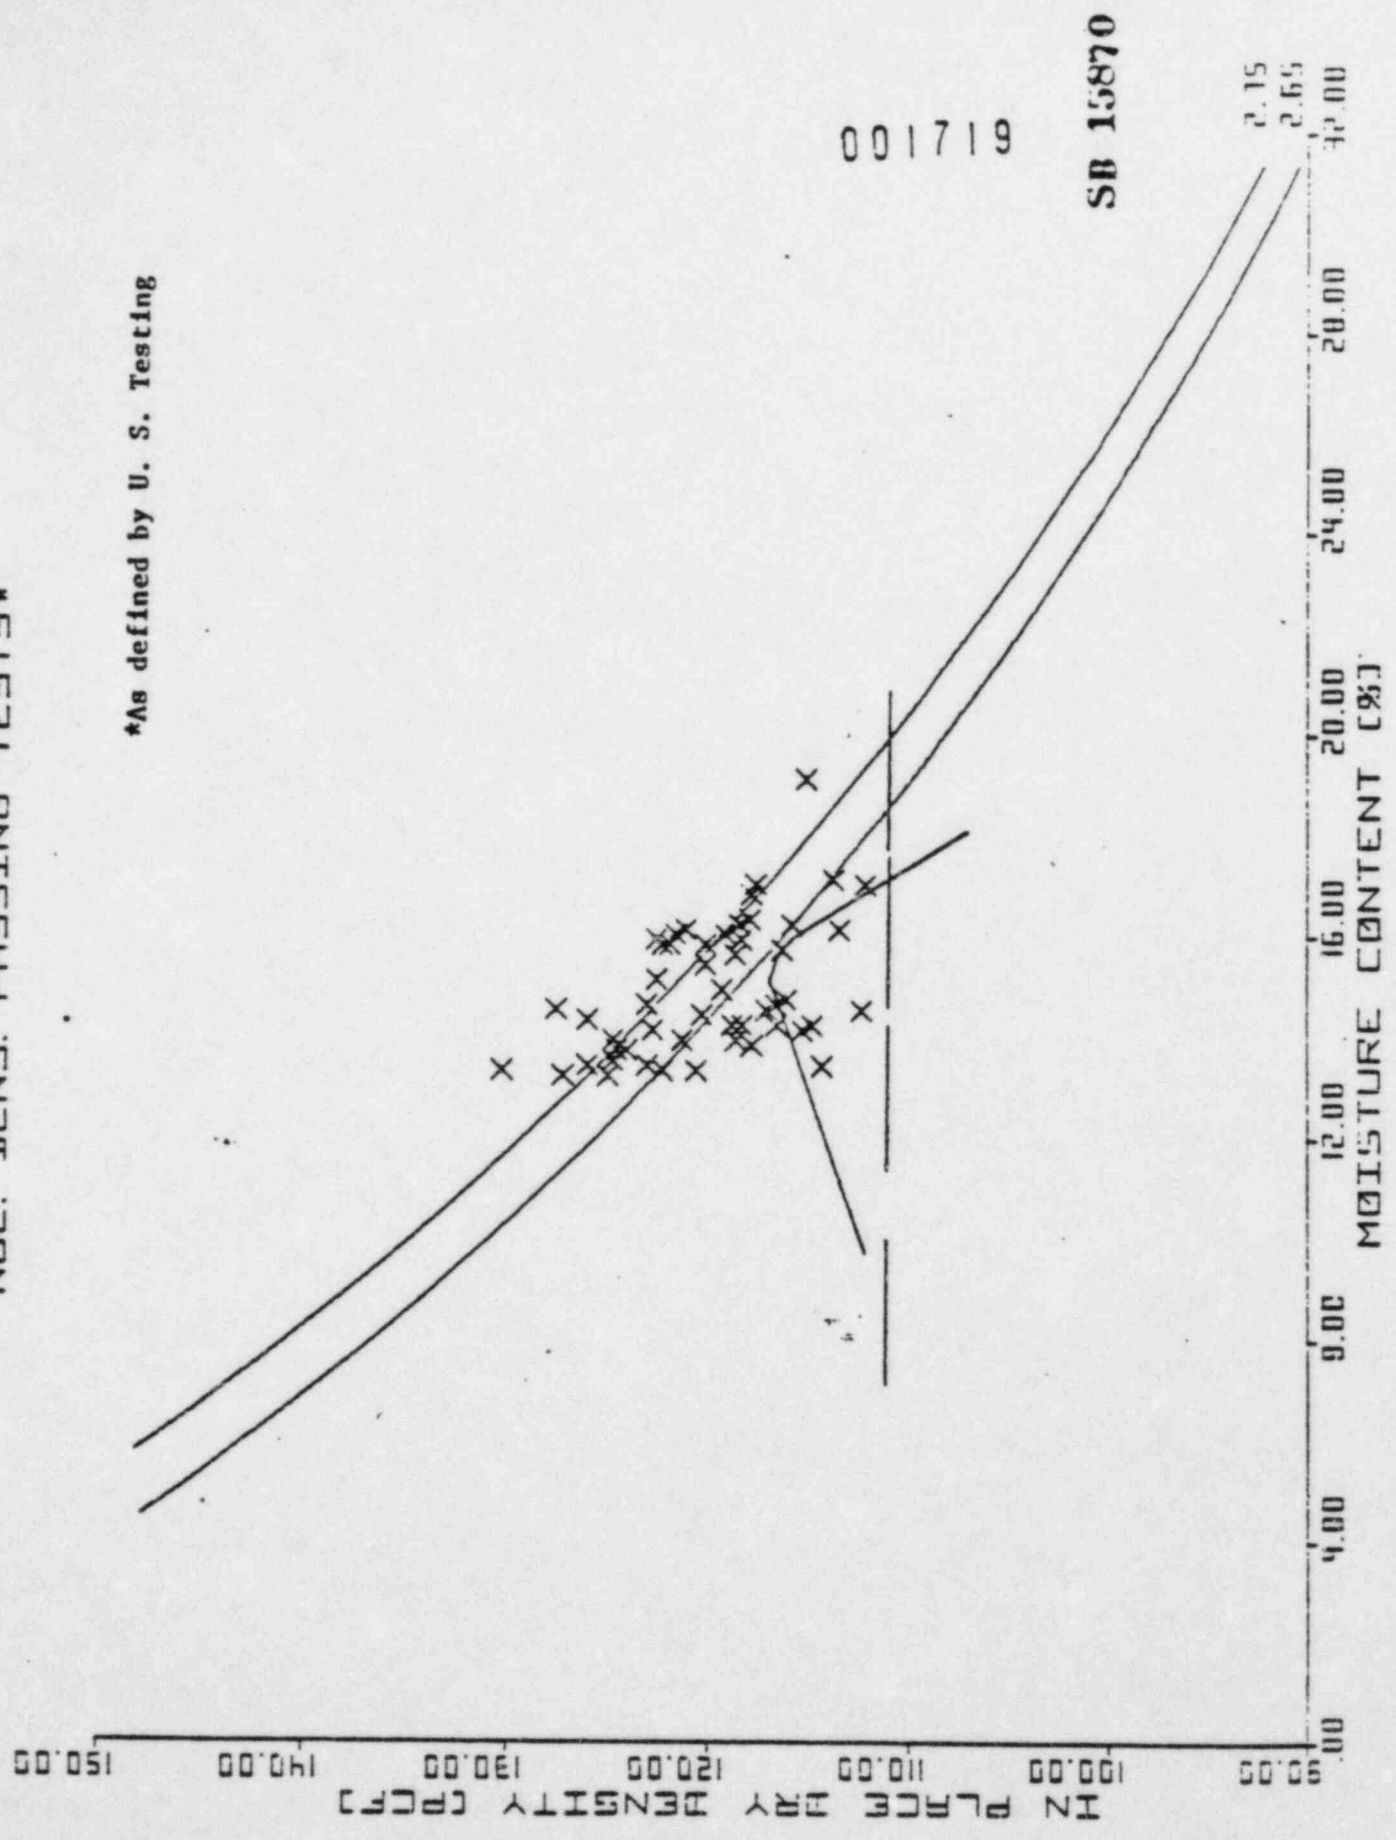
FIGURE 5

MOISTURE DENSITY FOR BMP 278
 SPECIFIC GRAVITY = 2.65
 NUC. DENS. PASSING TESTS*

*As defined by U. S. Testing

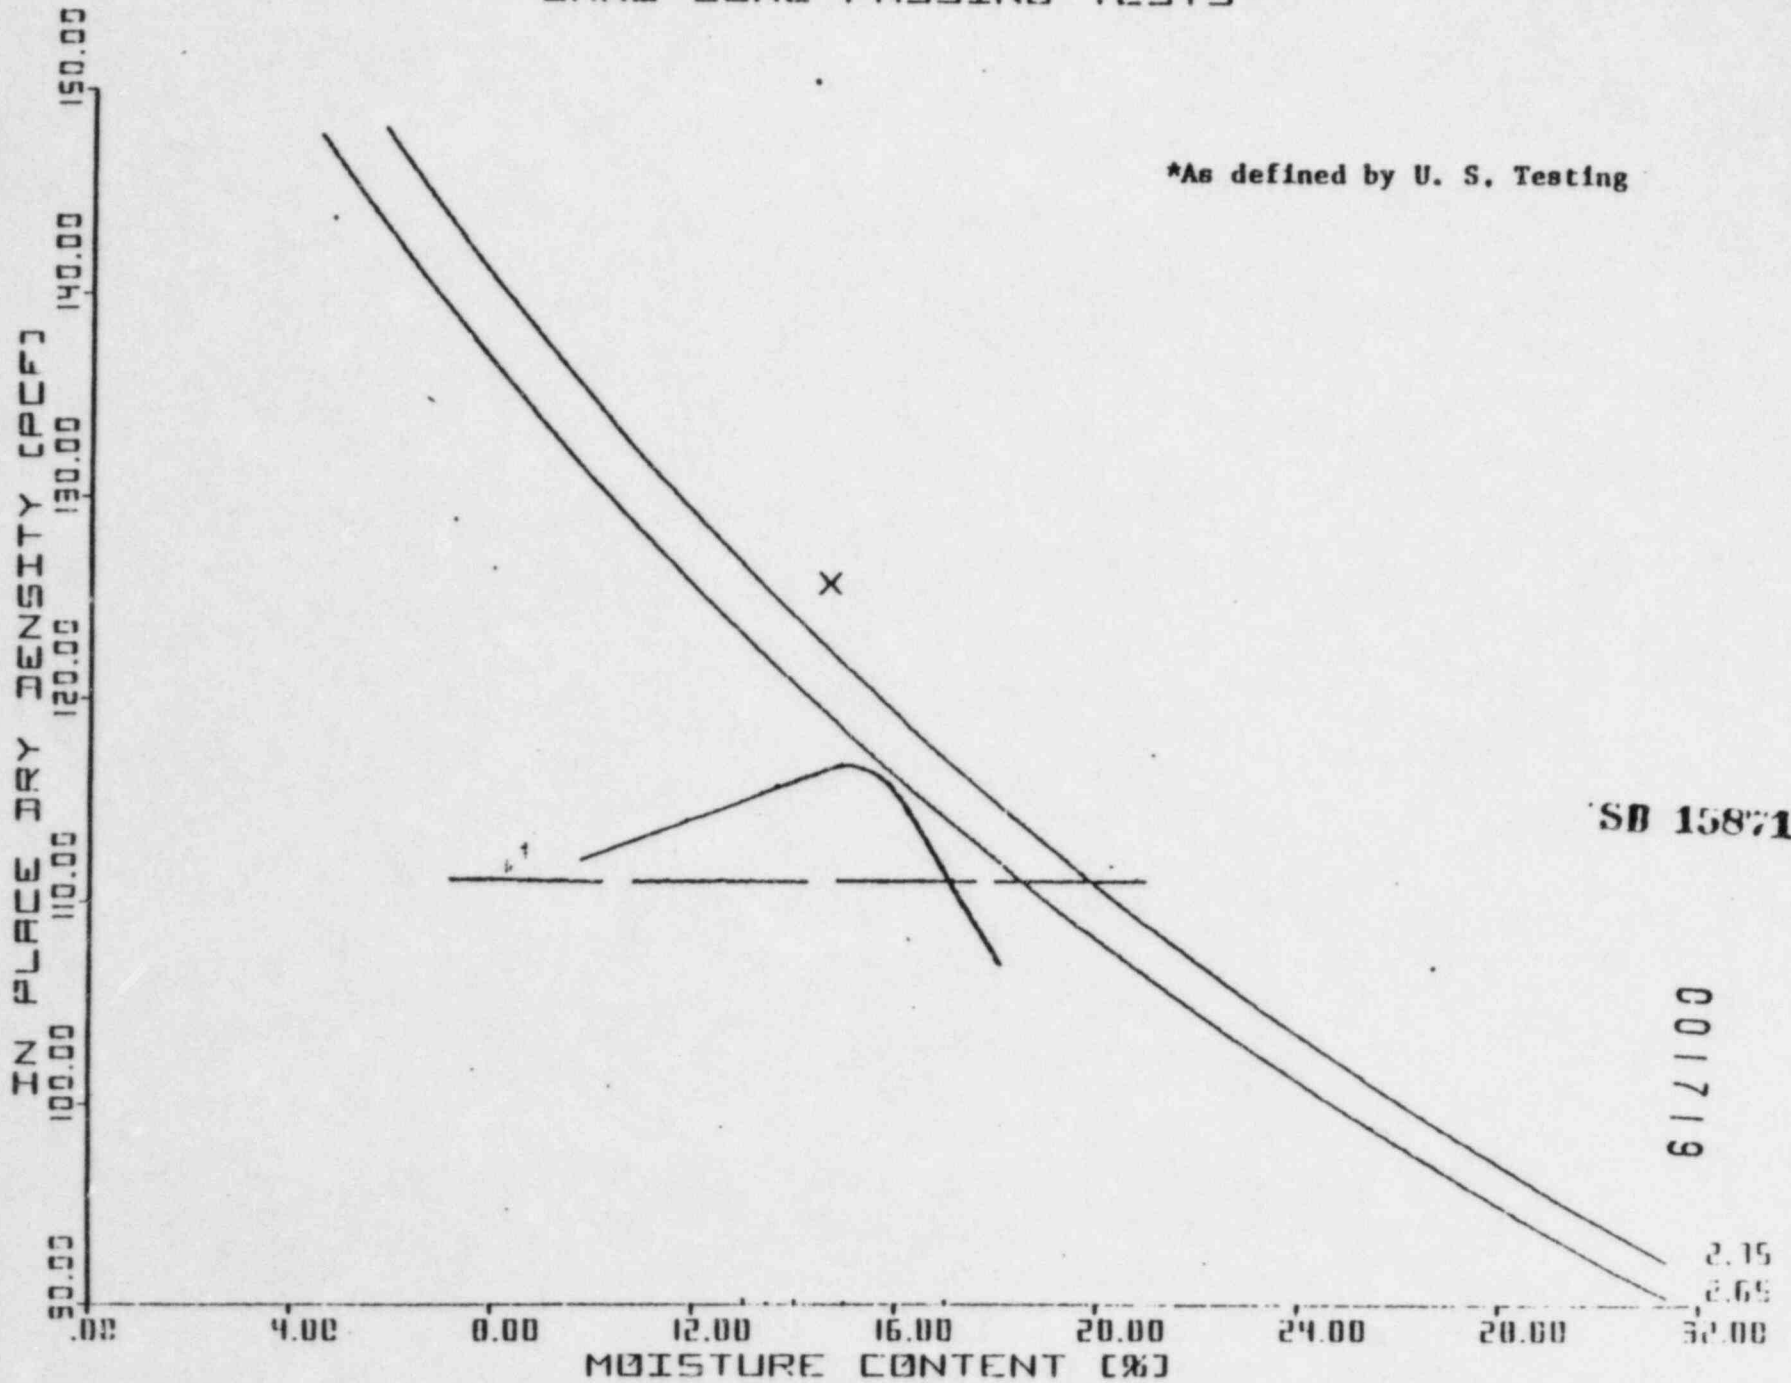
FIGURE 6

MOISTURE-DENSITY FOR BMP 278

SPECIFIC GRAVITY = 2.65
SAND-CONE PASSING TESTS *

*As defined by U. S. Testing
