MIDLAND UNITS 1 & 2
JOB NO. 7220

REVIEW OF U.S. TESTING
FIELD AND LABORATORY CONSTRUCTION
TEST DATA ON SOILS USED AS FILL

PREPARED BY
BECHTEL POWER CORPORATION
JUNE 12, 1979

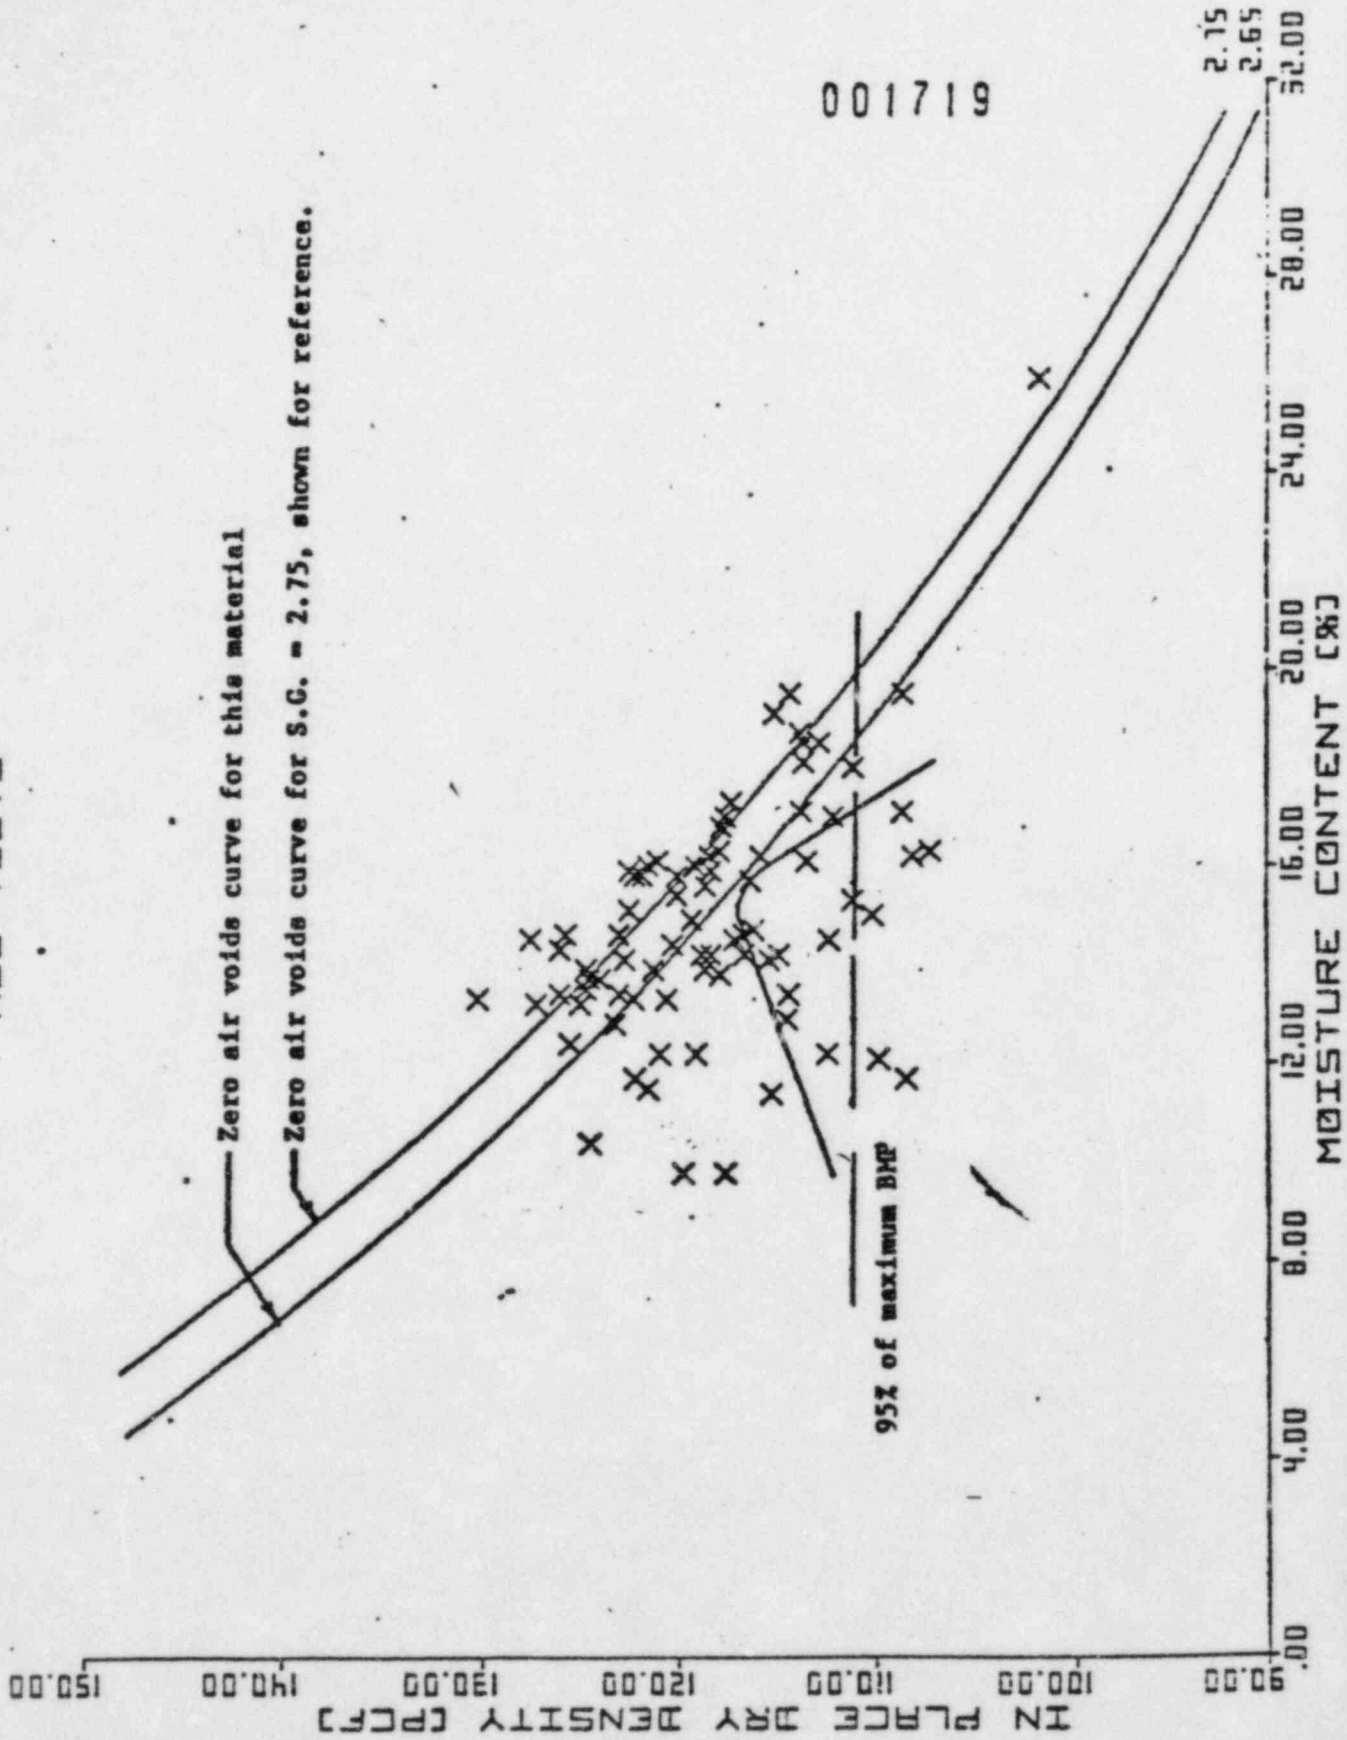
FIGURE 1

Also, referring to Figure 1 it would appear that soil density varied widely. Specifications called for compactive effort results as defined by ASTM D 1557 which is 56,255 ft-lb/ft³ energy. This was modified to a laboratory test compactive effort of about 20,000 ft-lbs/ft³ energy, often referred to as Bechtel Modified Proctor (BMP). Laboratory compaction test curves should be related to the same effort as that called for in the field for use in comparing with field density tests to determine percent compaction. According to plots of field data shown on Figure 1, density varied from about 108 lb/ft³ to about 130 lb/ft³. It is doubtful that the soil classification or other properties would be similar for such a wide variation in density. It is noted that 100 percent of modified Proctor (ASTM D 1557) which is difficult to obtain, is rated at 56,255 ft-lb/ft³ energy. The curve plotted on Figure 1 is at about 20,000 ft-lb/ft³ energy. For comparative purposes it was determined by U. S. Testing in 1974 that 100 percent of specified effort (20,000 ft-lb/ft³) is approximately equal to 95 percent of the maximum density as determined by ASTM D 1557 (56,255 ft-lb/ft³) Reference Figure 8.

MOISTURE-DENSITY FOR BMP 278
 SPECIFIC GRAVITY = 2.65
 ALL TESTS

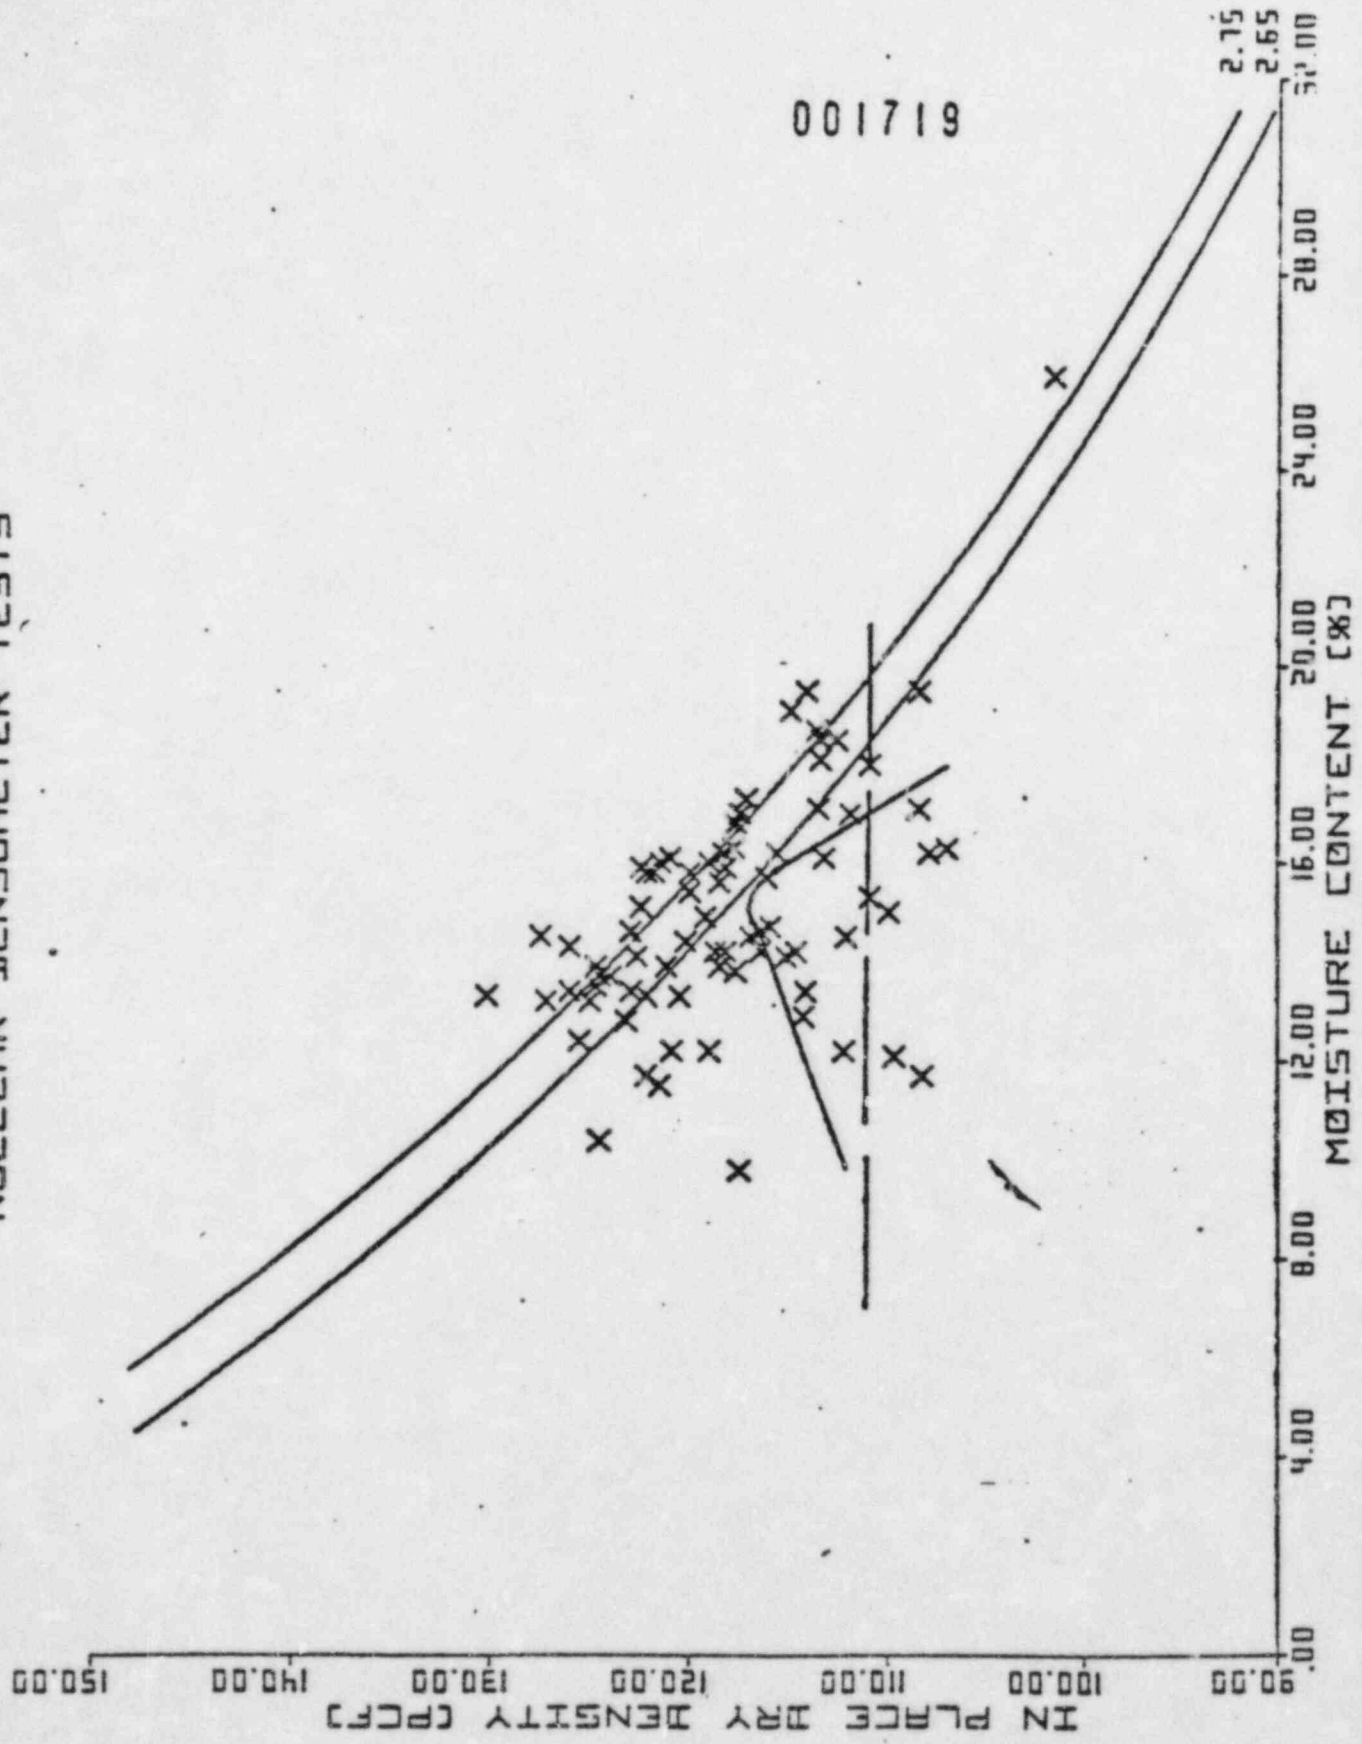
FIGURE 3

MOISTURE-DENSITY FOR BMP 278
 SPECIFIC GRAVITY = 2.65
 NUCLEAR DENSOMETER TESTS

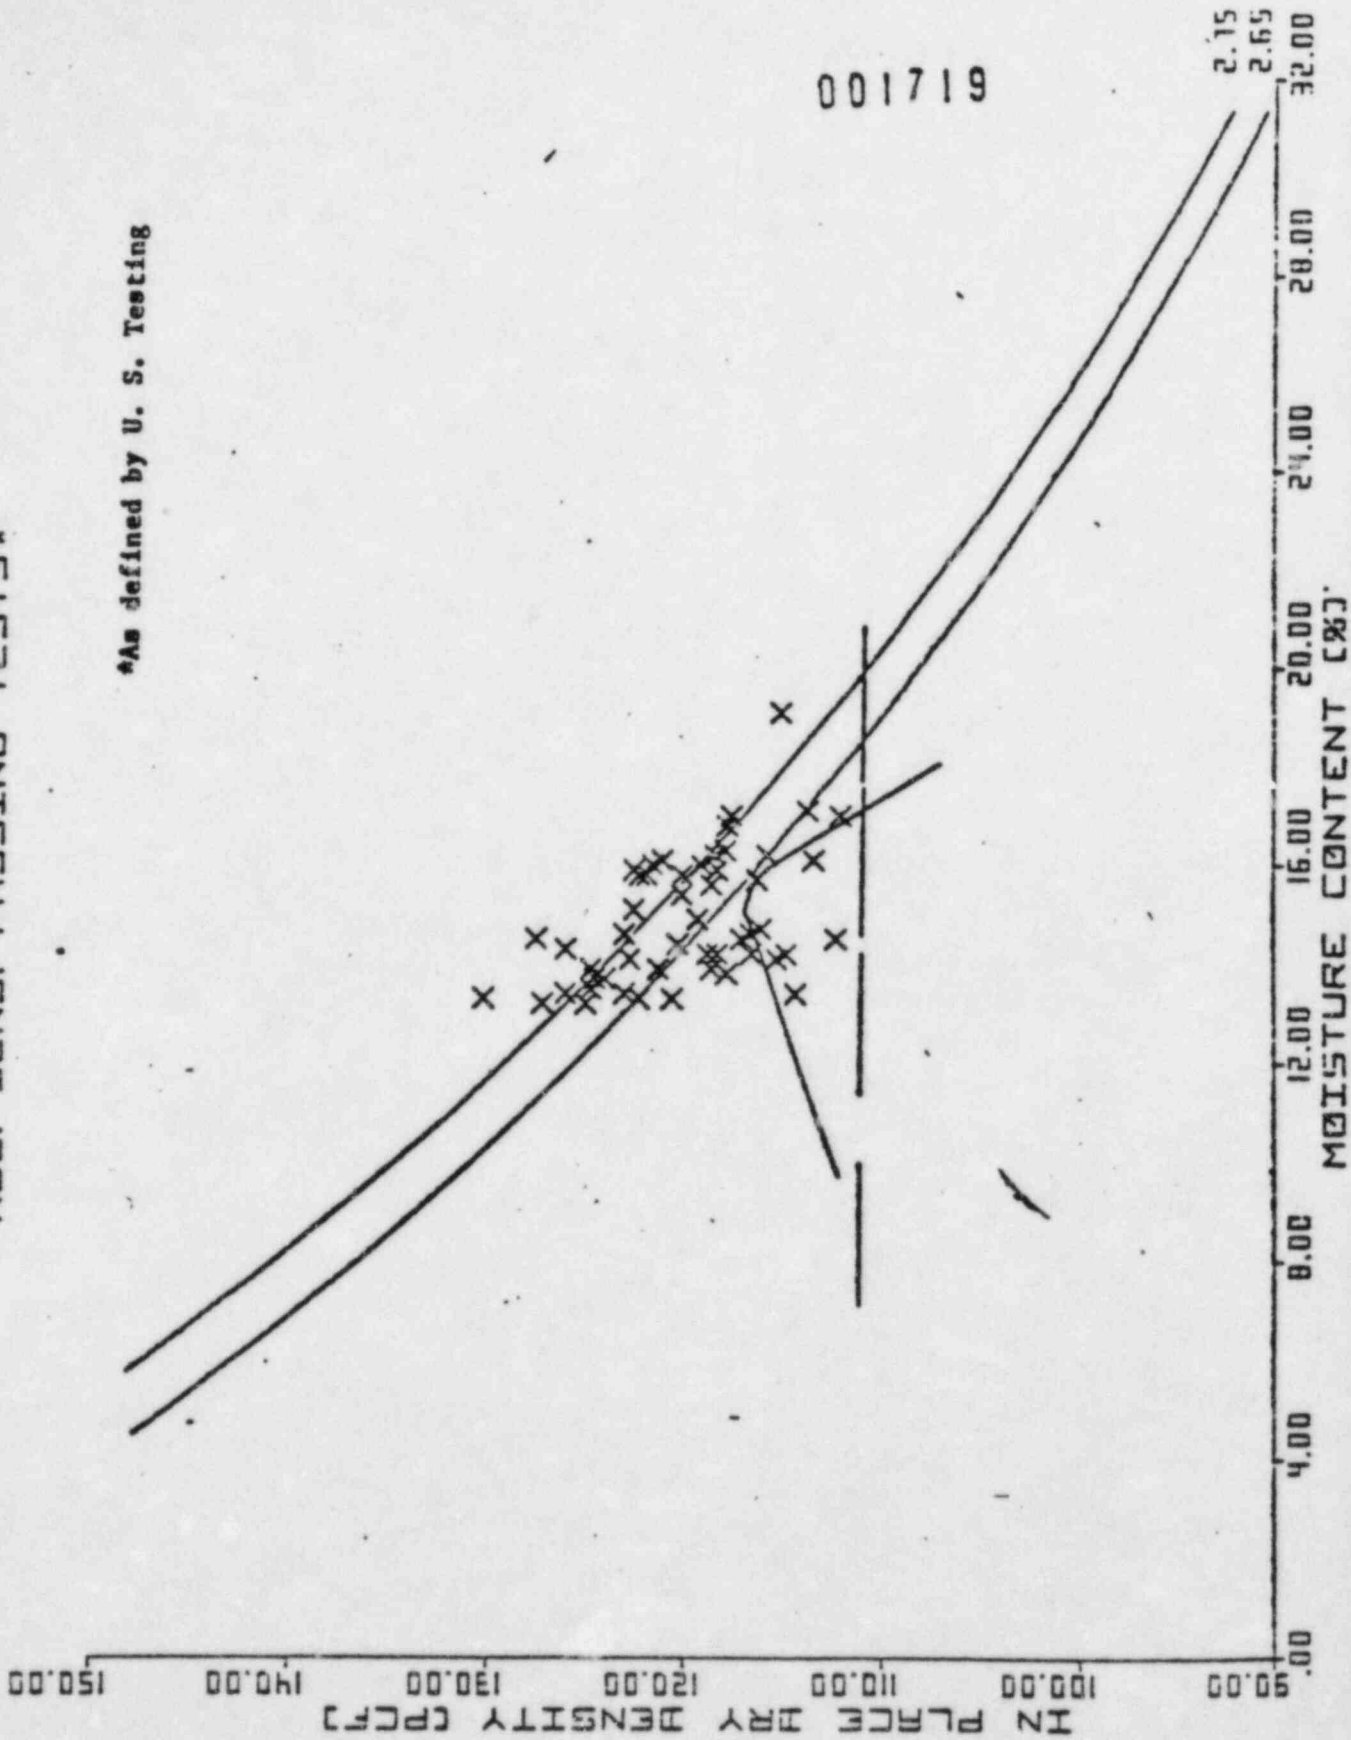
FIGURE 5

SPECIFIC GRAVITY = 2.65
 NUC. DENS. PASSING TESTS*

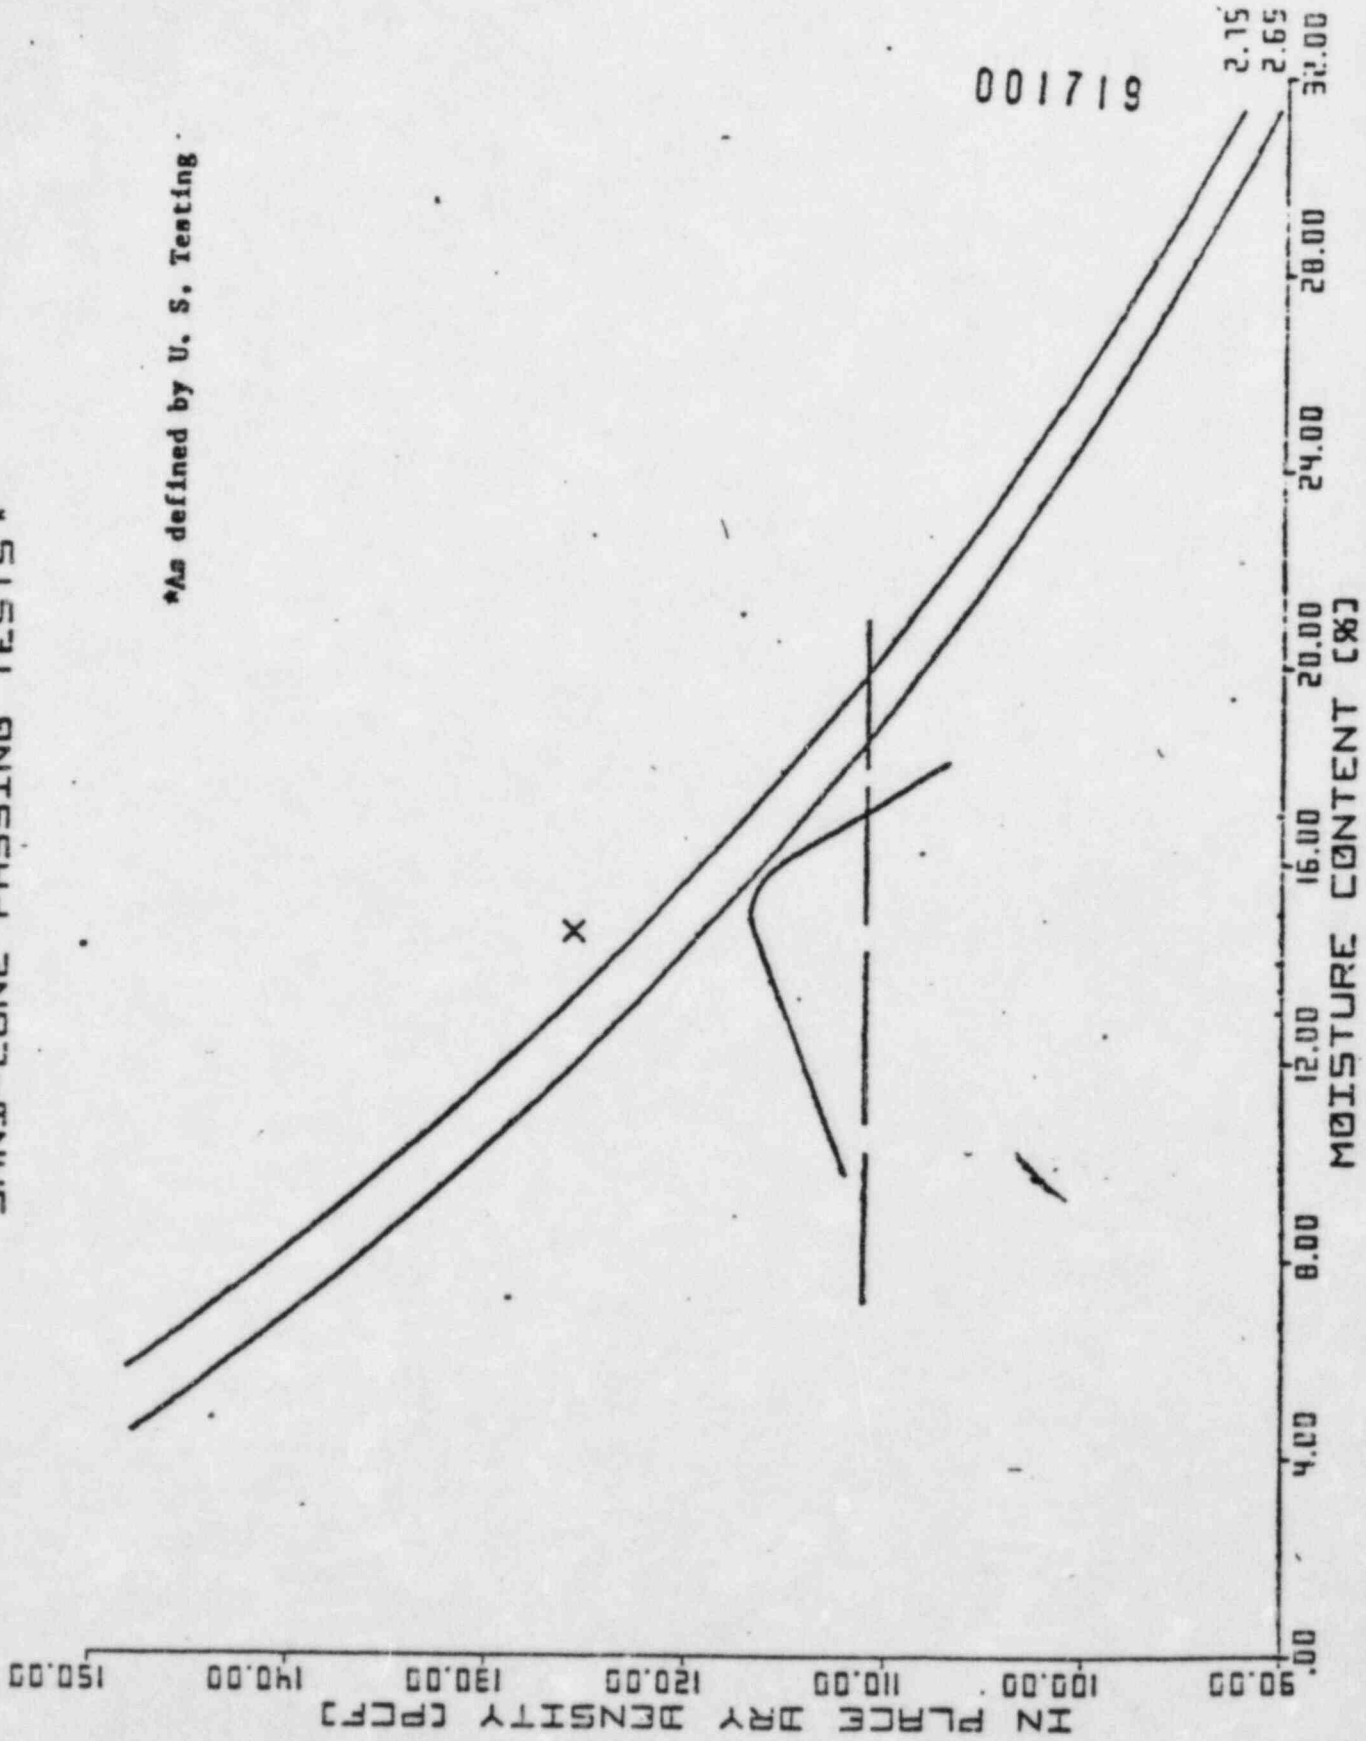
FIGURE 6

MOISTURE-DENSITY FOR BMP 278
 SPECIFIC GRAVITY = 2.65
 SAND-CONE PASSING TESTS*

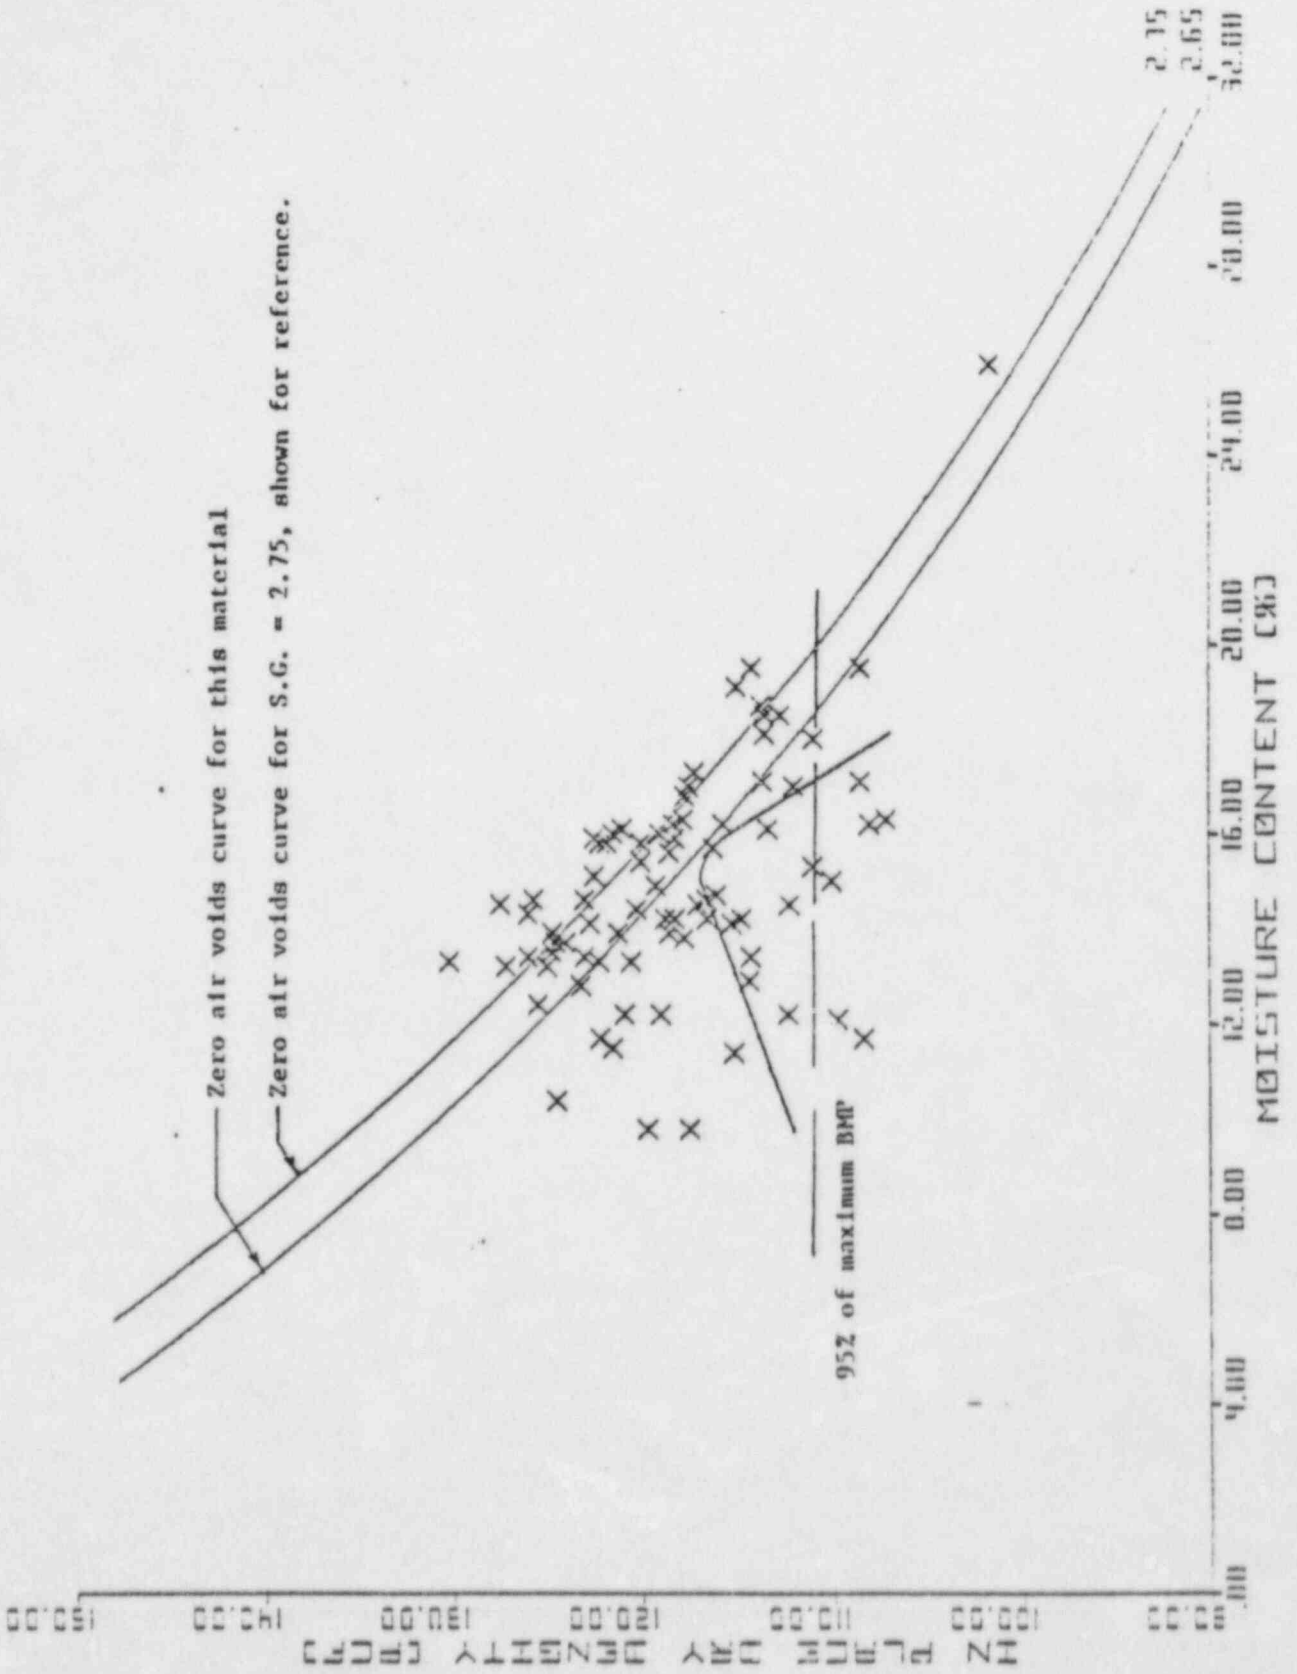
FIGURE 1

Also, referring to Figure 1 it would appear that soil density varied widely. Specifications called for compactive effort results as defined by ASTM D 1557 which is 56,255 ft-lb/ft³ energy. This was modified to a laboratory test compactive effort of about 20,000 ft-lbs/ft³ energy, often referred to as Bechtel Modified Proctor (BMP). Laboratory compaction test curves should be related to the same effort as that called for in the field for use in comparing with field density tests. According to plots of field data shown on Figure 1, density varied from about 108 lbs/ft³ to about 130 lbs/ft³. It is doubtful that the soil classification or other properties would be similar for such a wide variation in density. It is noted that 100 percent of modified Proctor (ASTM D 1557) which is difficult to obtain, is rated at 56,255 ft-lbs/ft³ energy. The curve plotted on Figure 1 is at about 20,000 ft-lbs/ft³ energy. For comparative purposes it was determined by U. S. Testing in 1974 that 100 percent of specified effort (20,000 ft-lbs/ft³) is approximately equal to 95 percent of the maximum density as determined by ASTM D 1557 (56,255 ft-lbs/ft³) Reference Figure 8. This means that a density up to 5 percent greater (dry density of 123.2 lbs/ft³) than that specified (dry density of 117.0 lbs/ft³) could be possible. However, some points shown on Figure 1 give an apparent density up to 11 percent above that specified.

MOISTURE DENSITY FOR GMP 278
 SPECIFIC GRAVITY = 2.65
 ALL TESTS

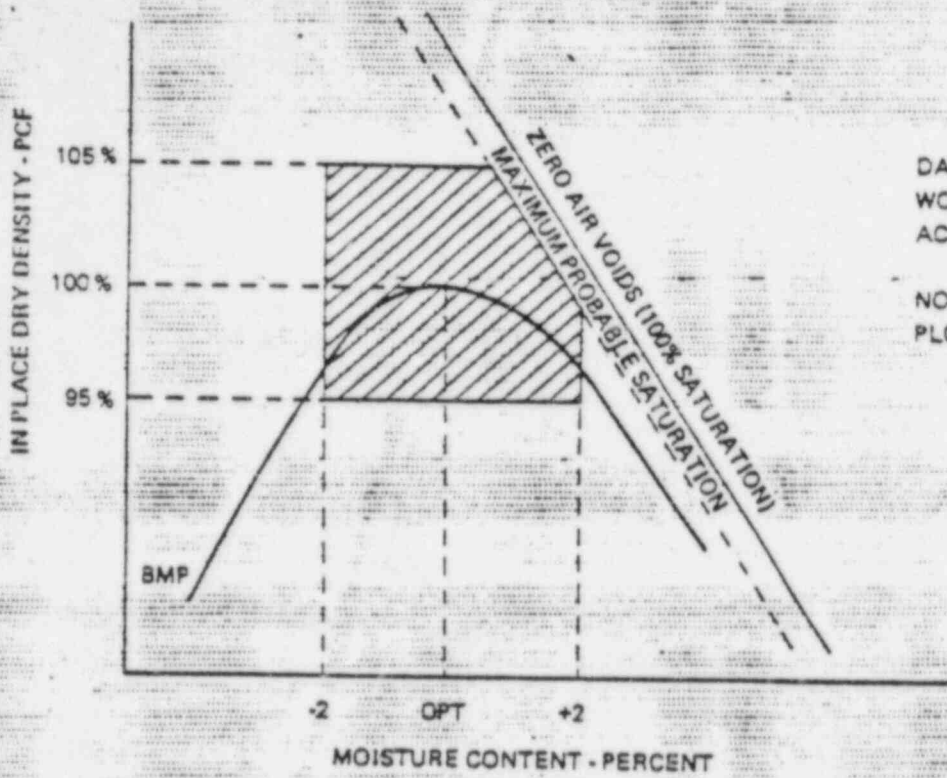
FIGURE 7-A-

DATA POINTS THAT PLOT IN SHADED AREA WOULD BE GENERALLY ACCEPTABLE ACCORDING TO SPECIFICATIONS

NOTE: ABOUT 25% OF ALL FIELD DATA PLOTS IN THE SHADED AREA

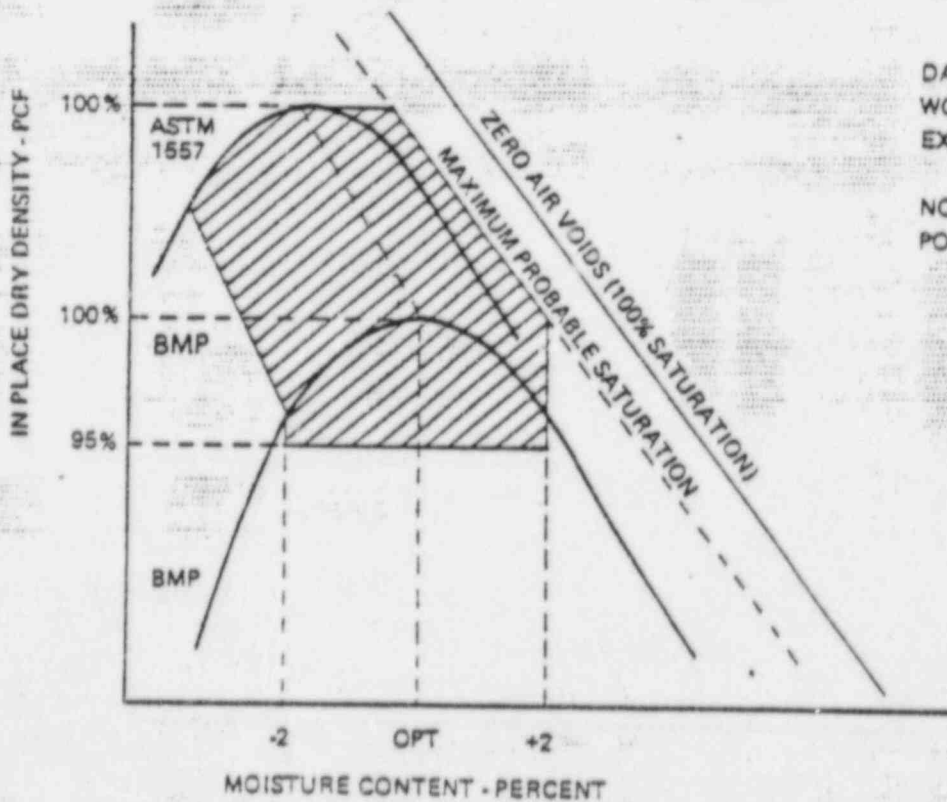
DATA POINTS THAT PLOT IN SHADED AREA WOULD BE ACCEPTABLE REGARDLESS OF EXACT SPECIFICATION WORDING

NOTE: ABOUT 40% OF ALL FIELD DATA POINTS PLOT IN THE SHADED AREA

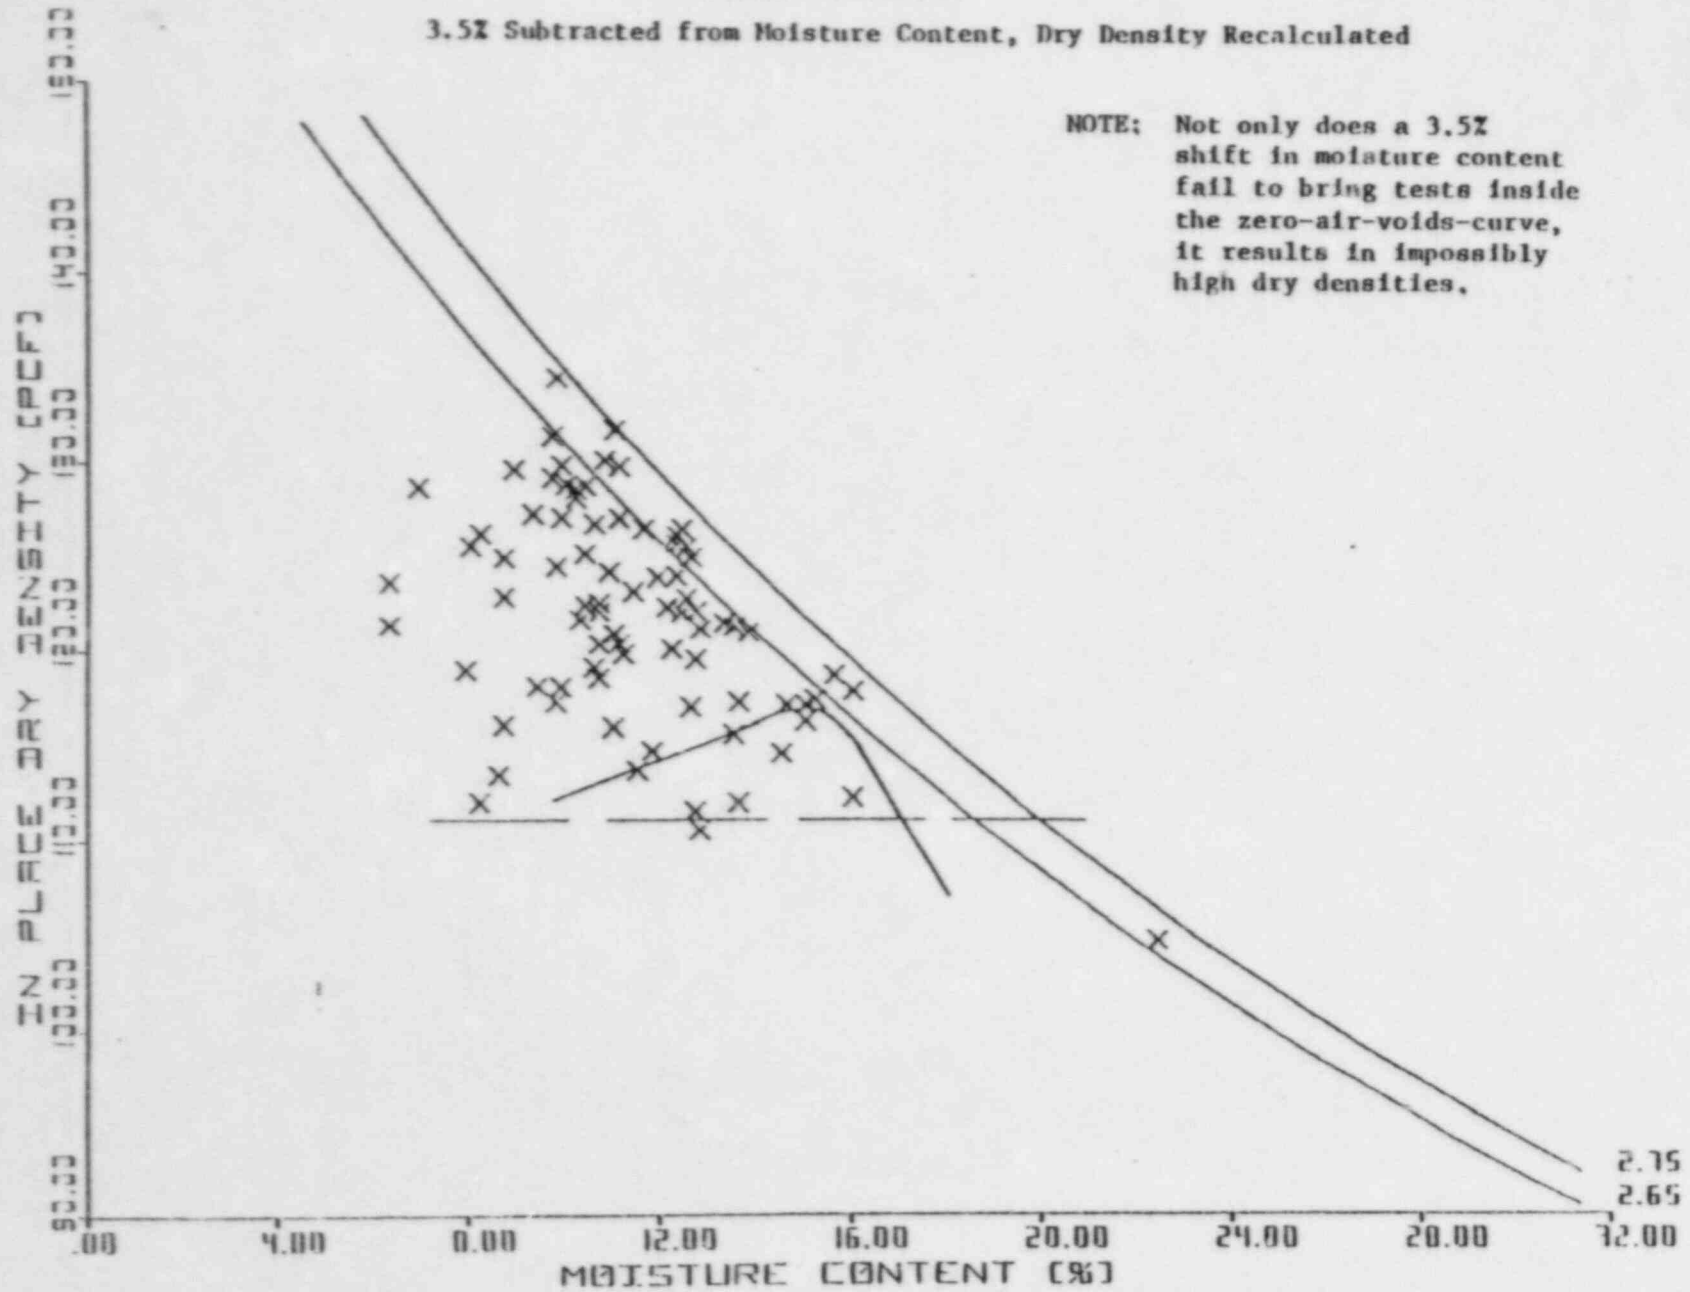
FIGURE 9

Contrary to the assumption regarding figure 9 with its "impossibly high dry densities" current test data closely resembles this graphical representation.

In a letter from U. S. Testing to Bechtel (dated May 30, 1974), the average deviation of the nuclear device from oven-dry moistures was +.12% for a set of 30 tests. However, the standard deviation is 1.77% for the data with the range of differences being from - 3.2% to +3.9%. Thus, accuracy of the nuclear device is questionable, and could translate into errors of roughly ± 4 pcf in the dry density calculation. (It should be noted that errors in the moisture content tend to shift the position of test results on a moisture density plot approximately parallel to the zero air voids curve, assuming the in-place wet density is correct, and thus do not explain the large number of points which plot outside this limit. See Figure 9).

3.5% Subtracted from Moisture Content, Dry Density Recalculated

NOTE: Not only does a 3.5% shift in moisture content fail to bring tests inside the zero-air-voids-curve, it results in impossibly high dry densities.

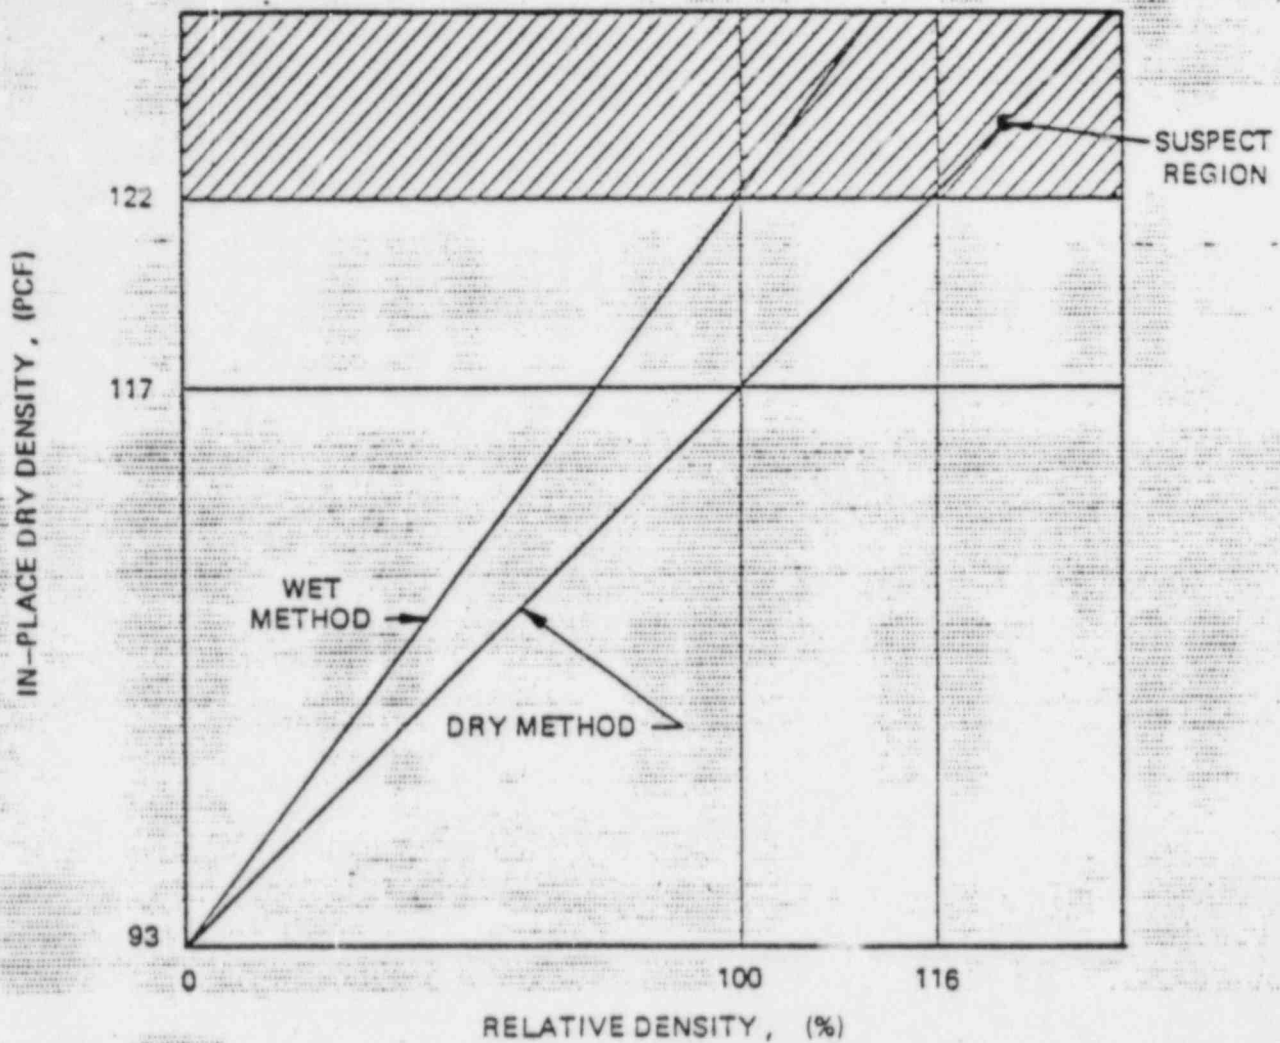
FIGURE 10
 CHANGE IN RELATIVE DENSITY SCALE FROM DRY TO WET METHODS
 OF OBTAINING MAXIMUM DENSITY, BASED ON: RECENT LAB RESULTS

a radical change of materials occurs, the maximum density test should be performed on both wet and dry soil to determine which method results in the higher maximum densities, (in excess of one percent) it shall be followed in succeeding tests." An example of wet and dry relative density is shown on Figure 10. U. S. Testing Company did not do this. As a consequence many field density test results exceed 100 percent of maximum dry laboratory relative density. As an example, for laboratory test RD55 a total of 566 field tests were made. Of this total, 364 tests showed greater than 100 percent compaction. The highest relative density found was 142.2 percent with the majority of tests over 100 percent falling in the range of 100 percent to about 130 percent. Since the difference in maximum density between wet and dry methods is about 4 to 5 lbs/cu. ft. (based on recent data) any test result greater than about 115 percent (based on the dry method) is suspect.

NOTE: VALUES FOR DRY DENSITY ARE TYPICAL OF A RANDOM FILL SAND. ANY TESTS SHOWING MORE THAN 117% RELATIVE DENSITY WOULD BE SUSPECT IN THIS EXAMPLE. STRUCTURAL SANDS TEND TO SHOW ONLY 2 OR 3 PCF INCREASE IN MAXIMUM DENSITY AND THUS RESULTS AT MUCH LOWER RELATIVE DENSITY WOULD BE SUSPECT, SAY 105 - 110 PERCENT

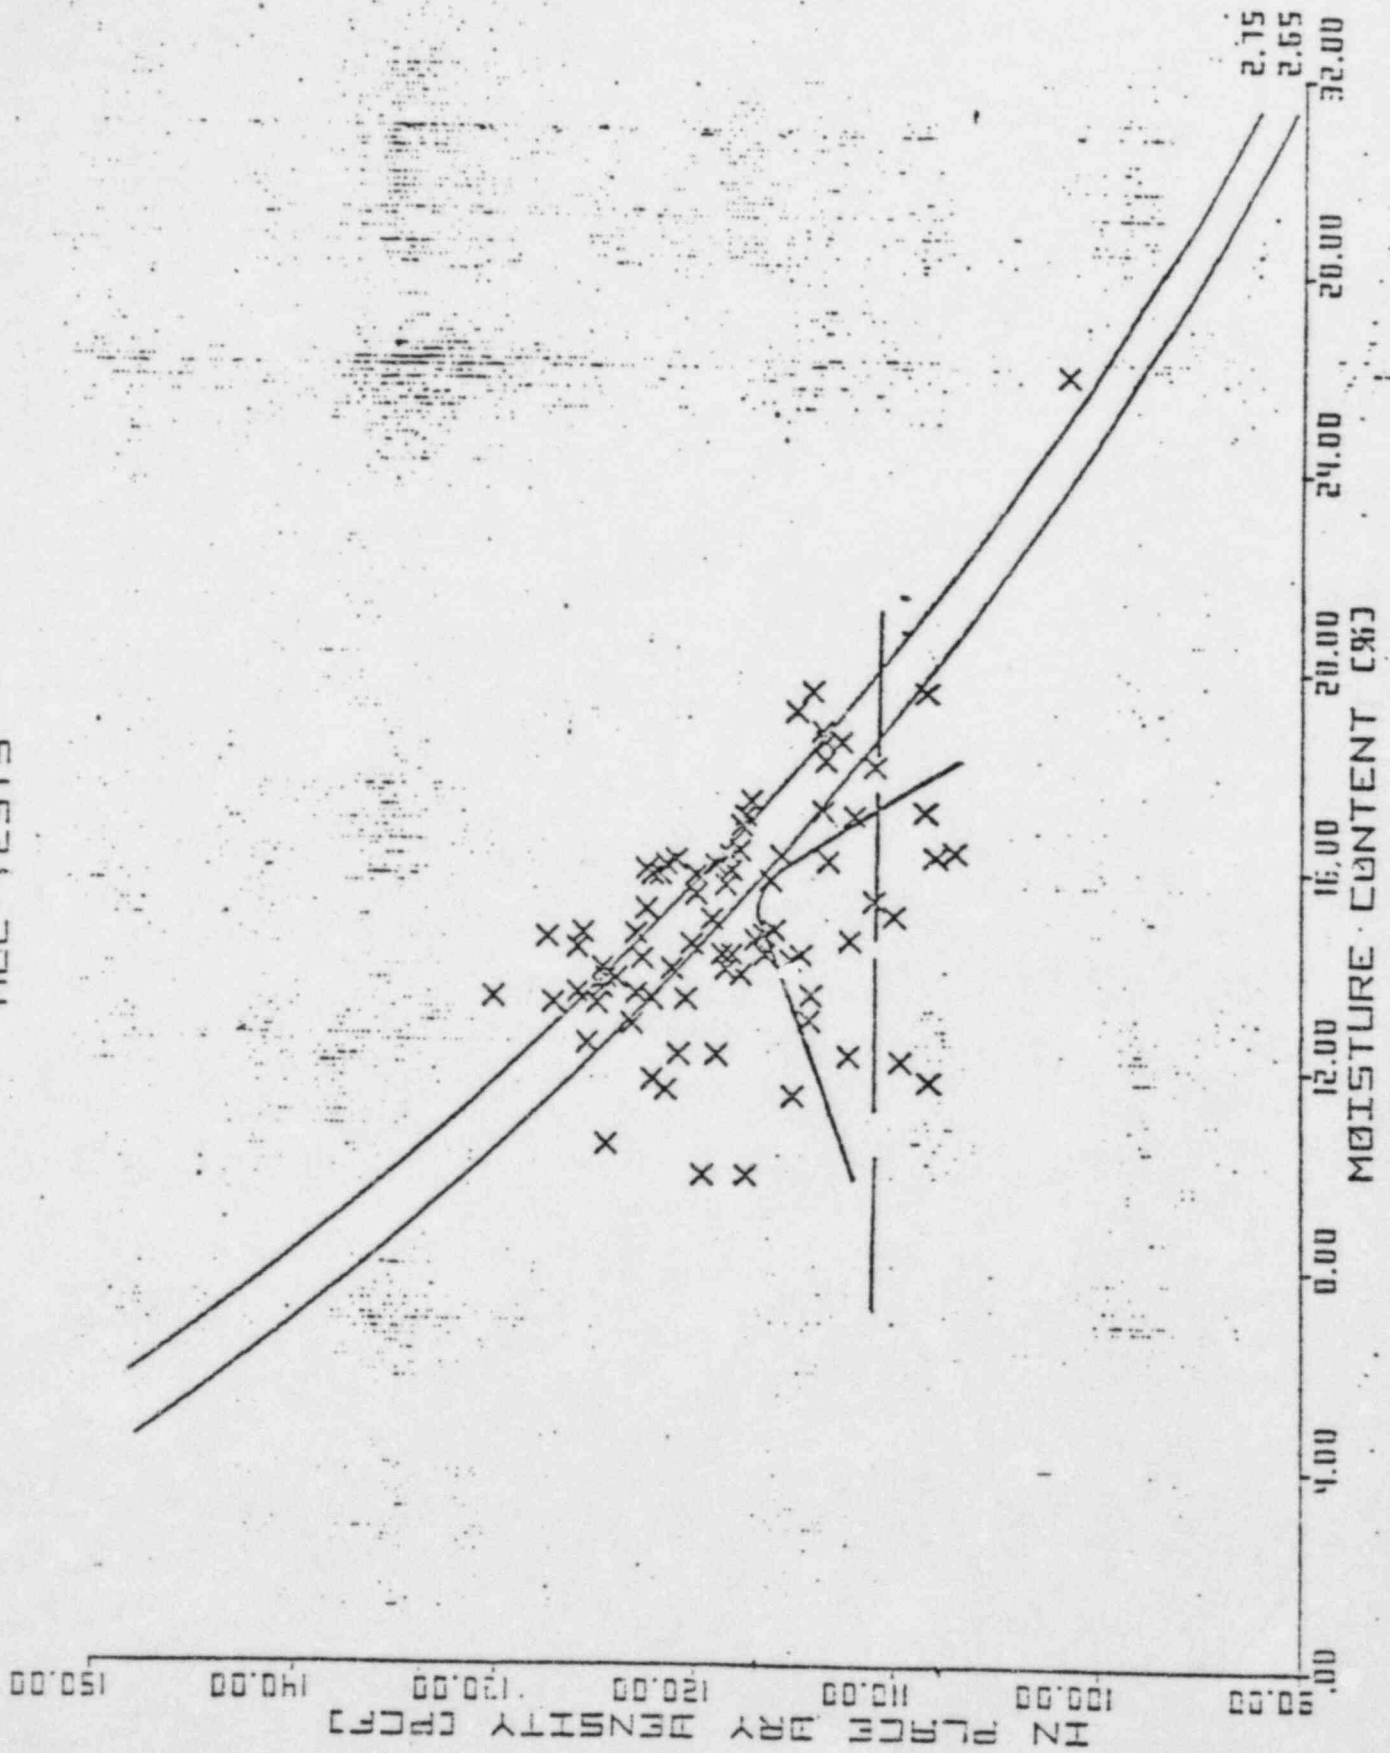
FIG. 81

8. For the first month (4/77) all BMP 278 tests fell on or outside the zero air voids curve. For the next month, over half the tests did the same, or have greater than 105% compaction. The standard was used over half a year, with 43 out of a total of 82 tests outside the zero air voids curve.

MOISTURE-DENSITY FOR BMP 278
 SPECIFIC GRAVITY = 2.65
 ALL TESTS
